USAARL REPORT NO. 72-07

DYNAMIC AND CRASHWORTHY EVALUATION
OF THE UH-1B, C, D, H, MEDICAL ATTENDANT'S SEAT

January 1972

U. S. ARMY AEROMEDICAL RESEARCH LABORATORY

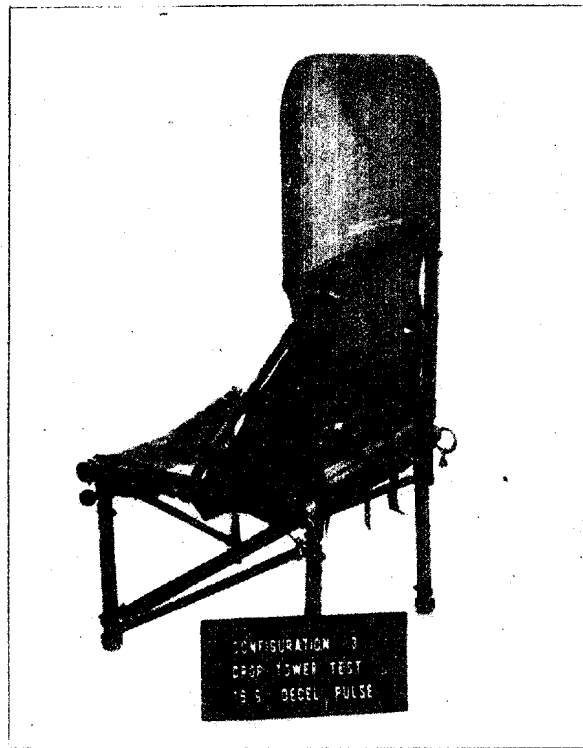
Post-test inspection revealed seat failure in four places. The seat front lateral cross tube failed in the center at a 1/8-inch diameter hole where a screw fastens the seat canvas to the structure, the seat right front corner joint pulled out, the seat back tube failed on the left side at the back brace tube, and the canvas seat also failed. Figure 26 shows a post-test seat side view. Peak dummy chest vertical deceleration was 23.8G. The pelvis experienced a very high vertical deceleration of 40G. (See Figures 24 thru 31.)

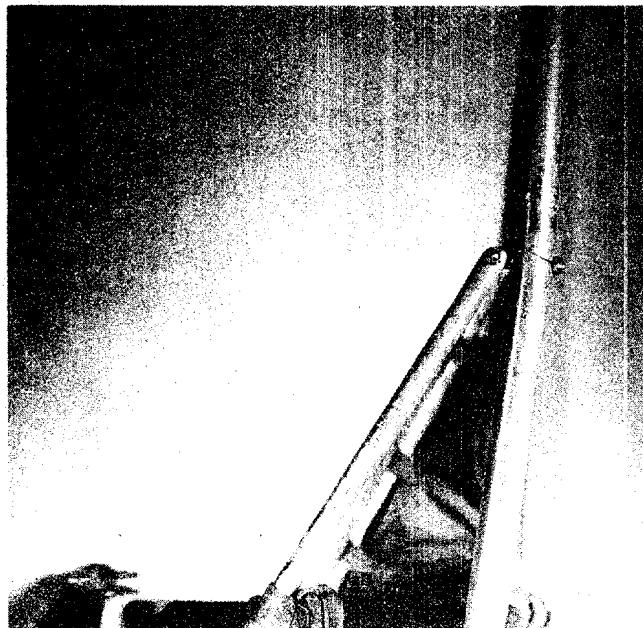
Figure 27. Closeup of Seat Back Failure
Slip-out of Joint in Background.

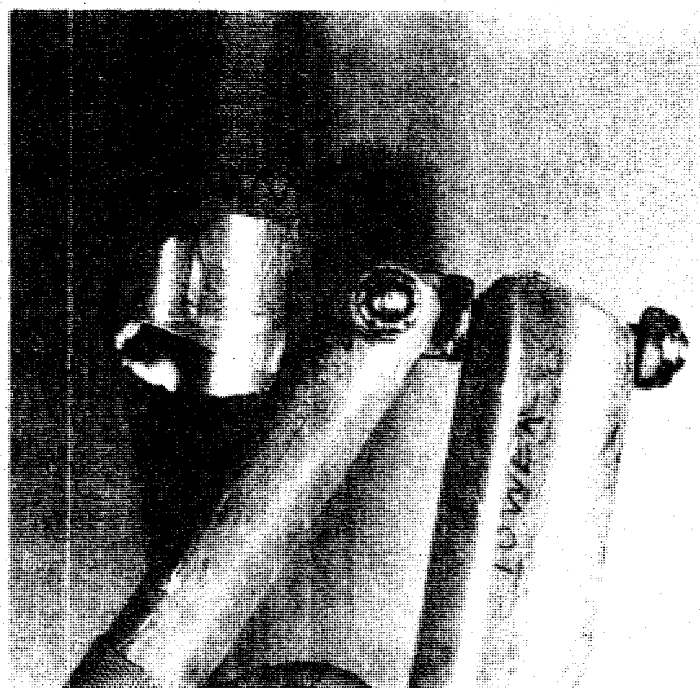
Figure 29. Closeup of Failed Seat Back

Figure 30. Closeup, Seat Back Failure

From the nature of the failure it is obvious that the aluminum seat back is very brittle in nature. The support tube pin served as a pivot about which only 150 + ft-lbs were necessary to fail the notch-sensitive tube.

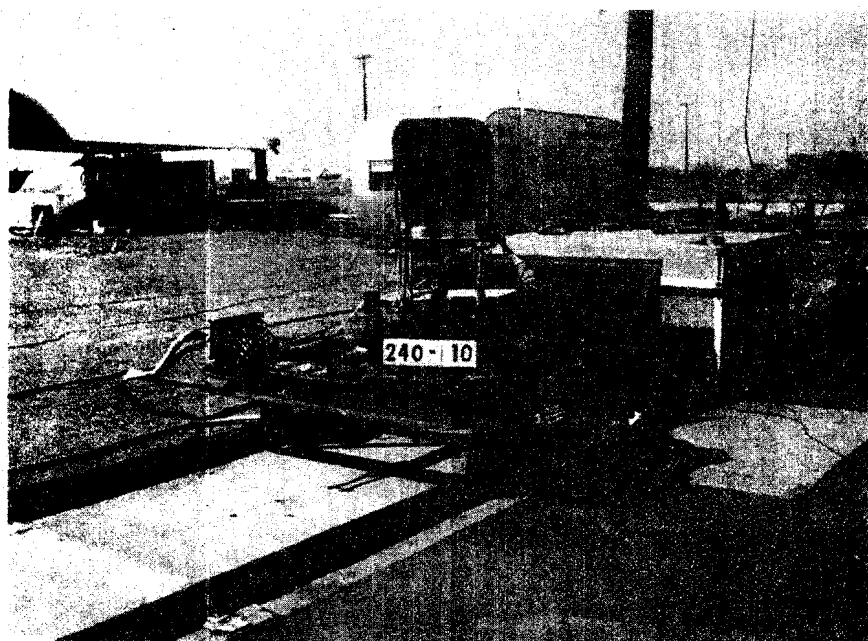
Figure 36. Post-test Position of Dummy in Test 10.

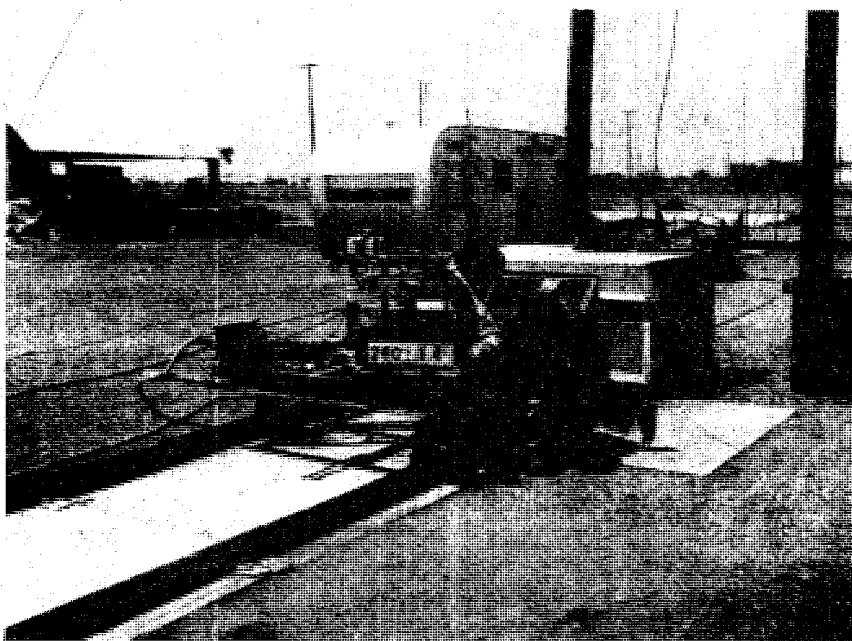
Post-test inspection revealed four failures as shown in Figures 42 thru 44. The seat back tube failed at the back brace tube bolt holes, the left lap belt ring weld failed, the right front seat joint started to pull loose, and the seat canvas failed. The dummy moved out of the seat and onto the left side of the sled; however, the dummy and instrumentation were not damaged. (See Figures 41 thru 44.) The maximum dummy deceleration was measured in the chest and was 13.9G in the vertical direction.

Figure 42. Post-test Position of Dummy After Test 14.

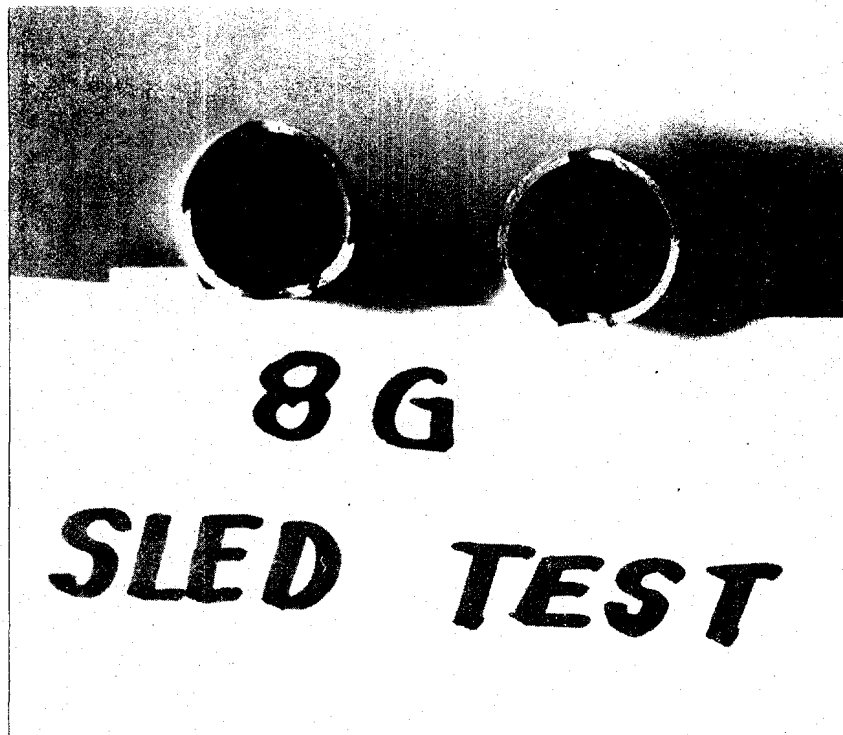
Figure 44. End View of Failed Seat Back Tubes.

The picture in Figure 44 shows an end-to-end view of one of the failures of the seat back tube.

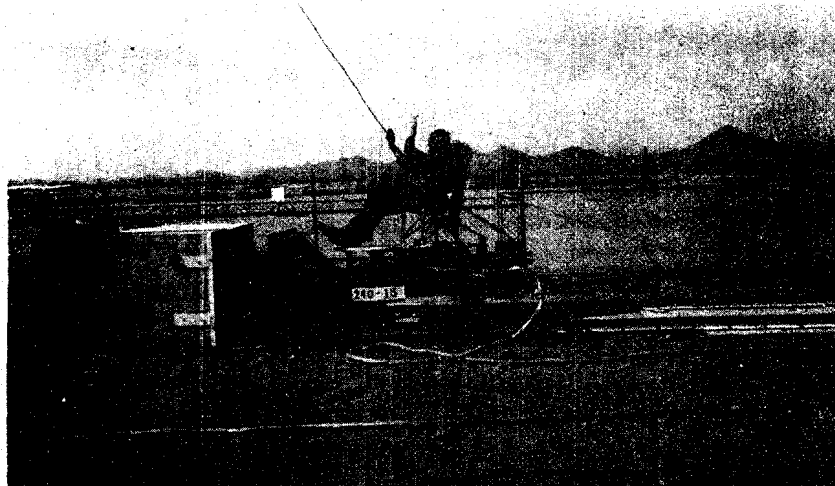
Post-test inspection revealed four failures or incipient failures. The right and left side longitudinal seat tubes failed at the back brace tube joints (shown in Figures 47 and 50), the left side steel seat back tube was bent at the stiffener, the left side back brace tube was bent, and the male tangs on the upper end of all four leg assemblies were bent. The leg fittings were probably bent as a result of load shifting after failure of the longitudinal seat tubes. (See Figure 49) The maximum deceleration measured in the dummy was 8.91G in the longitudinal direction in the pelvis.

Figure 46. Seat Configuration 4 After Test 15.

Figure 47. Failed Longitudinal Seat Tubes Sustained in Test 15.

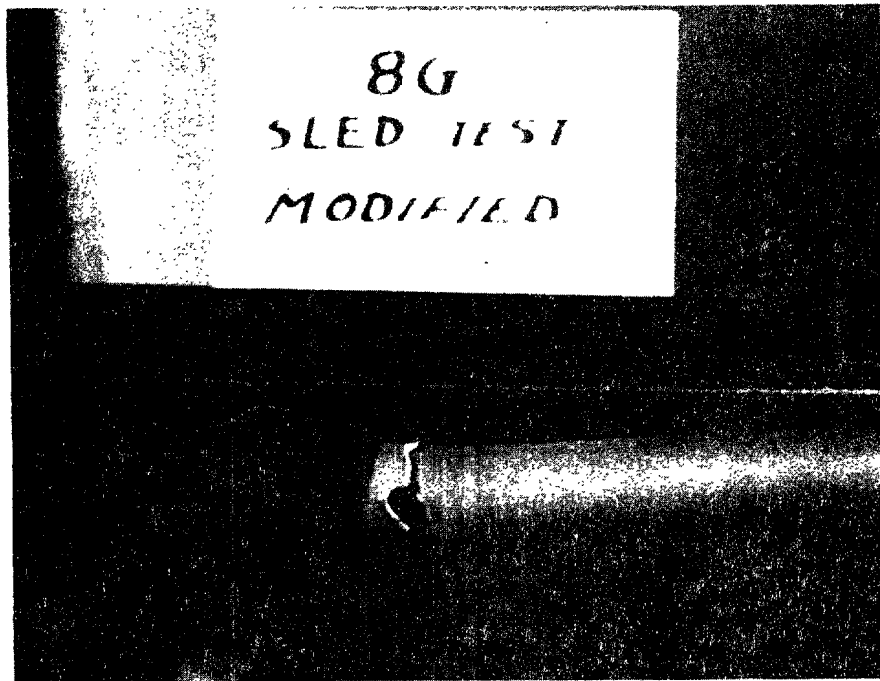
Figure 50. Closeup Longitudinal Frame Failure

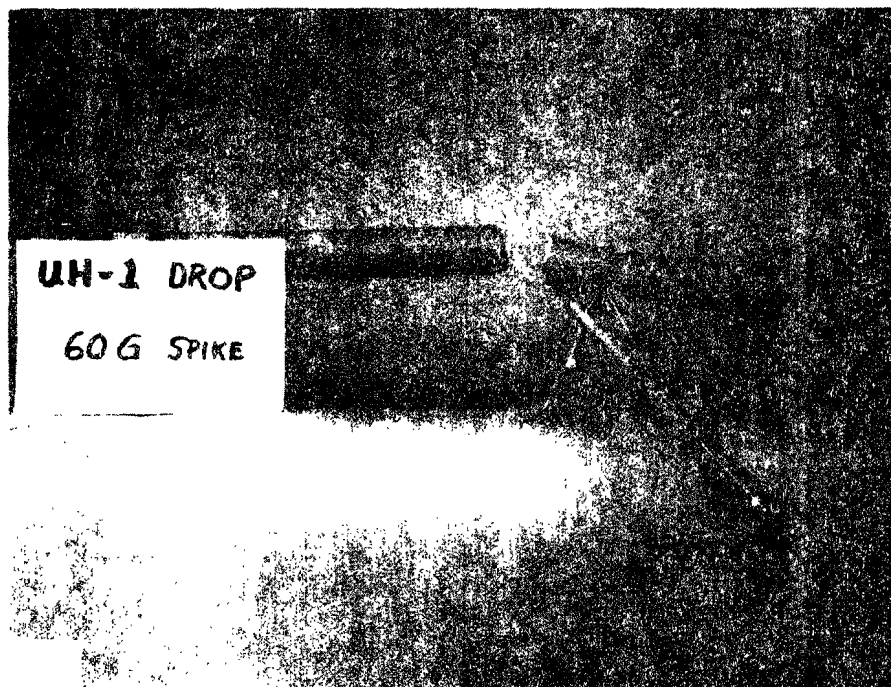
Figure 53. Closeup of Front Cross Tube.
Note Break Through Screw Hole.
