LETTER REPORT

Supplement to Technical Note N-1032, July 1969

EFFECTIVENESS OF ZINC COATING ON REINFORCING STEEL IN CONCRETE  
EXPOSED TO A MARINE ENVIRONMENT

Naval Civil Engineering Laboratory  
Port Hueneme, California 93041

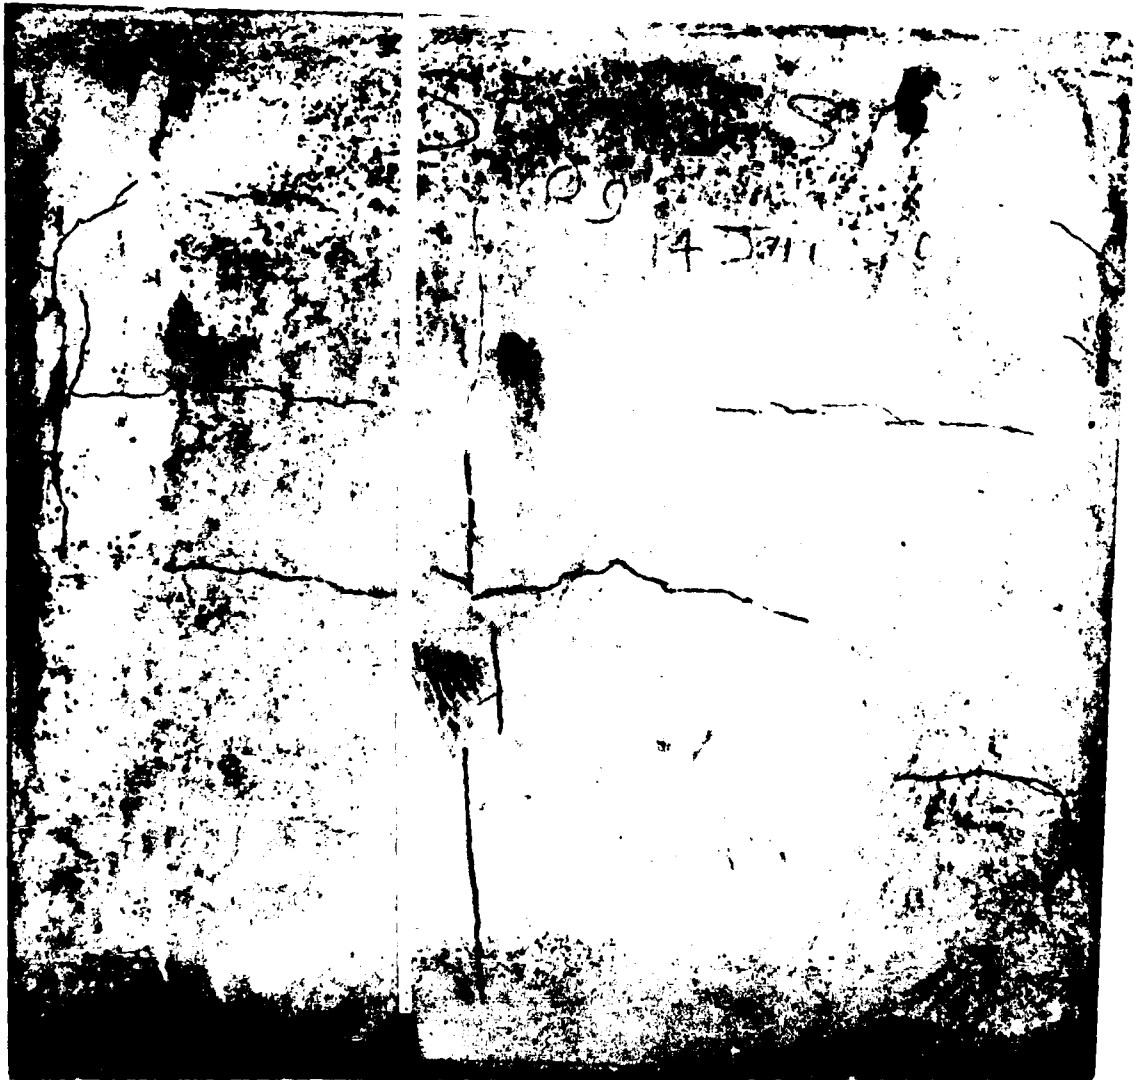
Figure 1. Sea side (South face) of wall No. 109.

Wall 109 destroyed 16 Jan 1970 with the following observations:

Cracking - See Figures 1, 2, and 3. Cracks generally are opposite steel bars.
