CONDITION SURVEY, ROBERT GRAY ARMY AIRFIELD, FORT HOOD, TEXAS

P. J. Vedros

April 1968

CONDITION SURVEY, ROBERT GRAY ARMY AIRFIELD

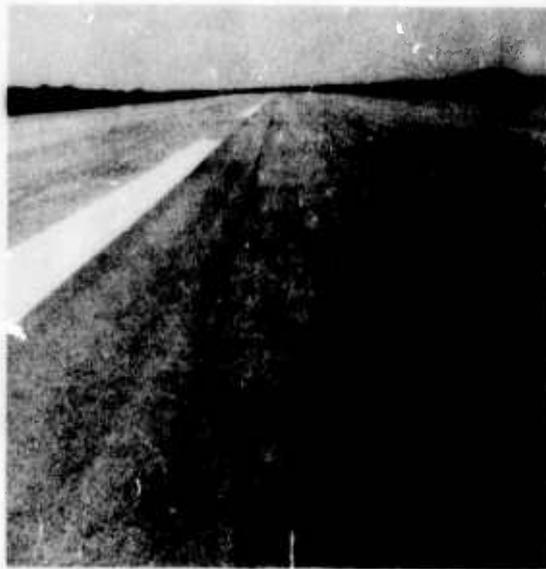
8. In June 1967, the condition of the pavement surface ranged from excellent to poor. The section of the runway reconstructed in 1965 (sta 56+00 to 75+00) was in excellent condition (photograph 1). The section of the runway that was reconstructed in 1963 (sta 75+00 to 90+00) was in good condition, but there was evidence of random cracking and opening of the longitudinal paving joints (photograph 2). About 90 percent of the takeoffs originate from this section of the runway. The remaining flexible pavements contained numerous cracks, with the cracking most pronounced on the taxiway leading to the northwest end of the runway and on the northwest end of the

Photograph 1. Runway from sta 56+00 to 75+00, 1965 reconstruction area, is in excellent condition; June 1967

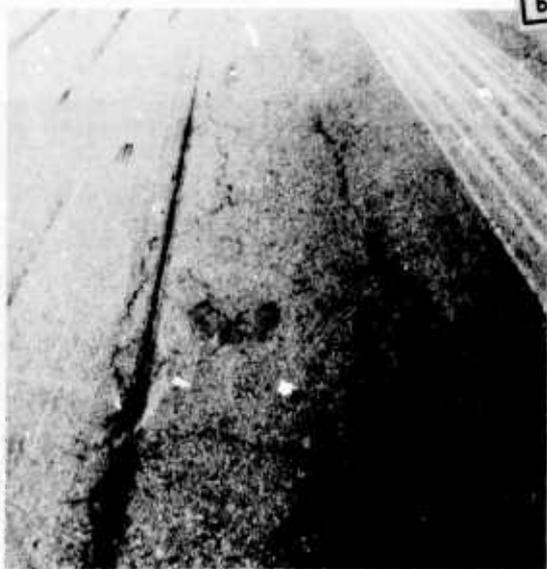
a. Random surface cracking

Photograph 2. Runway from sta 75+00 to 90+00; June 1967

- b. Maintenance in the form of crack sealing should be performed in the area from sta 75+00 to 90+00 to prevent infiltration of water into the base course. The base course contains an excessive amount of fines (approximately 15 percent passing -200 mesh) and will decrease rapidly in strength with an increase in moisture.

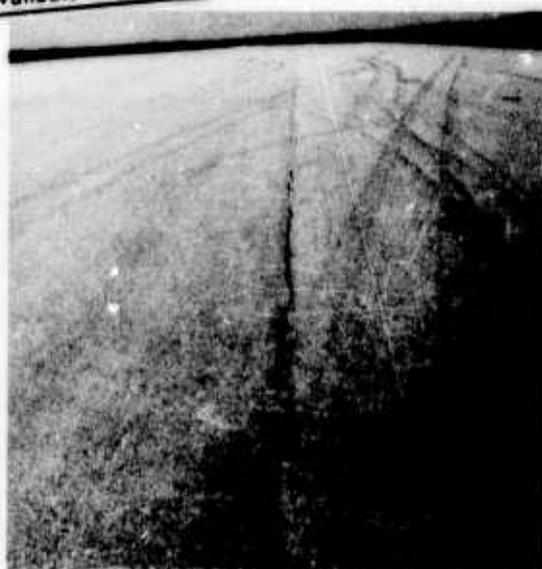
b. Opening of longitudinal joints

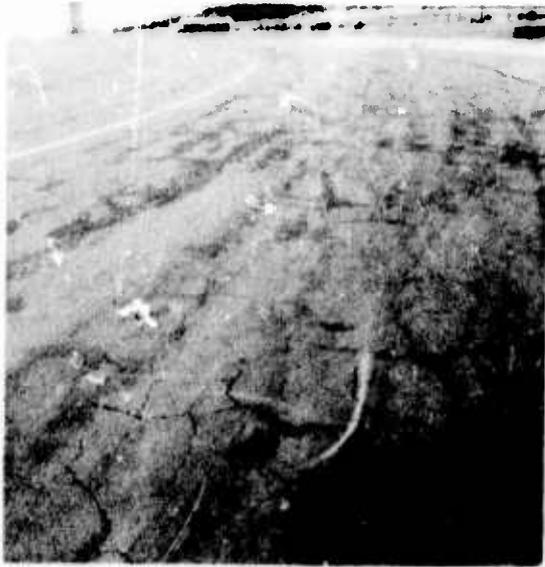
runway (photograph 3). The cracking appeared to have increased since the inspection made by the U. S. Army Engineer Waterways Experiment Station (WES) in 1964, and there was evidence of slight deformation associated with the cracking.

a. Taxiway leading to northwest end of runway

Photograph 3. Areas of pronounced surface cracking

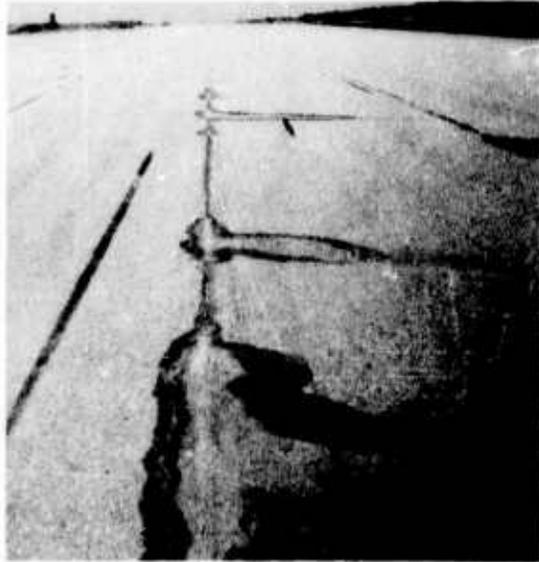
9. As described in the report of the 1964 inspection (reference paragraph 5c(2)), a seepage problem exists at this field. During certain periods, free water seeps through cracks in the pavement and puddles on the surface. Cracks have developed in the runway pavement in the area between sta 75+00 and 90+00 since the evaluation made by the WES in 1964. Seepage puddles have been observed in this area (photograph 4). There was no water standing on the pavement at the time of the current inspection, probably due to drouth conditions, but stains surrounding the cracks indicated that it had done so in the past.

Photograph 4. Evidence of water seepage in the vicinity of sta 85+00

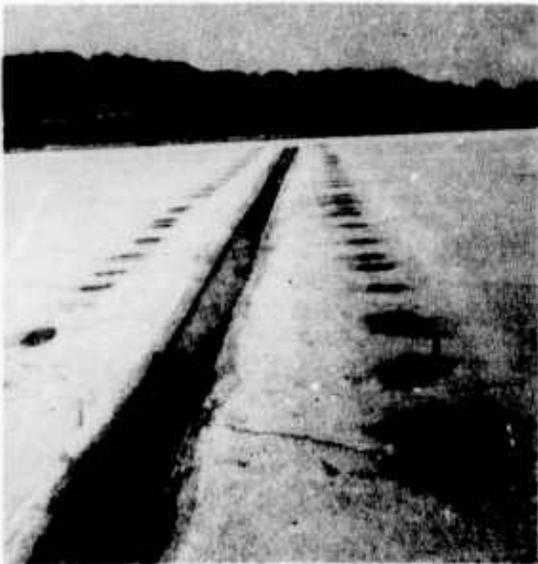
10. In an attempt to eliminate seepage in this area, the Post Engineer has installed a series of subsurface drains (photograph 5). Locations of the drains are shown in plate 3. It was reported that these drains are functioning and helping to keep the pavement relatively dry. The subsurface drains were installed at the time that the area from sta 56+00 to 75+00 was reconstructed. Layout of the drainage system is shown in plate 3.

a. Installation on east side of runway from sta 84+00 to 88+40

Photograph 5. Subdrains installed to eliminate seepage

- c. The efficiency of the subsurface drainage system should be checked periodically by WES to determine if the system is removing excess moisture from the base course material. Permeability studies by WES on similar base course material obtained from the south parking apron indicated that the material is not free-draining, and drains would be ineffective in reducing the saturated condition of the base course.

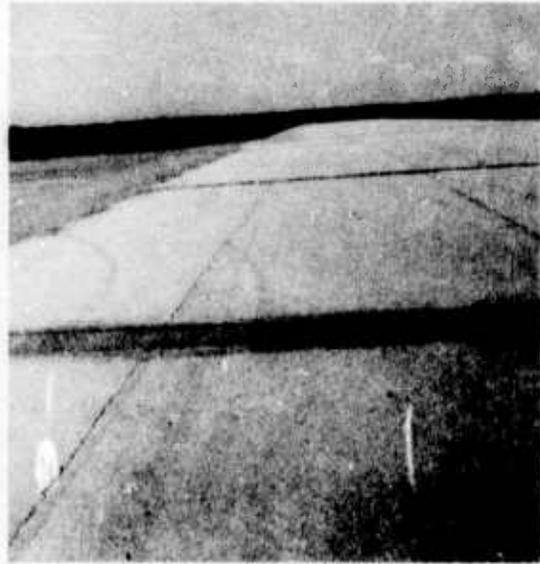
b. Installation on west side of runway from sta 88+40 to 90+00
