Special Report 170

**PRELIMINARY INVESTIGATIONS OF
PETROLEUM SPILLAGE ,
HAINES-FAIRBANKS MILITARY PIPELINE, ALASKA**

**Warren E. Rickard
and
Frederick Deneke**

April 1972

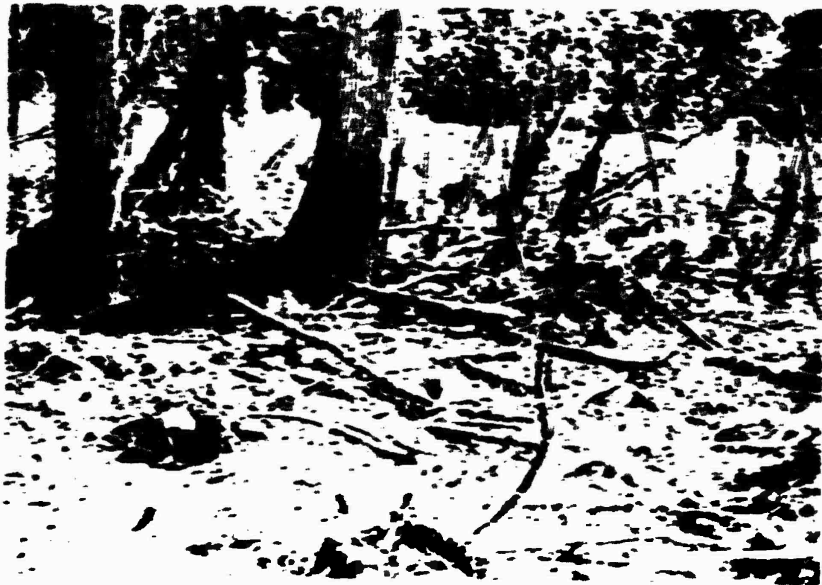
Figure A4. Closeup of interior of the cottonwood stand at MP 17.7 showing some willow and alder growing out from base of original trunk.

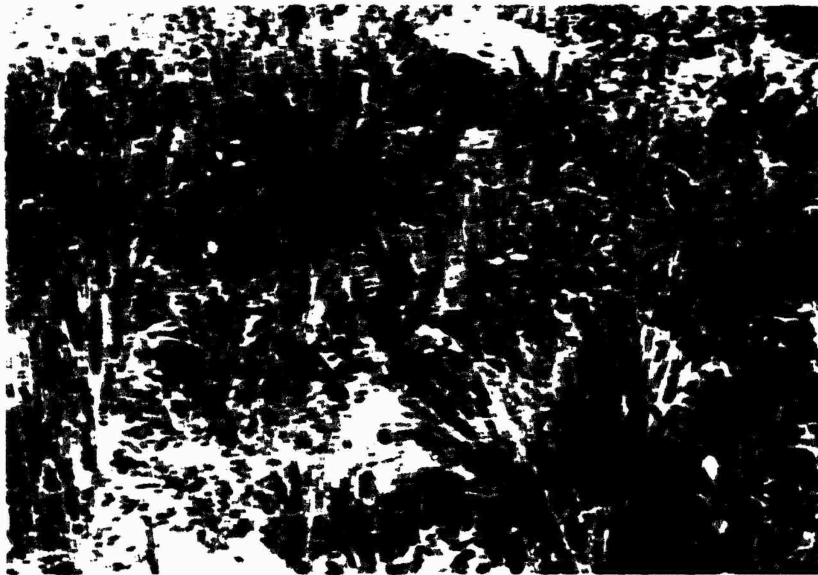
Figure A5. Control area adjacent to MP 17.7 with luxuriant growth.

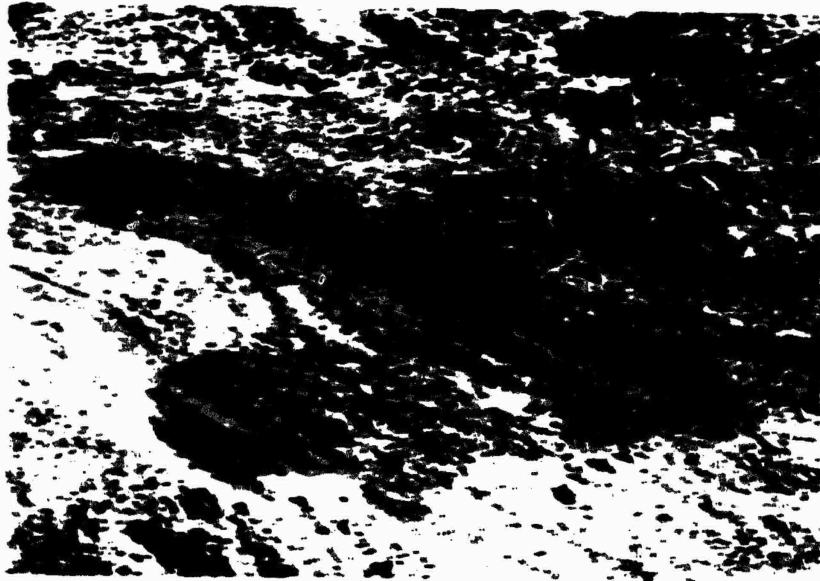
Figure A9. Fuel spillage on the surface of an access trail through the spill area at MP 119.1.

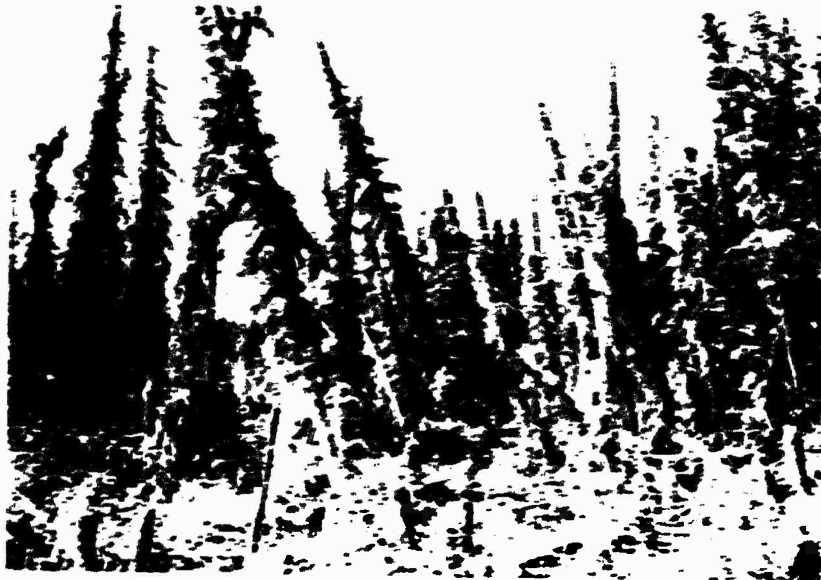
Figure A12. Looking upslope at MP 197.1 into kill area. Small spruce are growing in the cleared area at the base of the slope.

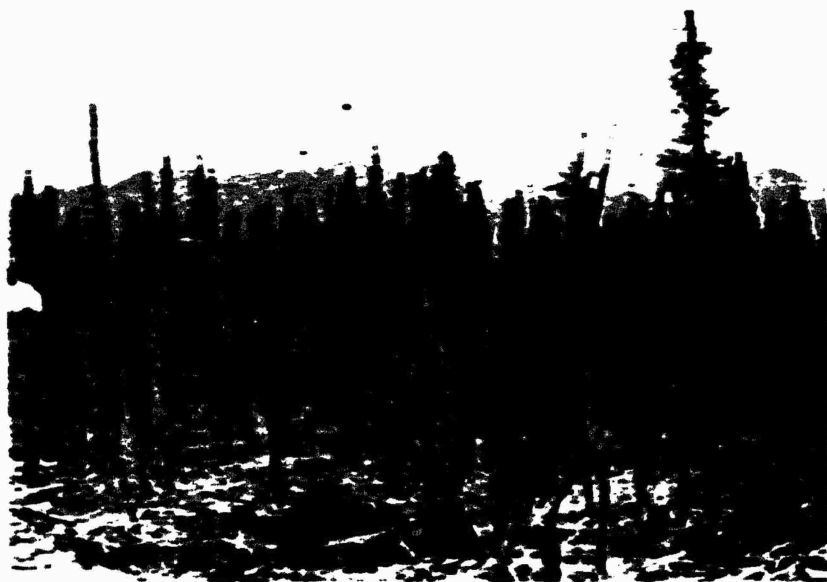
MP 207.6, 2 February 1956. This is a large area 200 feet wide near the pipe and forms an inverted V-shape 700-800 feet down a gentle slope. The area could be called a small watershed basin. Vegetation is completely lacking in the center of the main spill area. Three soil pits were placed in the kill area and on the fringe. Odors of petroleum were present in all three with the soil frozen at 20 cm.

Figure A13. View of 1936 line cuts at MP 207.6.

Figure A14. View of 1936 line cuts at MP 207.6.

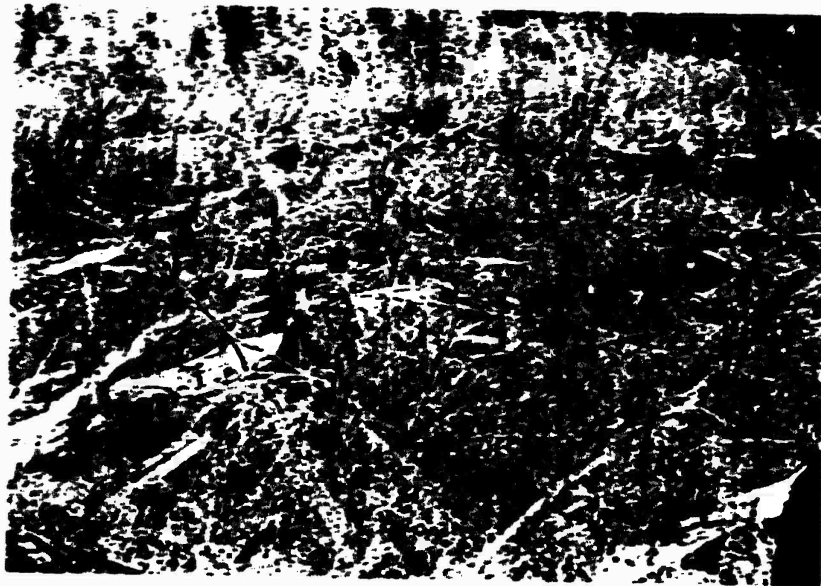
Figure A17. The interior of the MP 217.1 spill is covered with considerable recent growth.

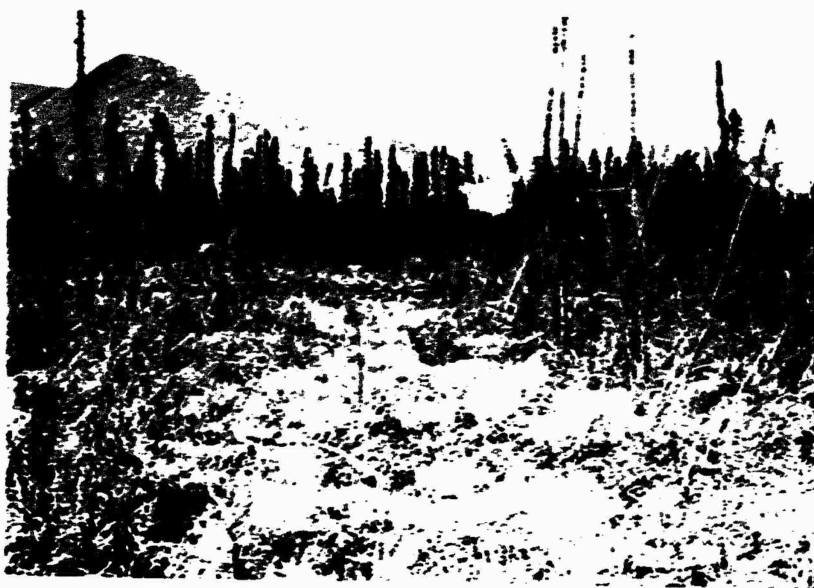
MP 273.2, 29 February 1956. This is a rather large spill area at least 250 feet in diameter. The pipe was purged into a small drainage area on the 1-2° slope. All vegetation, of which black spruce predominates, was apparently killed at the time. The main drainage area now has vegetation growing in it. However, in those areas not directly in the drainage basin no vegetation has yet become established. A soil pit was placed in both living and dead areas.

Figure A18. A spill at 273.2 has little new growth except in the drainage basin that traverses the area.

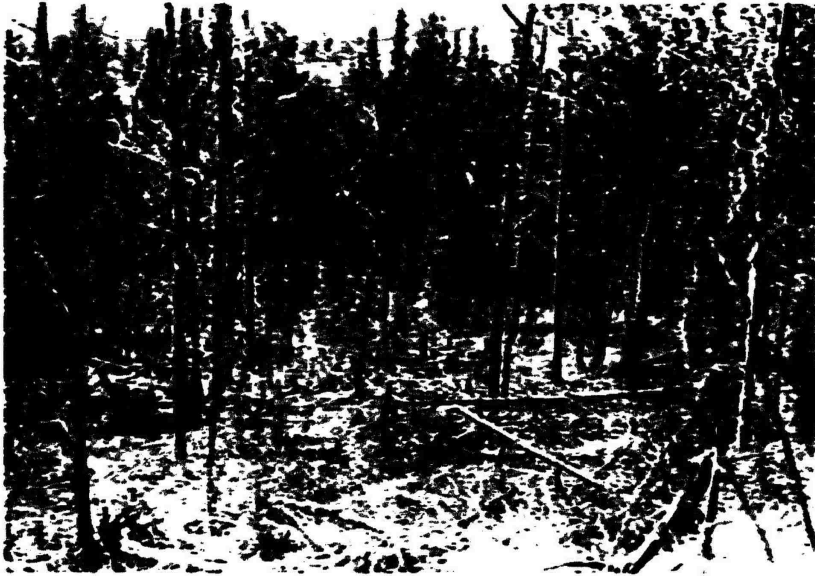
MP 382.5, 16 March 1956. Fuel spilled at this location was gasoline, called Mo Gas by the Petroleum Distribution Office. The site is on a very steep 40° south-facing slope. Soil is a well drained silt loam and contains a layer of fine volcanic ash. The spill killed aspen 4 to 6 inches in diameter and all the surface cover. Brumus, small aspen, fireweed and bearberry are growing at scattered locations within the area. Soil pits from mid-slope gave a strong odor of gasoline.

Figure A19. Downslope view of area at MP 382.5.

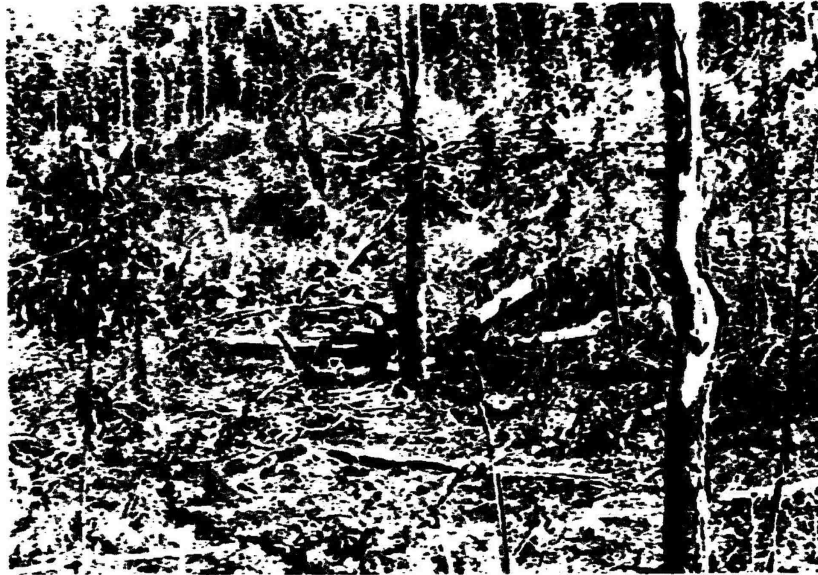
Figure A20. Side view at edge of MP 382.5 spill with dead aspen in foreground.

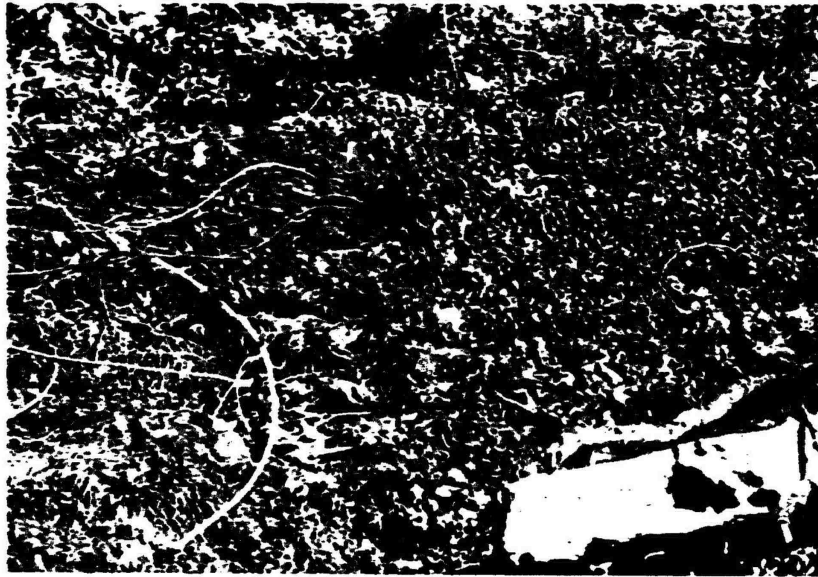
Figure A21. Close up of bearberry at MP 382.5 growing at edge of spill area to left of photo.
