DEEP MOORED INSTRUMENT STATION CRUISE REPORT

NORTH PACIFIC STUDY

Cruise 2

U.S.C.G.C. ACUSHNET

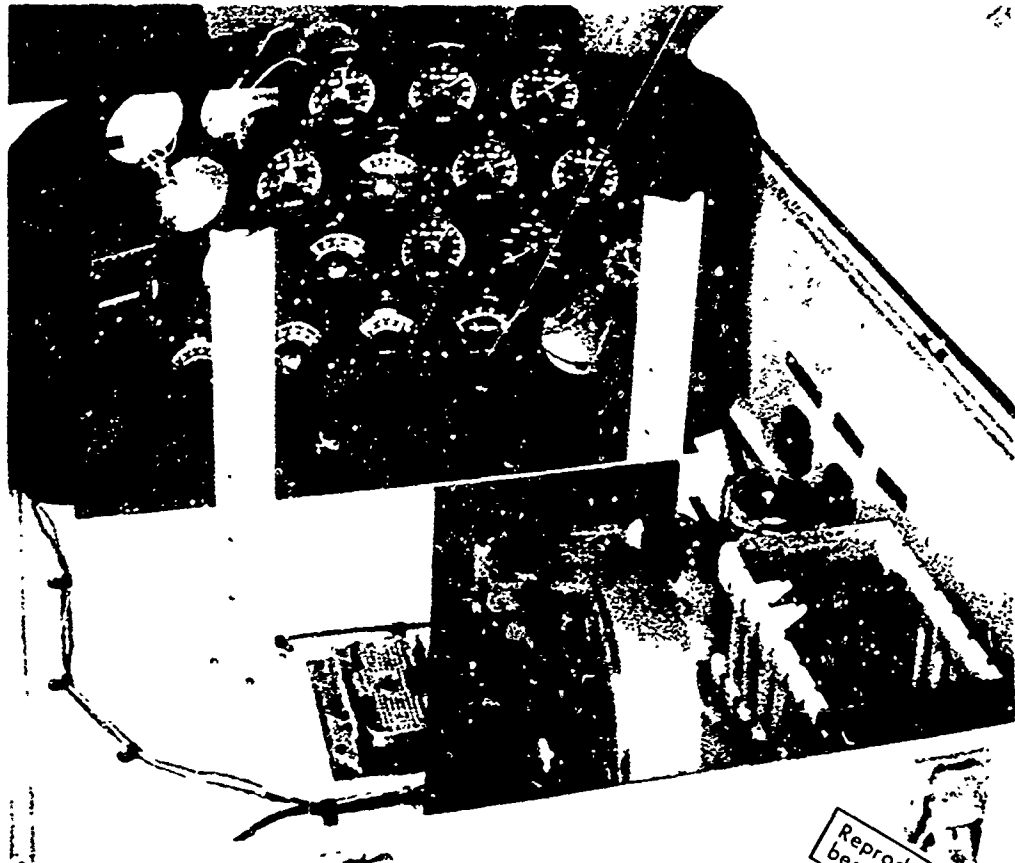
Opened instrument box showing instrument panel and panel light frames.

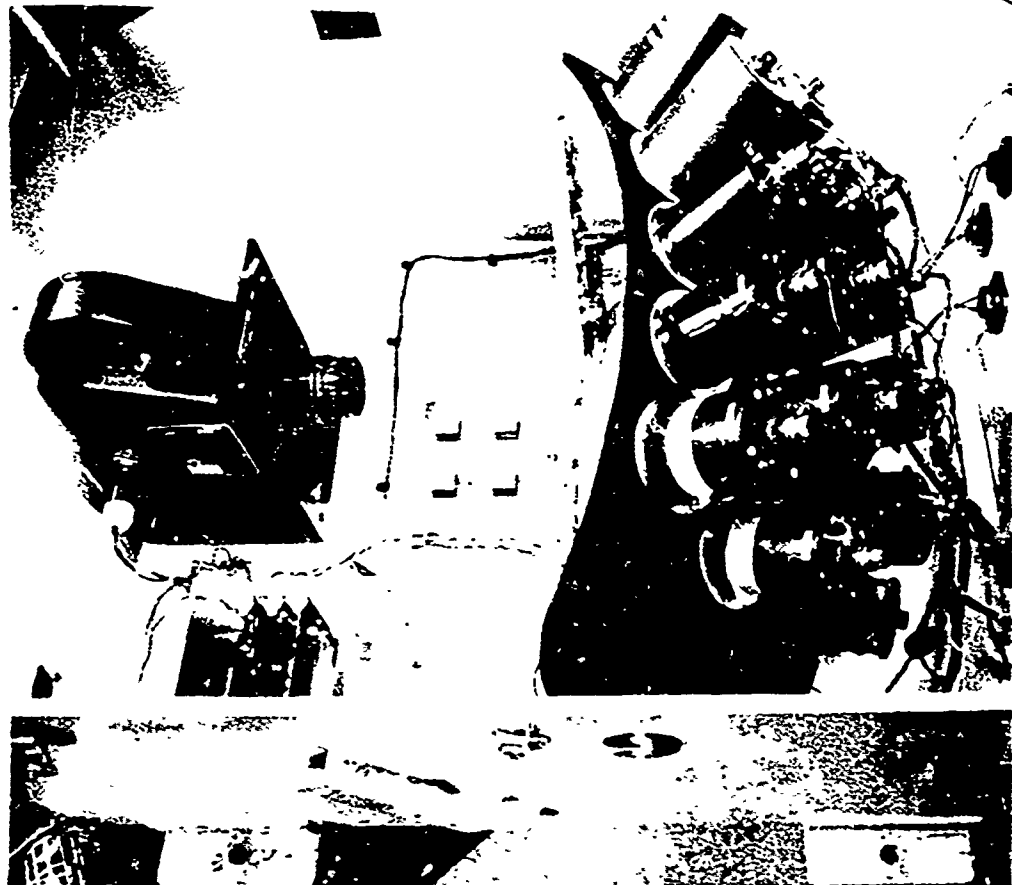
Instrument box showing camera with instrument panel tipped forward for servicing.
