MISCELLANEOUS PAPER S-72-27

EROSION CONTROL AT THE ARES FACILITY KIRTLAND AIR FORCE BASE, NEW MEXICO

C. R. Styron III

Conducted by **U. S. Army Engineer Waterways Experiment Station**
Soils and Pavements Laboratory
Vicksburg, Mississippi

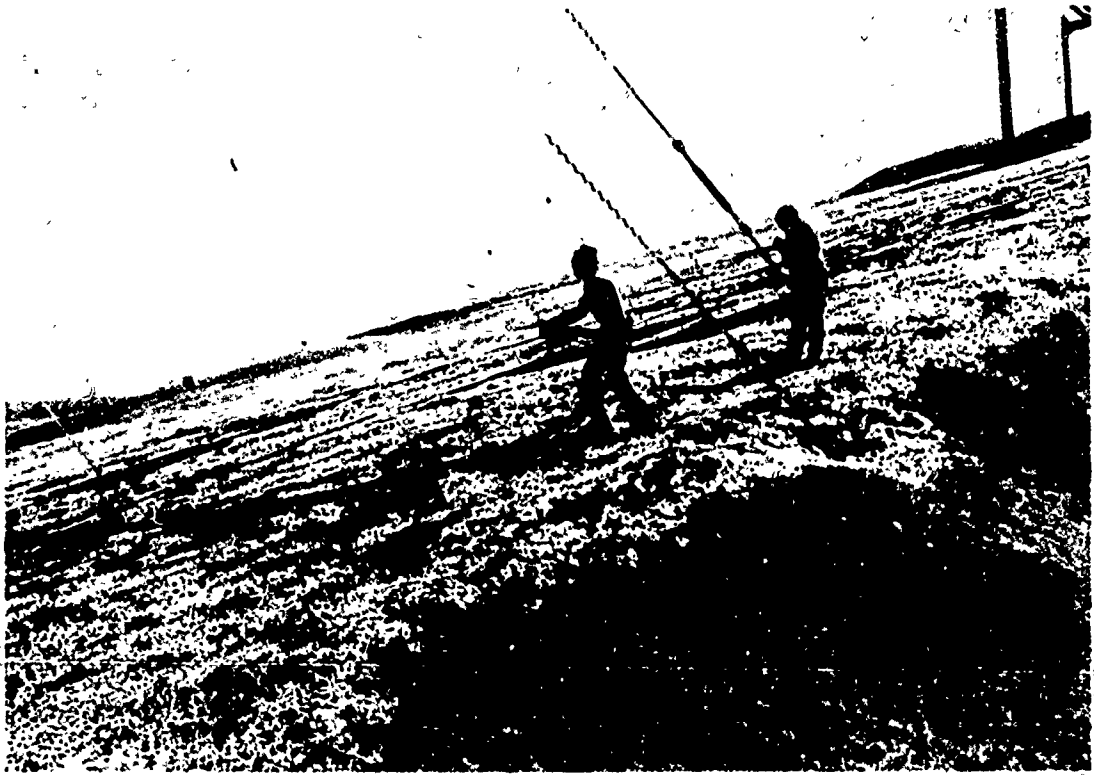
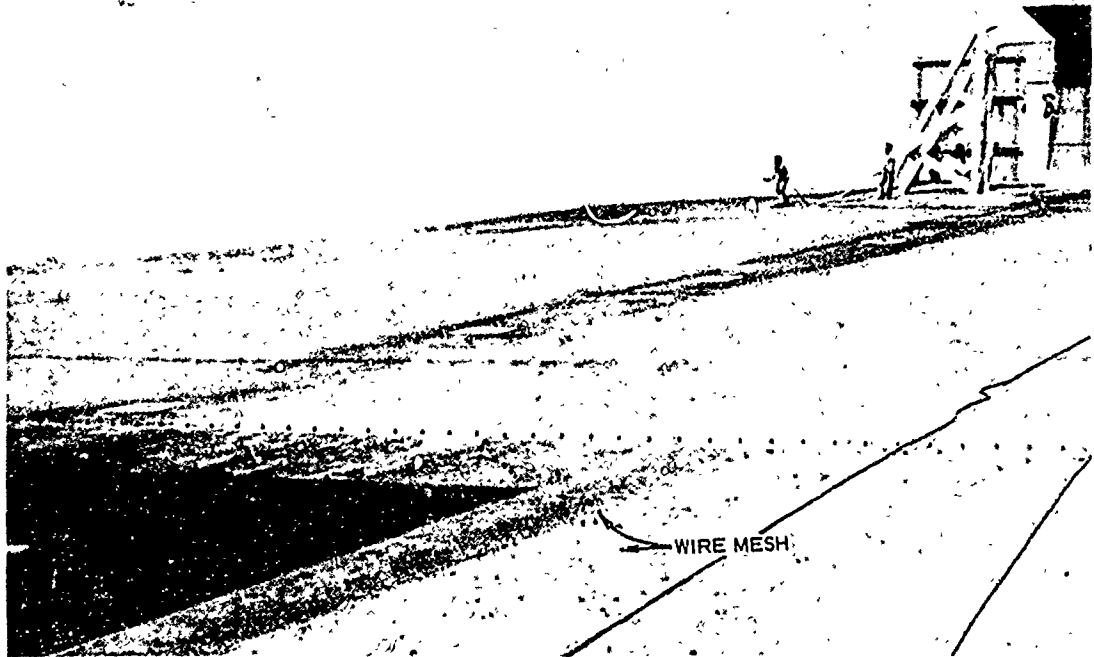
27. Wire mesh, some with 2- by 2-in. grids but most with 4- by 4-in. grids, and wire cables cover the east and west slopes. Views of typical areas on these slopes before and after regrading are shown in photos 4 and 5. Vehicles are not permitted to operate on the wire mesh on the east and west slopes, and the vehicles usually used to dispense the soil stabilizer materials could not traverse the north slope; therefore, all materials had to be applied with hand-held pressure hoses. Four hundred feet of 5/8-in.-diam, high-pressure hose was purchased for this project.

a. East slope

b. West slope

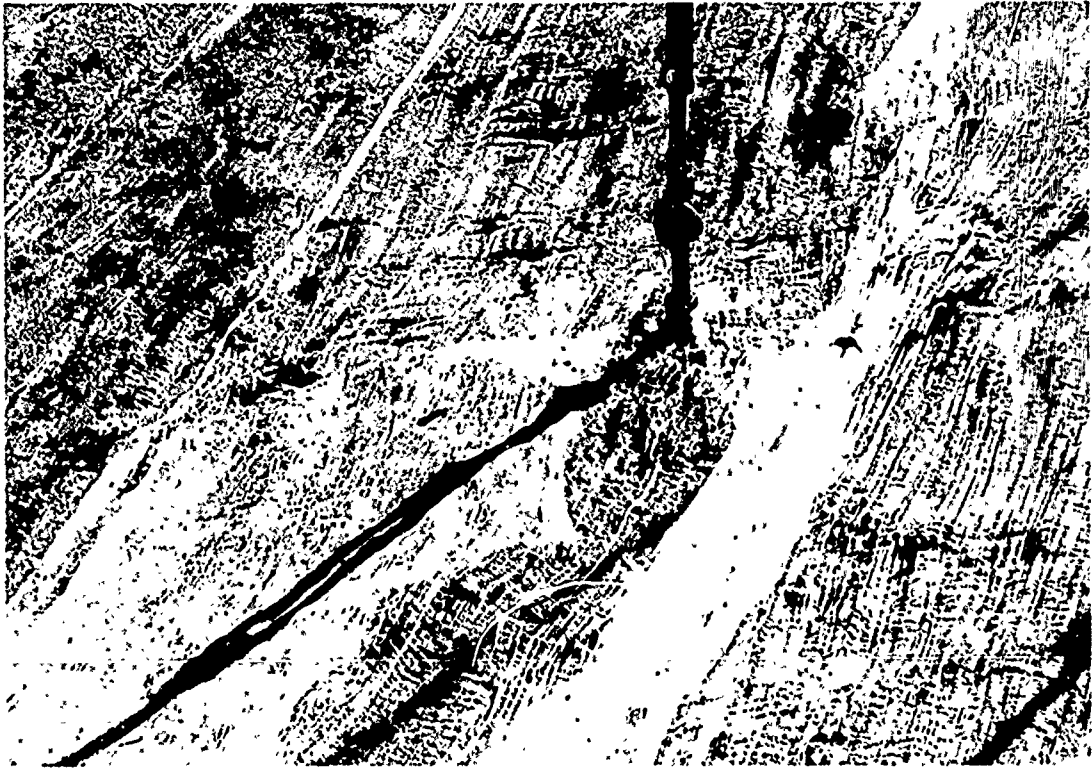
Photo 13. Area around guy wire base that received a heavier application of DCA-1295 due to expected occasional foot traffic

produced an average application of 4.3 lb/sq yd. Areas in which a concentration of foot traffic was expected, i.e., near the base of guy wires, etc., received a heavier application of DCA-1295 in an effort to prevent damage of the film (photo 13). No runoff of the solution was observed, and good coverage was obtained. Photo 14 shows a partial view of the completed scrim/DCA-1295 system.
