Marine Corrosion Studies

The Effects of Dissimilar Metal Couples and Toxicants from Antifouling Paints on the Corrosion of 5086 and 6061 Aluminum Alloys and Their Response to Cathodic Protection

(Fourteenth Interim Report of Progress)

NAVAL RESEARCH LABORATORY
Washington, D.C.

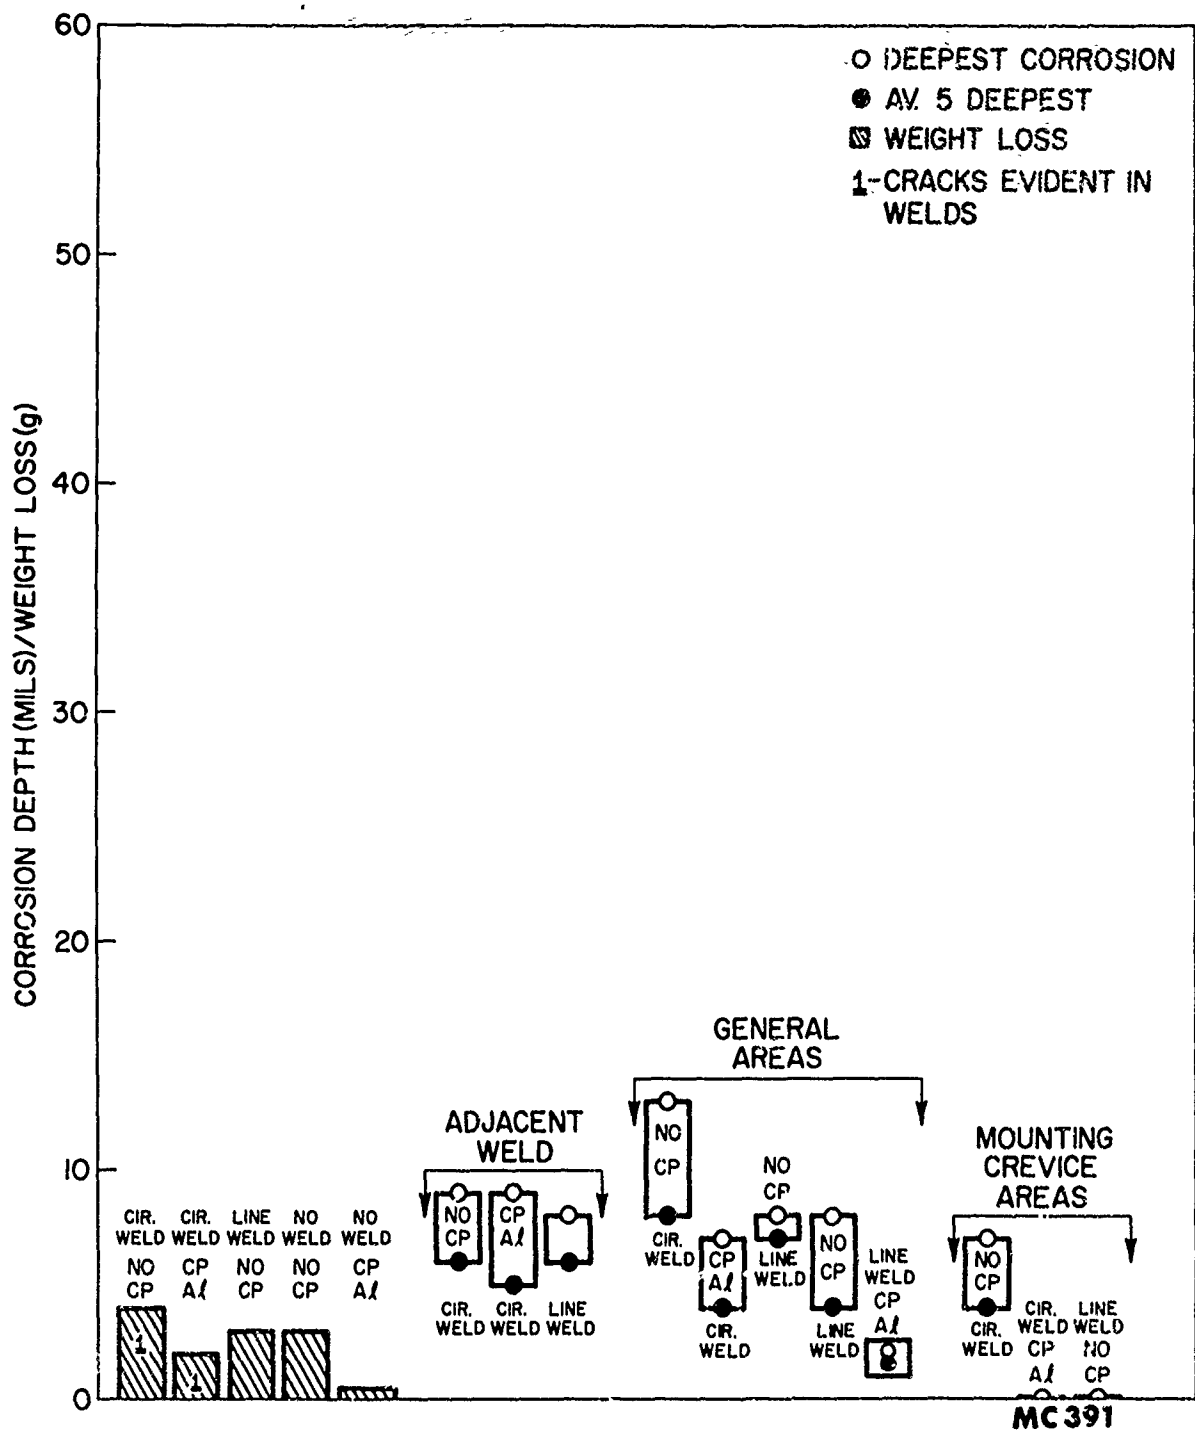
The depth of corrosion and the response to cathodic protection for various areas on the welded specimens of 5086-H32 aluminum are shown in Fig. 2. These data showed that the deepest corrosion on any of the welded specimens in seawater was 13 mils and that cathodic protection effectively reduced the depth of corrosion except at the area immediately adjacent to the weld on the circular welded specimen. There was evidence of cracks in the welds, notably on the circular welded specimen. The weld cracks were evident after exposure whether or not the specimen was cathodically protected by an aluminum anode, but it was not certain whether these cracks were present prior to the exposure. The weld area and areas adjacent to the weld on

Fig. 2 - Welded 5086-H32 aluminum; with and without cathodic protection (CP), 809 days in seawater at Key West, Florida.

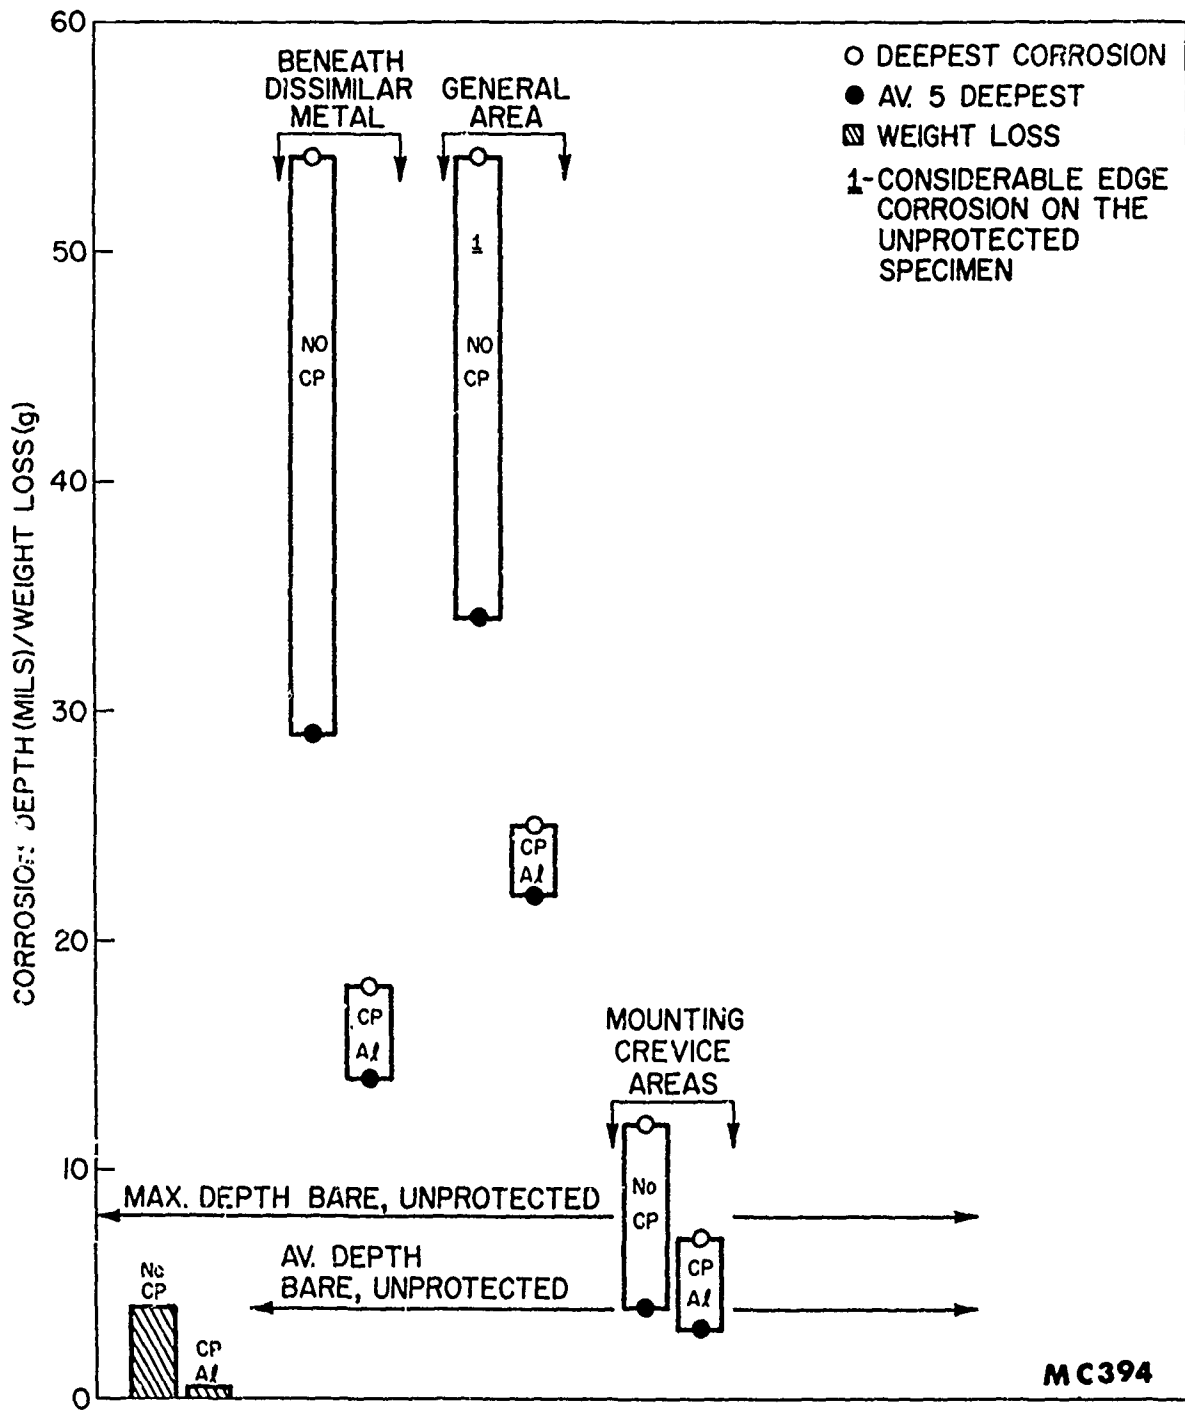
Each of the following dissimilar metals: copper nickel, 10%; yellow brass; 304 stainless steel; and mild steel caused accelerated corrosion at some location on the 5086-H32 aluminum. Of all the dissimilar metals studied the copper nickel caused the deepest corrosion beneath the dissimilar metal and on the general areas of the specimen. The 304 stainless steel accelerated the corrosion of the aluminum the most at the crevice formed by the phenolic mounting spacers. Edge corrosion of the aluminum was also caused by each of the dissimilar metals.

Fig. 5 - 5086-H32 aluminum coupled to copper nickel, 10%; with and without cathodic protection (CP), 809 days in seawater at Key West, Florida.

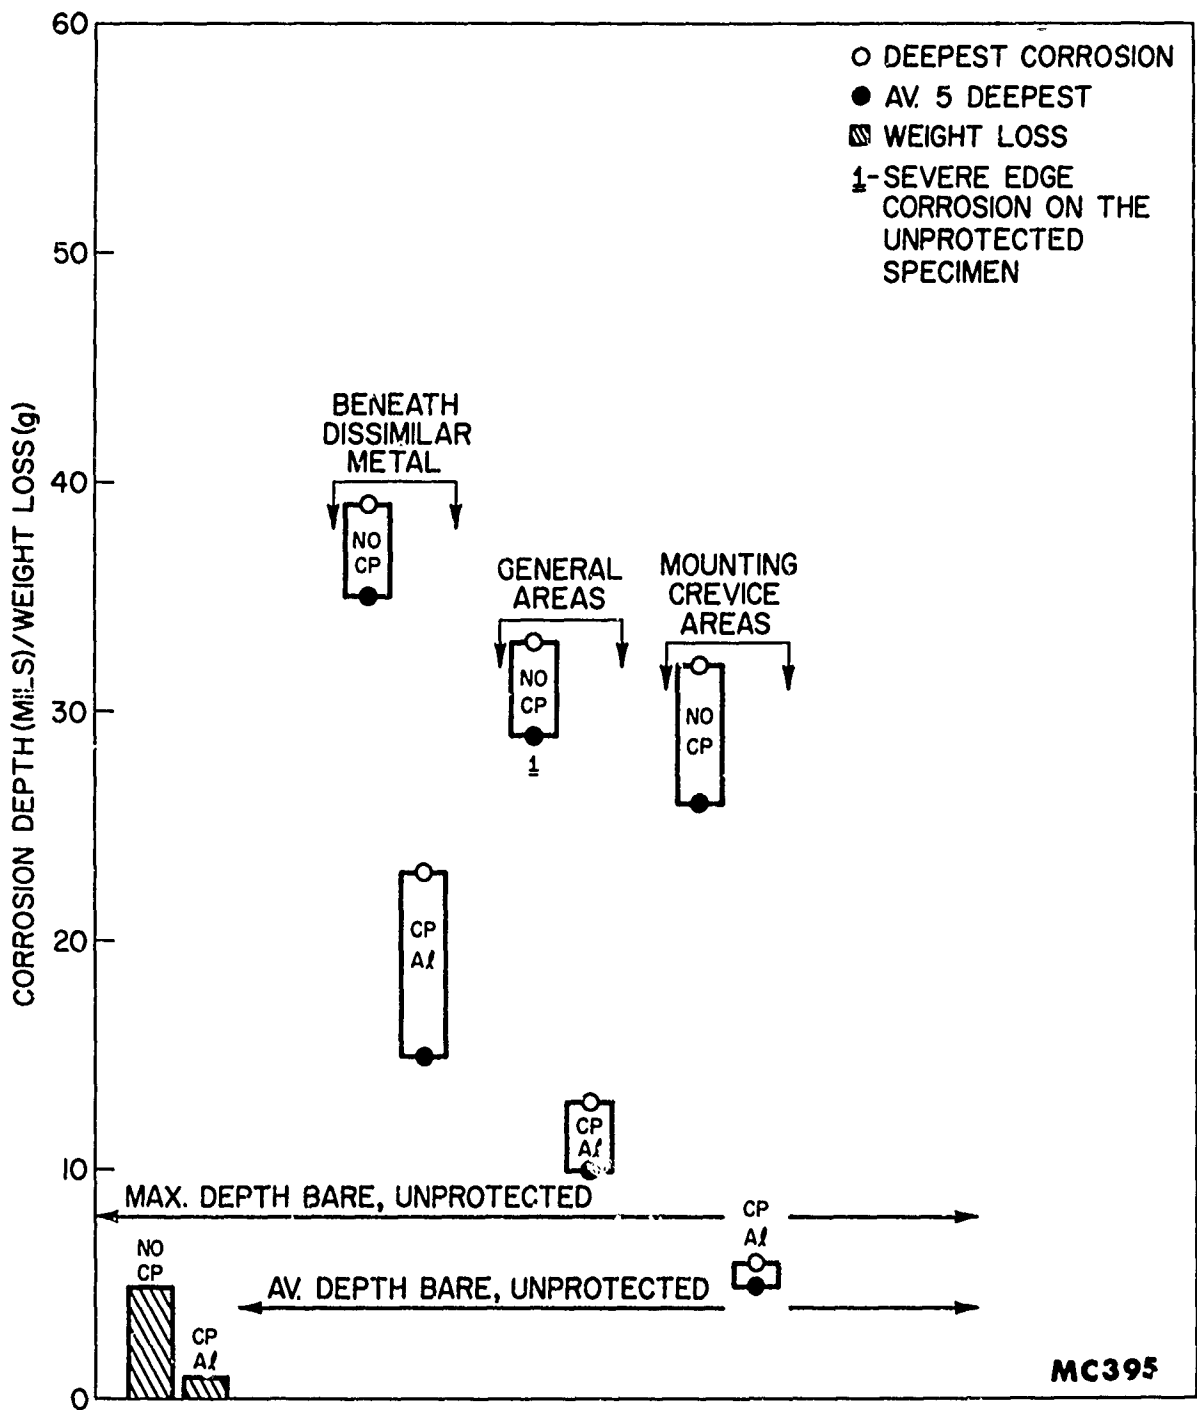
Fig. 6 - 5086-H32 aluminum coupled to yellow brass; with and without cathodic protection (CP), 809 days in seawater at Key West, Florida.

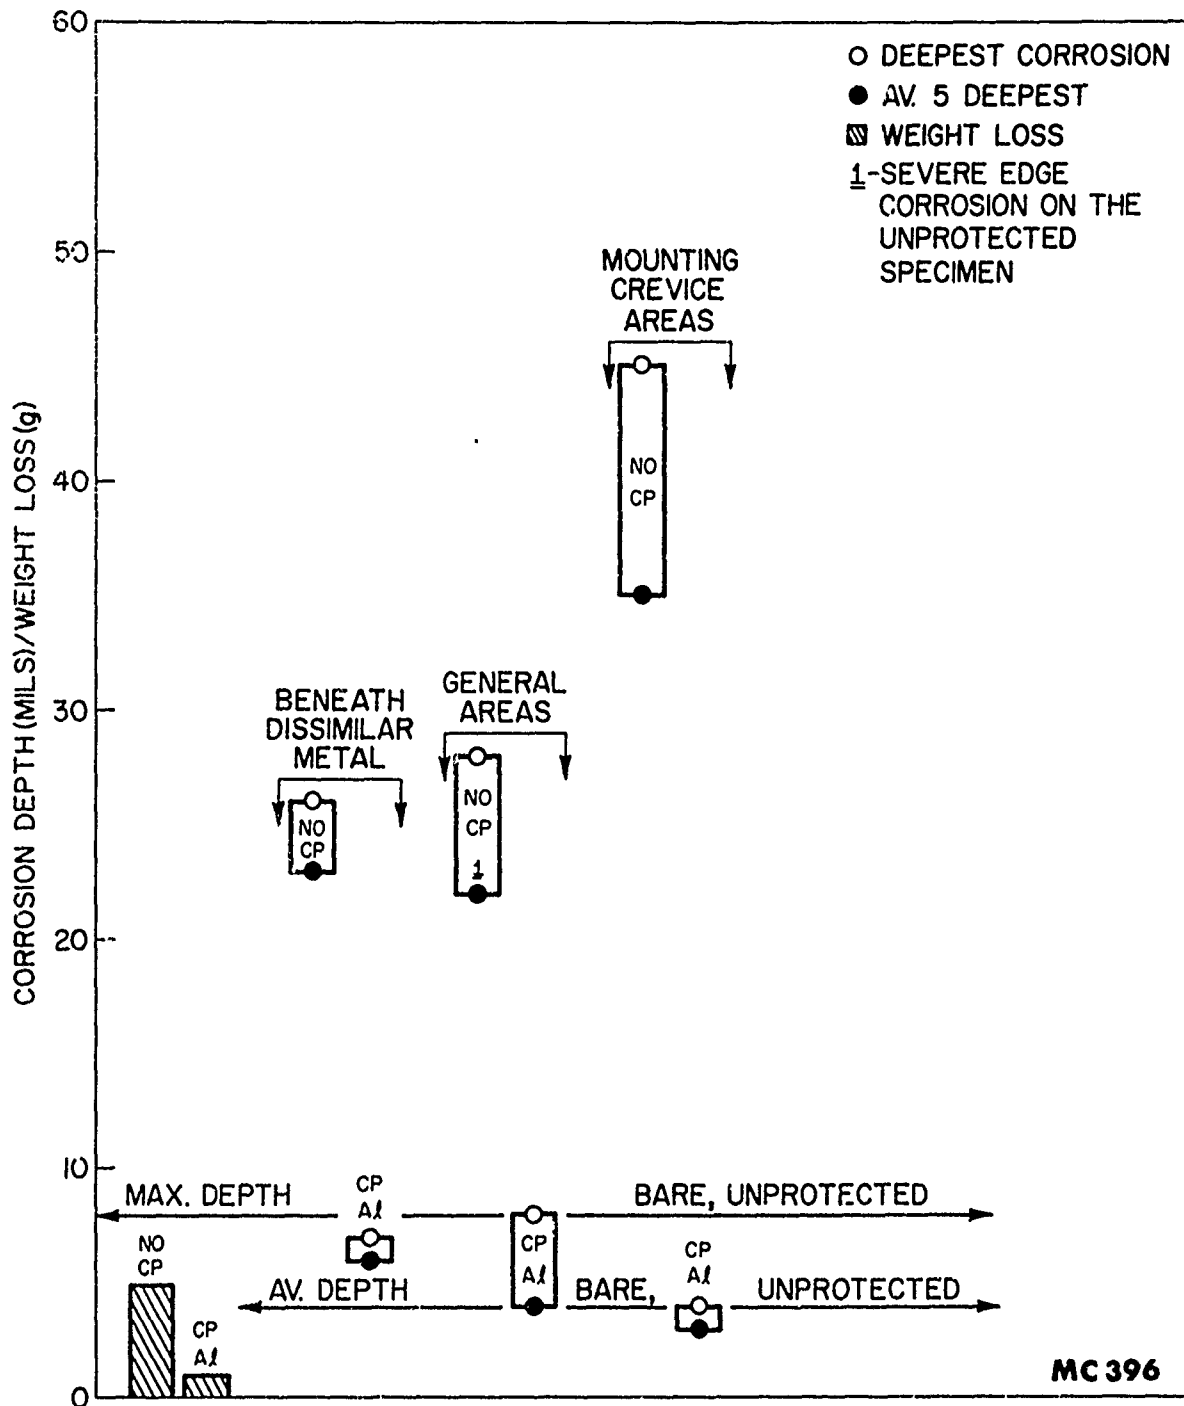
Cathodic protection from the aluminum anodes reduced the depth of corrosion on the 5086-H32 aluminum caused by the dissimilar metals, but only in the case of the 304 stainless steel couple (Fig. 7) was the depth of corrosion reduced to that observed on the bare, uncoupled and unprotected 5086-H32 aluminum. The depth of corrosion on bare 5086-H32 aluminum (with and without cathodic protection) and not coupled to a dissimilar metal has been shown on Fig. 9. The data for the maximum corrosion depth for bare and unprotected 5086-H32 aluminum have been shown on the appropriate graphs for comparative purposes.

Fig. 7 - 5086-H32 aluminum coupled to 304 stainless steel; with and without cathodic protection (CP), 809 days in seawater at Key West, Florida.

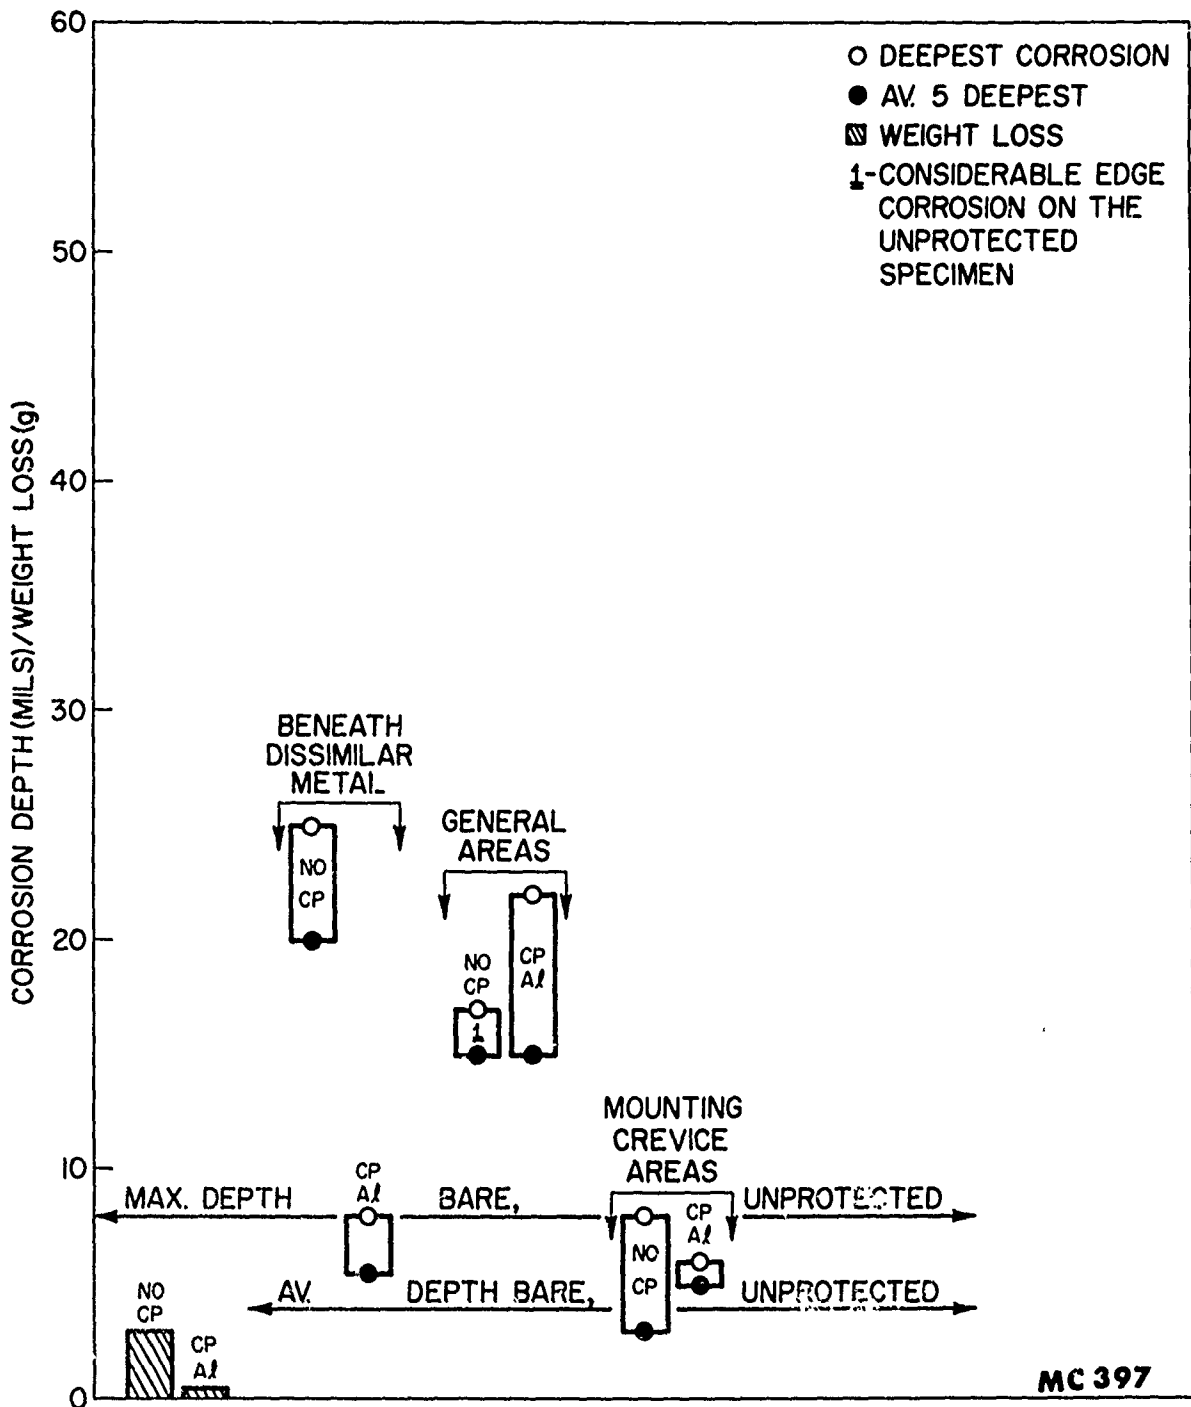
Fig. 8 - 5086-H32 aluminum coupled to mild steel; with and without cathodic protection (CP), 809 days in seawater at Key West, Florida.

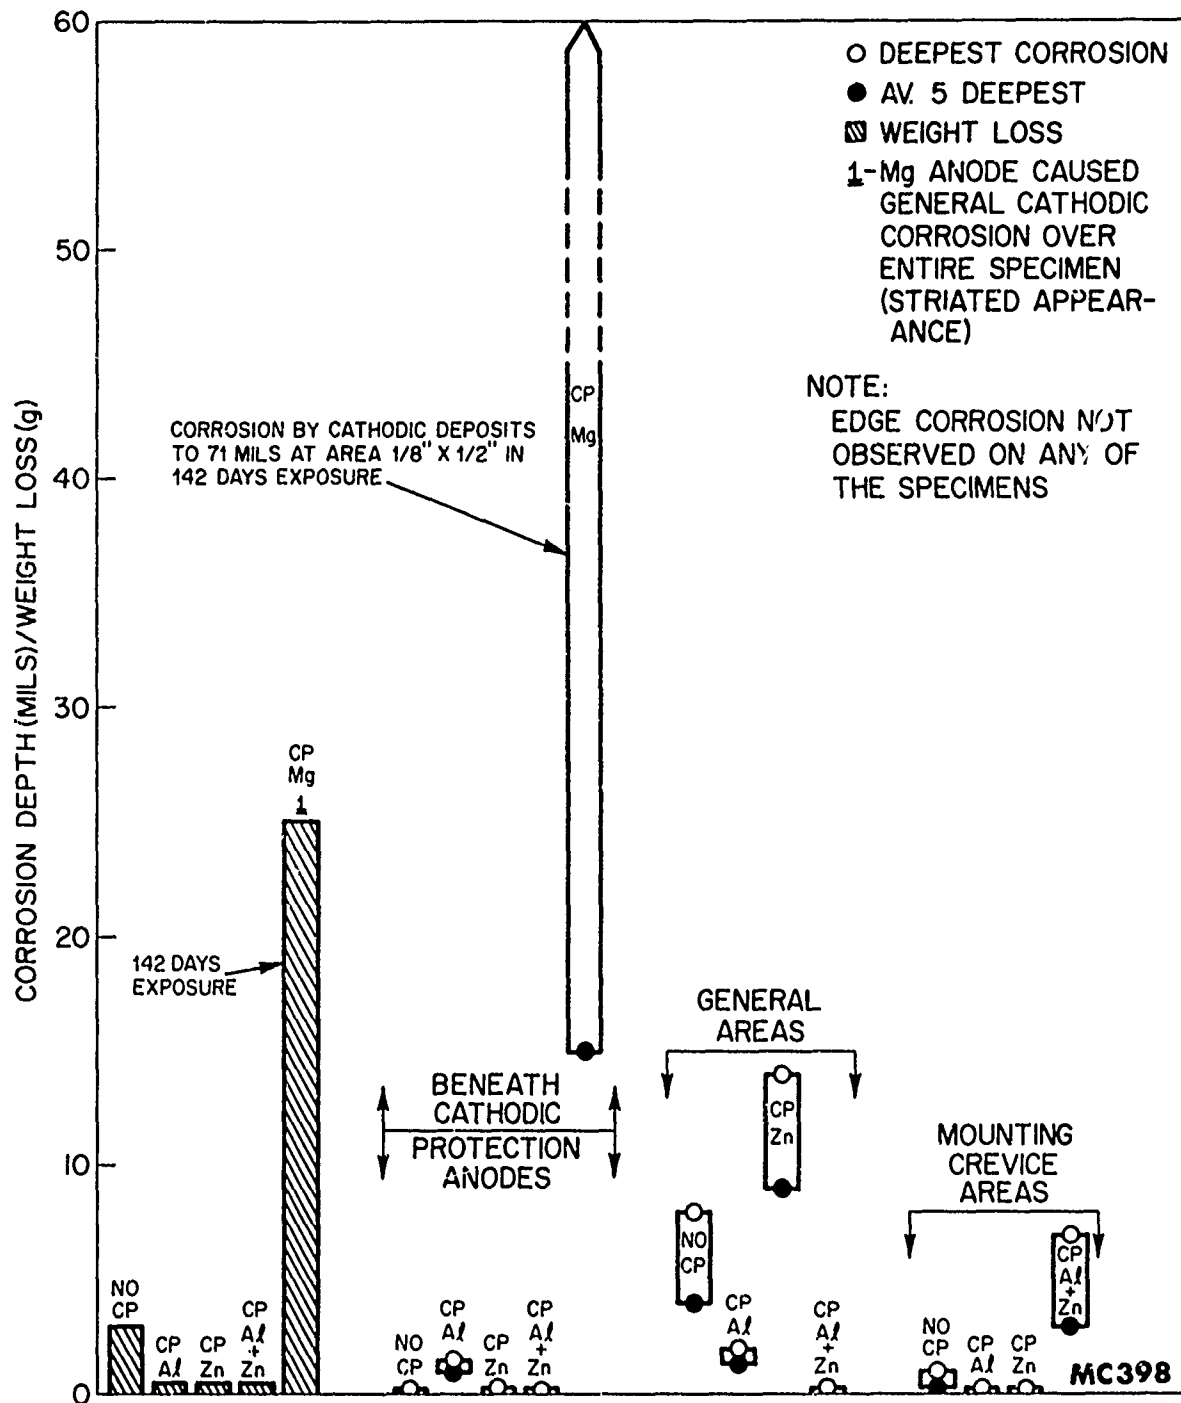
Fig. 9 - 5086-H32 aluminum; with and without cathodic protection (CP), 809 days in seawater at Key West, Florida.

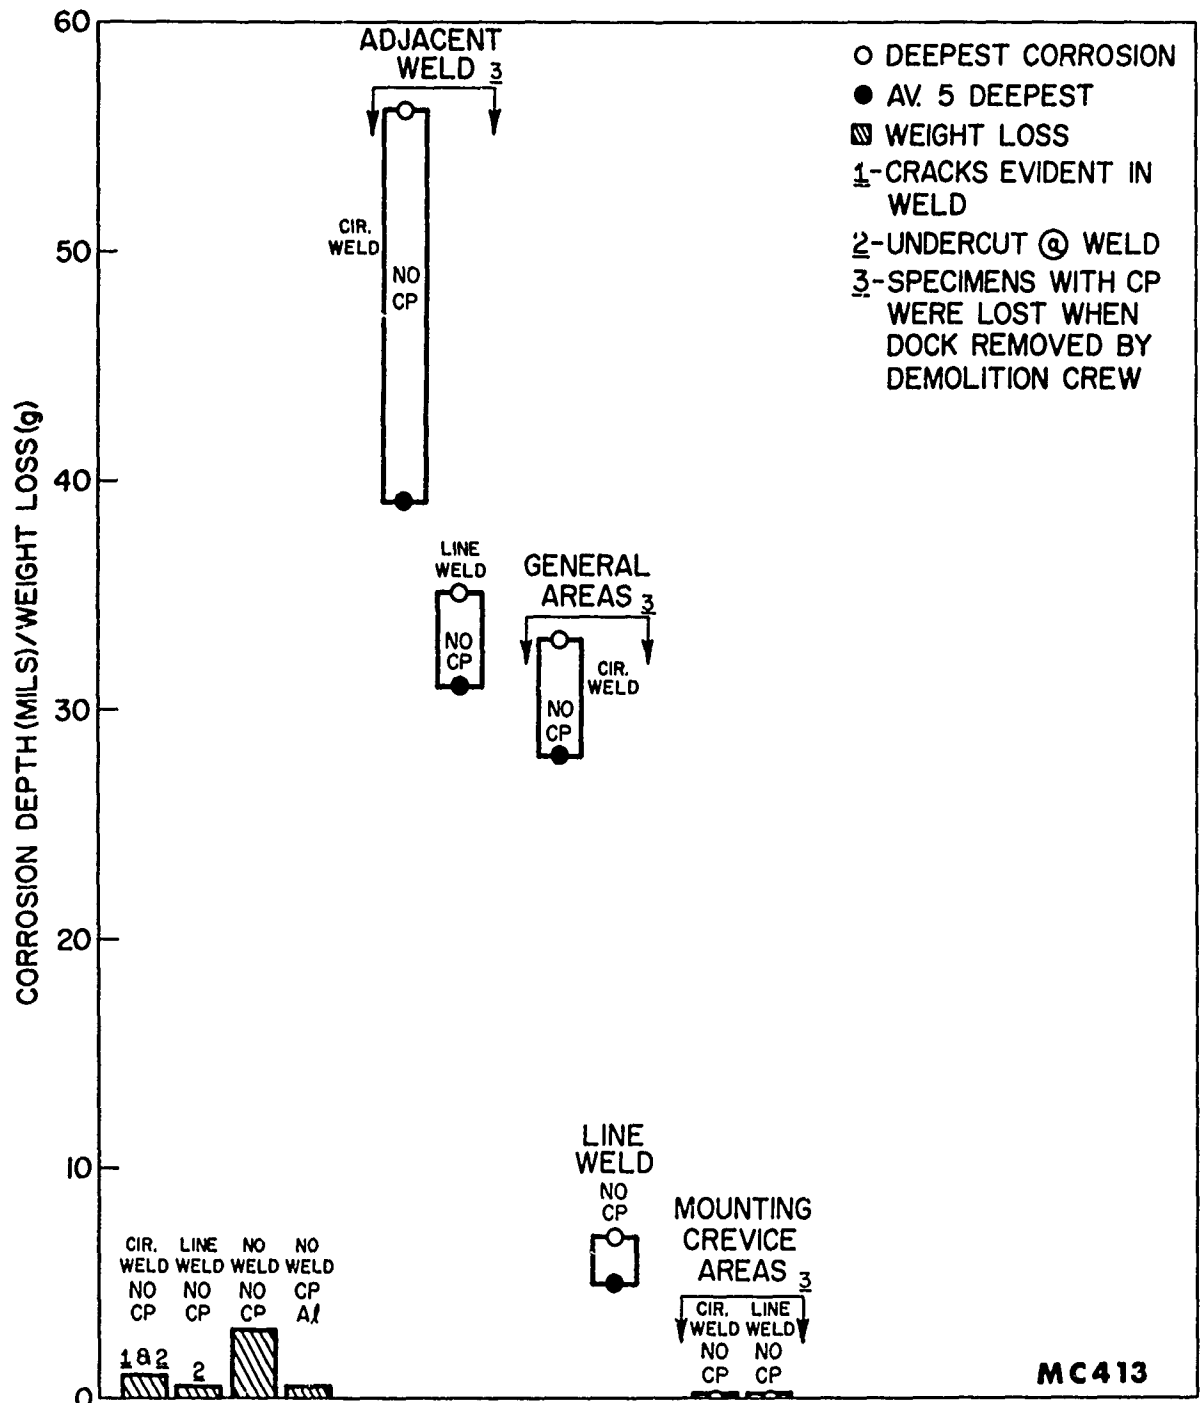
The data for the depth of corrosion on the welded specimens of 5086-H32 aluminum exposed for 675 days in the Potomac River are summarized in Fig. 24. The 5086-H32 aluminum corroded to a depth of 56 mils adjacent to the weld and to 33 mils on general areas of the specimen. The deepest corrosion occurred on the circular welded specimen which also showed slight cracks in the weld, but it was not certain whether these cracks were present prior to exposure. The weld and adjacent areas on this specimen are shown in Fig. 25.

Fig. 24 - Welded 5086-H32 aluminum after 675 days in the Potomac River.

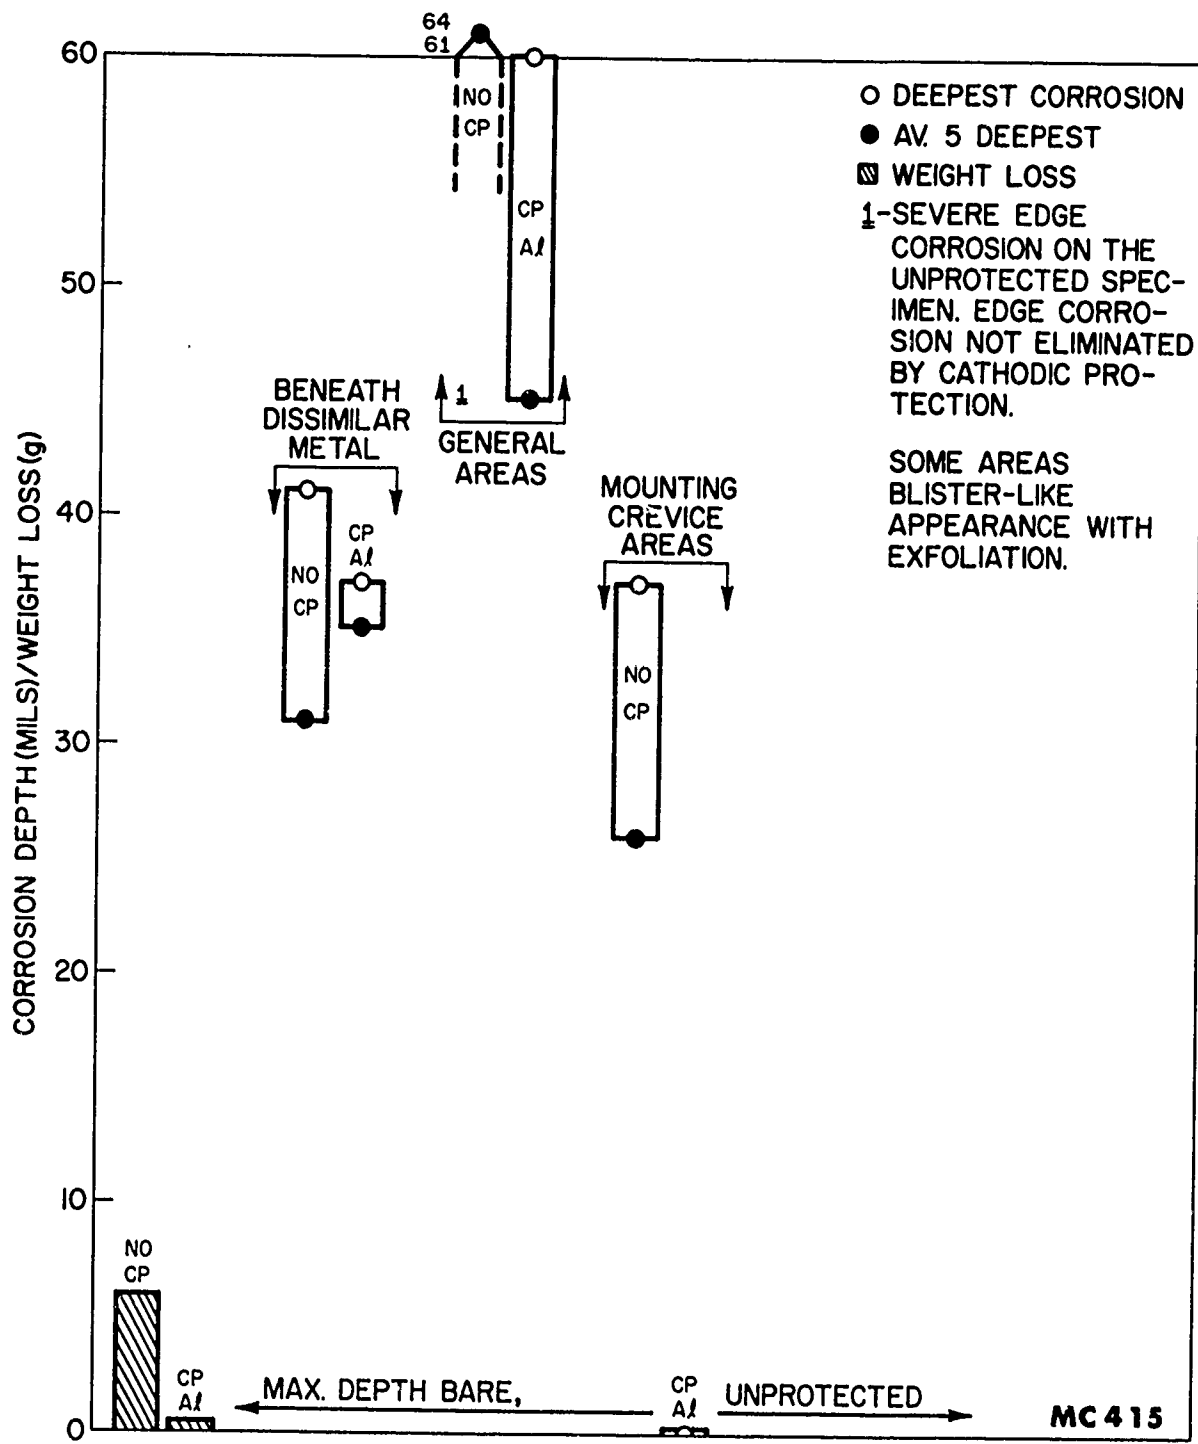
Fig. 26 - 5086-H32 aluminum coupled to copper nickel, 10%; with and without cathodic protection (CP), 675 days in the Potomac River.

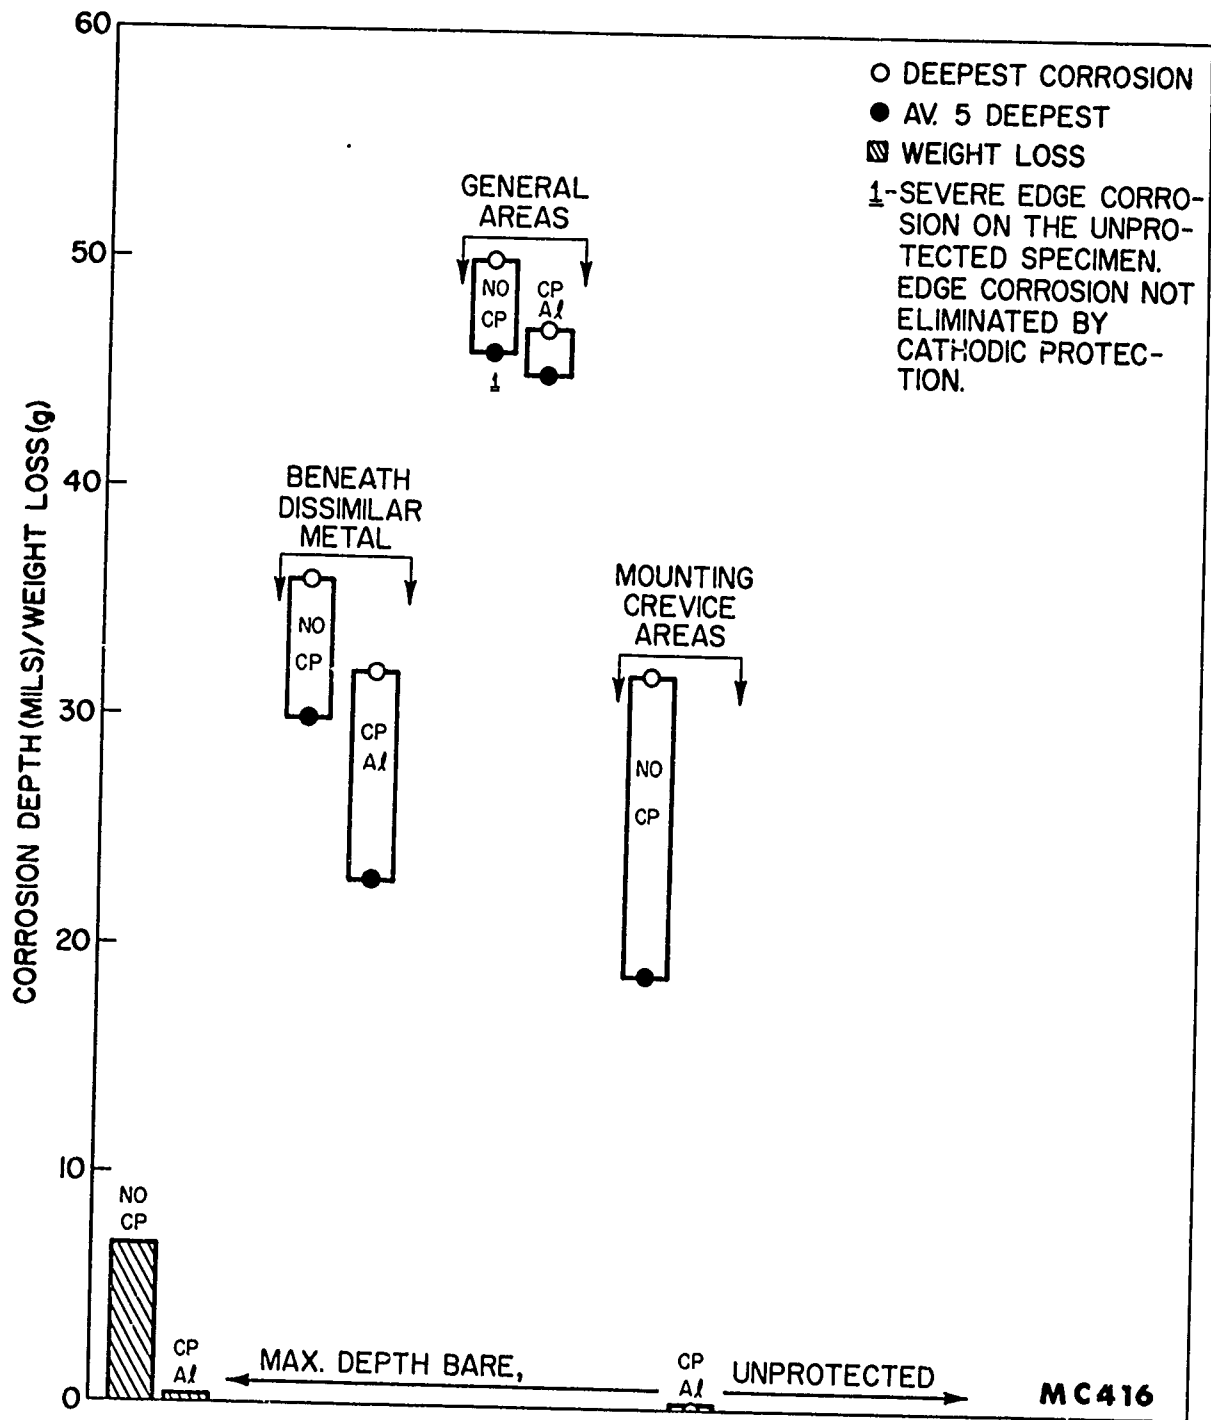
Fig. 27 - 5086-H23 aluminum coupled to yellow brass; with and without cathodic protection (CP), 675 days in the Potomac River.

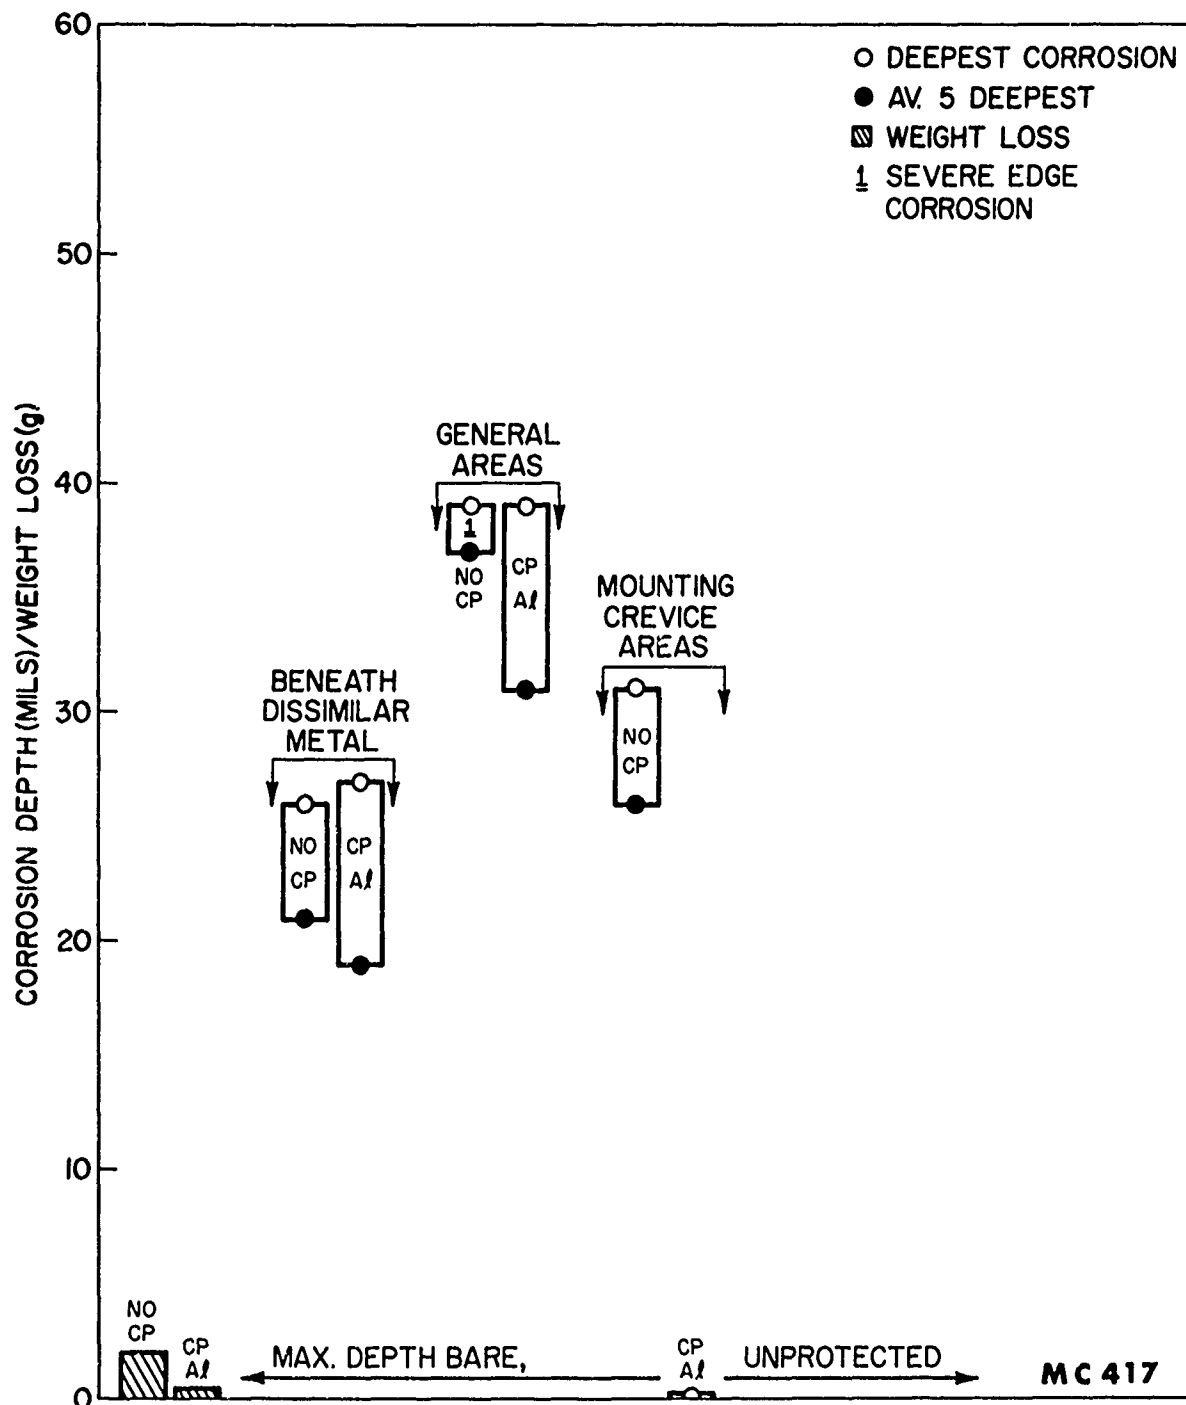
Fig. 28 - 5086-H32 aluminum coupled to 304 stainless steel; with and without cathodic protection (CP), 675 days in the Potomac River.

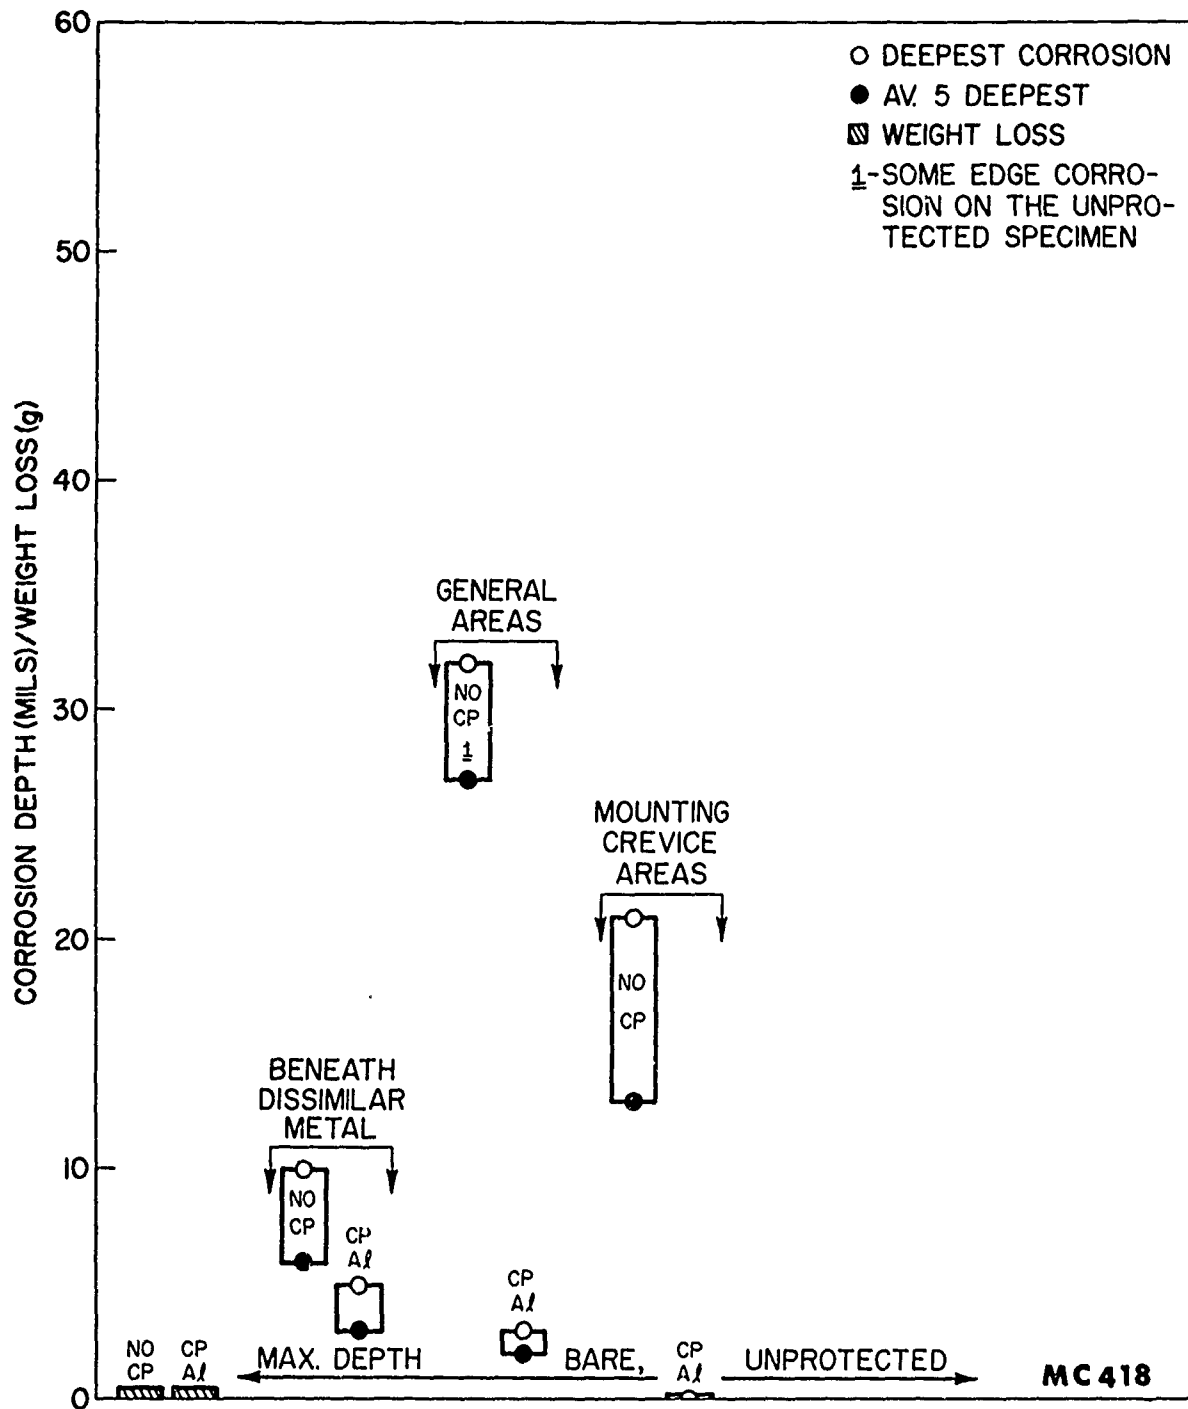
In the case of the mild steel couple in the Potomac River cathodic protection was effective and significantly reduced the depth of corrosion at all locations on the 5086-H32 aluminum, Fig. 29.

Fig. 29 - 5086-H32 aluminum coupled to mild steel; with and without cathodic protection (CP), 675 days in the Potomac River.

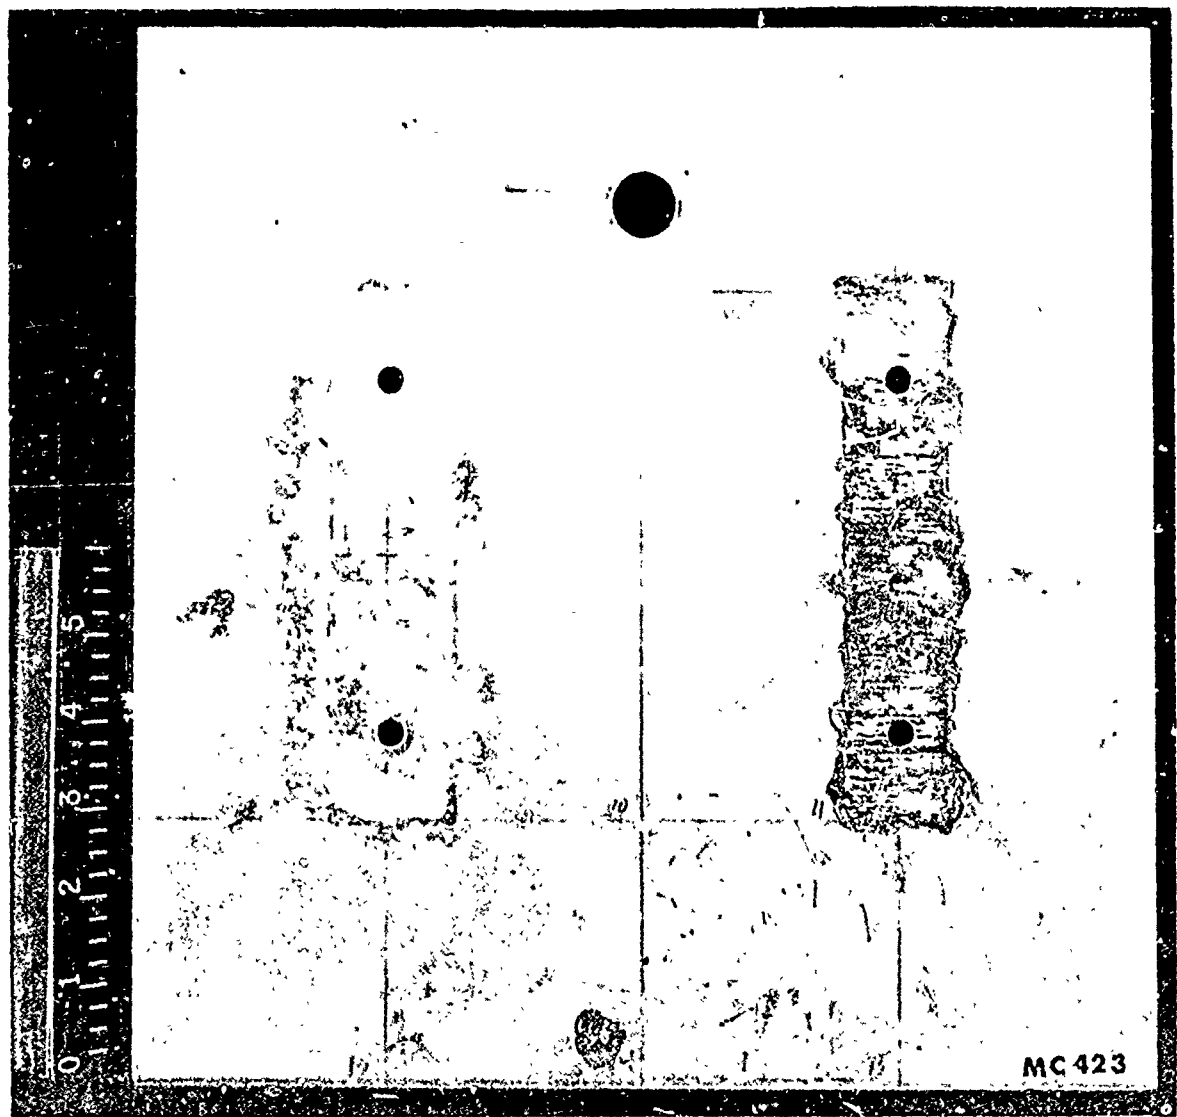
Fig. 34 - 5086-II32 aluminum coupled to yellow brass; with cathodic protection, 675 days in the Potomac River. Original magnification 0.5 X

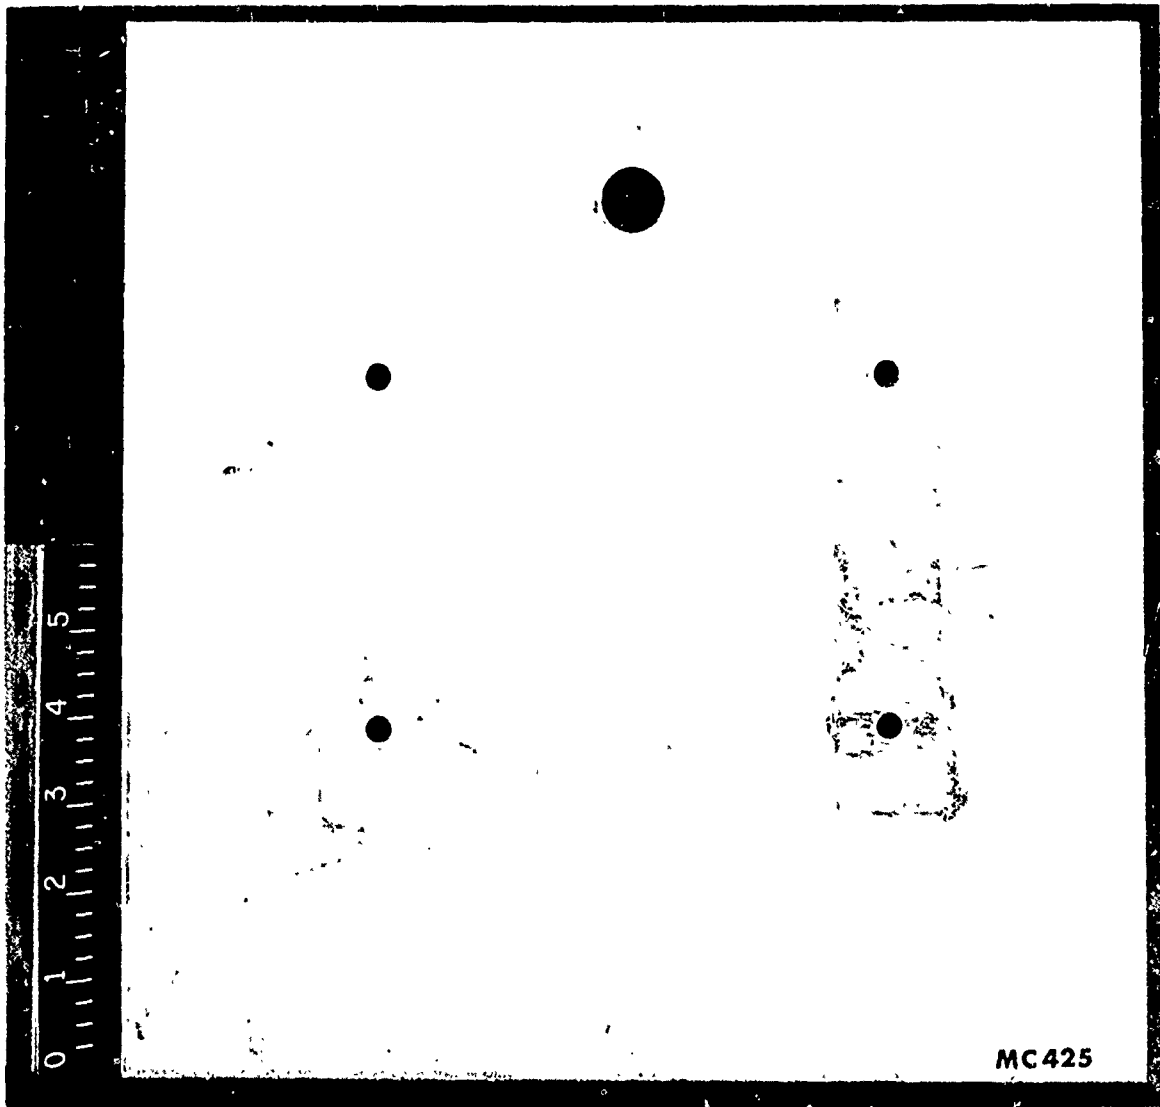
Fig. 36 - 5086-H32 aluminum coupled to 304 stainless steel;
with cathodic protection, 675 days in the Potomac River .
Original magnification 0.5 X
