Marine Corrosion Studies

The Effects of Dissimilar Metal Couples and Toxicants from Antifouling Paints on the Corrosion of 5086 and 6061 Aluminum Alloys and Their Response to Cathodic Protection

(Fourteenth Interim Report of Progress)

NAVAL RESEARCH LABORATORY
Washington, D.C.

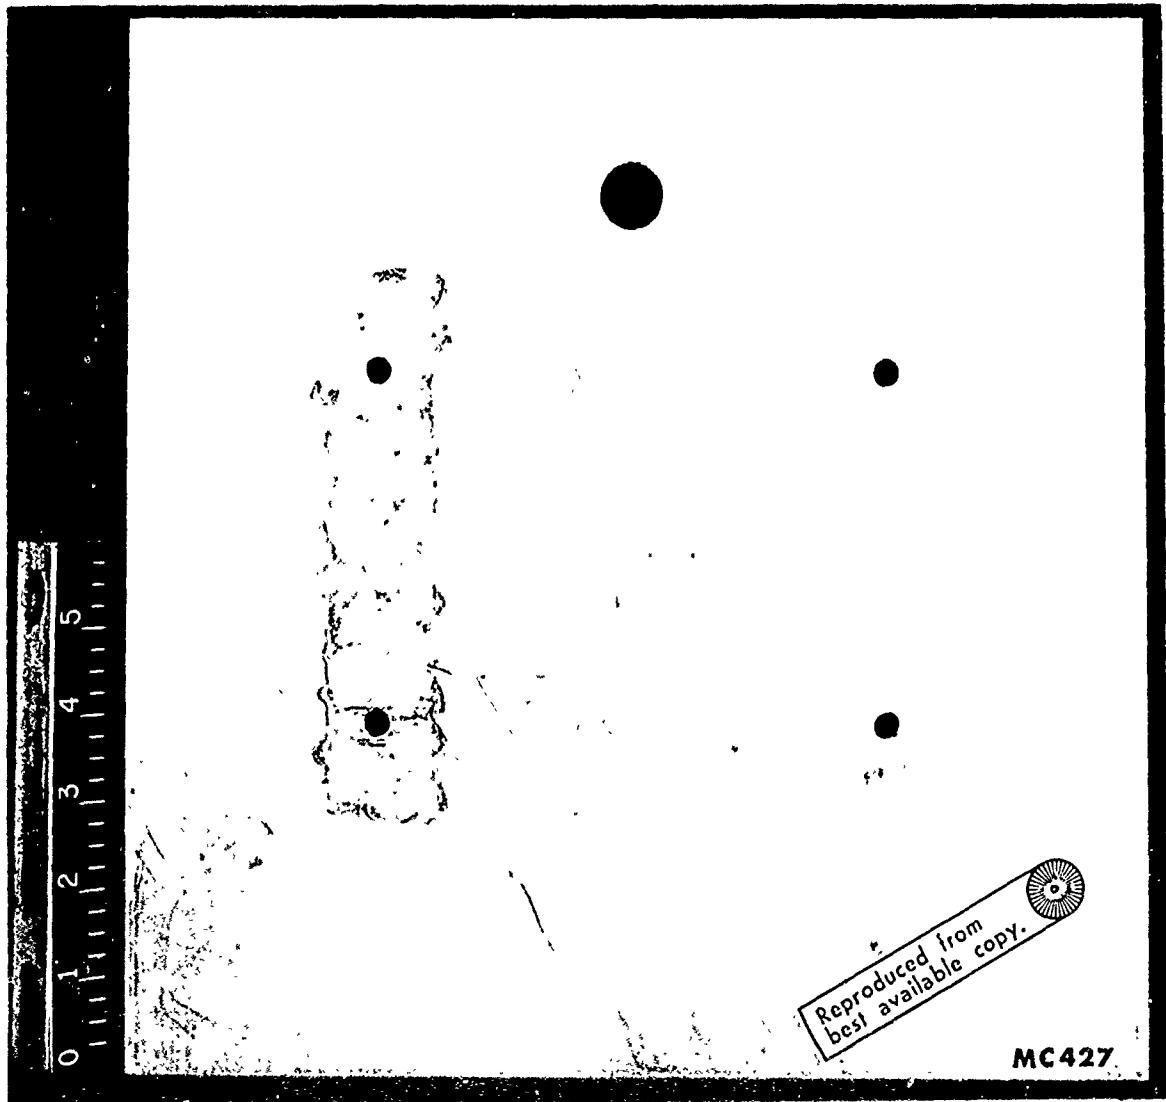
Fig. 38 - 5086-H32 aluminum coupled to mild steel; with cathodic protection, 675 days in the Potomac River. Original magnification 0.5X

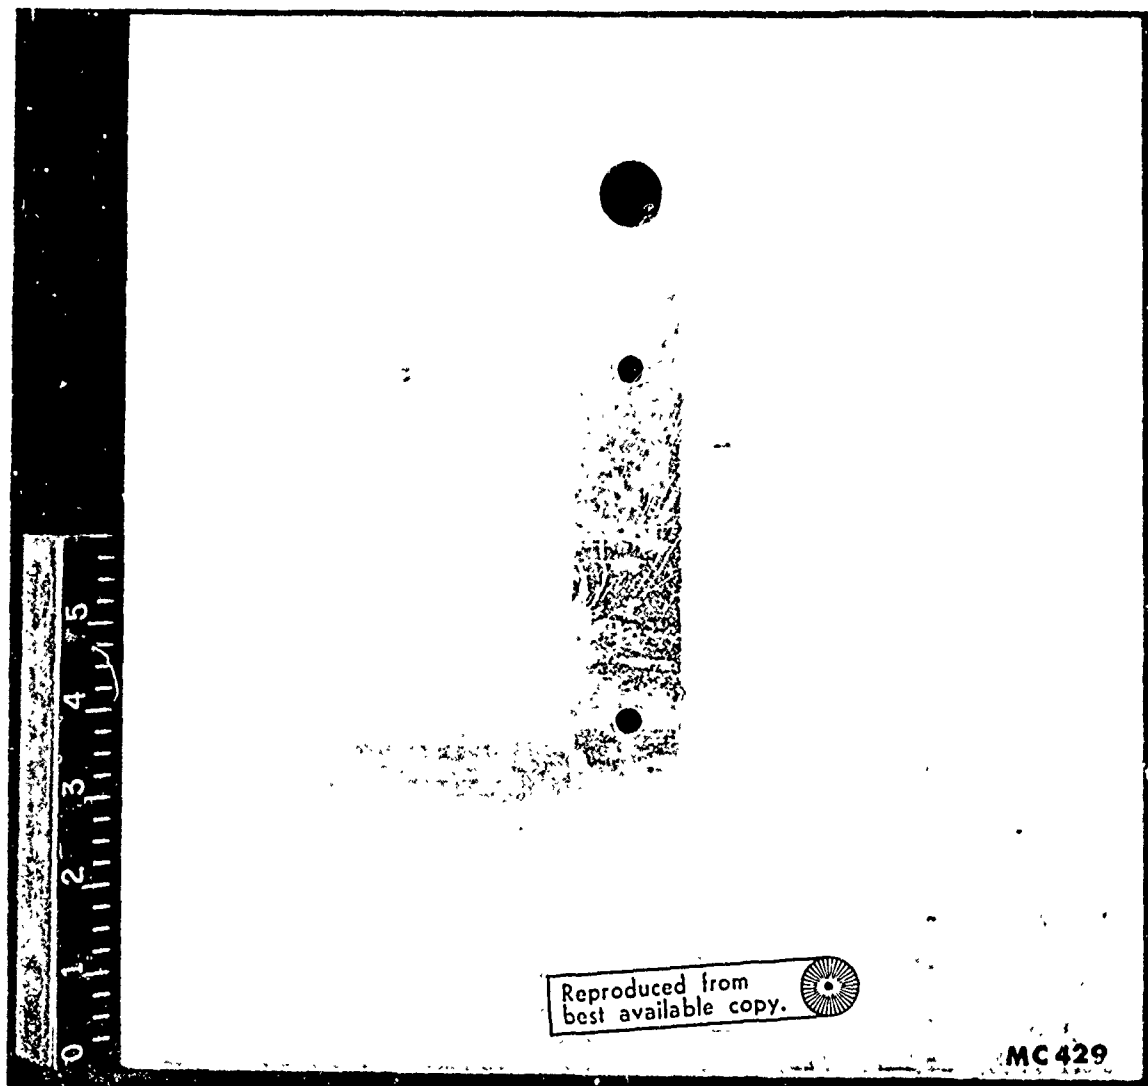
Fig. 40 - 5086-H32 aluminum; with cathodic protection, 675 days in the Potomac River. Original magnification 0.5 X
