CYCLE TESTING OF ACS VALVES IN CLF₅ FINAL REPORT

TECHNICAL REPORT AFRPL-TR-72-82

AUGUST 1972

AIR FORCE ROCKET PROPULSION LABORATORY

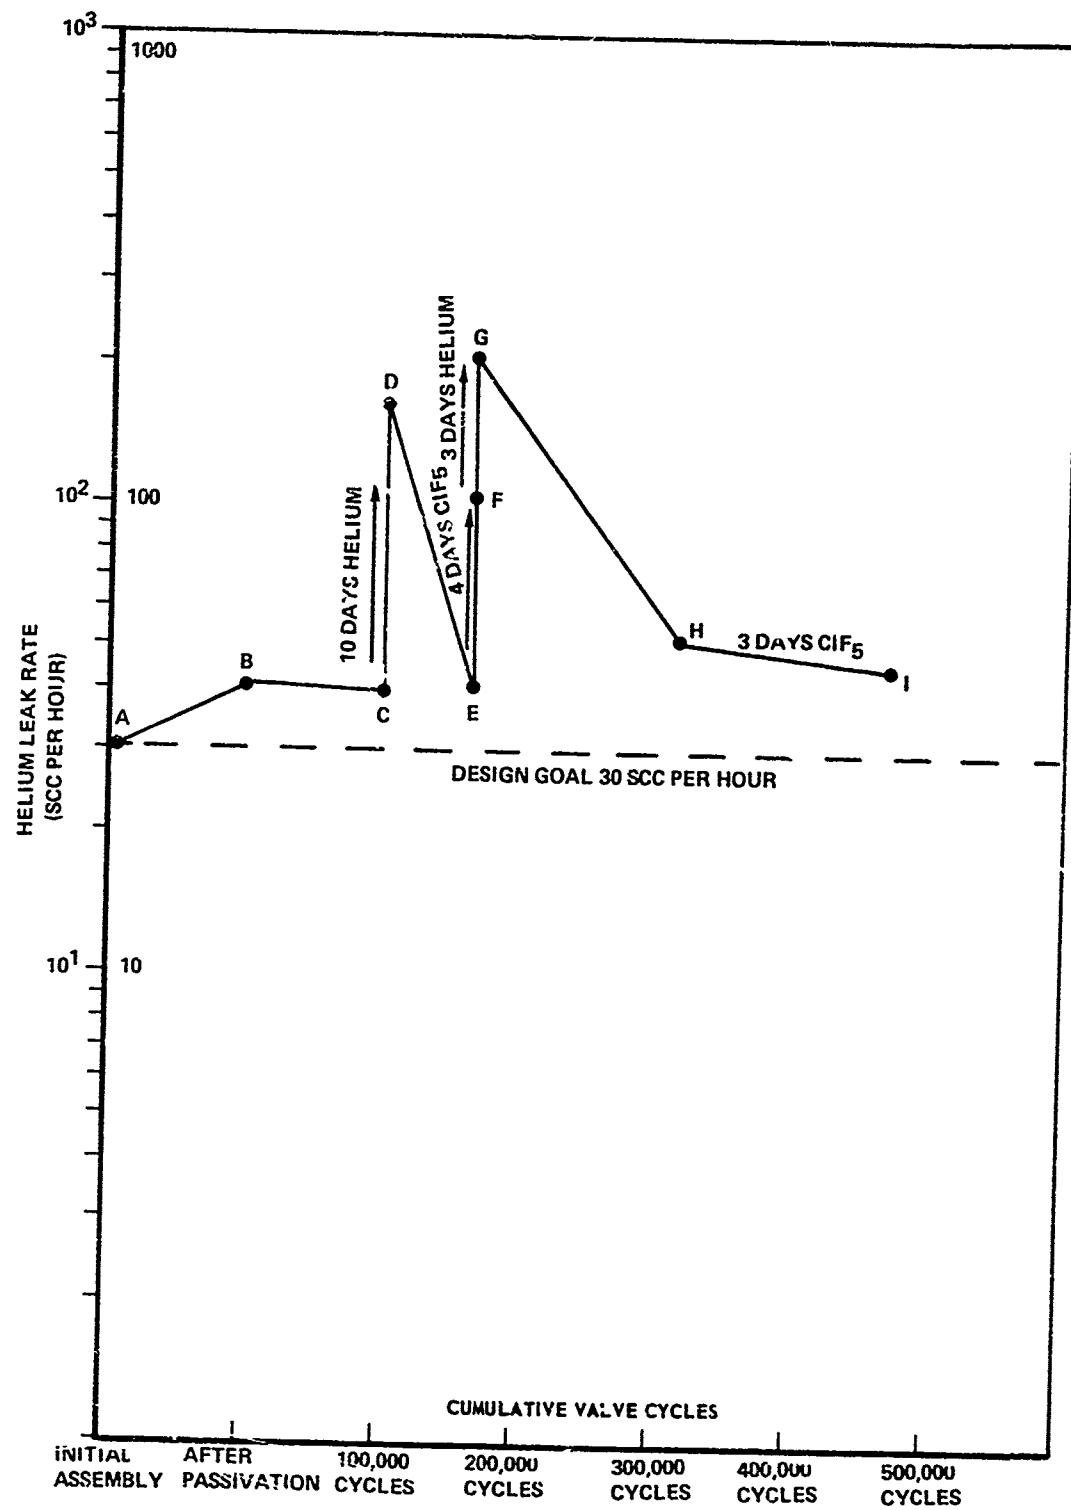
Figure 11. Leakage versus Valve Cycles, Test No. 14.

This test encompassed a 23-day period during which 10 days of ClF_5 exposure and 470,000 cycles were accumulated. Figure 11 depicts the leakage characteristics of the valve throughout the test.

Upon initial assembly, the valve leaked 30 scc helium per hour (Point A), and the leakage increased to 41 scc/hour (Point B) upon GF_2 passivation. During the first day's testing in ClF_5 , approximately 100,000 cycles were accumulated, resulting in a leak rate of 40 scc/hour (Point C). The valve was then left pressurized with helium for a 10-day period. For some reason, the leak rate measured at the end of this 10-day period increased to over 150 scc/hour (Point D). Cycling in ClF_5 was begun and an additional 63,000 actuations were accumulated. Leakage returned to a level of about 40 scc/hour after this day's test (Point E).

153,000 cycles in ClF_5 , the internal leakage returned to an acceptable 51 scc helium/hour (Point H). A total of 316,000 cycles in ClF_5 had now been accumulated on this hardware during this test.

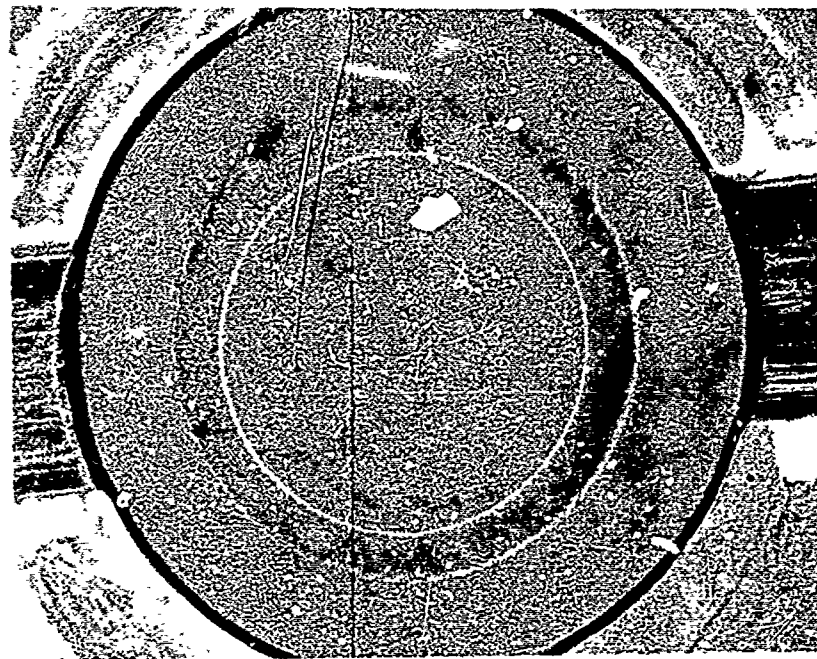
Figure 13. Poppet, K-96 Post-Test 14 (20X)

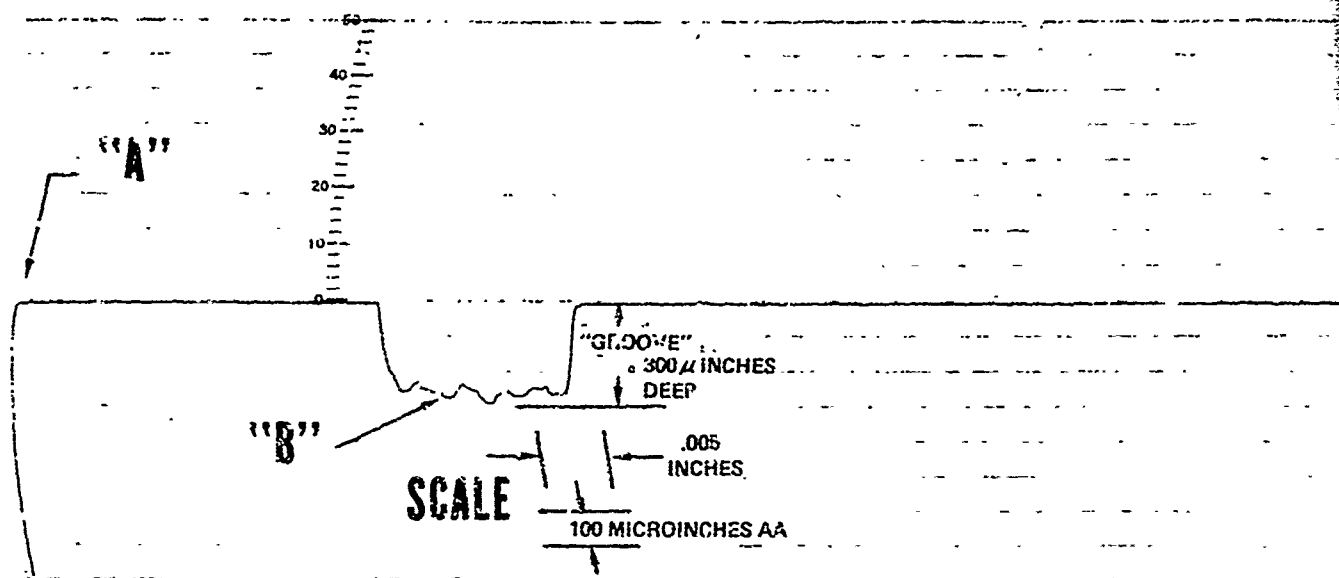
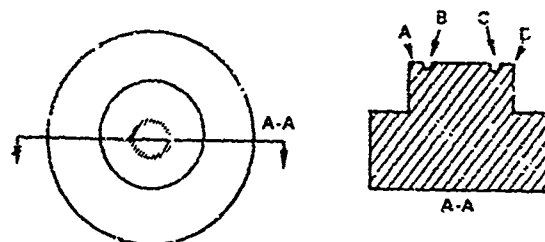
Figure 14. Proficorder Trace, K-96 Poppet, Post-Test 14.

WORN AREA ON POPPET FACE
WHERE SEAT CONTACT IS MADE

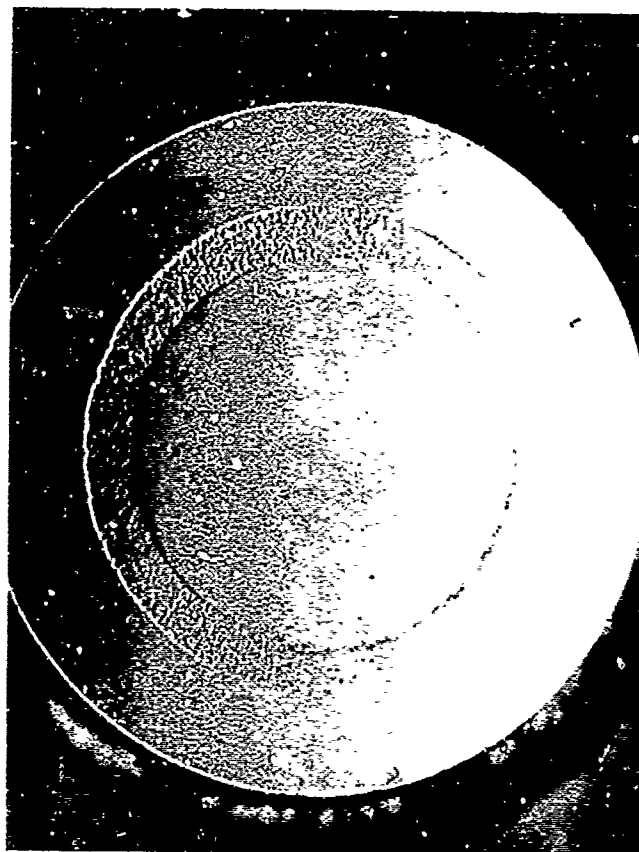
Figure 24. Poppet, K-801, Post-Test '9 (Dark-Field Lighting-20X)

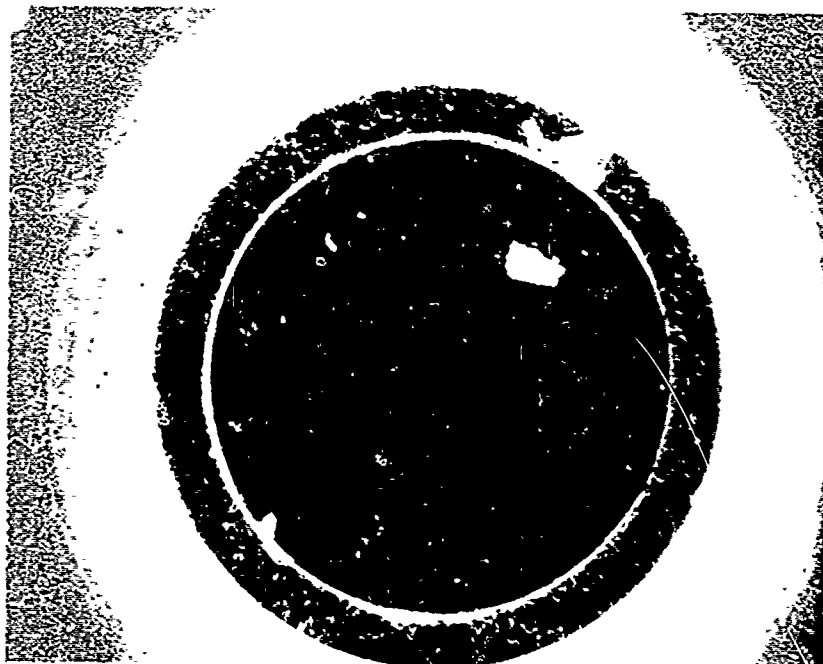
Figure 44. Seat, Aluminum on Ni 301,
Post-ClF₅ Testing (25X)

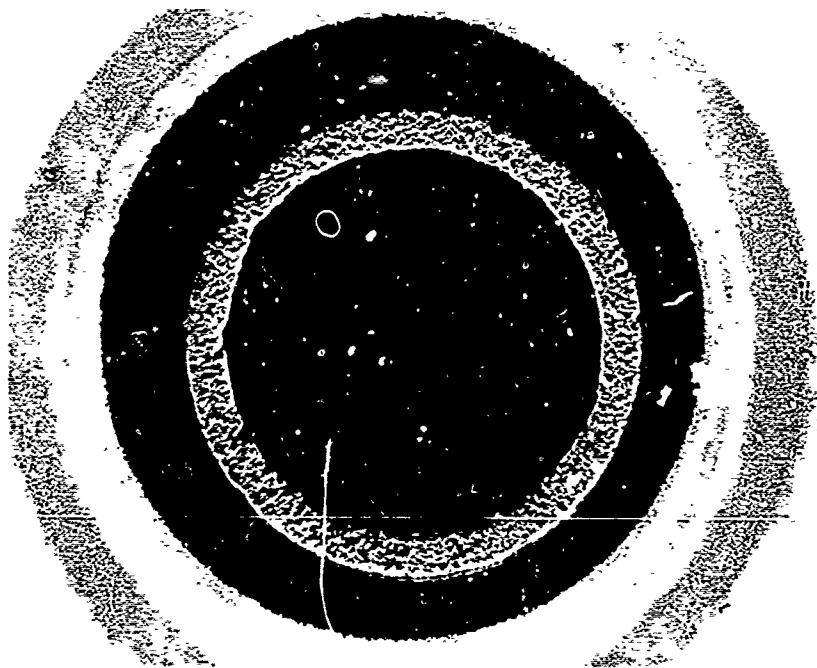
Figure 45. Poppet, Aluminum on Ni 301,
Post-ClF₅ Testing (20X)

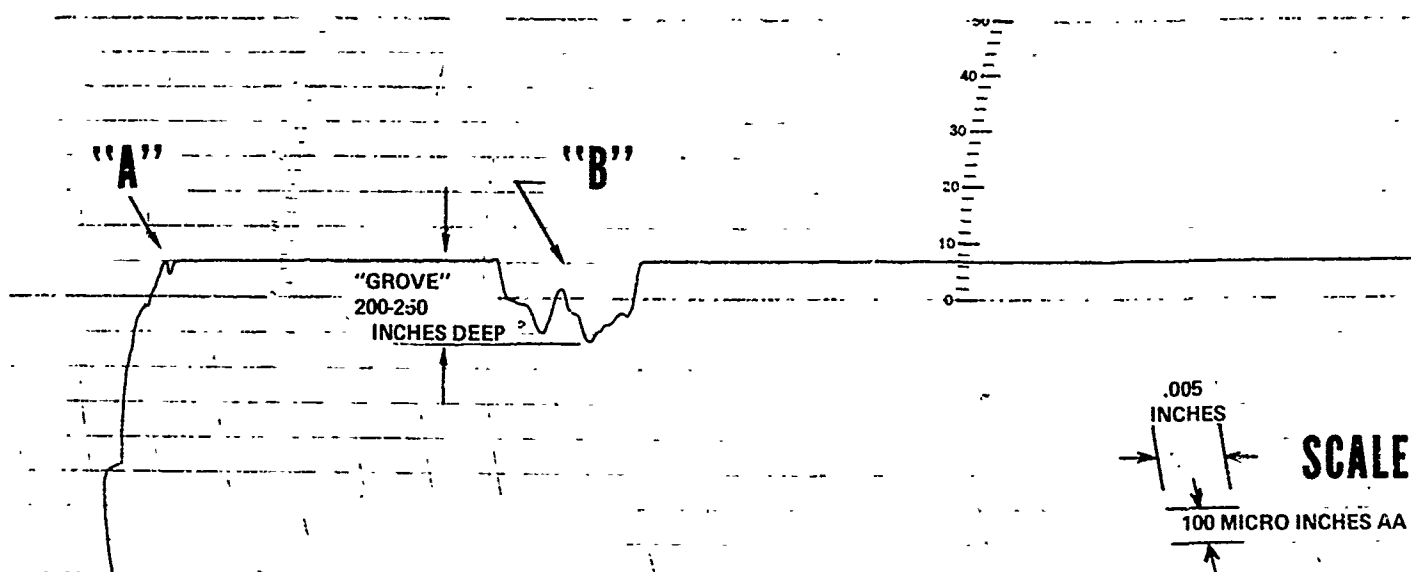
Figure 46. Proficorder Trace, Aluminum on Ni 301 Poppet,
Post ClF₅ Testing

WORN AREA ON POPPET FACE
WHERE SEAT CONTACT IS MADE

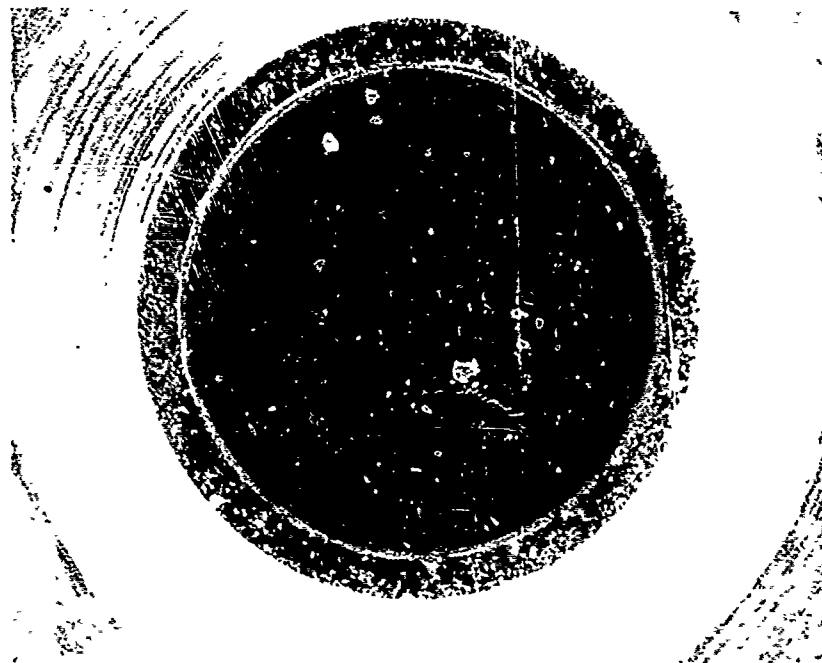
Figure 49. Seat, Sputtered Tungsten (1000Å)
on Ni 301, Post-ClF₅ Testing (25X)

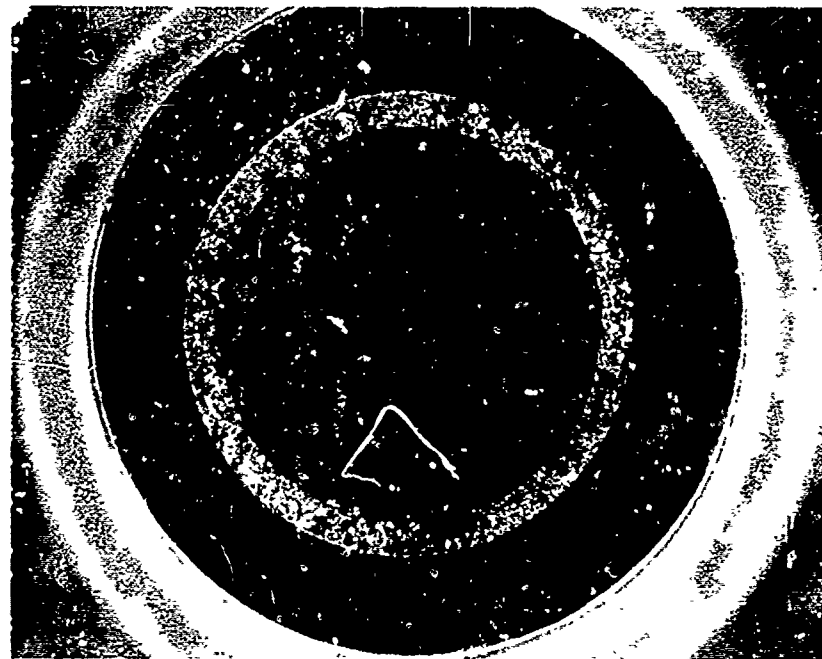
Figure 50. Poppet, Sputtered Tungsten (1000Å)
on Ni 301 Post-ClF₅ Testing (20X)

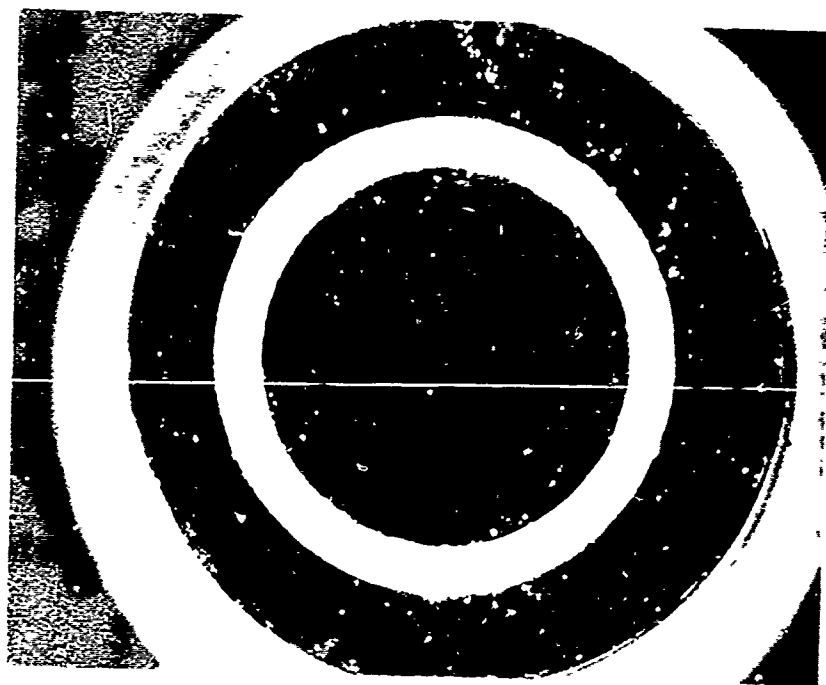
Figure 56. Poppet, 6000Å Chromium on Ni 301,
Post-ClF₅ Testing (20X)

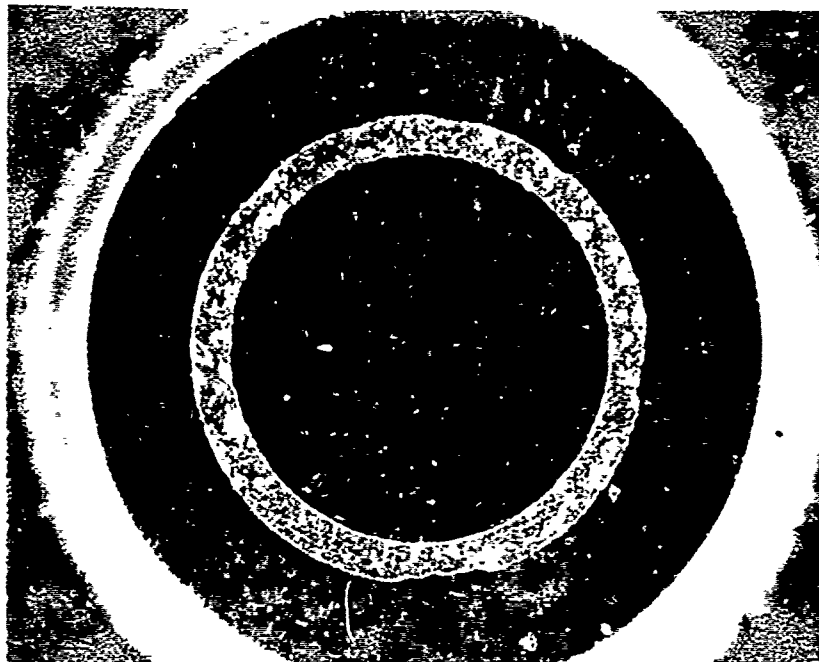
Figure 58. Poppet, 6000Å Tungsten on
Pyromet X-15, Post-ClF₅ Testing (20X)

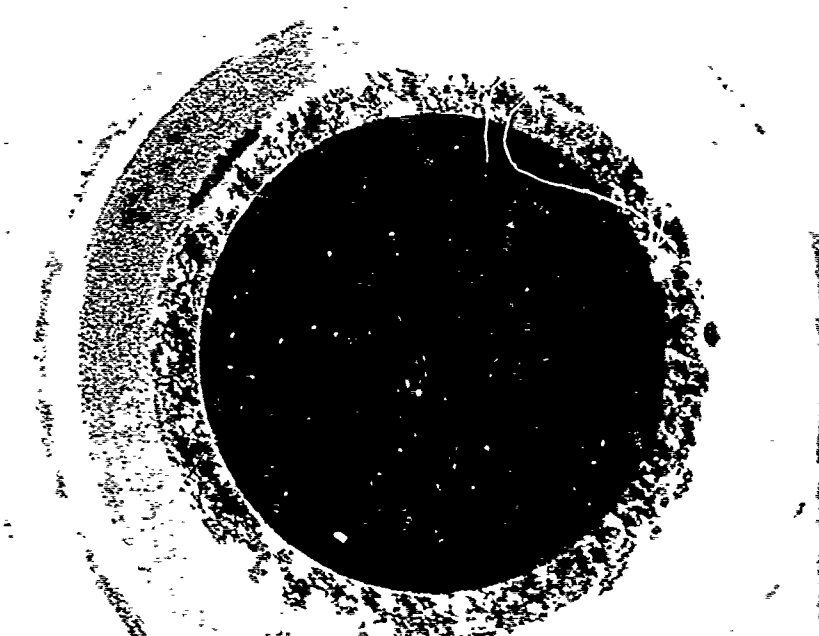
Figure 57. Seat, 6000Å Tungsten on
Pyromet X-15, Post-ClF₅ Testing (25X)
