IMPROVED MATERIALS AND MANUFACTURING
METHODS FOR GUN BARRELS. PART I

Army Weapons Command

August 1972

SWERR-TR-72-54

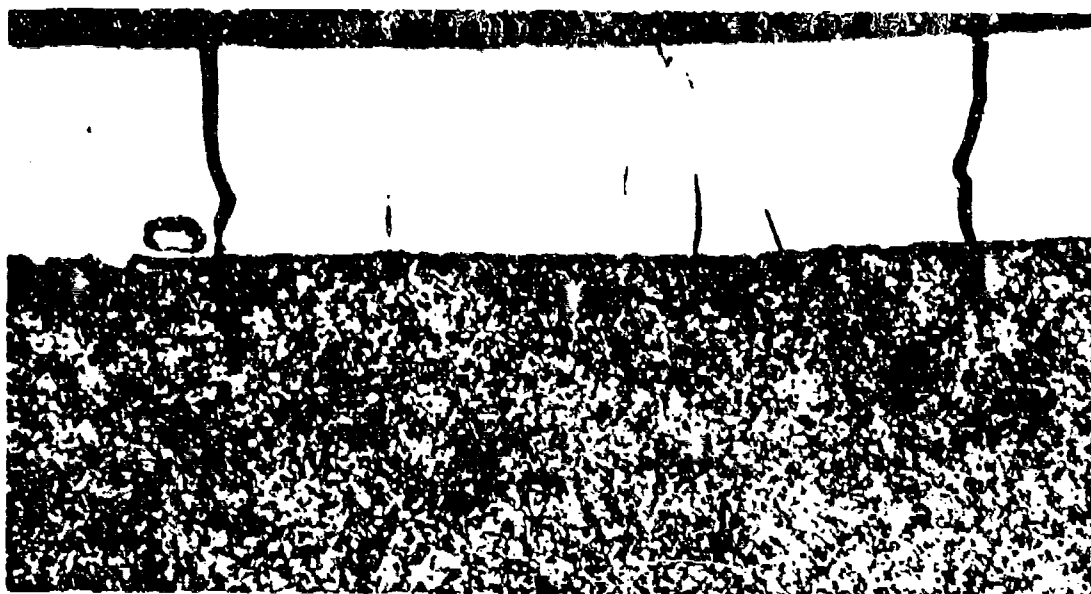
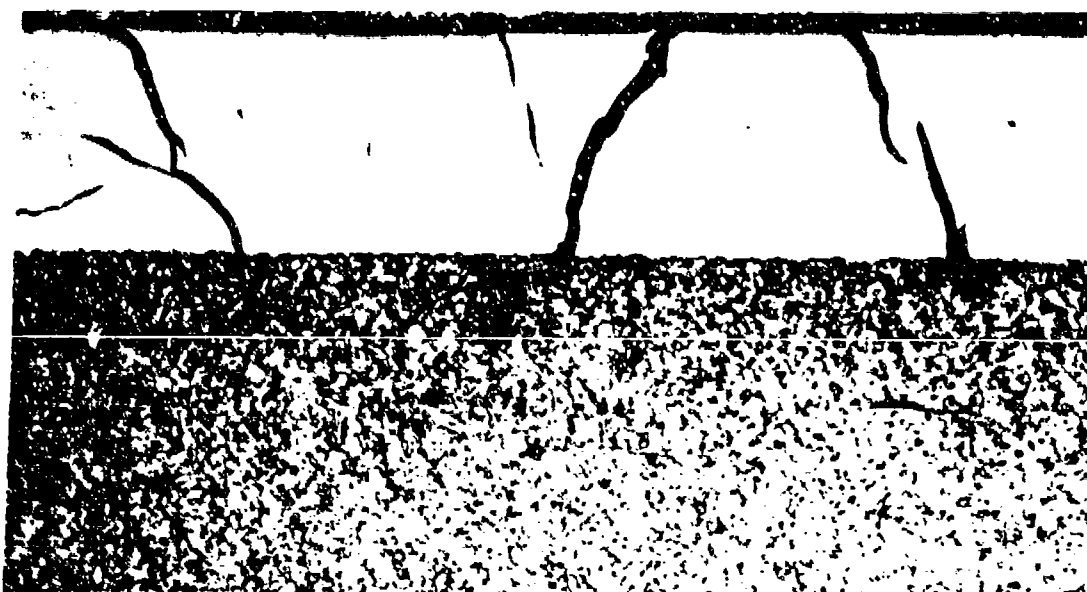
To determine the onset characteristics of erosion in the 7.62mm barrels, plated and unplated barrels were fired in continuous bursts for 1, 10, 50, 100, and 300 rounds. To establish the long-term characteristics a series of chromium-plated barrels which had been fired to rejection were examined. In the chromium-plated barrel, relatively large cracks are developed in the chromium plate after one shot. Each additional shot opens these cracks and causes them to propagate toward the steel. In a very short period (less than 300 rounds) the crack reaches the steel, the opening and closing of the crack is coupled to the steel at the chromium plate/steel interface, and the accompanying pressure and thermal excursions initiate a crack in the steel and propagation occurs. Figure 1 shows the plated barrel which was subjected to the 300-round burst. It should be noted that the crack in the steel is an extension of the crack in the chromium plate and that there is no white layer present. The cracks present in Figure 1 were examined at magnifications up to 20,000X, and no evidence of a white layer was seen. Figure 2 typifies a barrel which has been fired to failure. The cracking has significantly progressed into the steel, large regions of chromium plate and steel have been removed, and the cracks are encased in the white layer. Figures 3 and 4 are photomicrographs of a crack and associated white layer. Examination of Figure 4a and b reveals that cracking occurs around the white layer rather than through the layer. From this evidence, it appears that the white layer is produced after the crack has occurred. With continued firing the white layer flakes off and the crack widens.

FIGURE 1 PHOTOMICROGRAPHS SHOWING CHROMIUM PLATE/STEEL
INTERFACE OF A MINIGUN BARREL AFTER 300 SHOTS.

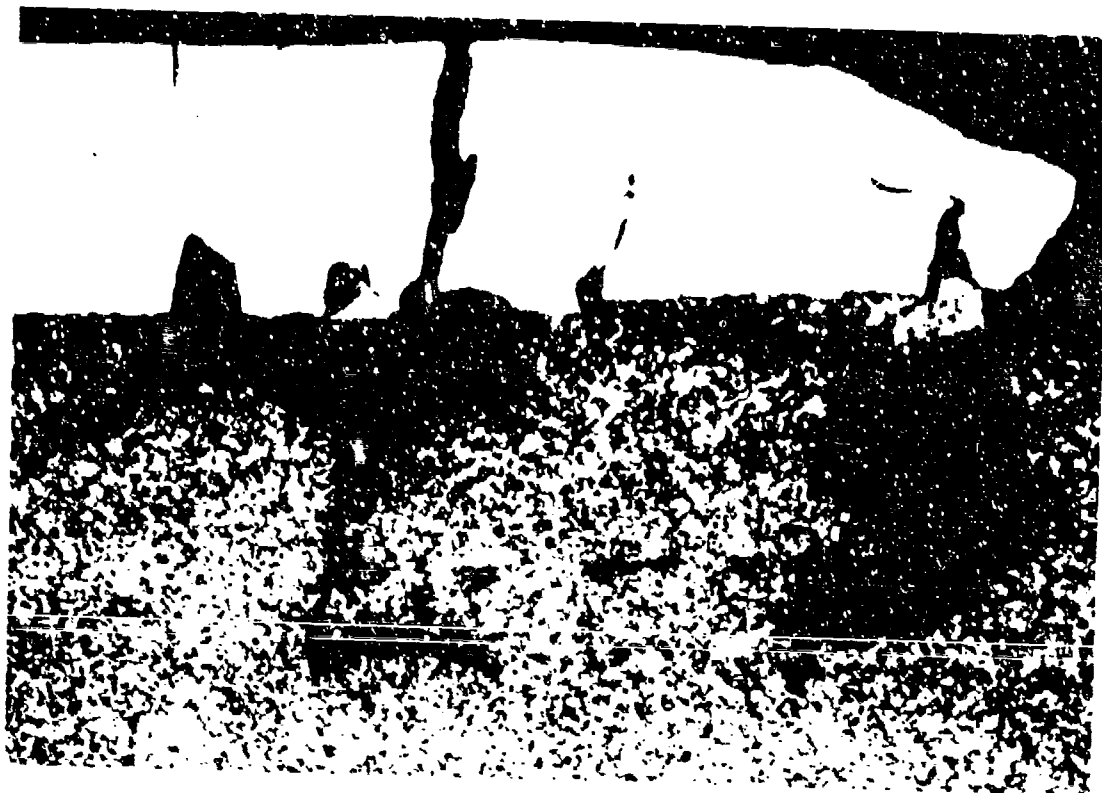
FIGURE 2 PHOTOMICROGRAPH OF A LONGITUDINAL SECTION SHOWING
TYPICAL CHROMIUM PLATE/STEEL INTERFACE
AFTER FIRING TO FAILURE.

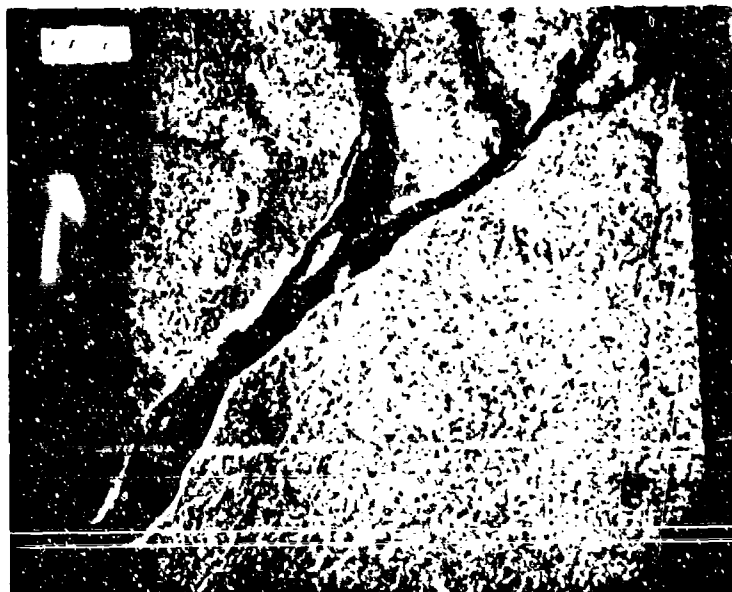
FIGURE 3 SCANNING ELECTRON MICROGRAPH SHOWING TYPICAL CRACK AND ASSOCIATED WHITE LAYER ON FAILED GUN BARREL.

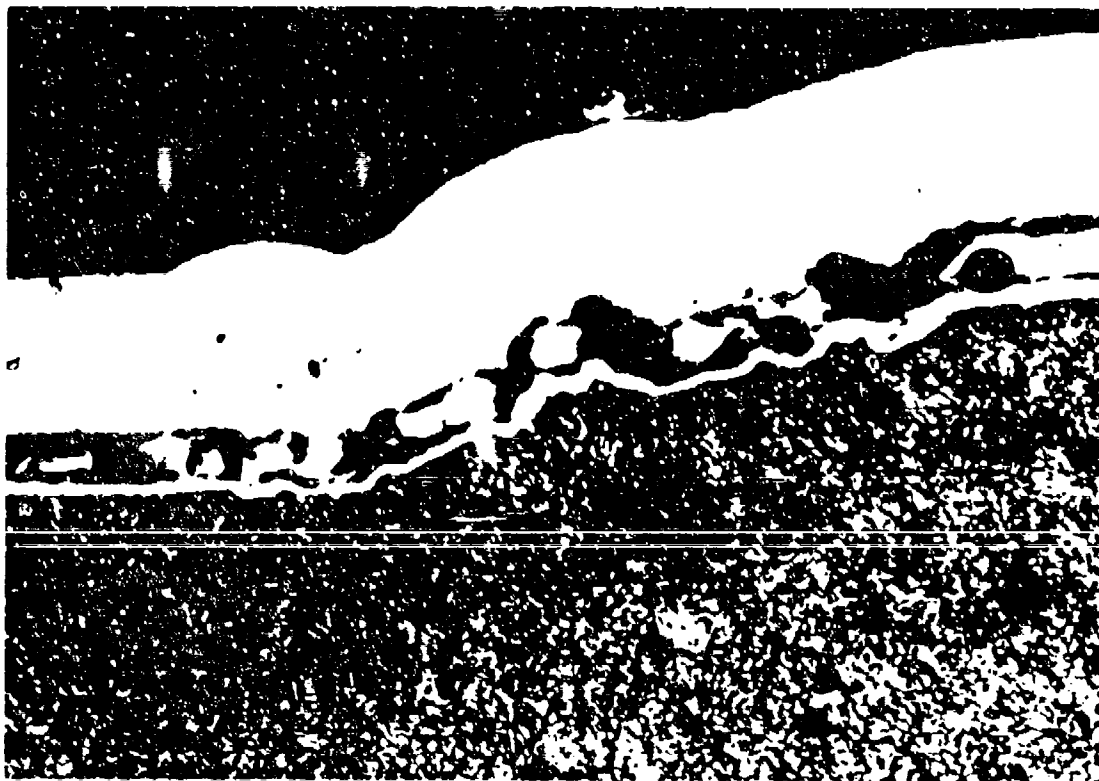
Examination of the fired unplated barrels revealed that material removal or erosion was the prime mode of failure for gun steel. The lands are flattened considerably by firing. Figure 5 typifies the microstructure along the bore surface and shows the intersection of a land and groove.

FIGURE 5 PHOTOMICROGRAPH SHOWING THE TRANSVERSE STRUCTURE
ALONG THE BORE SURFACE OF UNPLATED GUN BARREL AFTER 300 SHOTS.
(Bore surface was nickel plated for metallographic examination.)

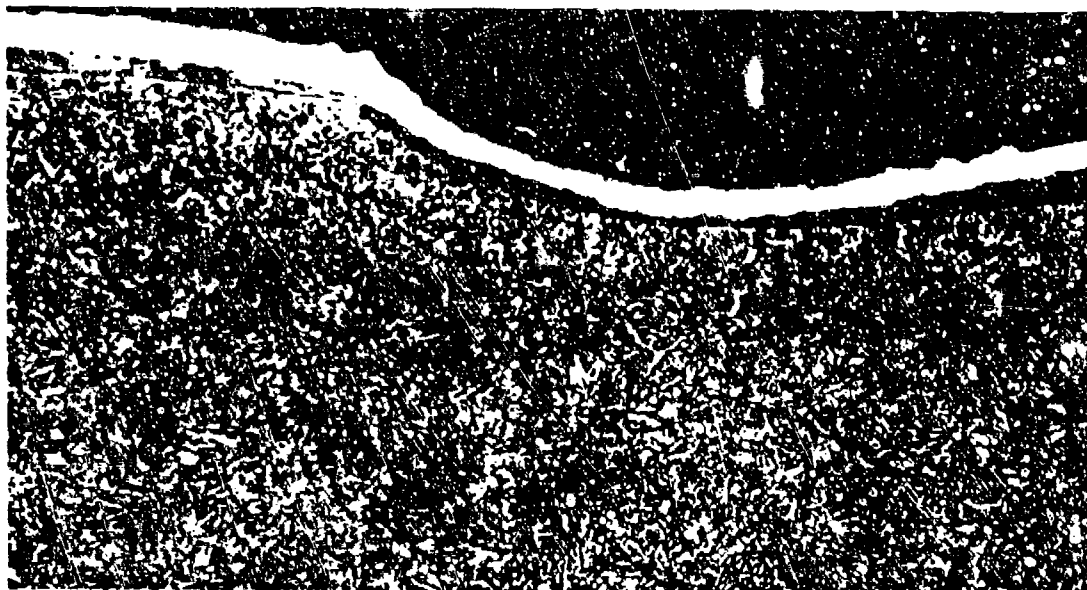
Each of the three vented bomb fired materials was metallographically examined. Figures 8 and 9 show the bore surface of the unplated rifled inserts which were fired with IMR and WC846 propellants. The bore surface was plated with nickel to preserve surface effects. Both sections shown in these figures are at a land and groove intersection. Evidently in the vented bomb gun steel does not crack, but rather there appears to be a general removal of metal along the bore surface and a rather sharp heat-affected zone present. In both cases, the rifling is flattened but much more extremely with the IMR propellant. This mode of failure is similar to that encountered in gun tests.

FIGURE 8 PHOTOMICROGRAPH REVEALING THE TRANSVERSE STRUCTURE
ALONG THE BORE SURFACE OF AN UNPLATED RIFLED INSERT AFTER
5 VENTED BOMB SHOTS WITH WC846 PROPELLANT.

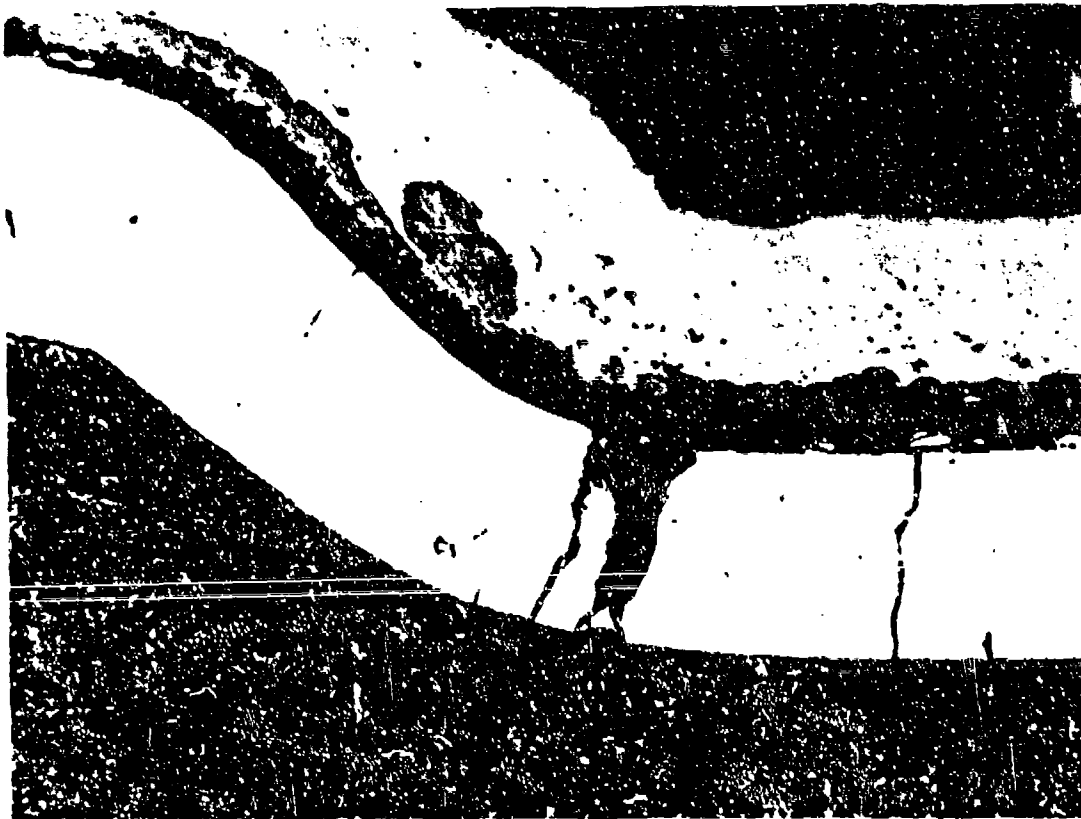
Typical land and groove intersections of the rifled, chromium-plated inserts subjected to 5 firings in the vented bomb with WC846 and IMR propellants are shown in Figures 10 and 11. It is apparent that cracking from the chromium plate has progressed into the steel, but no spalling off has occurred. This mode of failure is similar to that encountered in gun tests.

FIGURE 10 PHOTOMICROGRAPH REVEALING THE TRANSVERSE STRUCTURE
ALONG THE BORE SURFACE OF A CHROMIUM-PLATED RIFLED INSERT
AFTER 5 VENTED BOMB SHOTS WITH WC846 PROPELLANT.

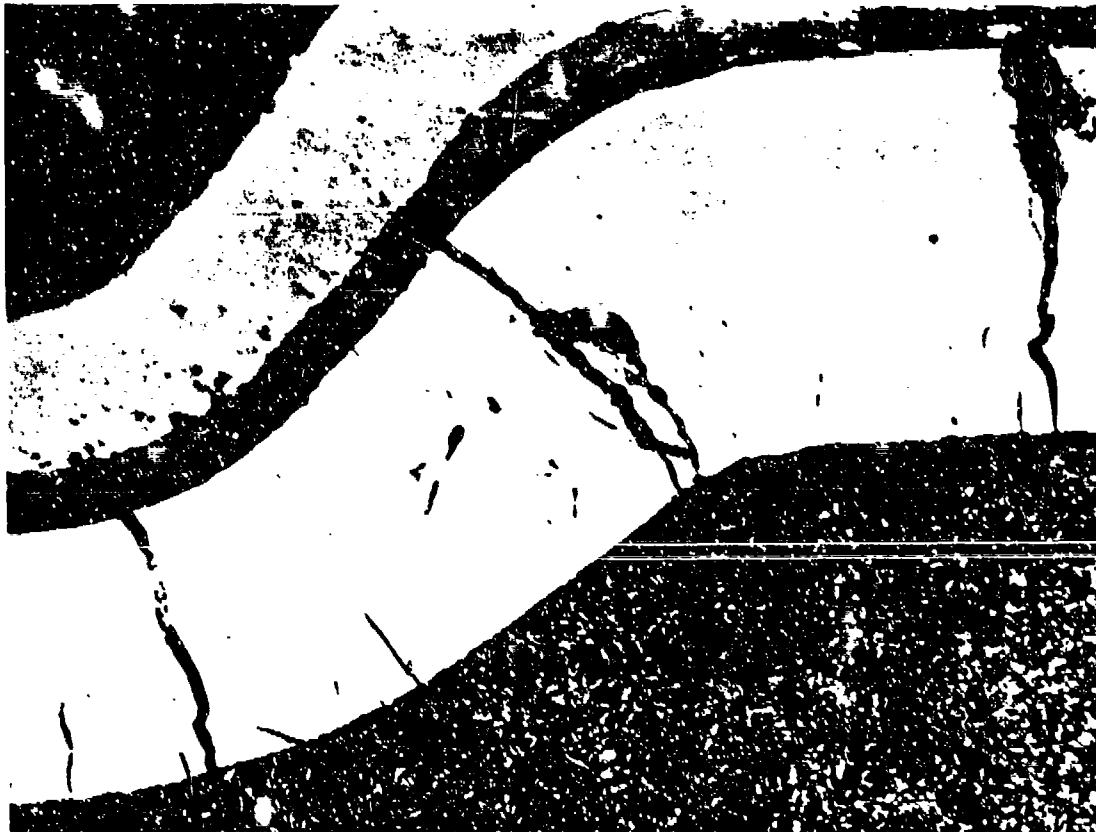
FIGURE 11 PHOTOMICROGRAPH REVEALING THE TRANSVERSE STRUCTURE
ALONG THE BORE SURFACE OF A CHROMIUM-PLATED RIFLED INSERT
AFTER 5 VENTED BOMB SHOTS WITH IMR PROPELLANT.

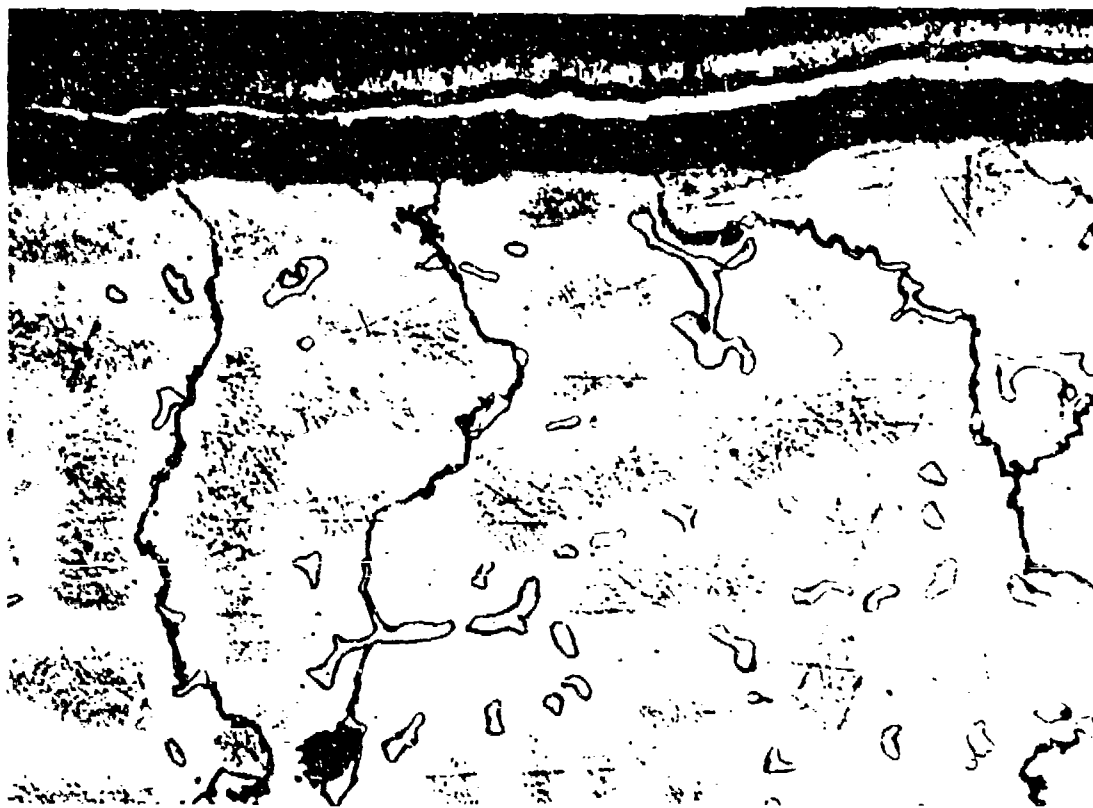
Figures 12 and 13 exhibit transverse microstructures along the bore of the Haynes Stellite 21 test insert after 5 firings in the vented bomb with IMR and WC846 propellants. The nickel plating did not adhere very well to the bore surfaces. The bore surfaces appear to be quite irregular, and chips of metal have been removed.

FIGURE 12 PHOTOMICROGRAPH REVEALING THE TRANSVERSE STRUCTURE
ALONG THE BORE SURFACE OF A HAYNES STELLITE 21 INSERT AFTER
5 VENTED BOMB FIRINGS WITH WC846 PROPELLANT.

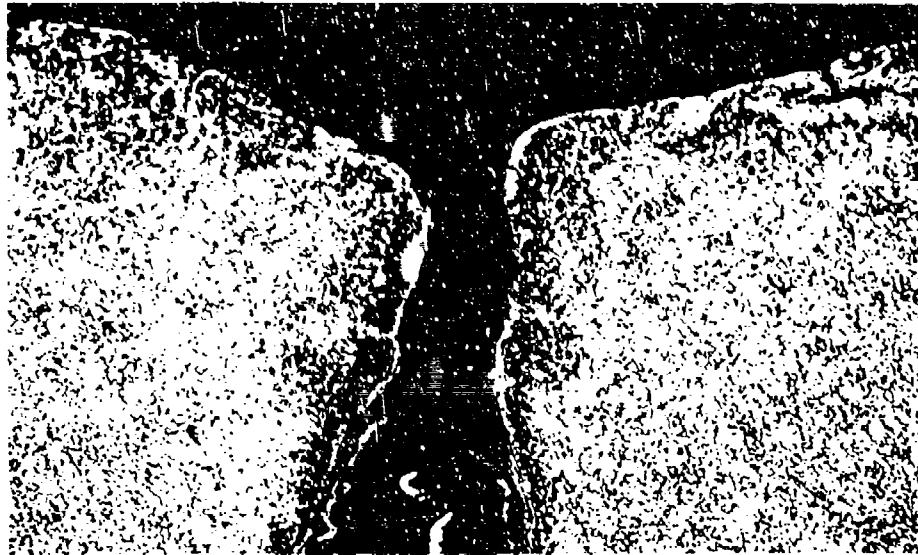
FIGURE 49 TRANSVERSE SECTION AT 1/2 INCH FROM THE CHAMBER OF A STANDARD CHROME-PLATED GUN BARREL AFTER FIRING 11,283 ROUNDS AND BEING DECLARED UNSERVICEABLE.

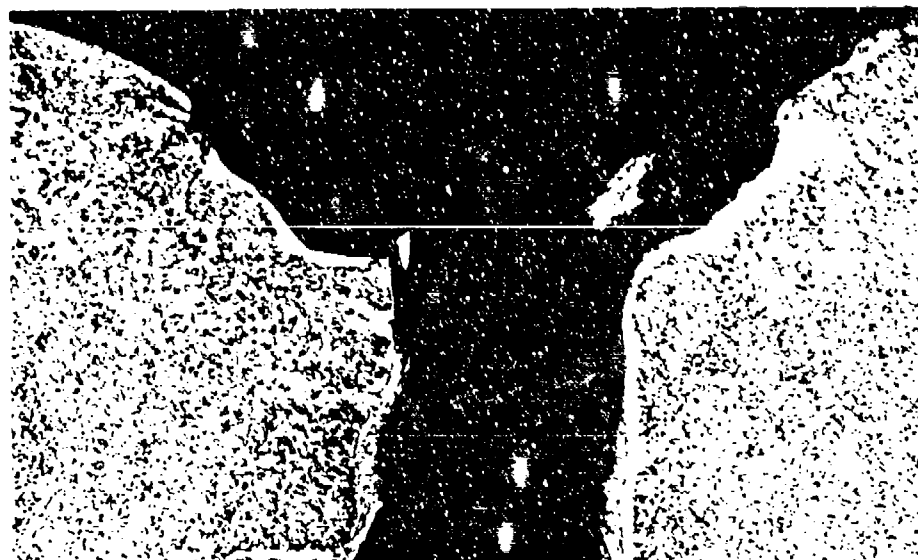
FIGURE 50 TRANSVERSE SECTION AT 1 1/2 INCHES FROM THE CHAMBER OF A STANDARD CHROME-PLATED GUN BARREL AFTER FIRING 11,283 ROUNDS AND BEING DECLARED UNSERVICEABLE.

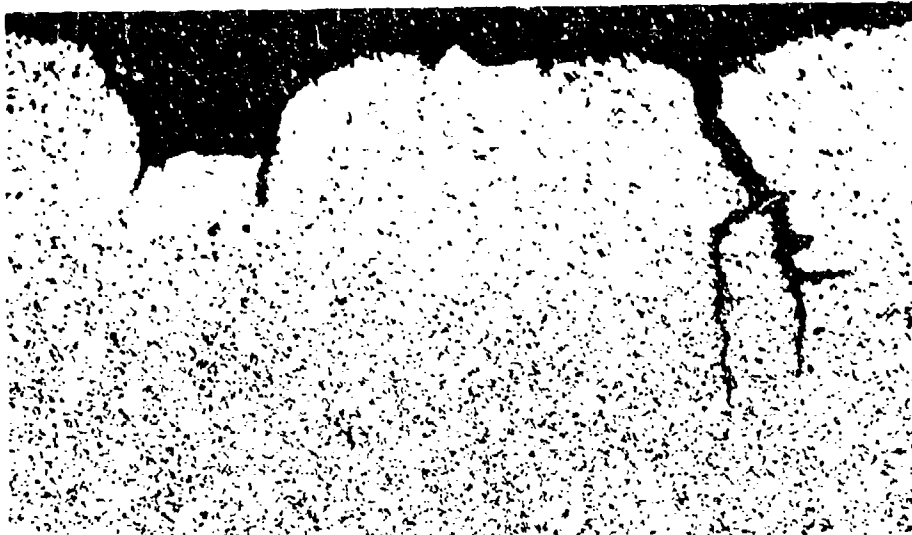
FIGURE 51 TRANSVERSE SECTION AT 2 INCHES FROM THE CHAMBER OF A STANDARD CHROME-PLATED GUN BARREL AFTER FIRING 11,283 ROUNDS AND BEING DECLARED UNSERVICEABLE.

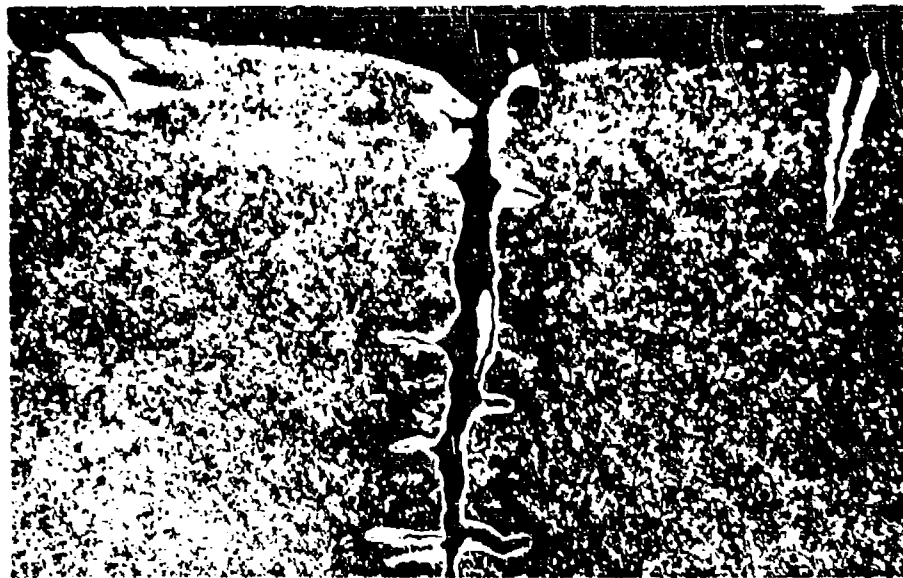
Examination of the transverse section which was cut 1/2 inch from the chamber was very similar to Figure 49. The chrome plating was completely removed, and large cracks with copper alloy in them were present; however, none of the cracks were more than half way through the barrel wall. Figure 55 shows one of the intermediate cracks and typifies the area at the 1/2 inch position.

FIGURE 55 TRANSVERSE SECTION AT 1/2 INCH FROM THE CHAMBER OF A STANDARD CHROME-PLATED GUN BARREL AFTER FIRING 12,068 ROUNDS AND BEING DECLARED UNSERVICEABLE.

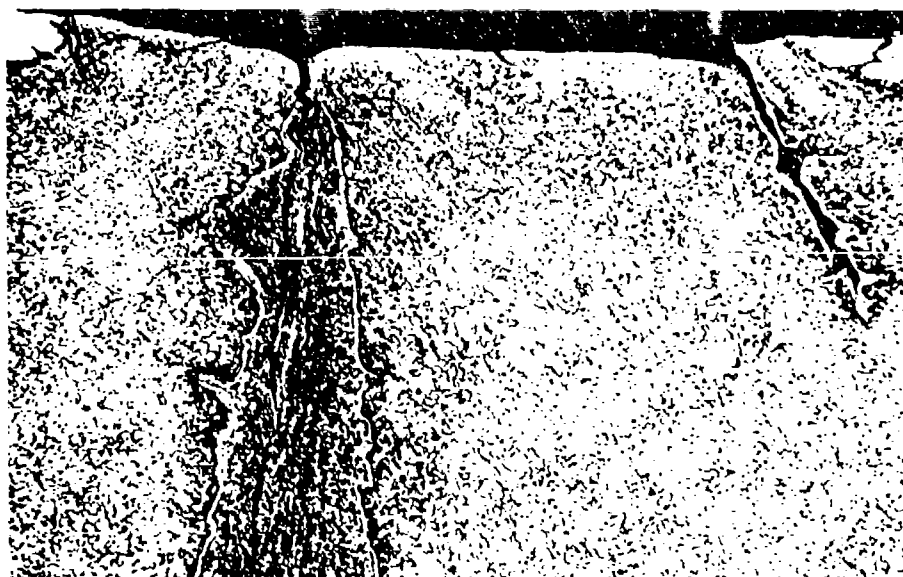
FIGURE 57 TRANSVERSE SECTION AT 2 INCHES FROM THE CHAMBER OF A STANDARD CHROME-PLATED GUN BARREL AFTER FIRING 12,068 ROUNDS AND BEING DECLARED UNSERVICEABLE.

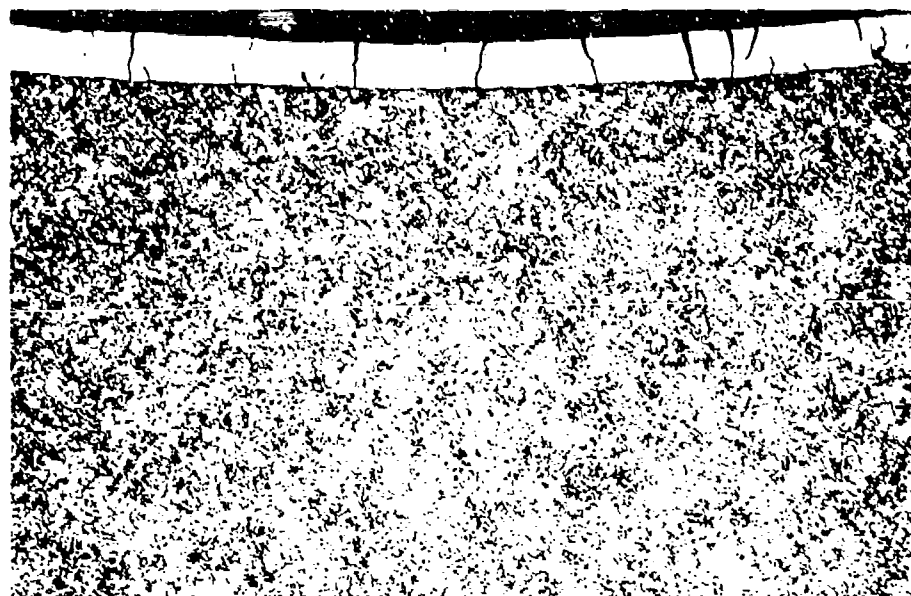
FIGURE 58 TRANSVERSE SECTION AT 10 INCHES FROM THE CHAMBER OF A STANDARD CHROME-PLATED GUN BARREL AFTER FIRING 12,068 ROUNDS AND BEING DECLARED UNSERVICEABLE.

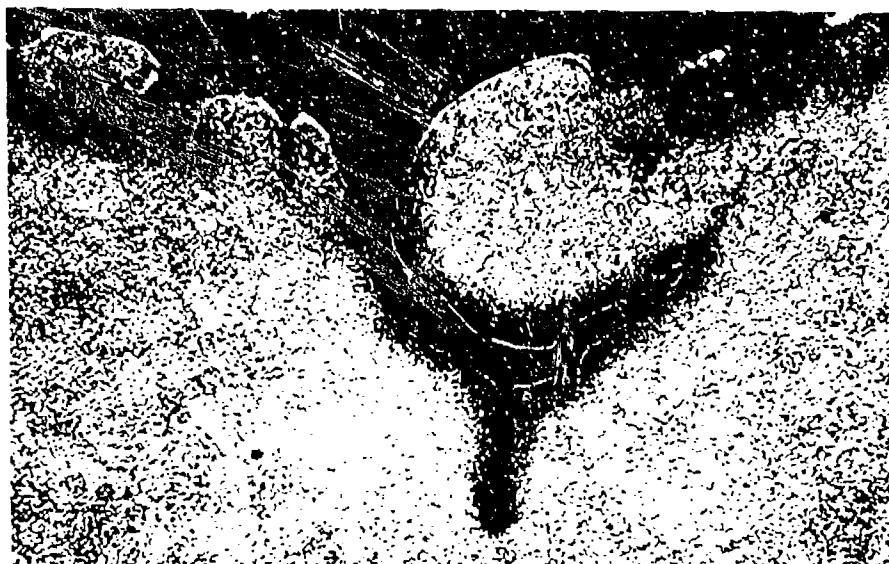
The transverse section at 1/2 inch from the chamber is shown in Figure 61. The removal of the chrome plate, the massive erosion of the steel, the crack in the steel, and the presence of white layer are apparent. The metallurgical

FIGURE 61 TRANSVERSE SECTION AT 1/2 INCH FROM THE CHAMBER OF A CHROME-PLATED H11 STEEL GUN BARREL AFTER FIRING 16,291 ROUNDS AND BEING DECLARED UNSERVICEABLE.

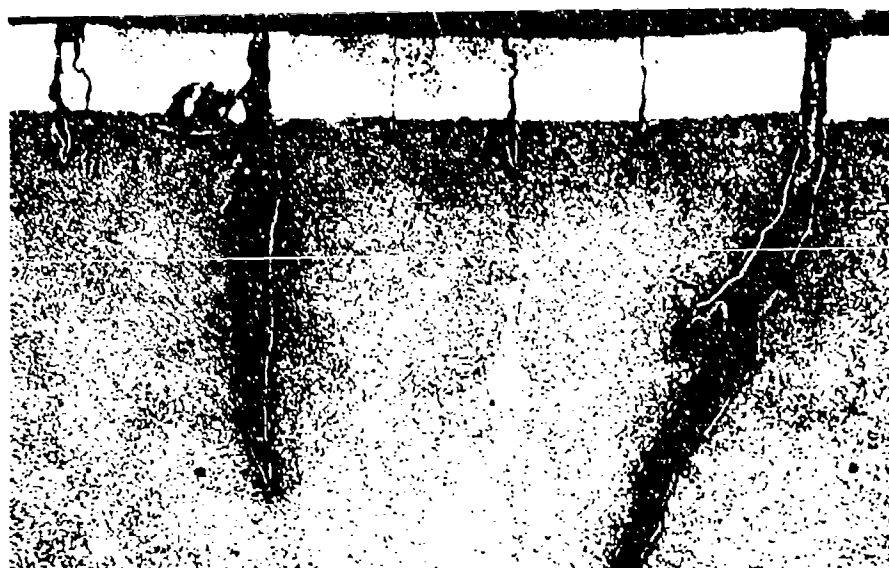
FIGURE 62 TRANSVERSE SECTION AT 1 1/2 INCHES FROM THE CHAMBER OF A CHROME-PLATED H11 STEEL GUN BARREL AFTER FIRING 16,291 ROUNDS AND BEING DECLARED UNSERVICEABLE.

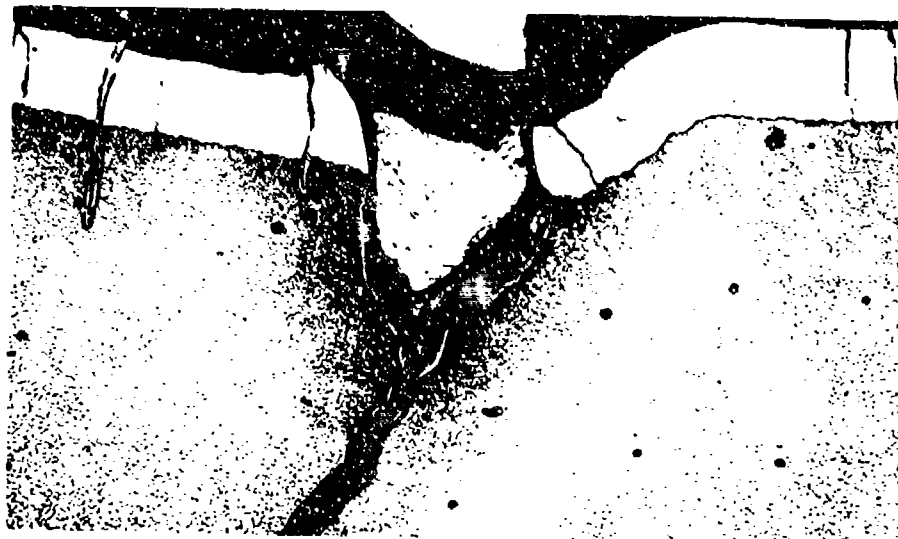
FIGURE 63 TRANSVERSE SECTION A' 2 INCHES FROM THE CHAMBER OF A CHROME-PLATED H11 STEEL GUN BARREL AFTER FIRING 16,291 ROUNDS AND BEING DECLARED UNSERVICEABLE.

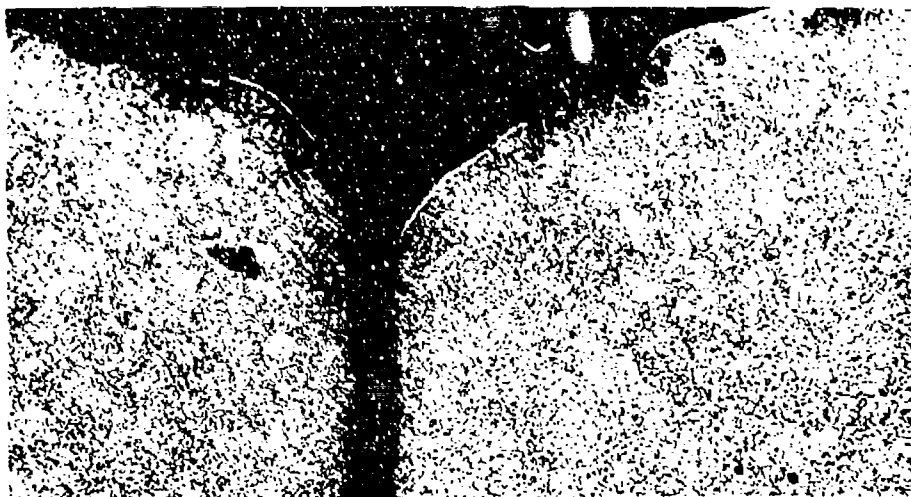
The major difference between the failure mode of the chrome-plated H11 barrels from that of the standard chrome-plated barrels can be attributed to the apparent tenacity of the chrome plate to the H11 steel, the support this steel gives the chrome plate, and the superior high temperature properties of this steel compared to the standard gun steel. Even though both H11 barrels received considerably more

FIGURE 67 TRANSVERSE SECTION AT 1/2 INCH FROM THE CHAMBER OF A CHROME-PLATED H11 STEEL GUN BARREL AFTER FIRING 24,466 ROUNDS AND BEING DECLARED UNSERVICEABLE.

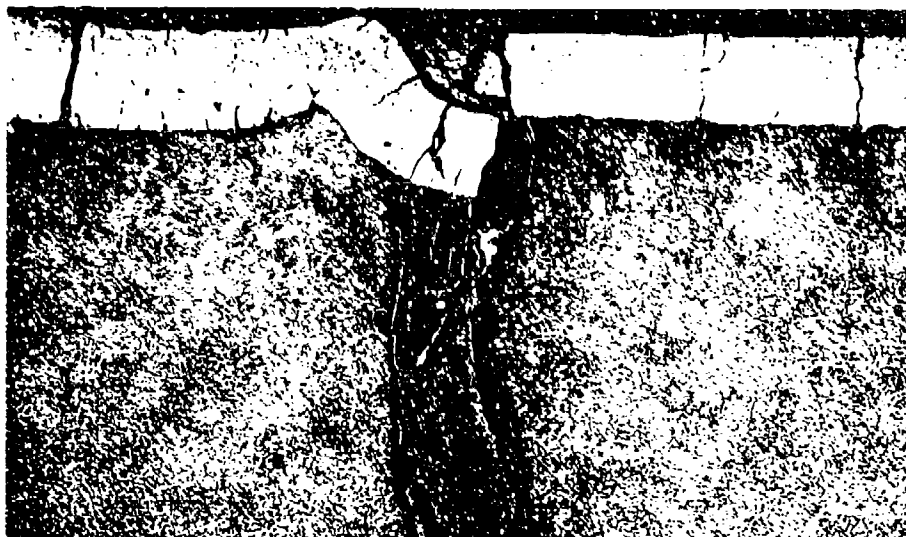
FIGURE 69 TRANSVERSE SECTION AT 2 INCHES FROM THE CHAMBER OF A CHROME-PLATED H11 STEEL GUN BARREL AFTER FIRING 24,466 ROUNDS AND BEING DECLARED UNSERVICEABLE.

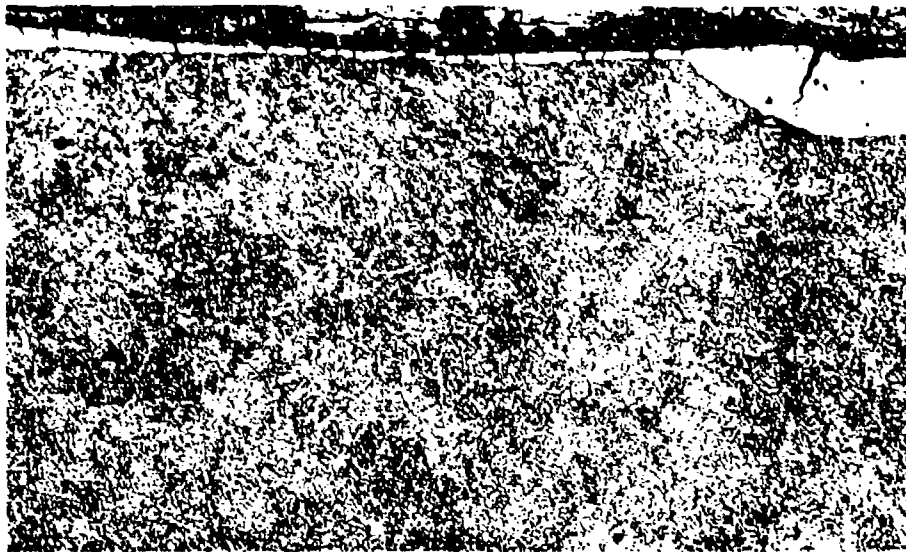
FIGURE 71 TRANSVERSE SECTION AT 17 1/2 INCHES FROM THE CHAMBER OF A CHROME-PLATED H11 STEEL GUN BARREL AFTER FIRING 24,466 ROUNDS AND BEING DECLARED UNSERVICEABLE.

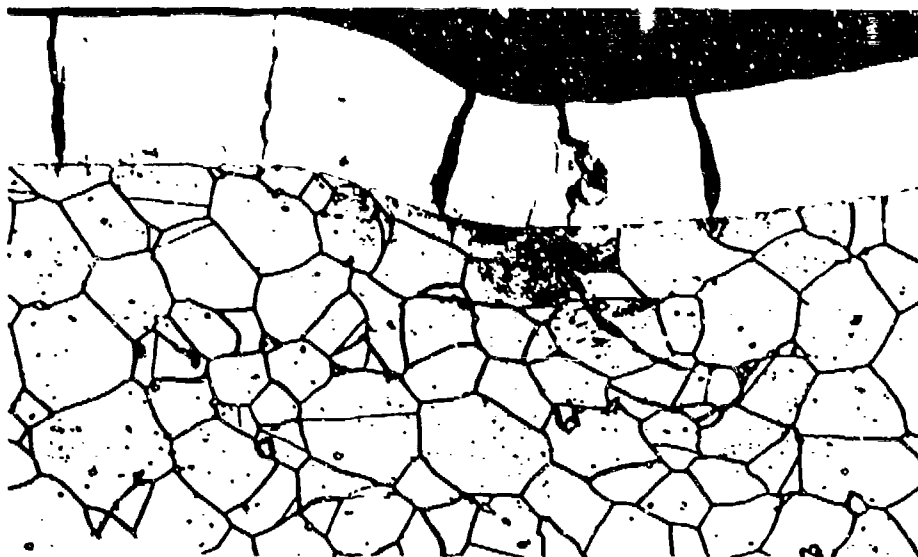
FIGURE 73 TRANSVERSE SECTION AT 1/2 INCH FROM THE CHAMBER OF A CHROME-PLATED CG-27 ALLOY BARREL AFTER FIRING 4,036 ROUNDS AND BEING DECLARED UNSERVICEABLE.

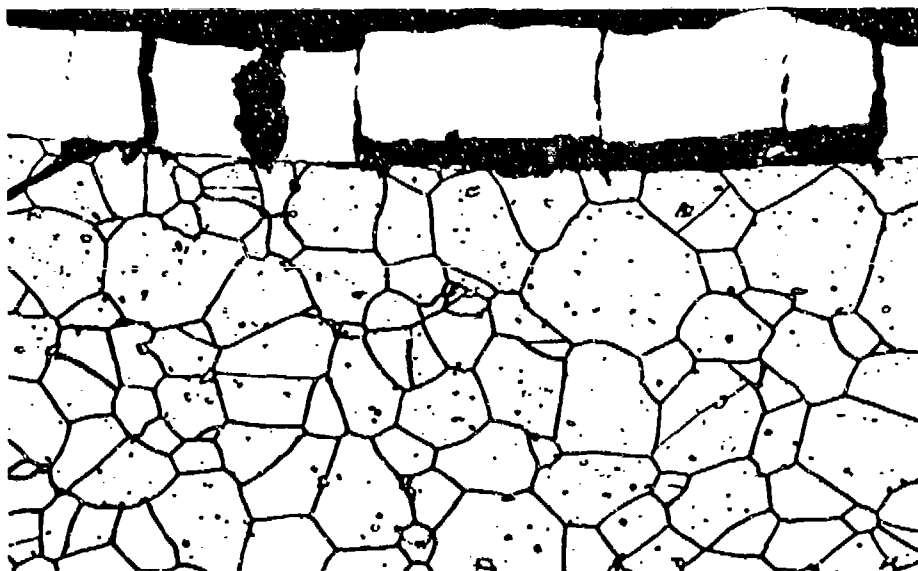
FIGURE 74 TRANSVERSE SECTION AT 1 1/2 INCHES FROM THE CHAMBER OF A CHROME-PLATED CG-27 ALLOY BARREL AFTER FIRING 4,036 ROUNDS AND BEING DECLARED UNSERVICEABLE.

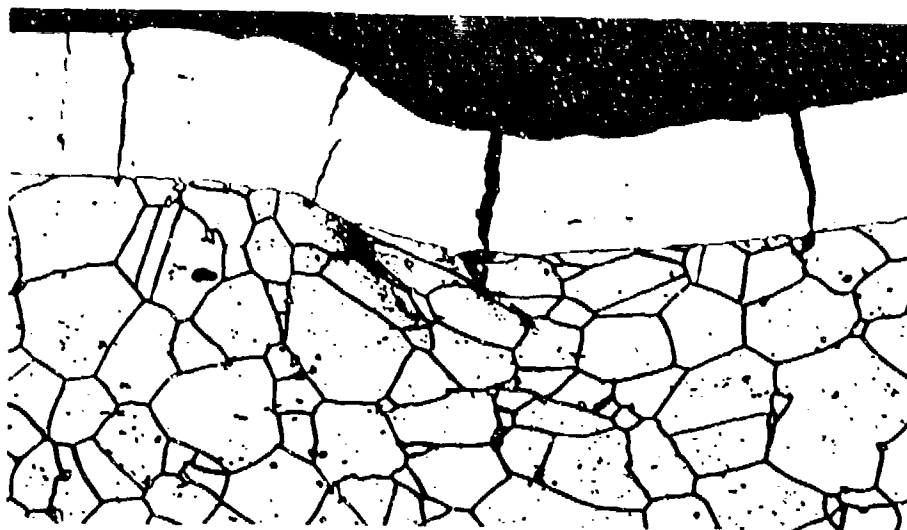
FIGURE 75 TRANSVERSE SECTION AT 2 INCHES FROM THE CHAMBER OF A CHROME-PLATED CC-27 ALLOY BARREL AFTER FIRING 4,036 ROUNDS AND BEING DECLARED UNSERVICEABLE.

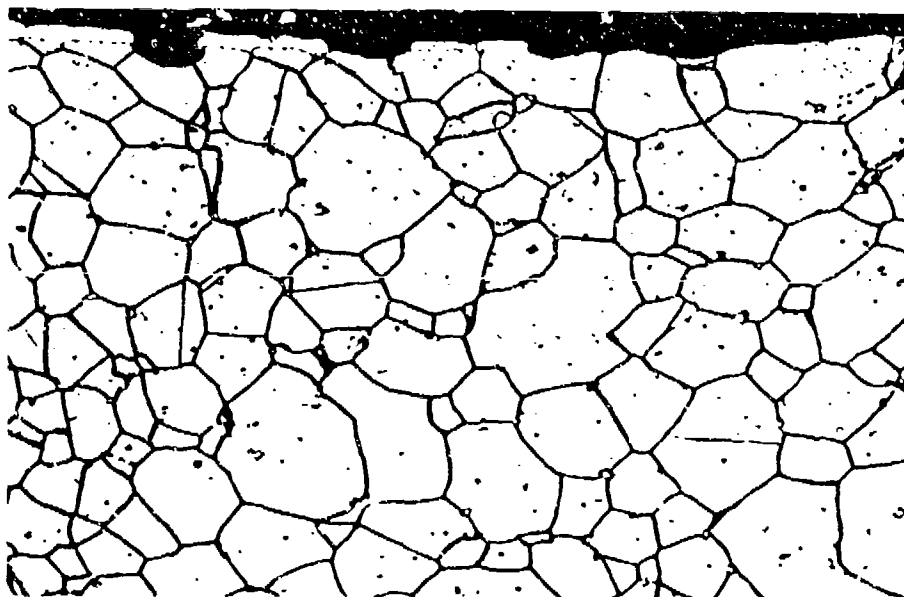
FIGURE 76 TRANSVERSE SECTION AT 10 INCHES FROM THE CHAMBER OF A CHROME-PLATED CG-27 ALLOY BARREL AFTER FIRING 4,036 ROUNDS AND BEING DECLARED UNSERVICEABLE.

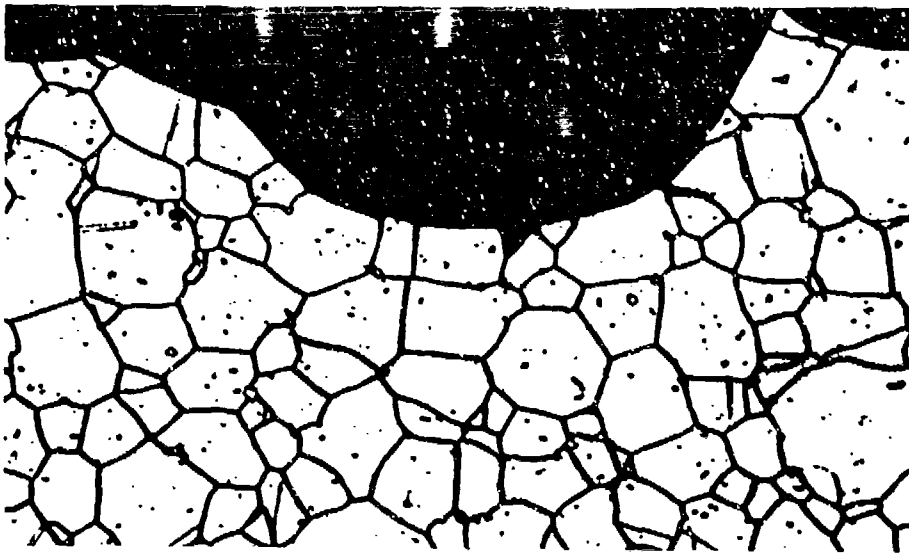
The structure of the bore at the 17 1/2 inch and 18 inch positions from the chamber is shown in Figures 77 and 78. In both positions it appears that extensive material has been removed from the bore surface. This can be attributed to a gas-metal reaction in which the nickel has probably combined with sulfur in the propellant gases to form a low-melting alloy which has washed away.

FIGURE 77 TRANSVERSE SECTION AT 17 1/2 INCHES FROM THE CHAMBER OF A CHROME-PLATED CG-27 ALLOY BARREL AFTER FIRING 4,036 ROUNDS AND BEING DECLARED UNSERVICEABLE.

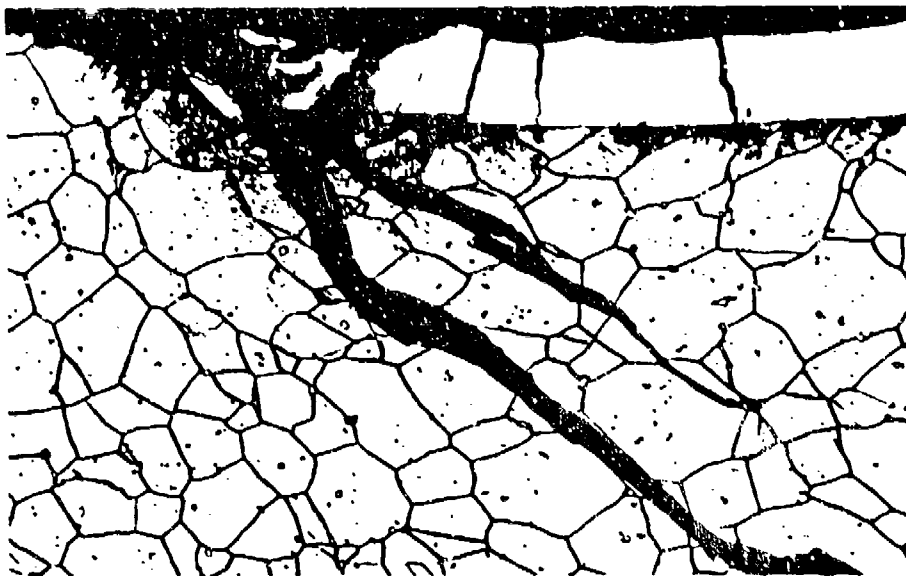
FIGURE 79 TRANSVERSE SECTION AT 1/2 INCH FROM THE CHAMBER OF A CHROME-PLATED CG-27 ALLOY BARREL AFTER FIRING 7,324 ROUNDS AND BEING DECLARED UNSERVICEABLE.

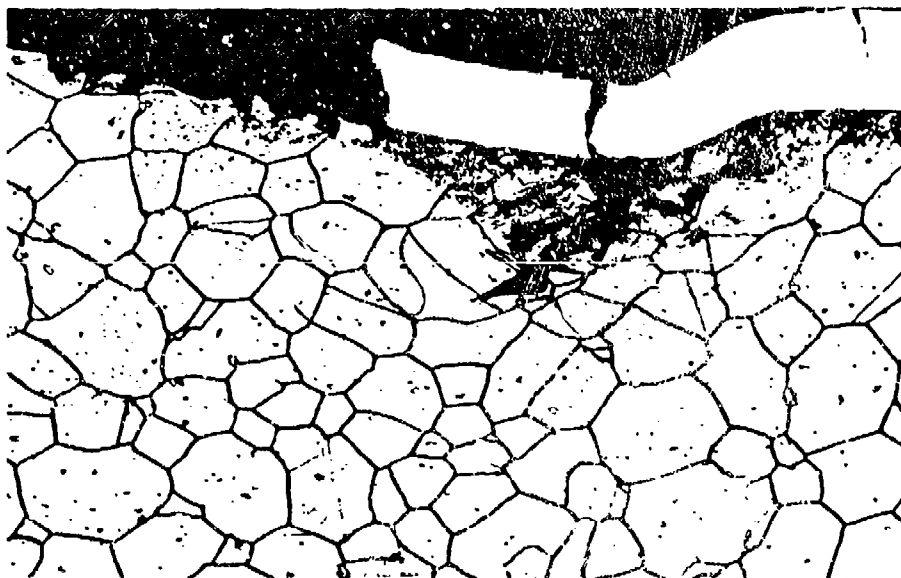
FIGURE 80 TRANSVERSE SECTION AT 1 1/2 INCHES FROM THE CHAMBER OF A CHROME-PLATED CG-27 ALLOY BARREL AFTER FIRING 7,324 ROUNDS AND BEING DECLARED UNSERVICEABLE.

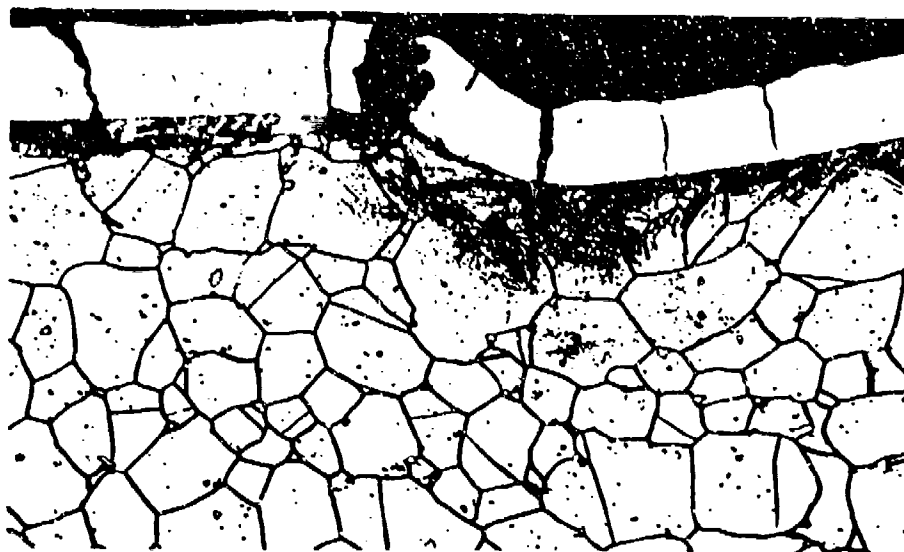
FIGURE 81 TRANSVERSE SECTION AT 2 INCHES FROM THE CHAMBER OF A CHROME-PLATED CG-27 ALLOY BARREL AFTER FIRING 7,324 ROUNDS AND BEING DECLARED UNSERVICEABLE.
