TECHNIQUES FOR OVERLAYING DETERIORATED
LANDING MAT. BARE BASE SUPPORT

MISCELLANEOUS PAPER S-70-23

**TECHNIQUES FOR OVERLAYING
DETERIORATED LANDING MAT
BARE BASE SUPPORT**

Conducted by U. S. Army Engineer Waterways Experiment Station, Vicksburg, Mississippi

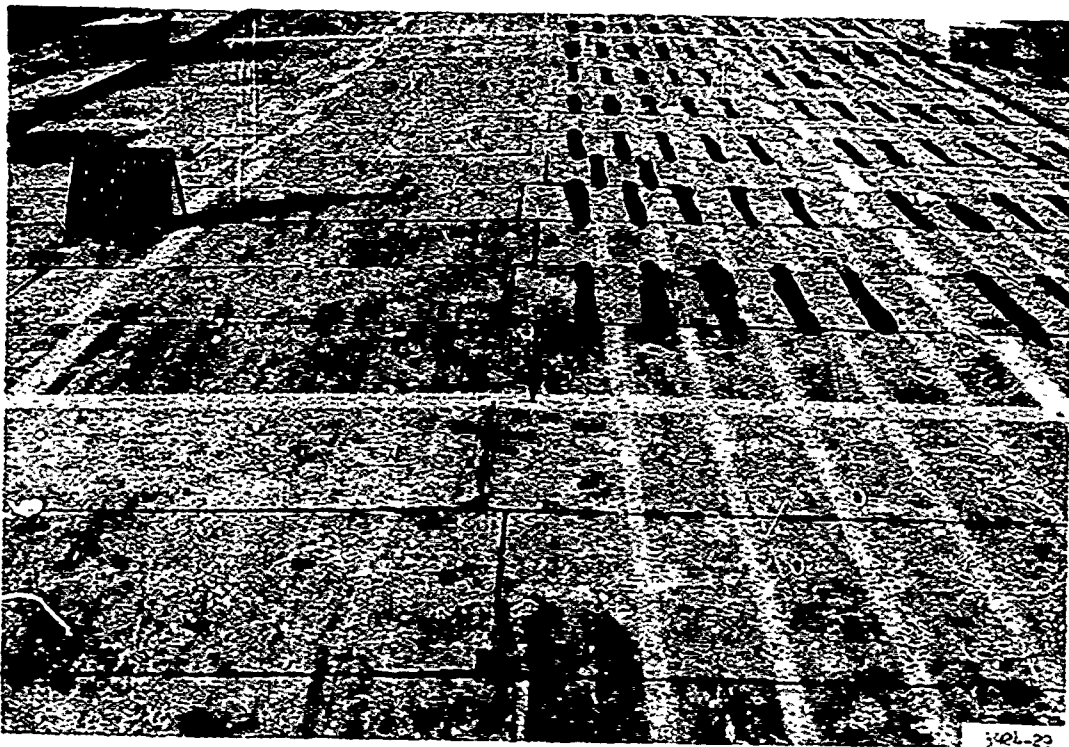
24. Item 1. A general view of item 1 after rearrangement of the mat at 26 coverages is shown in photograph 10. The first mat damage in item 1 appeared at 116 coverages when a small crack developed in an end-connector weld in panel 23. At 160 coverages, an additional three end-connector welds were cracked, but the item was still in serviceable condition. The first panel failure occurred at 210 coverages when the end connector of panel 23 sheared completely from the extruded part of the panel (see photograph 11). At 300 coverages, panel 17, which was two-piece AM2, failed due to severe cracks in both the end-connector weld and the center-line weld (see photograph 12). In addition to the two failed panels, there were eight panels with end-connector weld cracks. After 400 coverages of traffic, a total of 14 end-connector weld cracks had occurred. These cracks averaged about 2.5 in. in length and occurred mostly on the overlapping end connectors. The most severe cracks were in panel 14, where the end-joint weld was cracked almost entirely across the panel, and in panels 23A* and 19, both of which had large cracks on both ends of the end-connector welds. Panel 14 also had a severe crack in the center-line weld. At 457 coverages, panels 19 and 23A failed when the end connectors sheared off. At 500 coverages, panel 6 failed due to end-connector shear, and panel 14 failed due to longitudinal weld breaks. At this time, item 1 was considered failed, having six failed panels and 14 additional areas of panel breakage. A view of item 1 at failure is shown in photograph 13. During application of traffic, approximately 6.92 in. of rainfall was recorded in the test area. After periods of especially heavy rainfall, it was observed that a small amount of the sand in the leveling course had been washed from under the mat and deposited alongside the test section.

Photograph 10. Item 1 after rearrangement of mat at 26 coverages

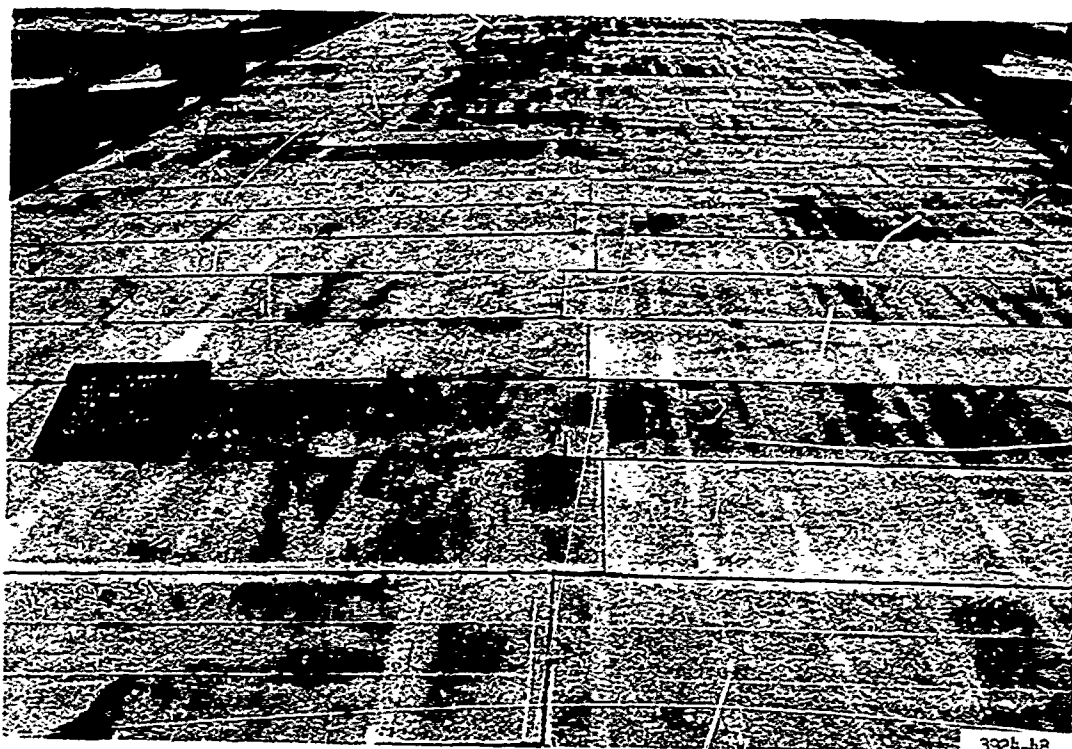
Photograph 13. Item 1 after failure at 500 coverages

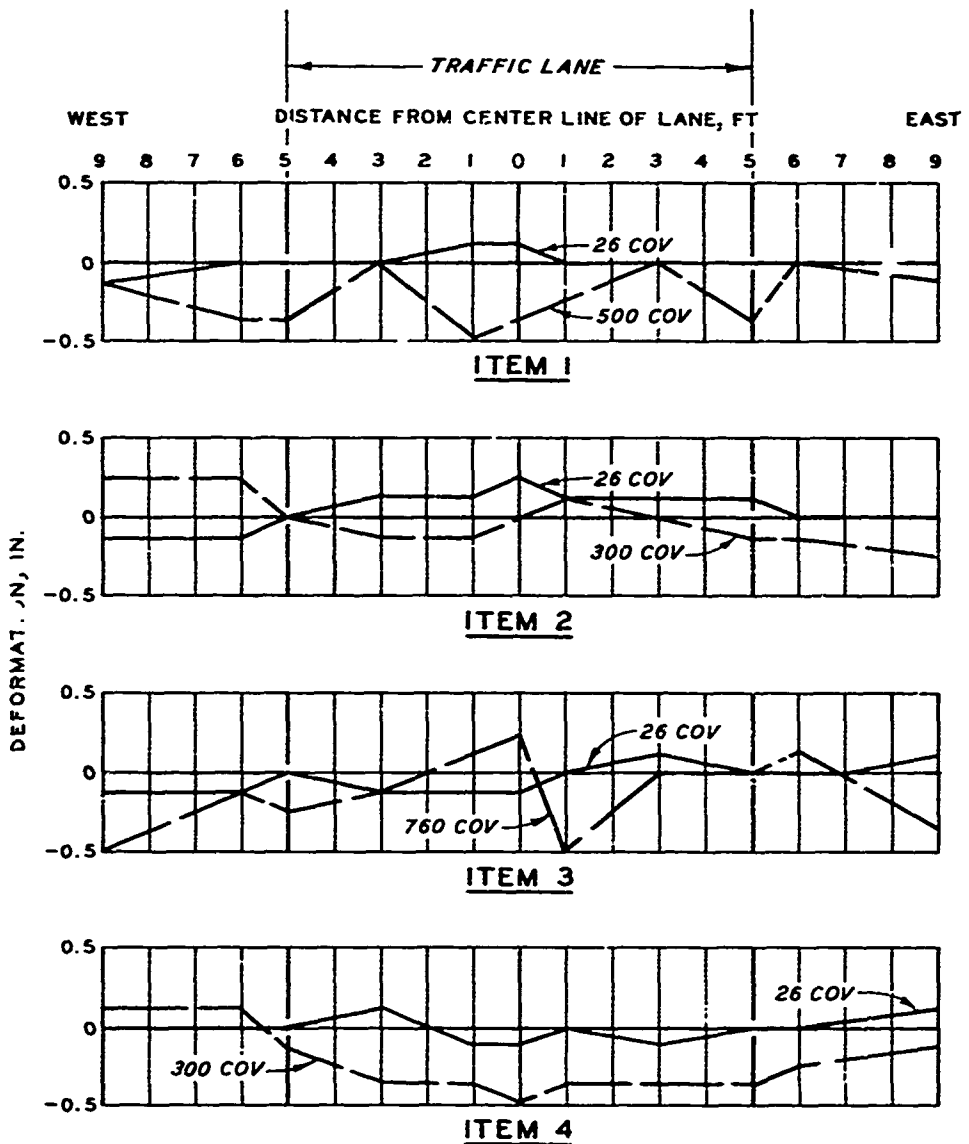
28. Permanent deformation. Plots showing mat deformation as determined from level readings taken at 26 coverages and at failure in each item are shown in plate 4. A maximum deformation of about 0.5 in. was measured at failure in items 1, 3, and 4. In item 2, the maximum deformation at failure was about 0.1 in.

PERMANENT
MAT DEFORMATION
TEST SECTION I
