CONDITION SURVEYS OF PAVEMENTS SUB-  
JECTED TO CHANNELIZED TRAFFIC, REPORT 2,  
MARCH AIR FORCE BASE, RIVERSIDE,  
CALIFORNIA

Army Engineer Waterways Experiment Station  
Vicksburg, Mississippi

June 1958

MISCELLANEOUS PAPER NO. 4-213

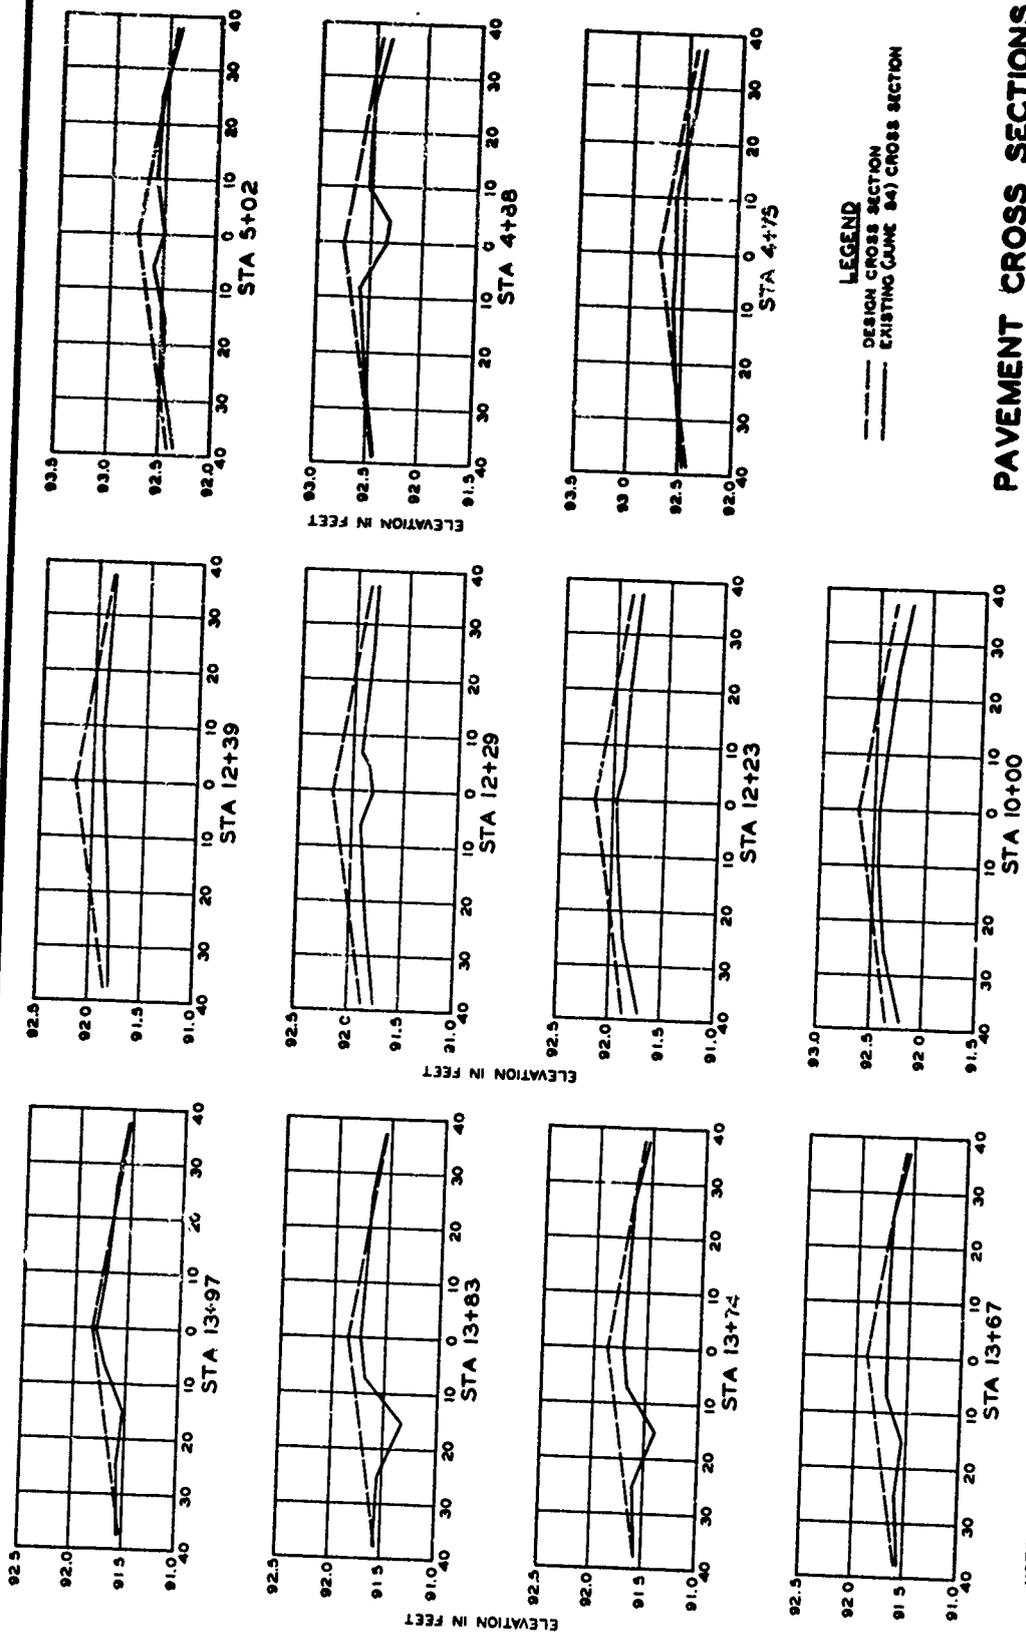
**PAVEMENT CROSS SECTIONS**  
**TAXIWAY 3**  
**STA 4+75 TO STA 13+97**

As indicated in the above table, testing was performed in areas where channelized traffic occurred and outside the areas of channelized traffic so that pavement behavior under different traffic conditions could be studied. The LAD tests were performed on the original taxiway pavement which consisted of about 4 in. of asphaltic concrete. WES test pits 1 and 4 were in areas where a leveling course had been placed prior to the overlay, while test pits 2 and 3 were in areas that had not required a leveling course but had been overlaid with only about 2 in. of asphaltic concrete. WES testing extended into the subsoil layer to a somewhat greater depth than the LAD test trenches. Data from test pit 3 were not intended for comparison of test results but were an attempt to determine the cause of the pavement depression that had occurred in the southeastern portion of runway 2. The deformation that had occurred on the taxiway is indicated on the pavement cross sections, plates 2 and 3.

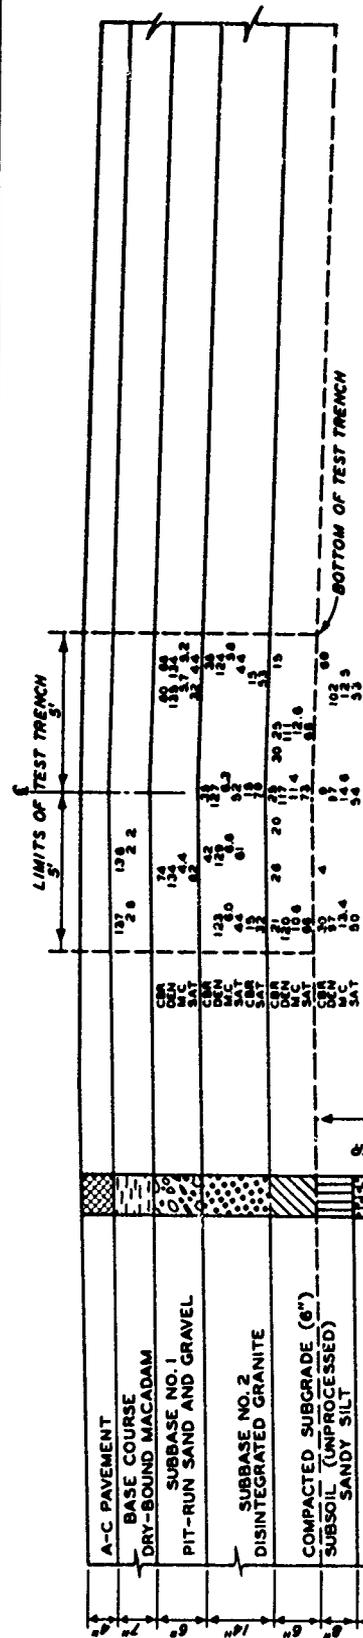
**PROFILE OF TEST TRENCH 2**  
 STA 30+78.5  
 NONFAILURE AREA

15. The 1954 investigation by the IAD indicated that the deformation that occurred on taxiway 3 was a result of compression of the subsoil layers. The 1954 testing extended to a depth of only 40 in. beneath the pavement surface or to a 6-in. depth in the subgrade. As stated previously, the WES investigation was intended to supplement the IAD investigation, and testing was to be extended into the subsoil layers. As the investigations are comparable, results from the 1954 tests are also used in this analysis. Prior to the 1955 tests, taxiway 3 had been patched and overlaid as described in paragraph 4; therefore, cross sections made in 1954 are presented in plates 2 and 3 to show the extent of the settlement that had occurred in the pavement surface. The profiles of test trenches 1 and 2 are shown in plate 5. Fig. 1 shows the type materials and magnitude of

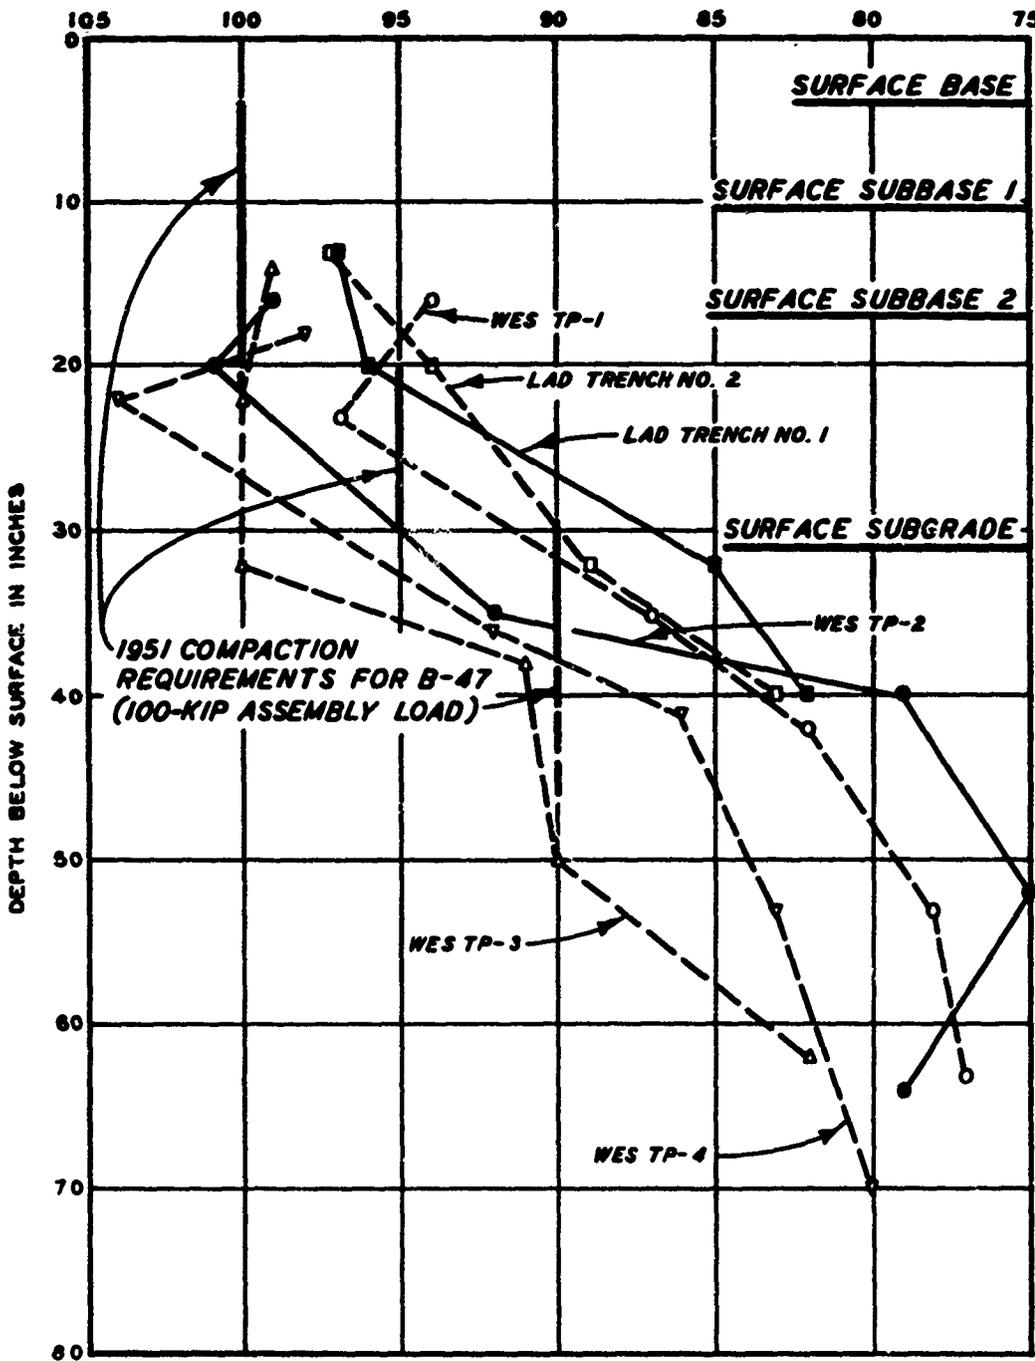
DENSITY VS DEPTH

20. In this analysis it is assumed initially that the density obtained during construction was about the same inside and outside the tracking lane. The plot of in-place density versus depth in plate 18 shows that below depths of about 32 in. at trench 1 and 40 in. at trench 2 considerable densification is indicated to have occurred in the tracking lane over that outside the tracking lane. From 40 in. to about 60 in. the density outside the tracking lane averaged about 81 per cent of modified AASHTO maximum density; that inside the tracking lanes averaged about 86 per cent. Below 60 in. the data indicated about the same density inside and outside the tracking lanes. Assuming that the density of the material between 40 and 60 in. has increased about 5 percentage points, an inch of deformation would be expected. Actually, the deformation amounts to nearly 4 in. This has three possible explanations: (1) the original assumption of equal construction densities is in error and the tracking lane was less dense than the untraveled area, (2) the densification extended to considerably more than 60 in., or (3) a combination of (1) and (2).

23. The densification which accounted for an appreciable portion of the settlement occurred at depths below 40 in.

25. Design studies should include moisture, density, and CBR data in the subsoil to a depth where the design wheel load will have little effect.
