REVIEW OF OBSERVATIONS FROM HYDROSTATIC  
PRESSURE MEASURING DEVICES, WAPPAPELLO  
DAM, WAPPAPELLO, MISSOURI

TECHNICAL REPORT NO. 3-460

June 1957

**U. S. Army Engineer Waterways Experiment Station  
CORPS OF ENGINEERS  
Vicksburg, Mississippi**

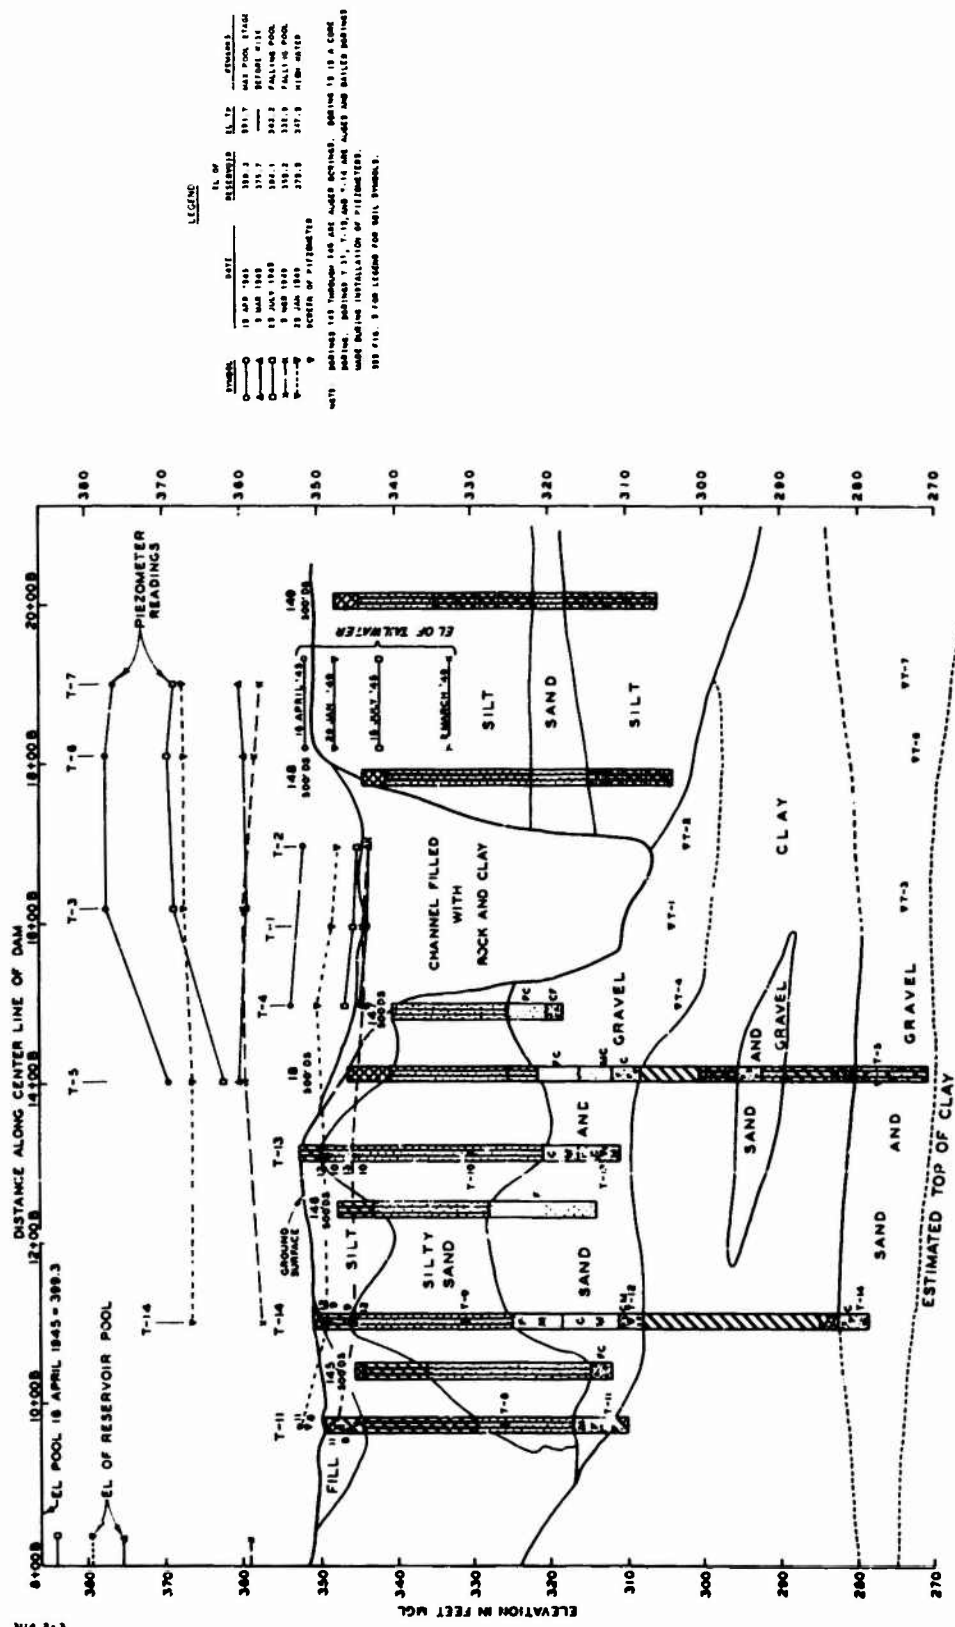
Fig. 7. Soil profile, location of piezometers, and piezometric data, 480 ft downstream from center line of dam

23. Piezometric profiles along the downstream toe of the dam are shown on fig. 7 for pertinent maximum reservoir stages and for rising and falling pool stages. This figure shows that the piezometers with tips at about the same elevation read approximately the same on a given date. During the high reservoir stage in 1945 the excess

hydrostatic head in the deep sand and gravel below el 280 was approximately 25 ft or about 50 per cent of the net head on the dam. The excess hydrostatic head in the upper sand and gravel stratum was considerably lower, ranging from 1 to 3 ft. Piezometers installed after the 1945 high pool stages in the silty sand stratum underlying the top stratum indicated that the hydrostatic head in the silty sand stratum is essentially the same as that existing in the underlying upper sand and gravel stratum. The bottom of the downstream toe drainage system extends into the silty sand stratum between the river channel and right abutment. Consequently it appears that significant pressure relief is provided by the toe drainage system.

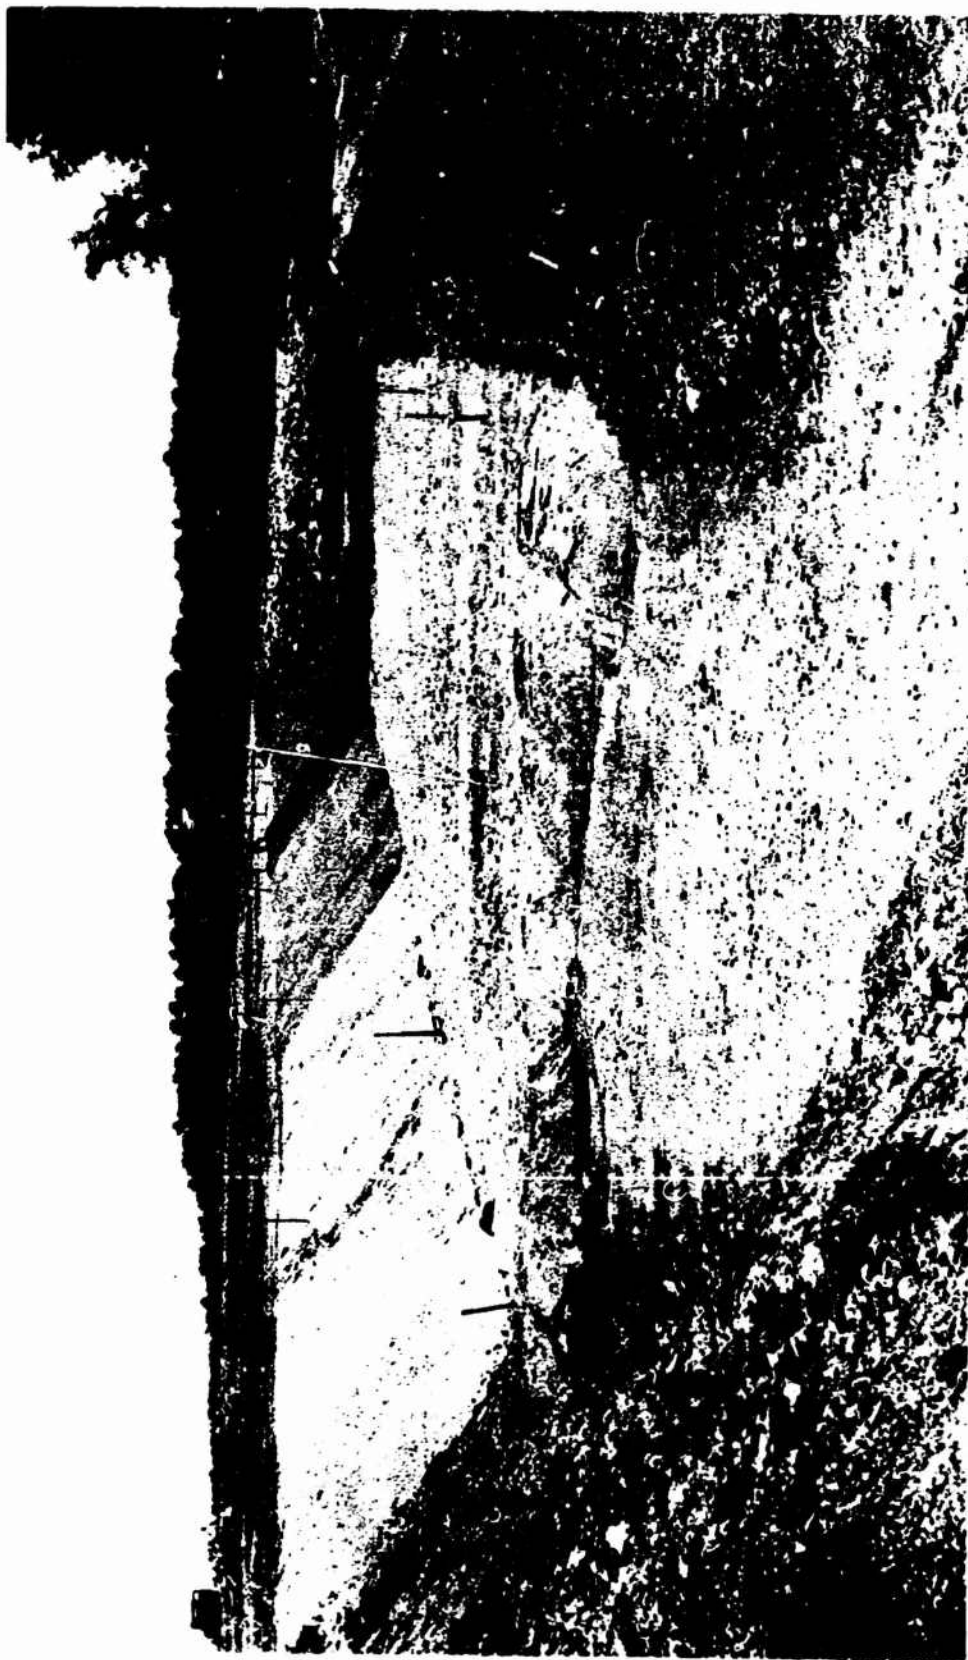
Fig. 9. Construction of toe drain at downstream toe of dam

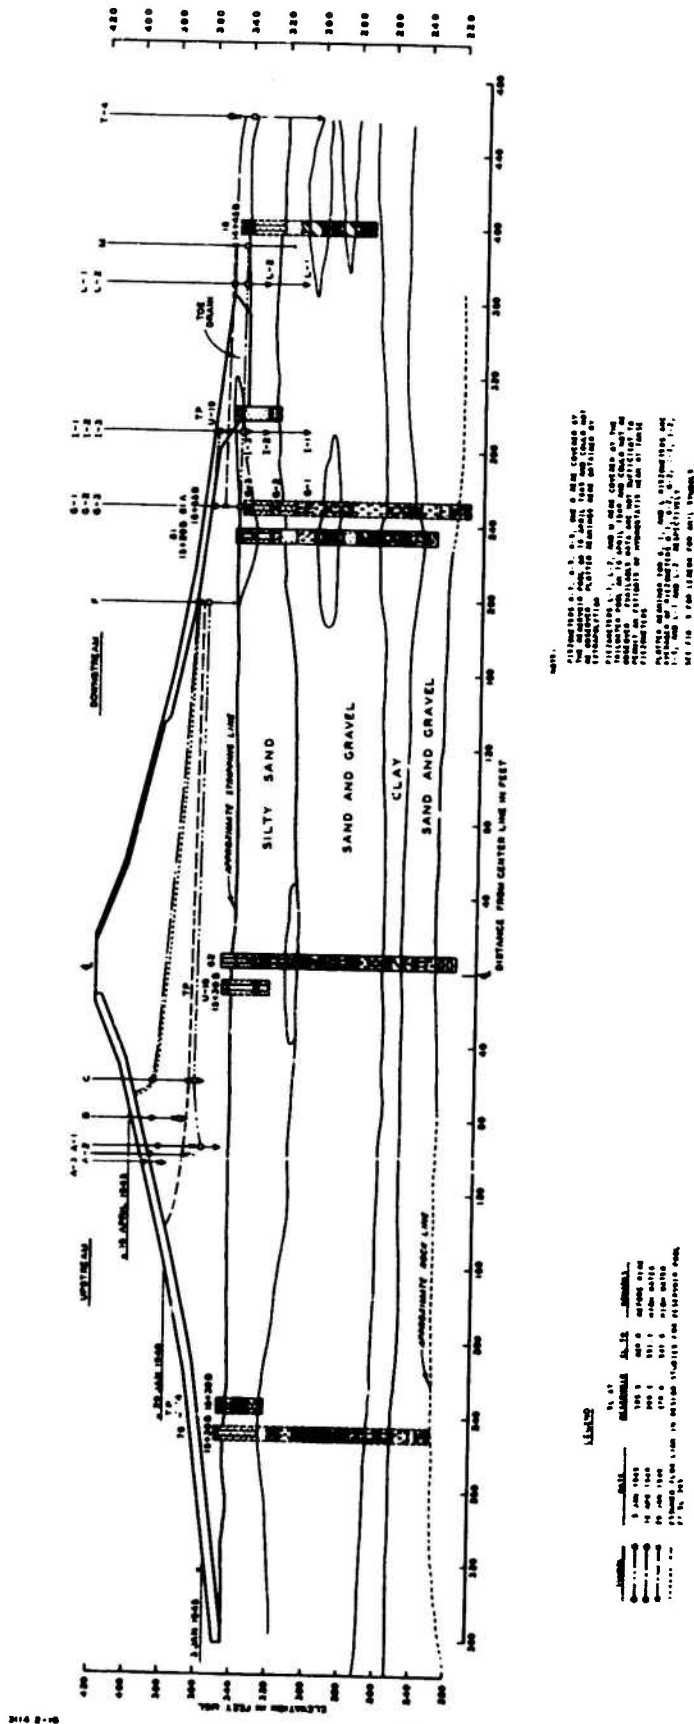
Fig. 11. Cross section, location of piezometers, and piezometric data, sta 15+05B

29. The locations of piezometers and seepage observation wells at sta 15+05B are shown on fig. 11. Readings of piezometers at sta 15+05B are plotted chronologically with corresponding reservoir stages on figs. 18 and 19. Available tailwater data are shown on fig. 18; sufficient data are not available to permit plotting a continuous record of tailwater elevations on this figure. Generally, the readings of piezometers A-1, -2, -3, B and C were higher than the reservoir pool and therefore a continuous plot for these piezometers is not shown on fig. 18. The fact that the readings of these piezometers generally are higher than the reservoir pool during low pool stages is attributed to the piezometers possibly being affected by capillary moisture, rainfall, and other factors. The readings of piezometer F also may be affected by surface runoff through the riprap on the downstream slope of the dam as the screen of this piezometer extends up through the riprap. Generally, the piezometer levels rose and fell with corresponding reservoir stages when the reservoir pool was about the tip of the piezometer; readings for the 1945 and 1949 high water periods and for the low water period prior to the rise of 1945 also are shown on fig. 11. Available piezometric data are not sufficient to estimate the distance to the effective source and exit of seepage. The A and B piezometers on the upstream side of the dam generally were submerged during the high water period and readings were not made. However, some readings of the A and B piezometers were obtained at high pool stages in 1945 before these piezometers became submerged. Readings for piezometers in each of the G, I, and L groups were approximately the same for each piezometer in the group for any given date. The line of seepage within the embankment for each of the above dates as approximated from the piezometer readings is shown on fig. 11. These lines of seepage are considered only approximate because many

of the piezometers at sta 15+05B appear to be affected somewhat by rainfall and other factors. Also shown for comparison is the uppermost flow line (phreatic line) for the reservoir pool at el 395 assumed for design purposes. The line of seepage through the embankment could not be traced to the downstream toe beyond piezometer F; however, it appears that the seepage may pass into the riprap on the lower face of the dam and thence into the toe drain. As no emergence of seepage was observed on the downstream face of the dam during the high water period of 1945, the dam is believed safe with respect to uncontrolled emergence of seepage through the embankment. It is considered that continuation of the observations of piezometers at sta 15+05B would not provide additional data of consequence and that future observations are not warranted.

- a. Readings of all pressure cells and those piezometers in the embankment and foundation at sta 15+05B be discontinued.
- b. Readings be continued for all other piezometers along the downstream toe of the dam to check on the continued effectiveness of the toe drain. Piezometers should be read at 10-ft intervals of rising reservoir stages above conservation pool stage of 355, at the crest, and for 10-ft intervals of falling reservoir stage down to conservation pool level.
- c. Valves on the piezometer riser pipes be checked periodically to insure that they do not leak.
- d. Seepage from the French drain be measured when the reservoir crests appreciably above the conservation pool. The elevation of the water in the area inclosed by the sand bag dikes should be determined at the same time.

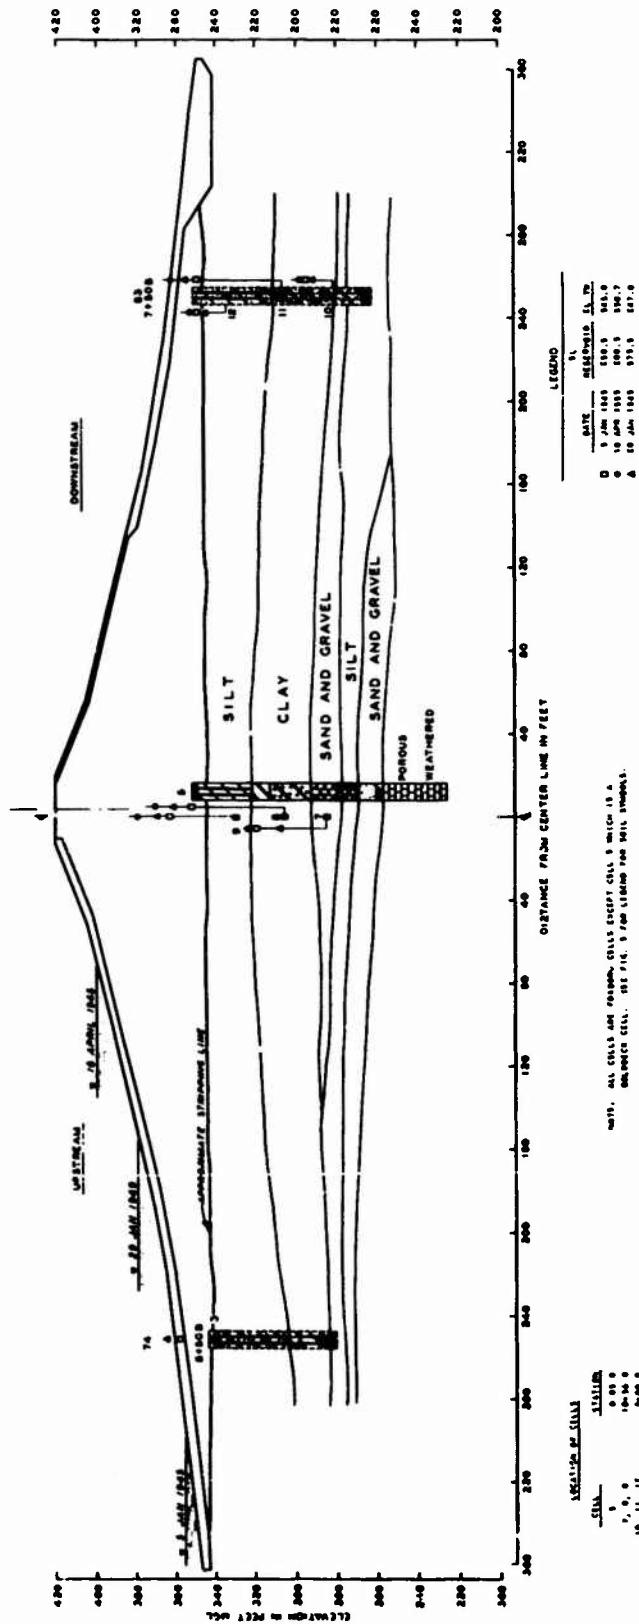
Fig. 12. Cross section and location of hydrostatic pressure cells, sta 9+00B

pertinent data from the standpoint of underseepage. Foundation conditions at sta 9+00B are complex and no attempt was made to evaluate the significance of the observed hydrostatic heads as measured by the pressure cells. As settlement observations indicate that the dam foundation is completely consolidated as of this date (1957) there appears to be no need for further observations on the hydrostatic pressure cells.

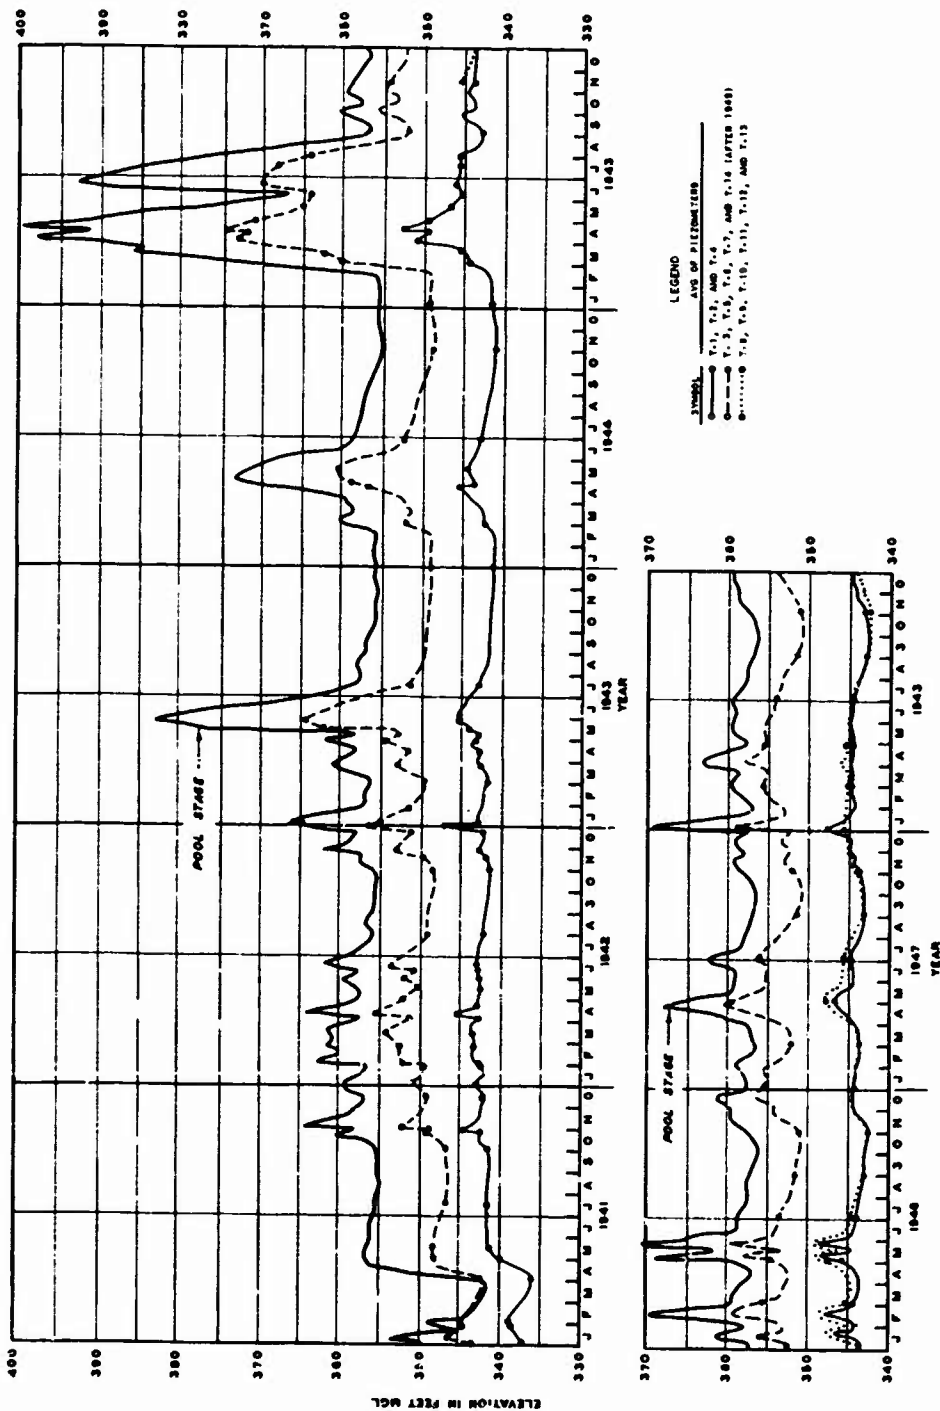
20. The piezometers installed at the downstream toe at approximately the same elevation and in the same kind of material have been grouped together for the purpose of plotting the piezometer readings and the corresponding reservoir pool stages vs time. The average readings of these piezometer groups are plotted vs time on figs. 13 and 14. Locations of these piezometers are shown in profile on fig. 7.

Fig. 13. Data from piezometers near downstream toe of dam, 1941-1948

One group, T-3, -5, -6, -7, and -14, lies in the deep sand at about el 274. Another group, T-1, -2, and -4, is in the sand and gravel strata beneath the old channel at about el 304. The third group, T-11, -12, -13, lies in the shallower sand and gravel between the old channel and the right abutment at about el 311. The fourth group, T-8 through -10, lies in the silty sand beneath the top stratum between the old channel and the right abutment at about el 329, just above the third group.

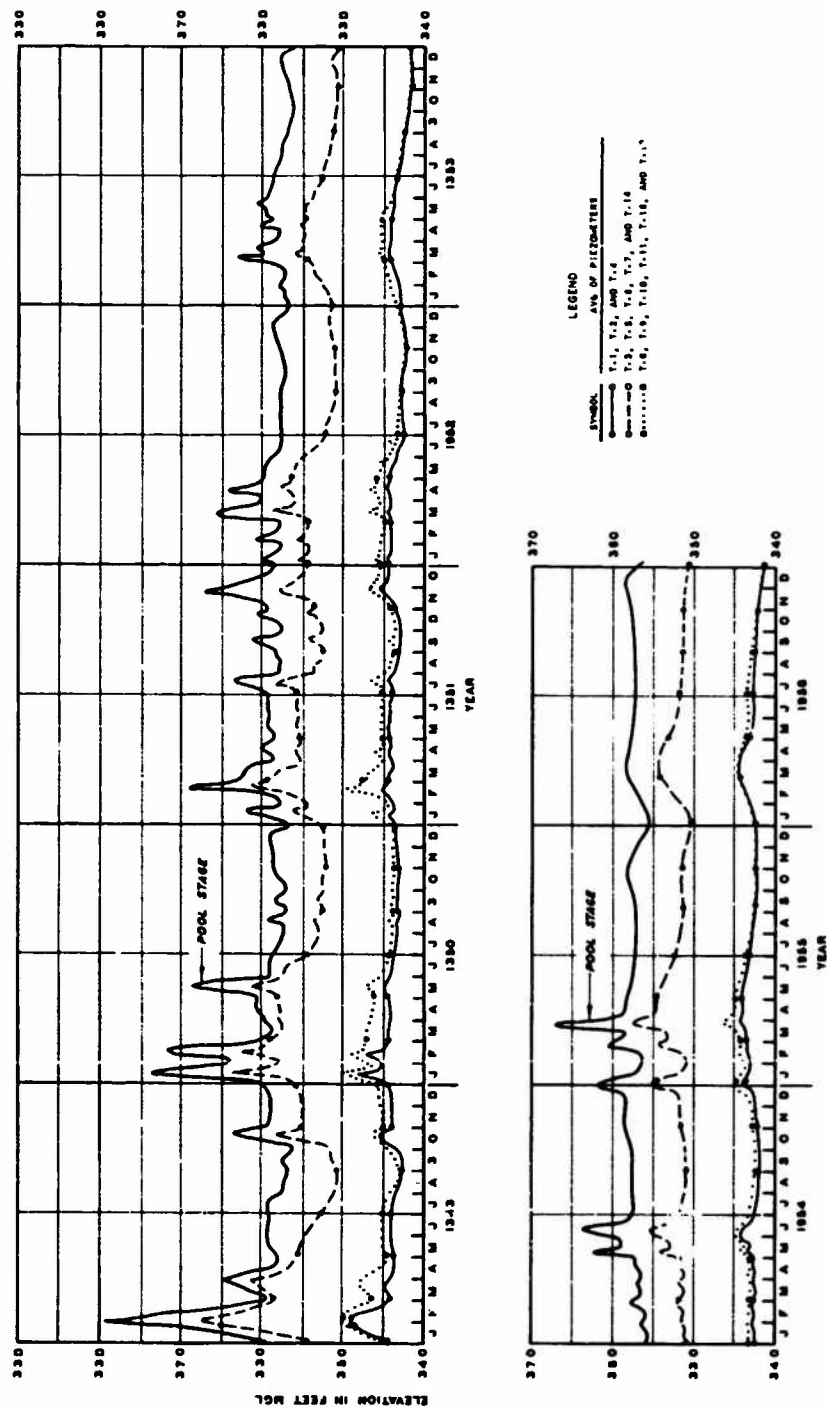
Fig. 14. Data from piezometers near downstream toe of dam, 1949-1956

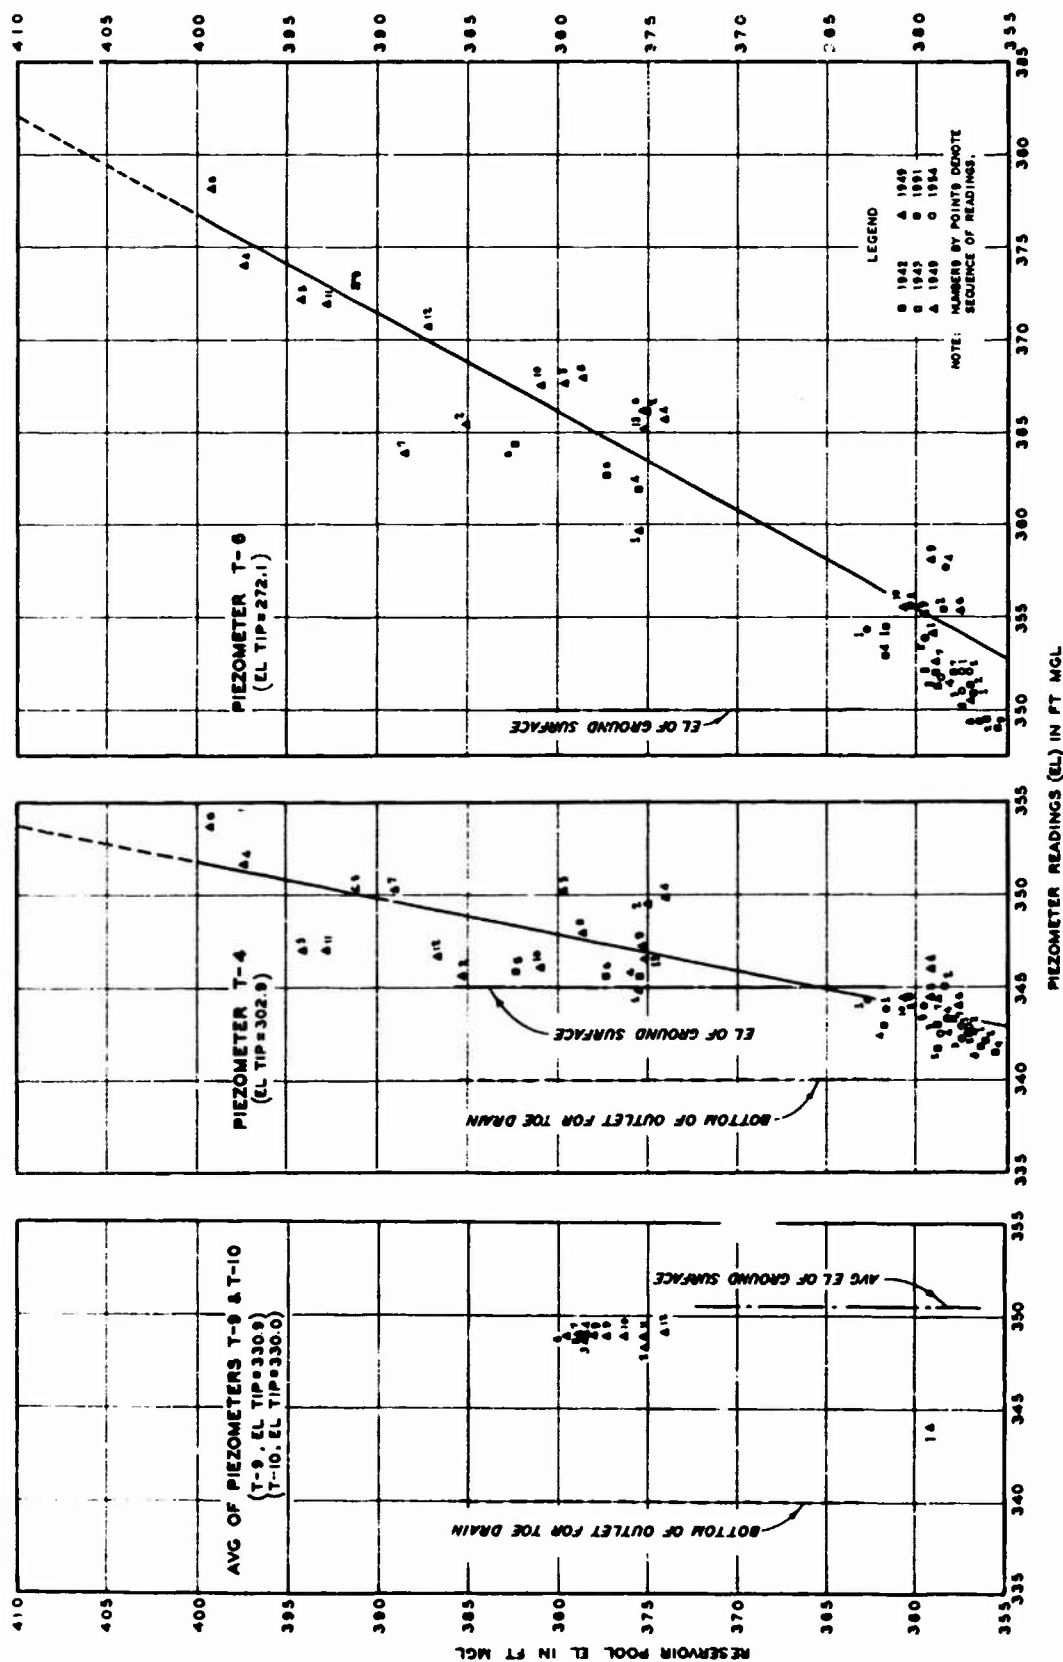
22. Readings for typical piezometers installed in the sand and gravel strata at about el 272 and 303 and at el 330 in the silty sand stratum are plotted vs reservoir pool stage on fig. 15 for years in which the reservoir pool stage was relatively high. The sequence of readings also is shown on fig. 15 and it can be noted that at high reservoir pool stages the readings at a given pool elevation generally are higher for a falling reservoir stage than for an increasing stage. The relationship between piezometer readings and reservoir pool stage is fairly consistent during the periods for which data are shown, indicating that the effective source of seepage entry was relatively constant.

Fig. 15. Readings of typical piezometers vs reservoir pool elevation

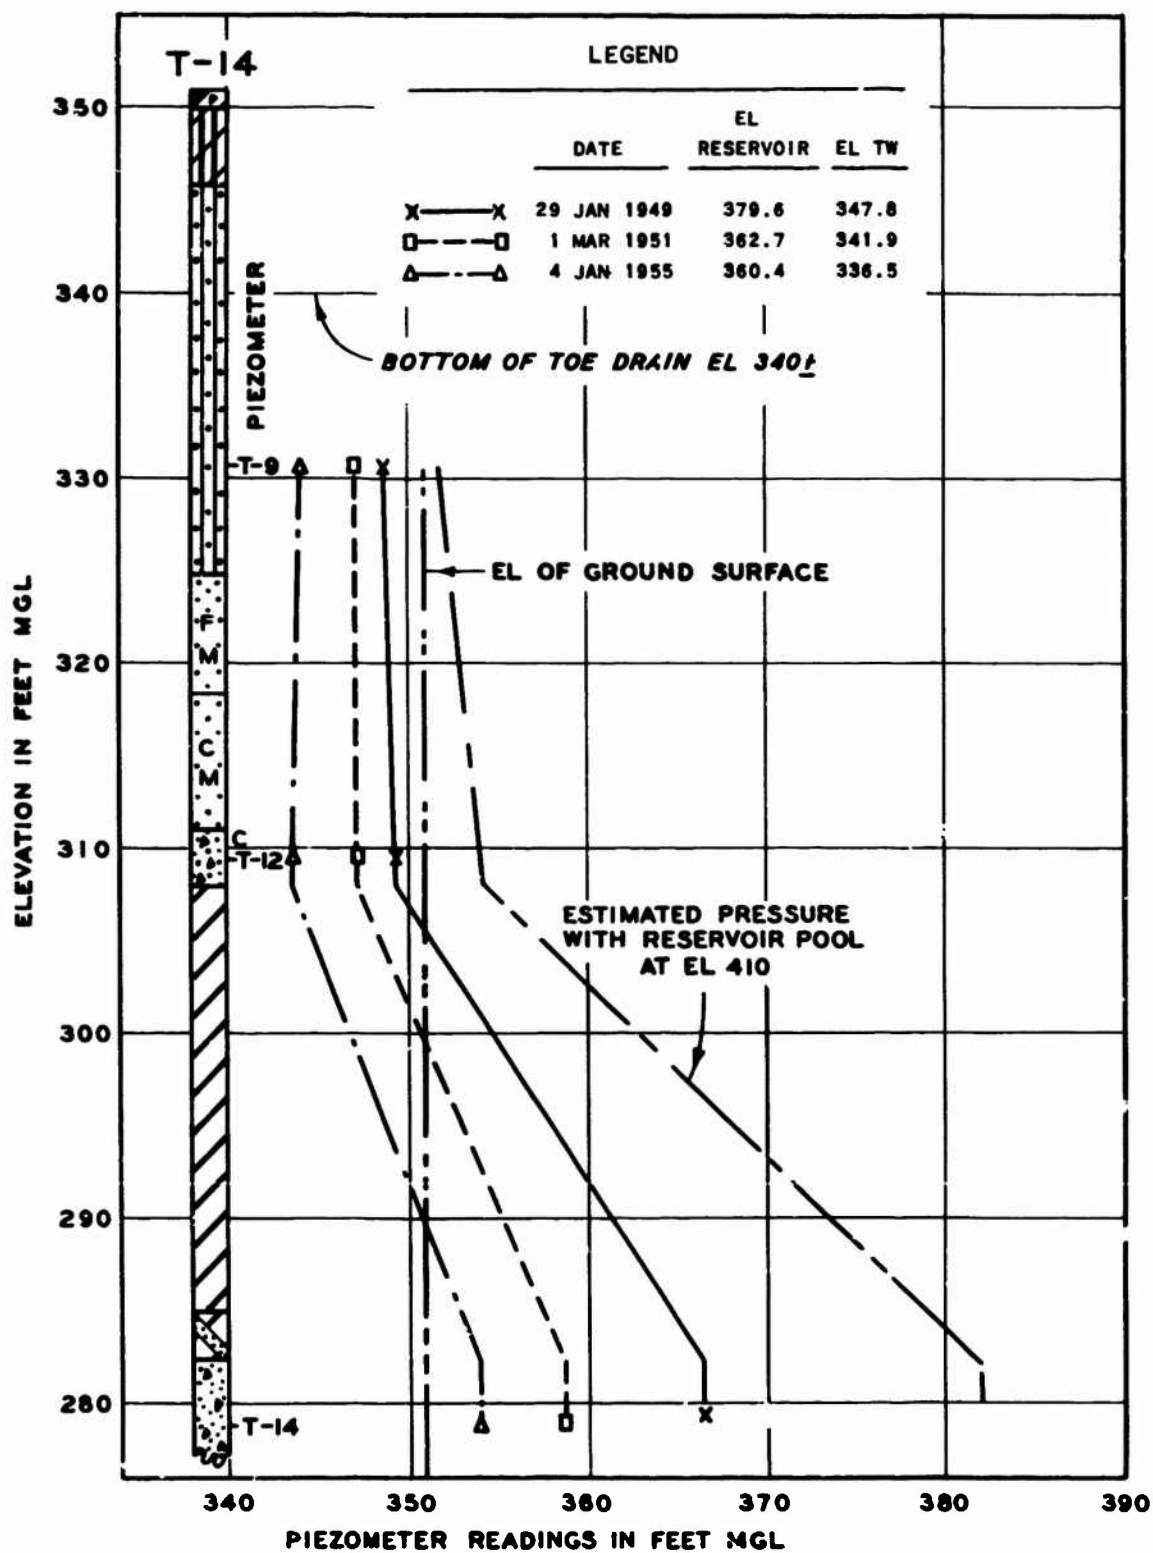
24. The effectiveness of the toe drain is further illustrated by the variation in hydrostatic head with depth, as shown on fig. 16. Readings of piezometers T-9, -12, and -14 for three reservoir stages are plotted on fig. 16. These piezometers are at sta 11+05B but at different elevations. It may be seen that there is a large drop in pressure between T-14, located in the deep sand and gravel, and T-12, located in the upper sand and gravel stratum. There is little difference in pressure between T-12 and T-9 which is located in the silty sand stratum overlying the upper sand and gravel. Also shown on fig. 16 is the estimated pressure in the foundation strata with the reservoir pool at el 410. The estimated pressure was based on extrapolation of data shown on fig. 15 for piezometers in the same strata as those shown on fig. 16. On the basis of data shown on fig. 16, little excess hydrostatic head will exist in the upper pervious strata for reservoir stages as high as el 410. Therefore, it is considered that the top stratum along the downstream toe is safe against failure due to uplift for the maximum reservoir pool.

Fig. 16. Hydrostatic pressure near downstream toe of dam vs depth,  
sta 11+05B

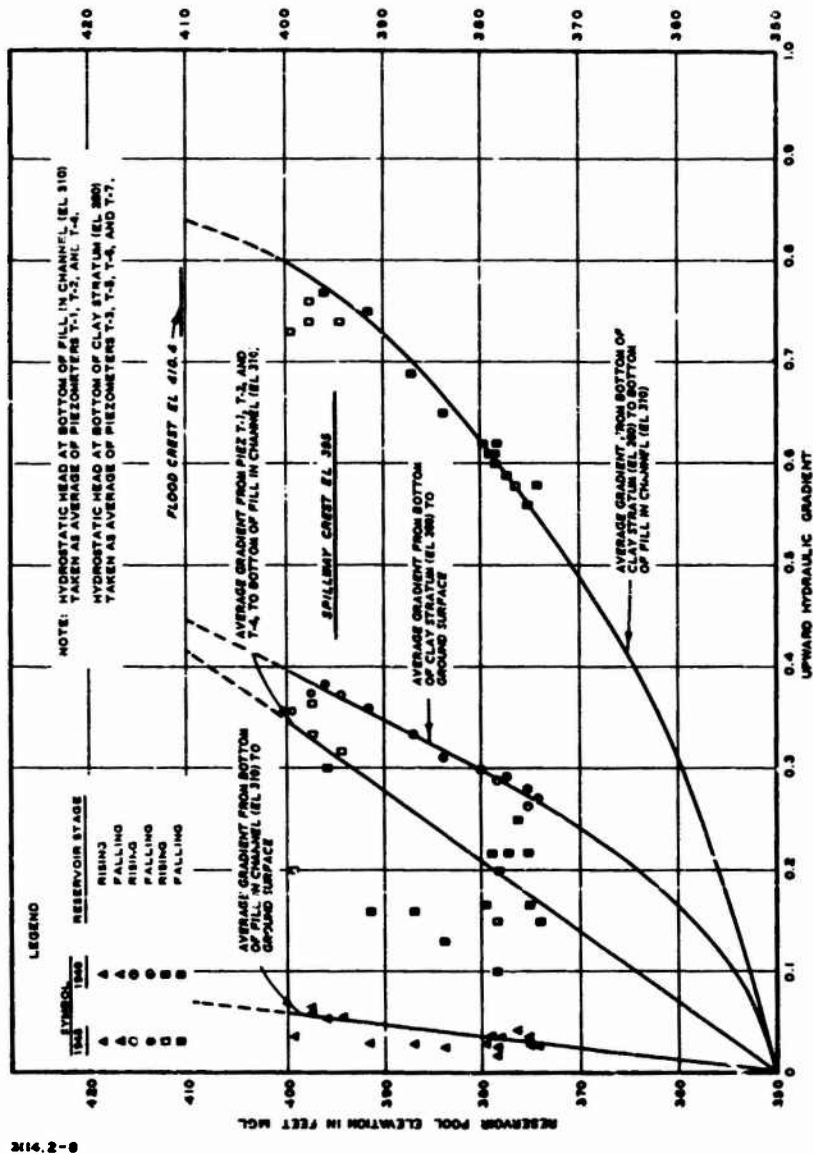
26. Upward hydraulic gradients. Upward hydraulic gradients were computed from the readings of piezometers along the downstream toe of the dam made during 1945 and 1949. The computed gradients are plotted vs reservoir pool elevation on fig. 17. Gradients were computed from the bottom of the clay stratum at el 280 to ground surface using an average excess hydrostatic head based on piezometers in the lower sand and gravel stratum (T-3, -5, -6, and -7). Gradients also were computed from the bottom of the river channel to ground surface, using average excess hydrostatic pressures from piezometers T-1, -2, and -4. Gradients from the bottom of the clay stratum at el 280 to ground surface during the 1945 high water period ranged from about 0.31 to 0.38 as shown on fig. 17. These gradients will be about 0.45 at the maximum reservoir pool and indicate that the pressures probably are not high enough to cause any uplift or blow-out. Gradients from the bottom of the channel fill to ground surface ranged from 0.02 to 0.06 in 1945 and probably will be about 0.07 at the maximum reservoir pool.

27. Piezometers T-1 through T-7 were installed primarily to observe the upward hydraulic gradient into the filled river channel. The channel is underlain by fine sand. If the hydraulic gradient through the fine sand should approach the critical gradient (about 0.9) it was originally thought the sand might pipe into voids in the channel fill. Gradients immediately beneath the channel fill were computed assuming that the excess hydrostatic head indicated by piezometers T-1,

Fig. 17. Upward hydraulic gradients through foundation along downstream toe of dam

-2, and -4 was dissipated between the piezometer tips and the bottom of the channel fill. The upward hydraulic gradients computed in this manner are shown for various reservoir pool stages on fig. 17. In 1945 the gradients ranged from about 0.16 to 0.36. With the reservoir at maximum pool this gradient will be about 0.42, indicating the piping into the channel fill is unlikely. Furthermore, the channel fill material is believed to be relatively impervious, consisting of rock and clay, which would lessen further the possibility of piping. That the fill is relatively impervious is confirmed by the fact that pools of rainwater 1-1/2 ft above the level of the tailwater have been observed standing in the old channel near the toe of the dam during periods of high water. Gradients were computed also from the bottom of the clay stratum at el 280 to the bottom of the channel fill as shown on fig. 17. The computed gradient for maximum reservoir pool stage will be about 0.84. However, there is little likelihood of dangerous piping under this gradient, because it is believed the clay stratum is continuous between el 280 and about 300. The dam safely withstood a high water stage of el 399 (4 ft above spillway crest) creating a gradient of 0.75.

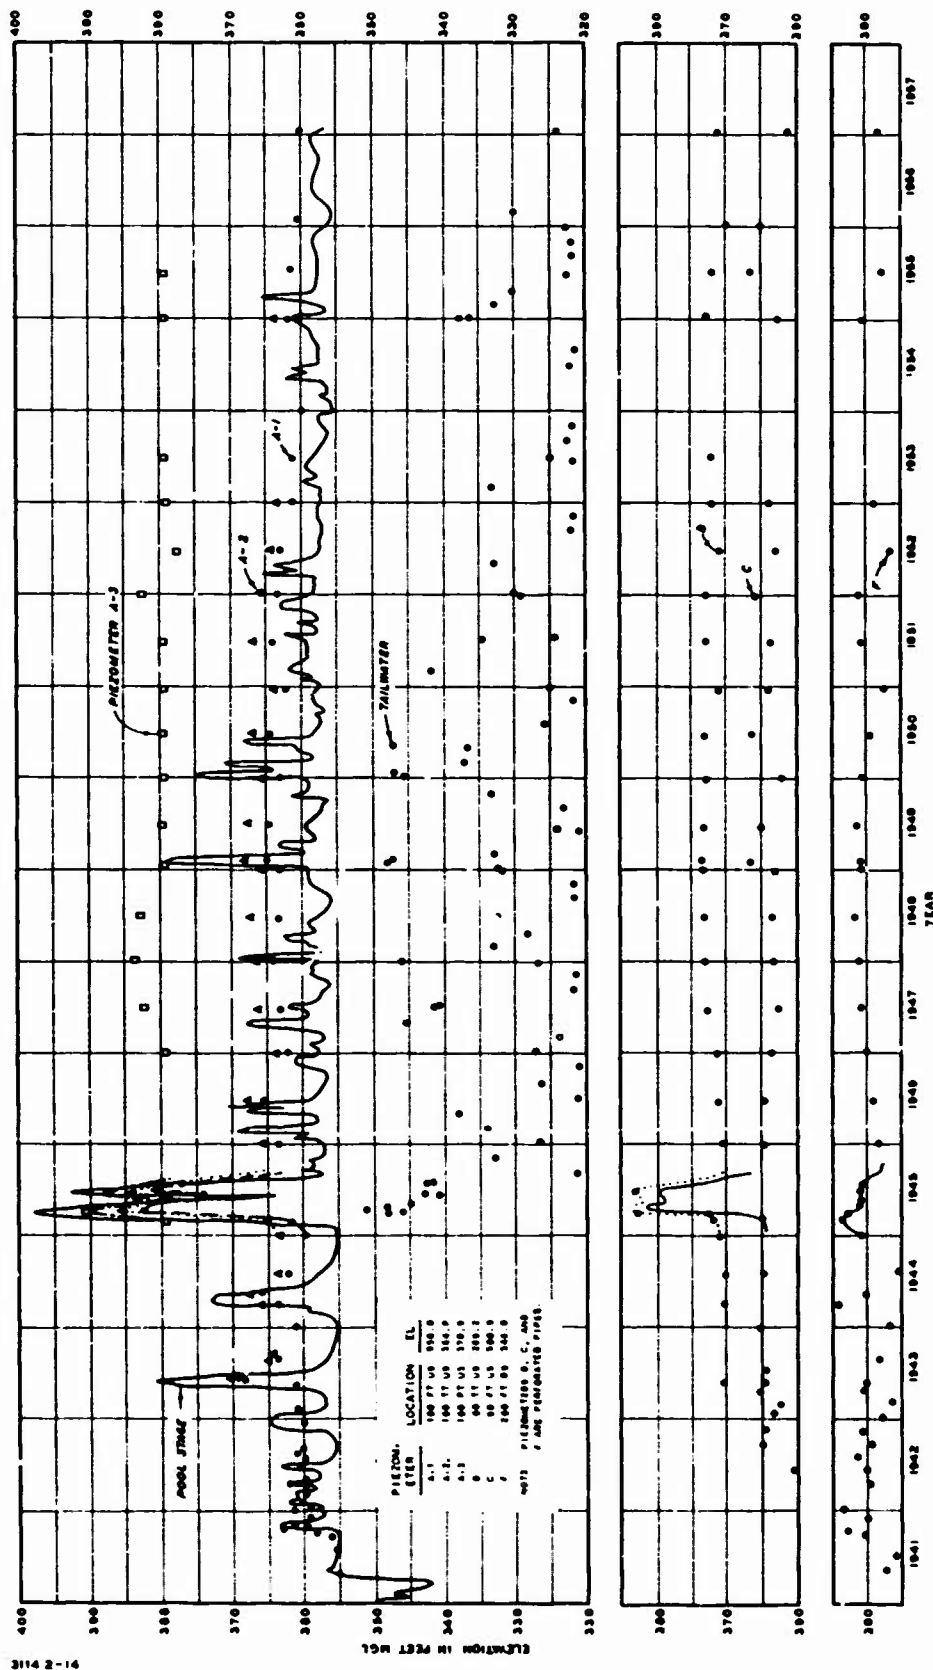
Fig. 18. Data from piezometers at sta 15+05B, piezometers A, B, C, and F

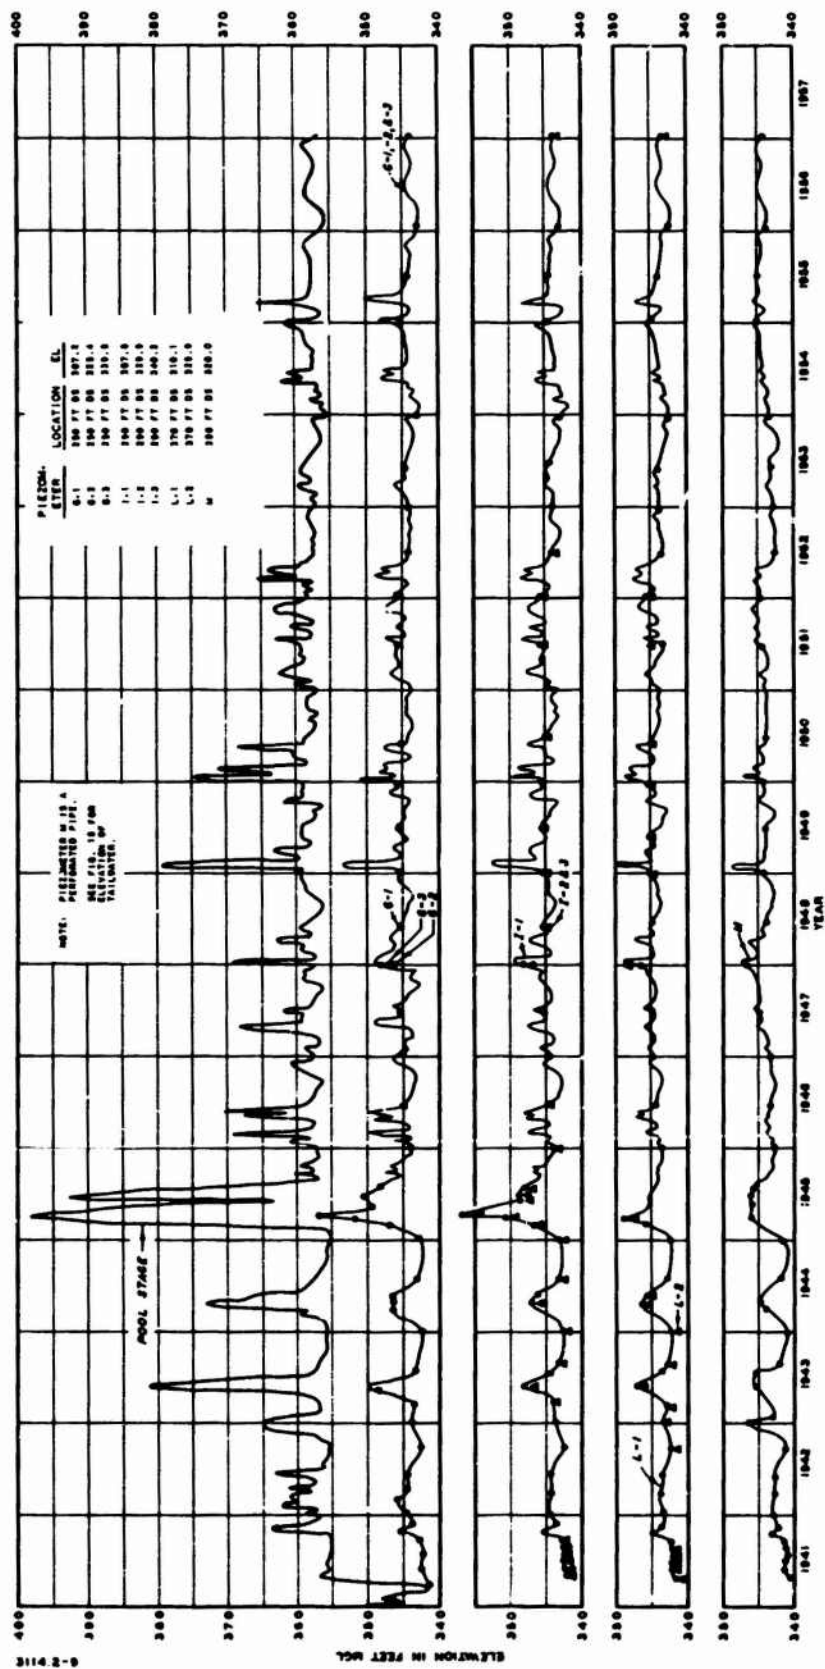
Fig. 19. Data from piezometers at sta 15+05B, piezometers G, I, L, and M

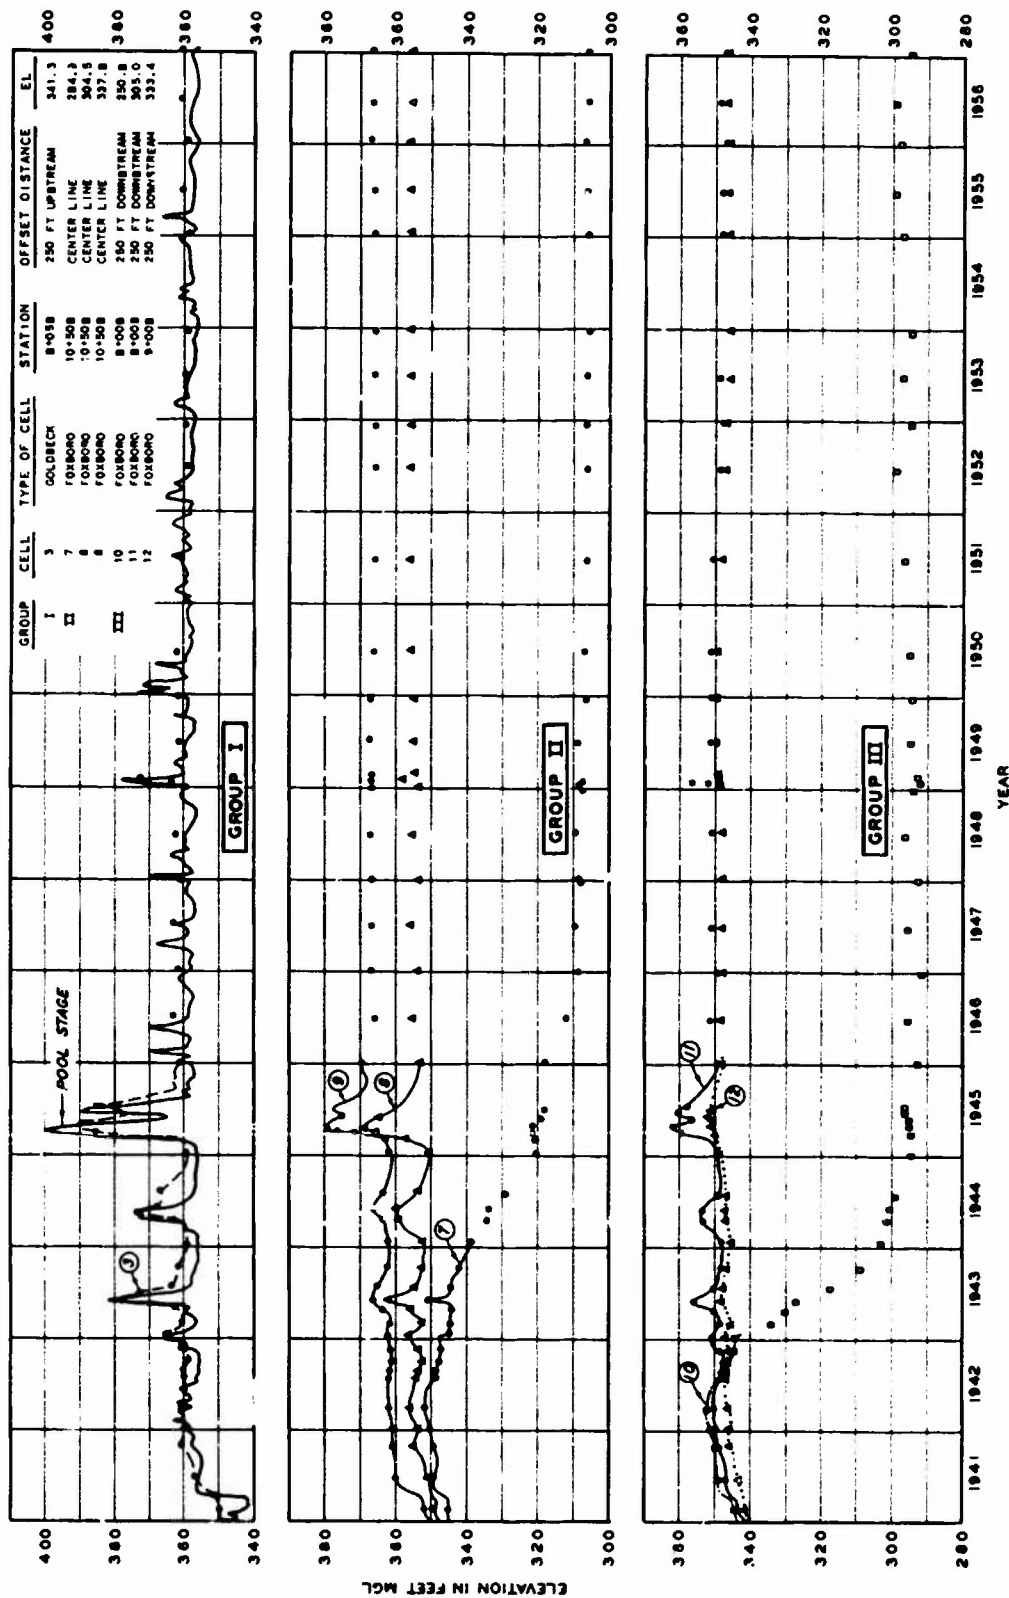
30. Readings of those hydrostatic pressure cells still functioning are plotted chronologically with reservoir stages on fig. 20. Data from cells 24 and 25, which appear to be giving consistent readings, are not shown on fig. 20, as they are located near the upstream toe of the dam and are not pertinent to the problem of underseepage. It may be noted from fig. 20 that the readings of cells 7 and 10 have decreased with time to such extent that it is doubtful if the cells still are functioning properly. Hydrostatic pressure cell readings for the 1945 and 1949 high water periods and for the low water prior to the rise of 1945 are shown on fig. 12. It may be noted that the majority of the cells are located in relatively impervious soil strata and accordingly would not be expected to reflect quickly the excess hydrostatic pressures in the sand foundation due to high reservoir stages. As the cells still functioning are mainly those installed to determine foundation pore pressures caused by consolidation, they offer little

Fig. 20. Data from hydrostatic pressure cells

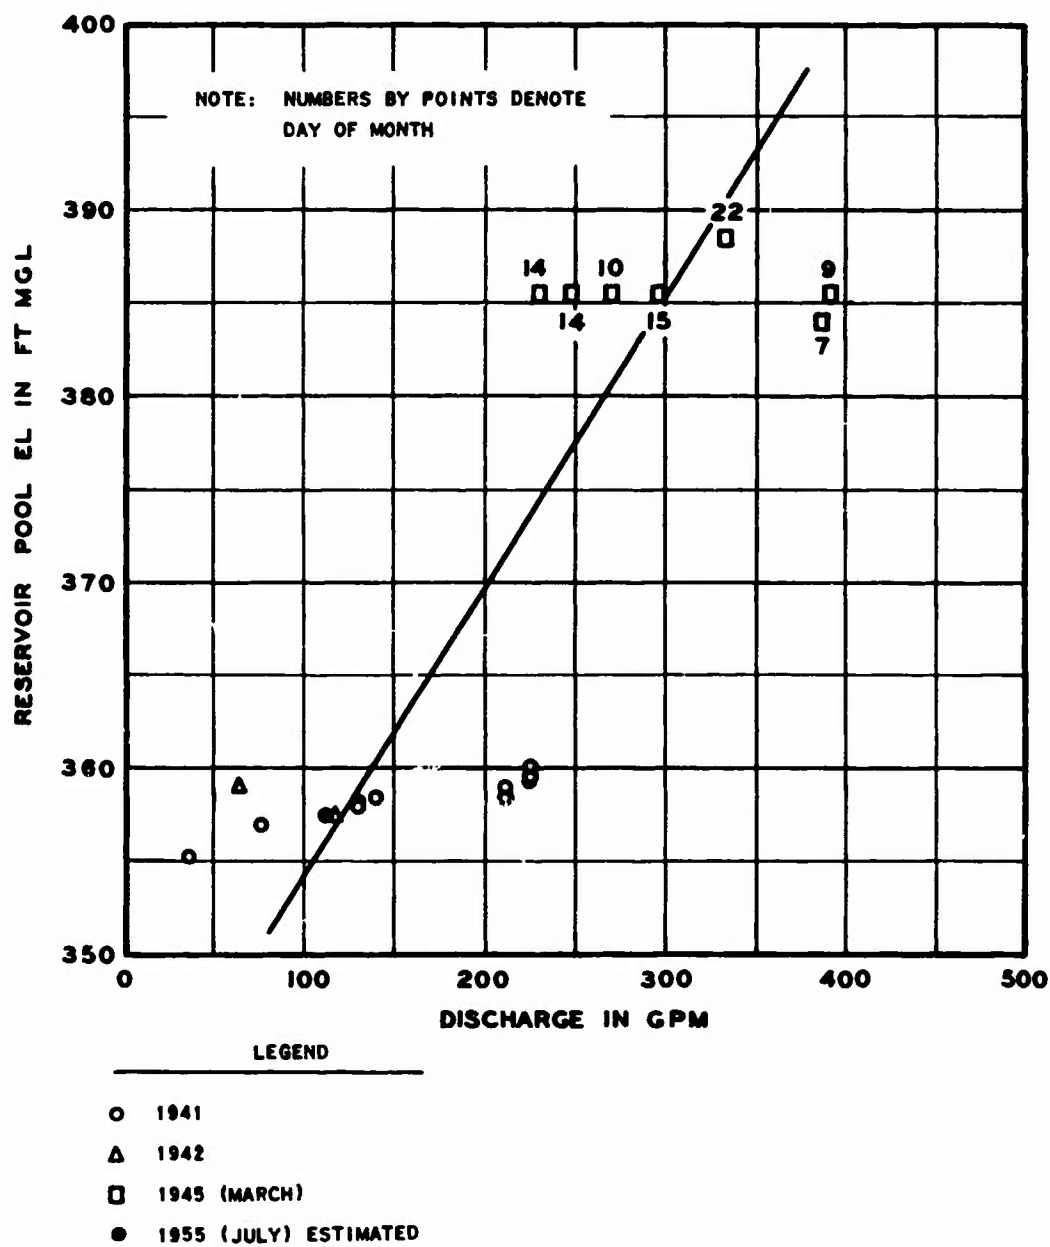
32. A plot of seepage discharge vs reservoir pool elevation is shown on fig. 21. The seepage measurements vary so much for such a small range in reservoir elevation that they can be related only approximately to reservoir pool elevation. On the basis of fig. 21 it appears that seepage beneath the dam is equivalent to approximately 6.5 gpm per foot of net head above tailwater (el 340  $\pm$ ). It is believed that most of this seepage enters the toe drainage system along

Fig. 21. Measured seepage from toe drain

the downstream toe of the dam between the right bank of the river channel (about sta 15+00B) and the right abutment, as the toe drain does not penetrate into pervious foundation strata left of the river channel and the compacted fill in the river channel apparently is relatively impervious. It is not possible to determine what percentage of the total flow the observed seepage represents, in view of the heterogeneity and complexity of the foundation conditions. The amount of seepage is not considered excessive and, as it emerges in a controlled manner, is not considered significant.
