FILAMENT COMPOSITE MATERIAL LANDING  
GEAR PROGRAM, VOLUME I

Bendix Corporation

Air Force Flight Dynamics Laboratory

AFFDL TR 72-78, Vol. I

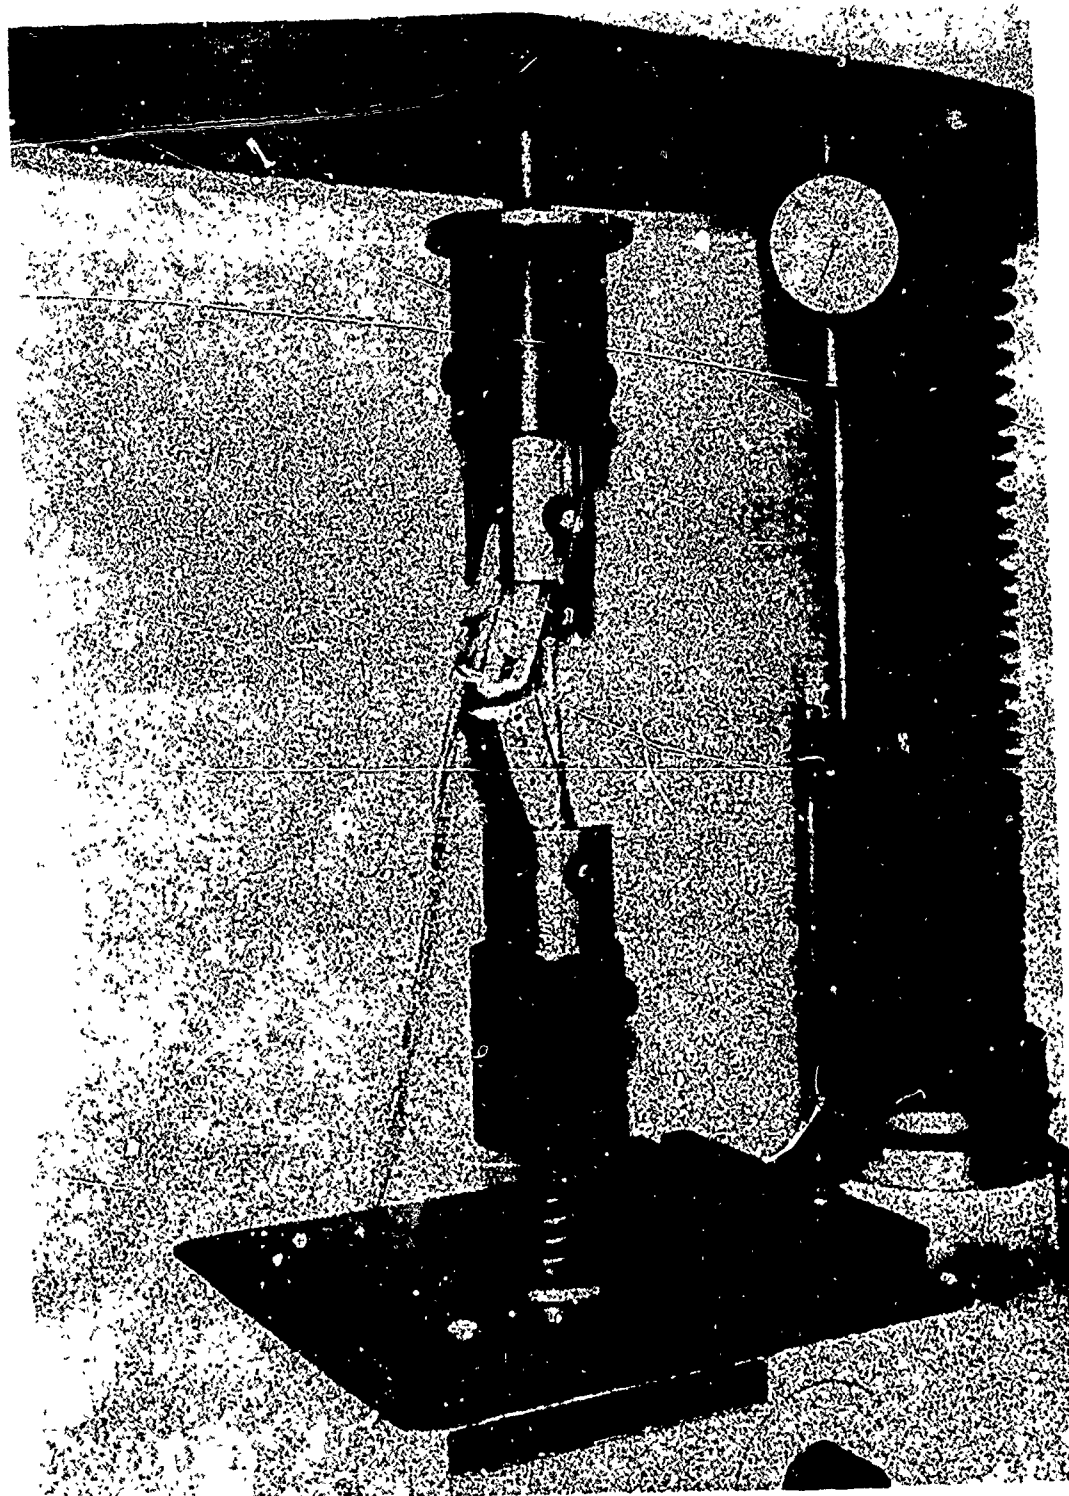
Figure 5-12. Side Brace Fractured in Test Assembly

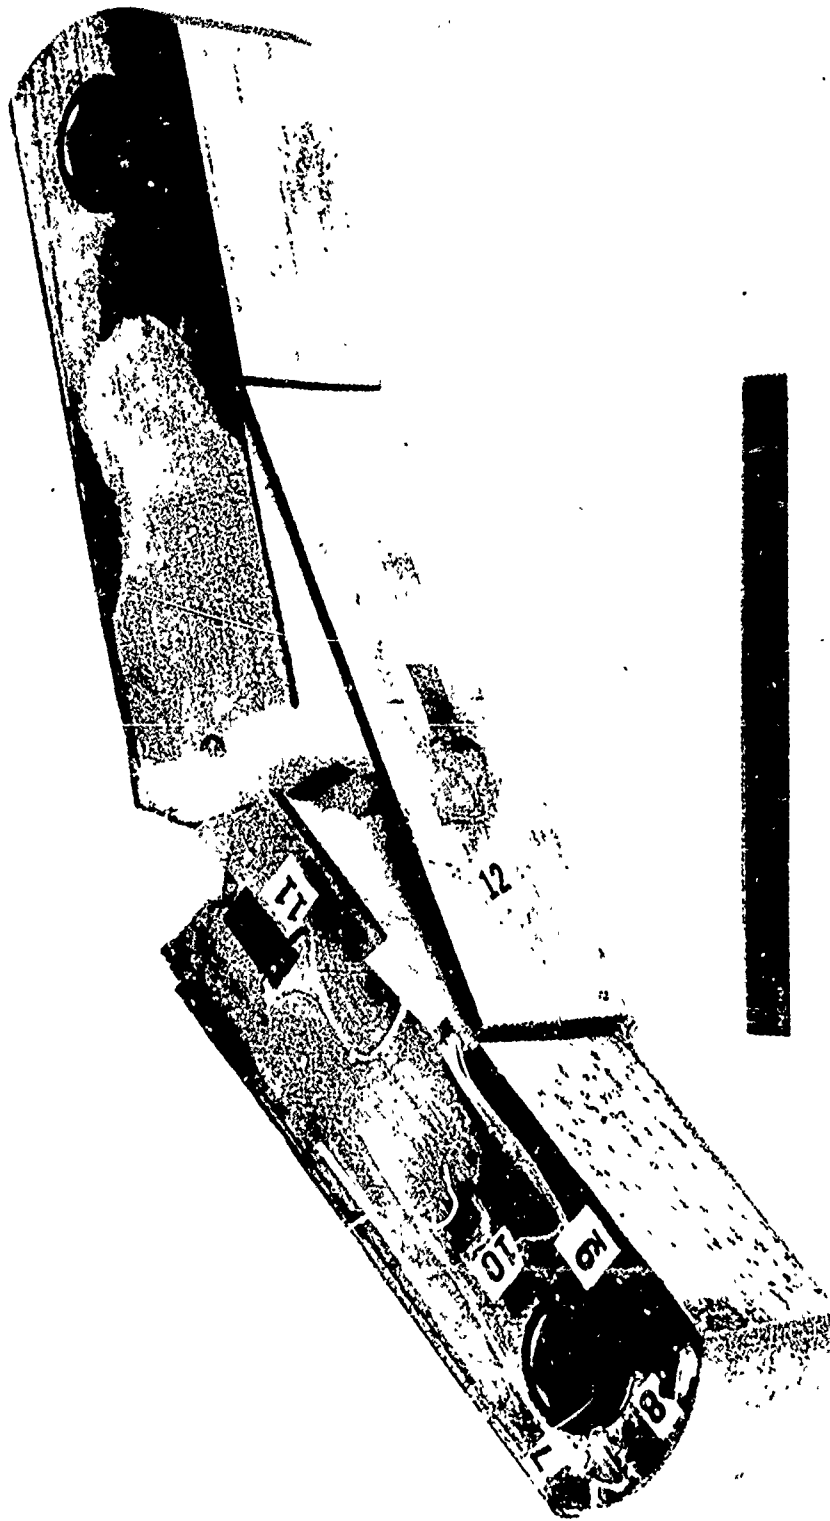
Figure 5-13. Side Brace Fractured

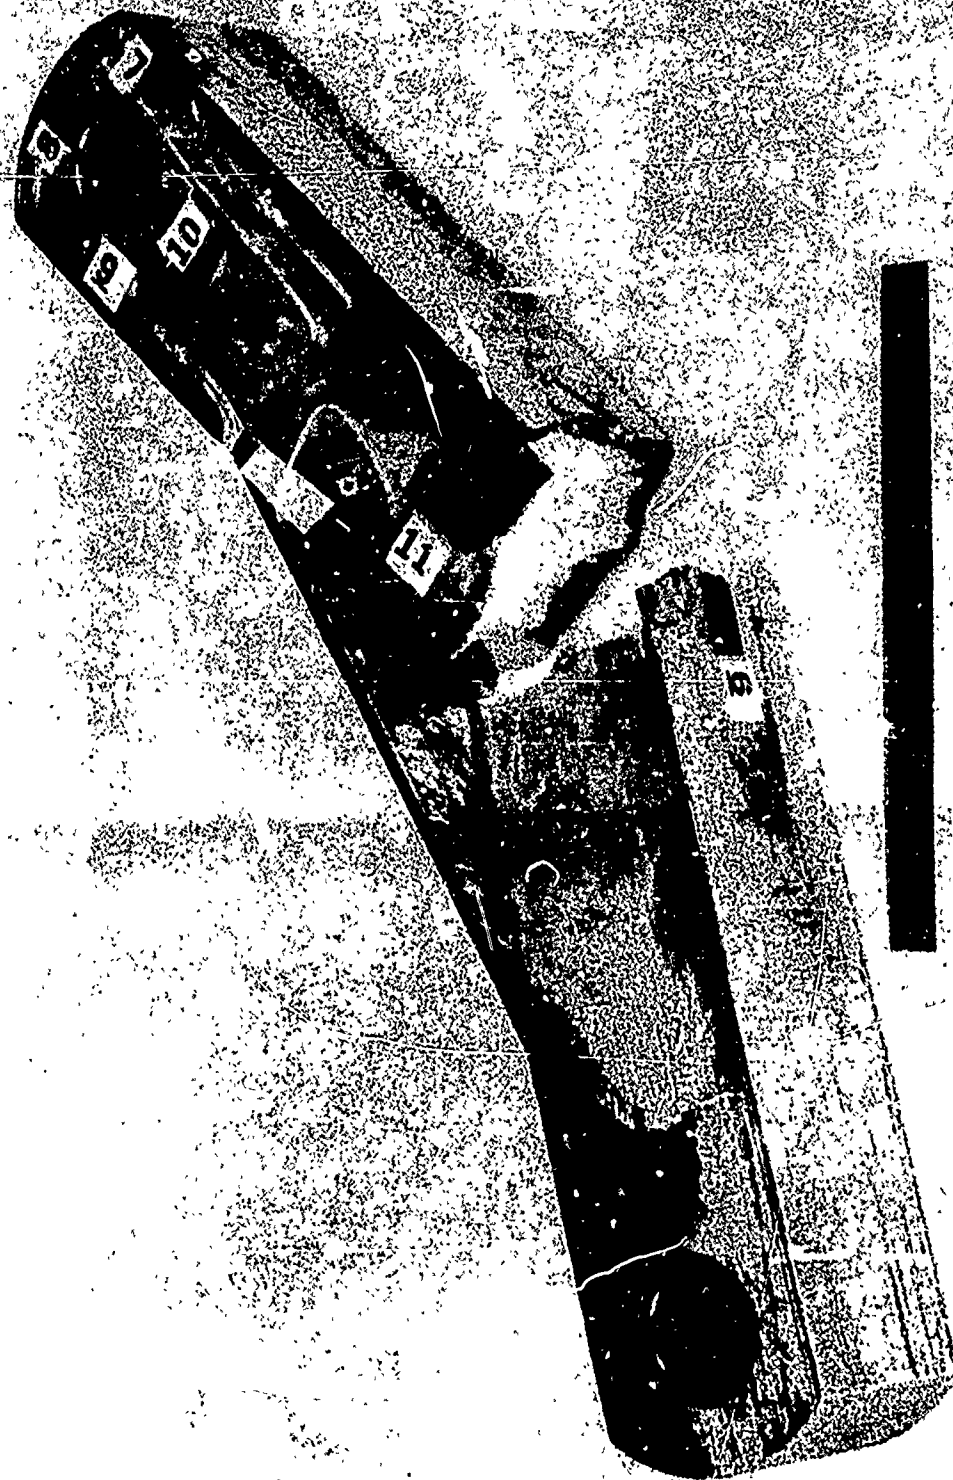
Figure 5-14. Side Brace Fractured

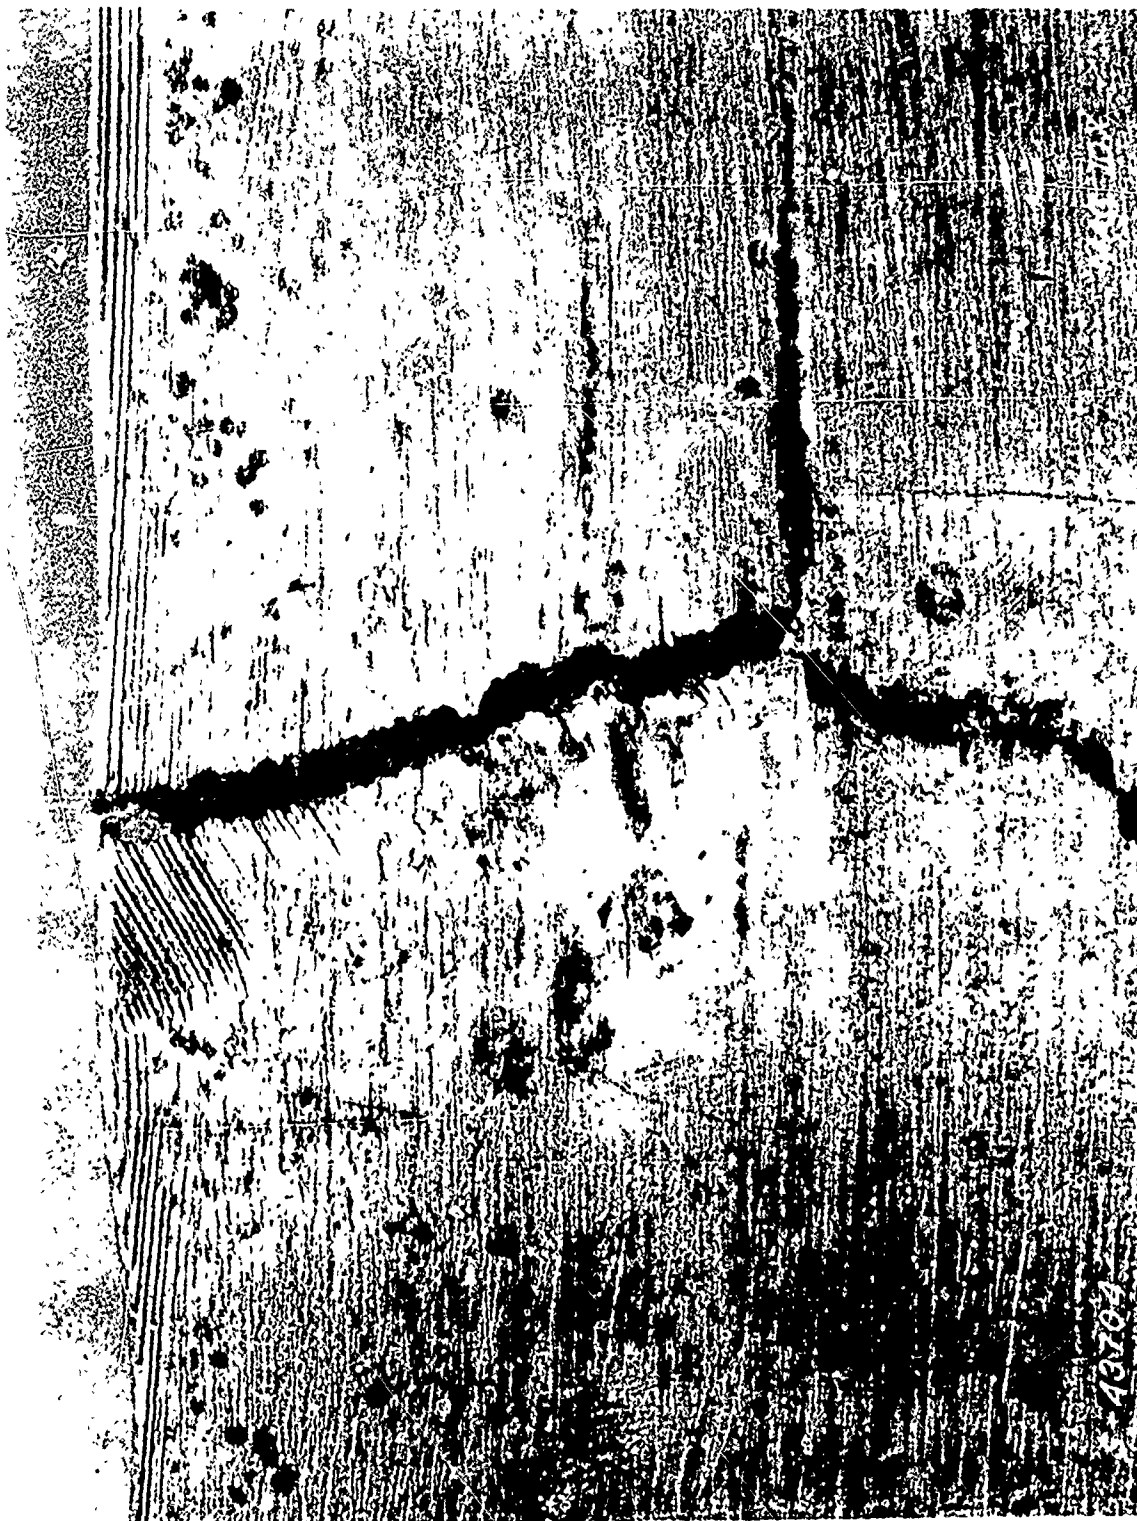
Figure 5-15. Fractured Area - 10X Magnification

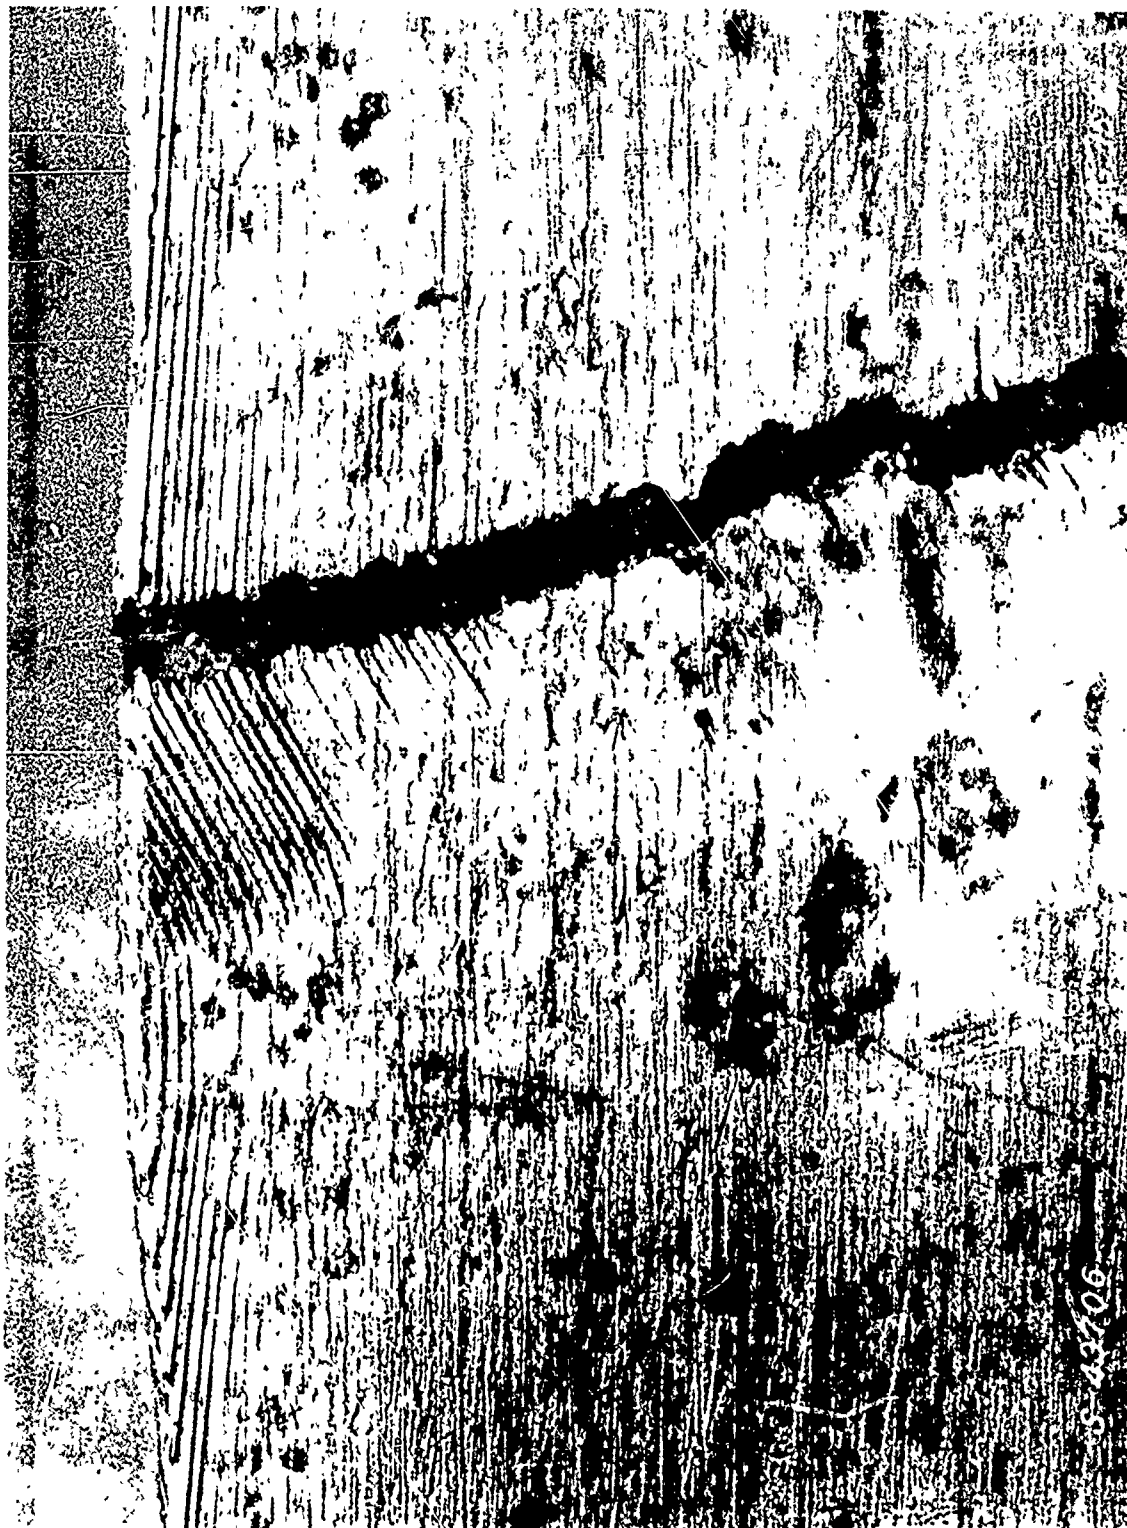
Figure 5-16. Fractured Area

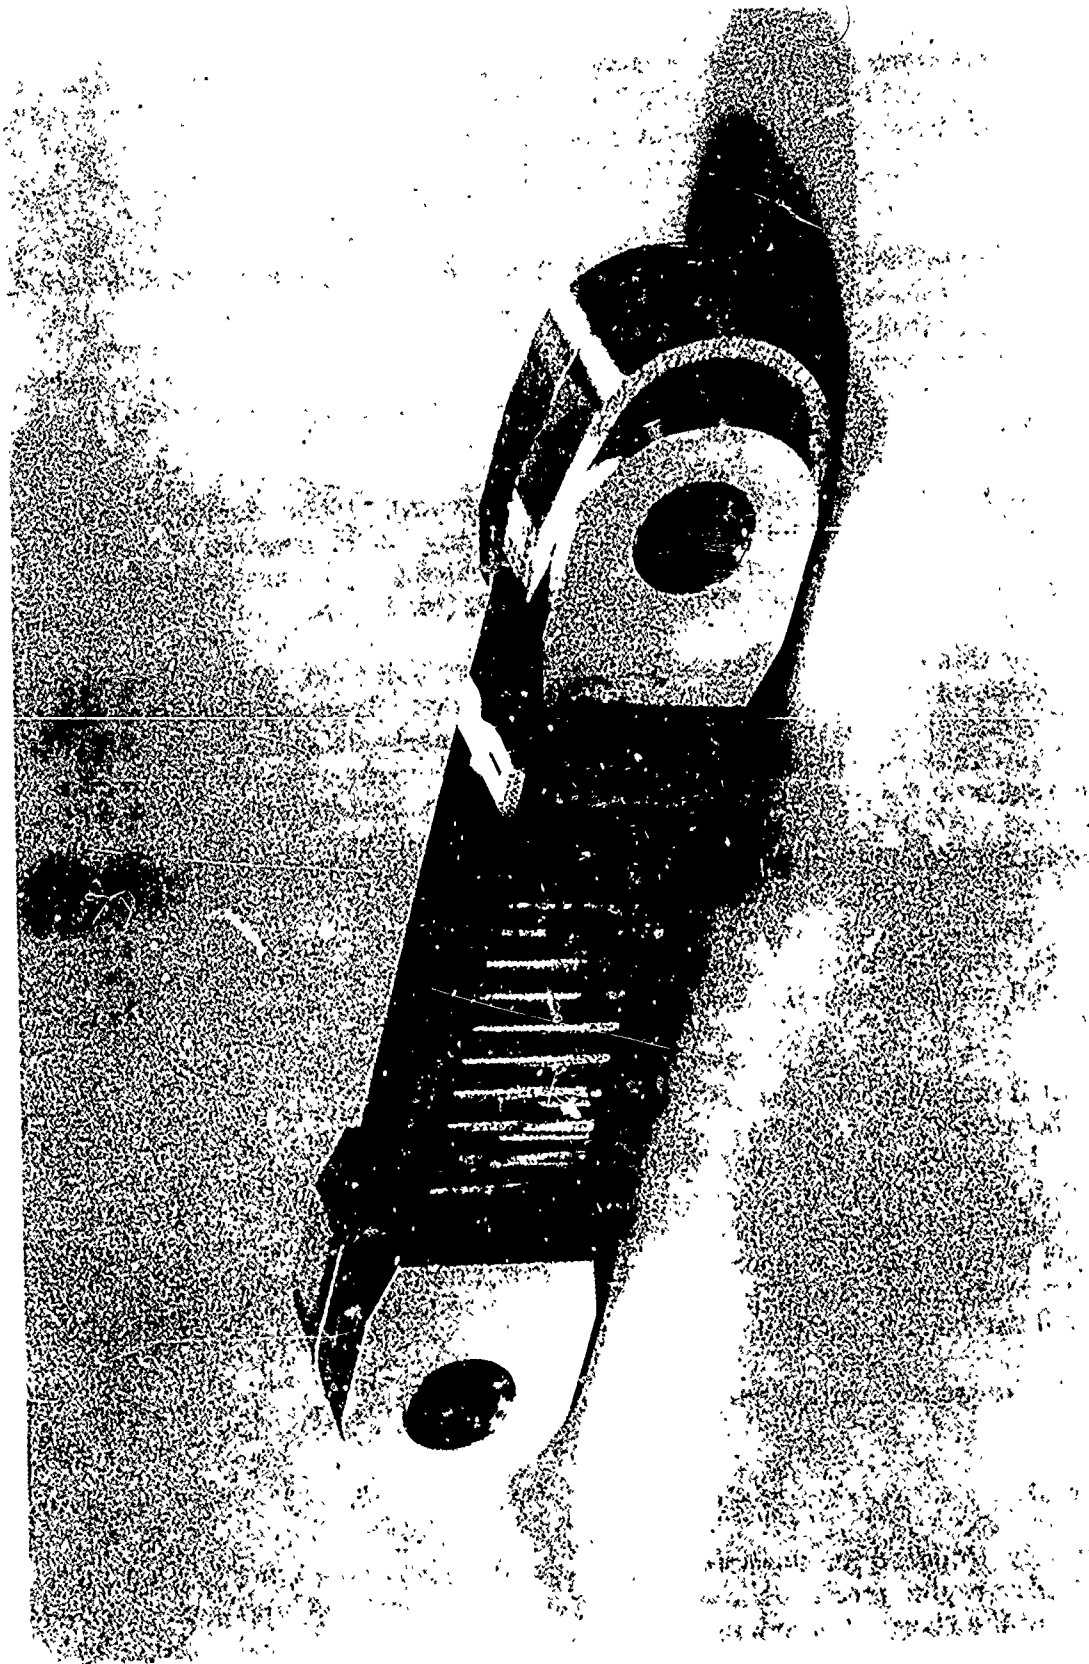
Figure 5-45. Failed Boron-Epoxy Side Brace Specimen

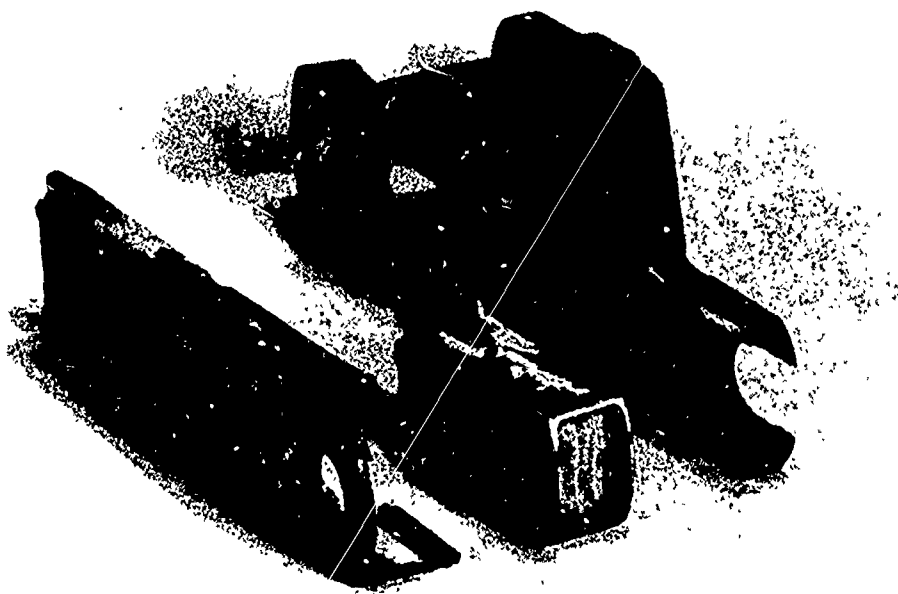
Figure 5-52. Failed Boron-Epoxy Torque Arm Specimen

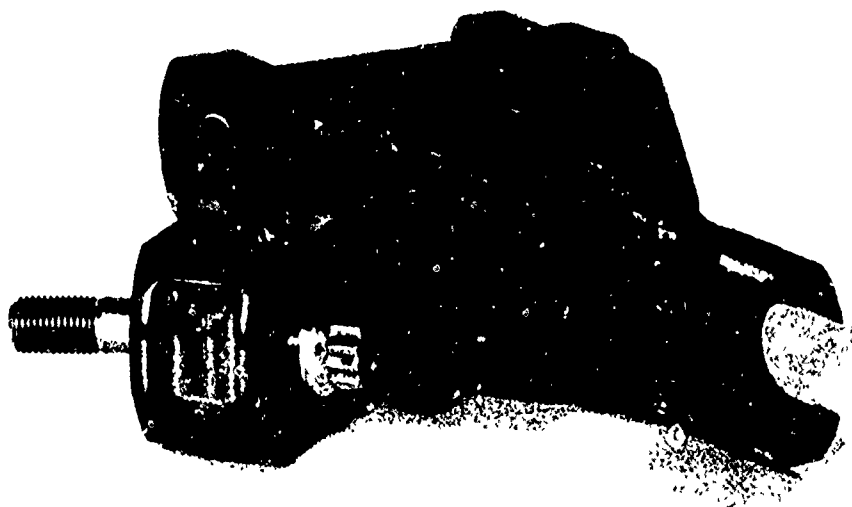
Figure 5-53. Failed Boron-Epoxy Torque Arm Specimen

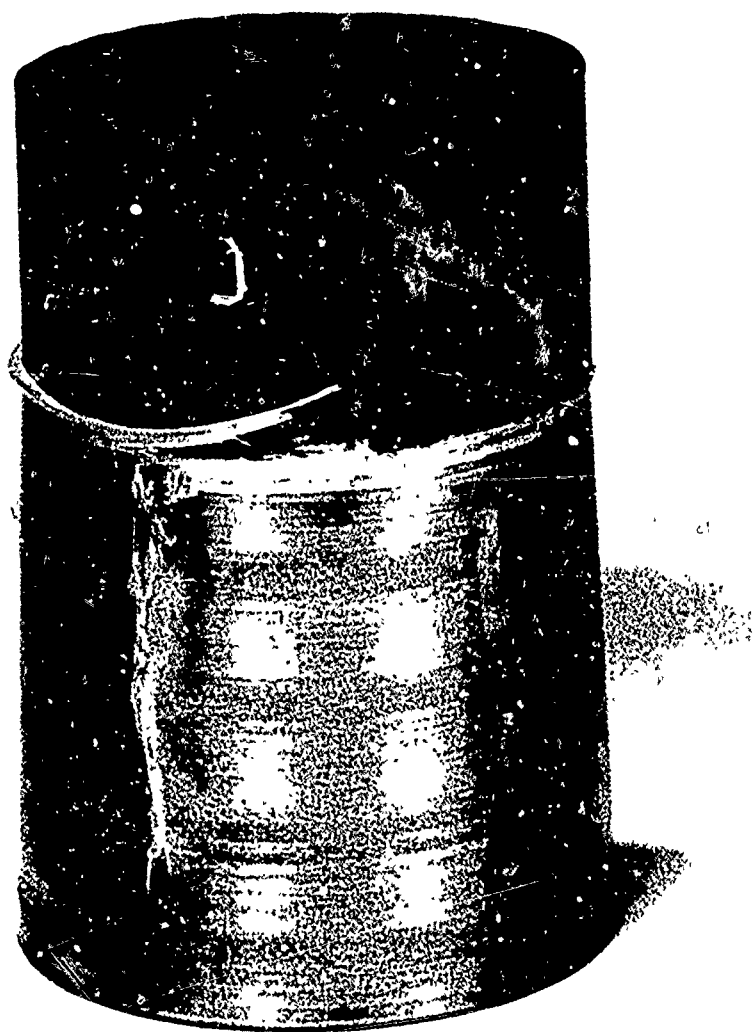
Figure 5-72. Failed Forty-Eight-Ply Cylinder (Second Design)

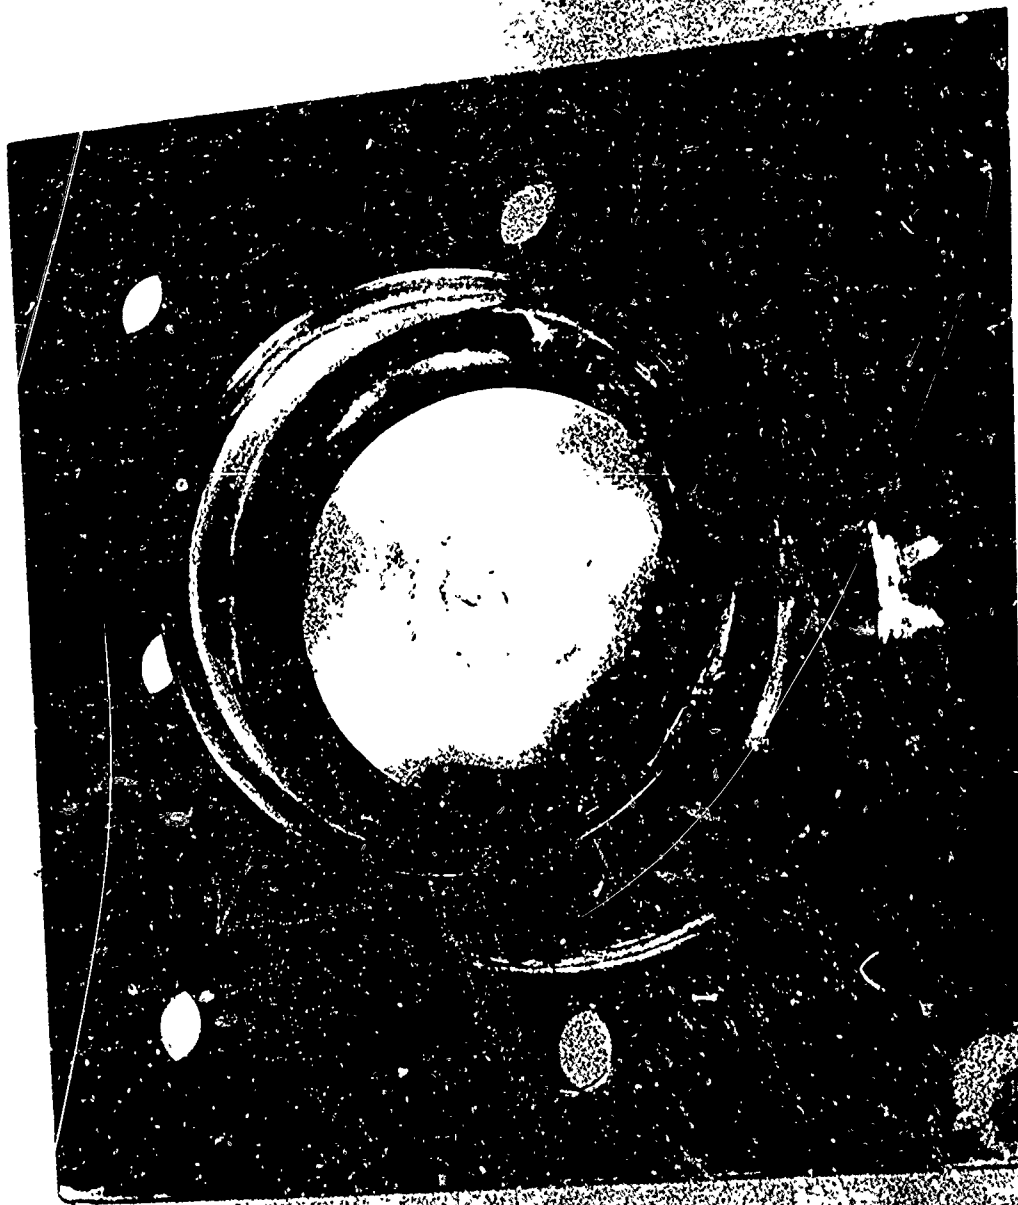
Figure 5-75. Failed Forty-Eight-Ply Cylinder, Boron-Epoxy, (Third Design)

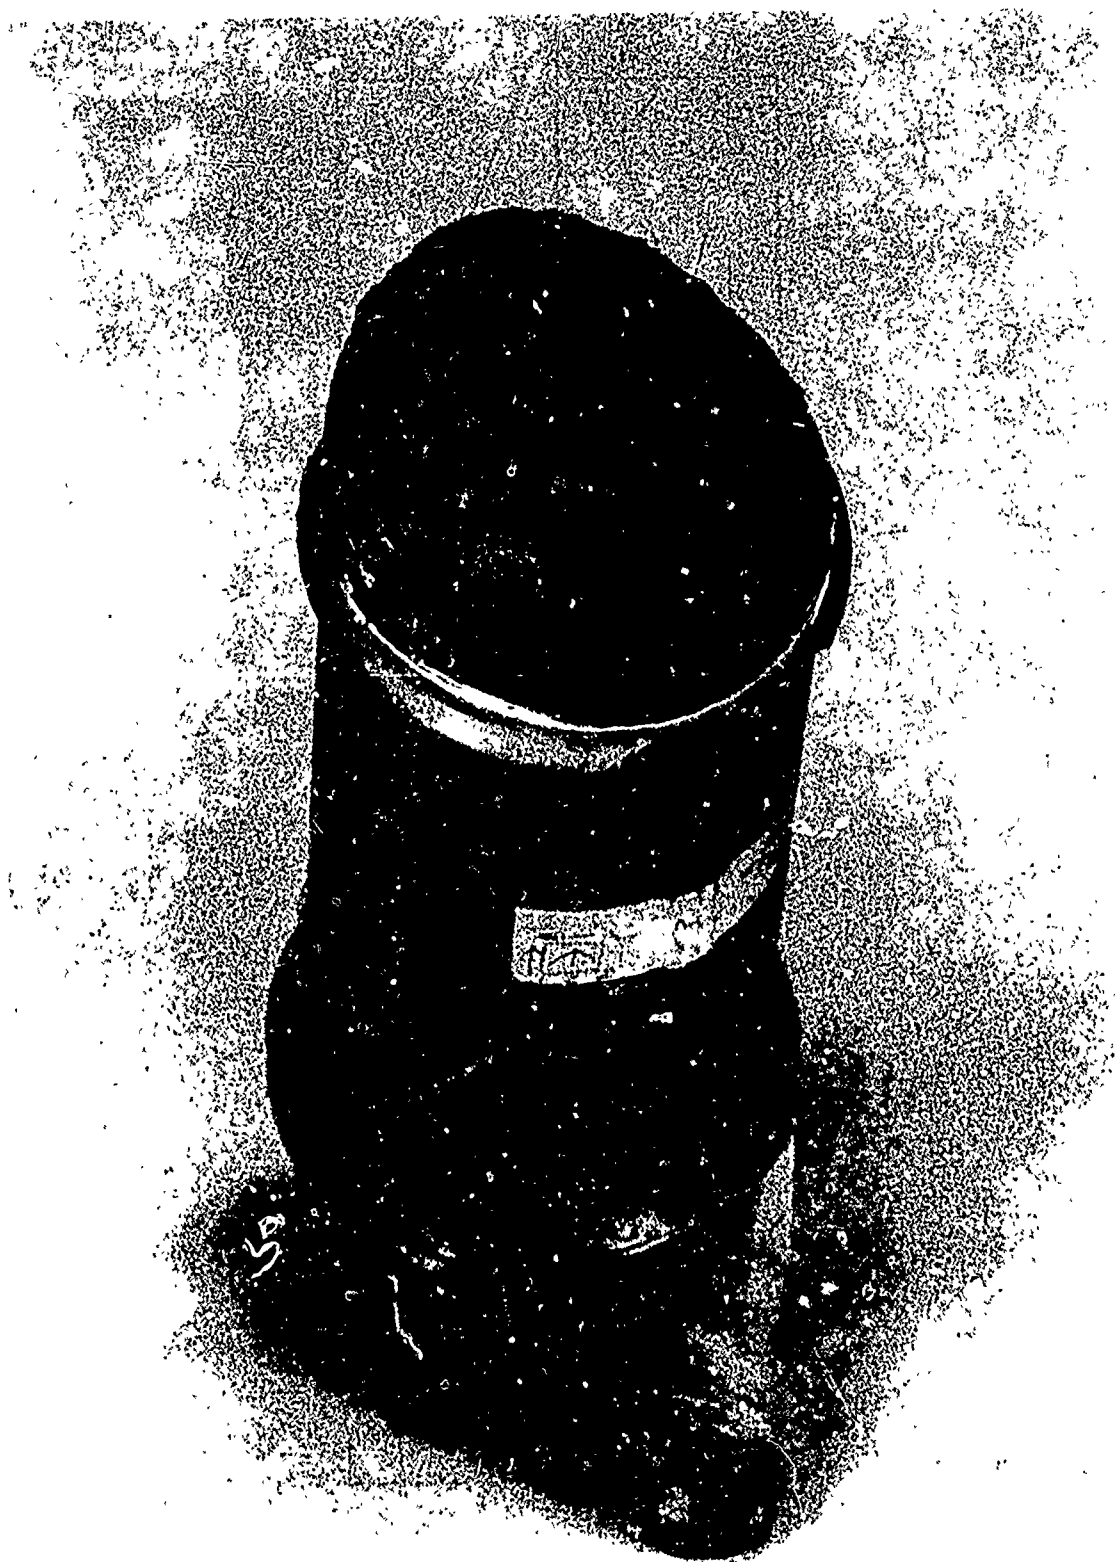
Figure 5-76. Failed Boron-Epoxy Forty-Eight-Ply Cylinder (Third Design)

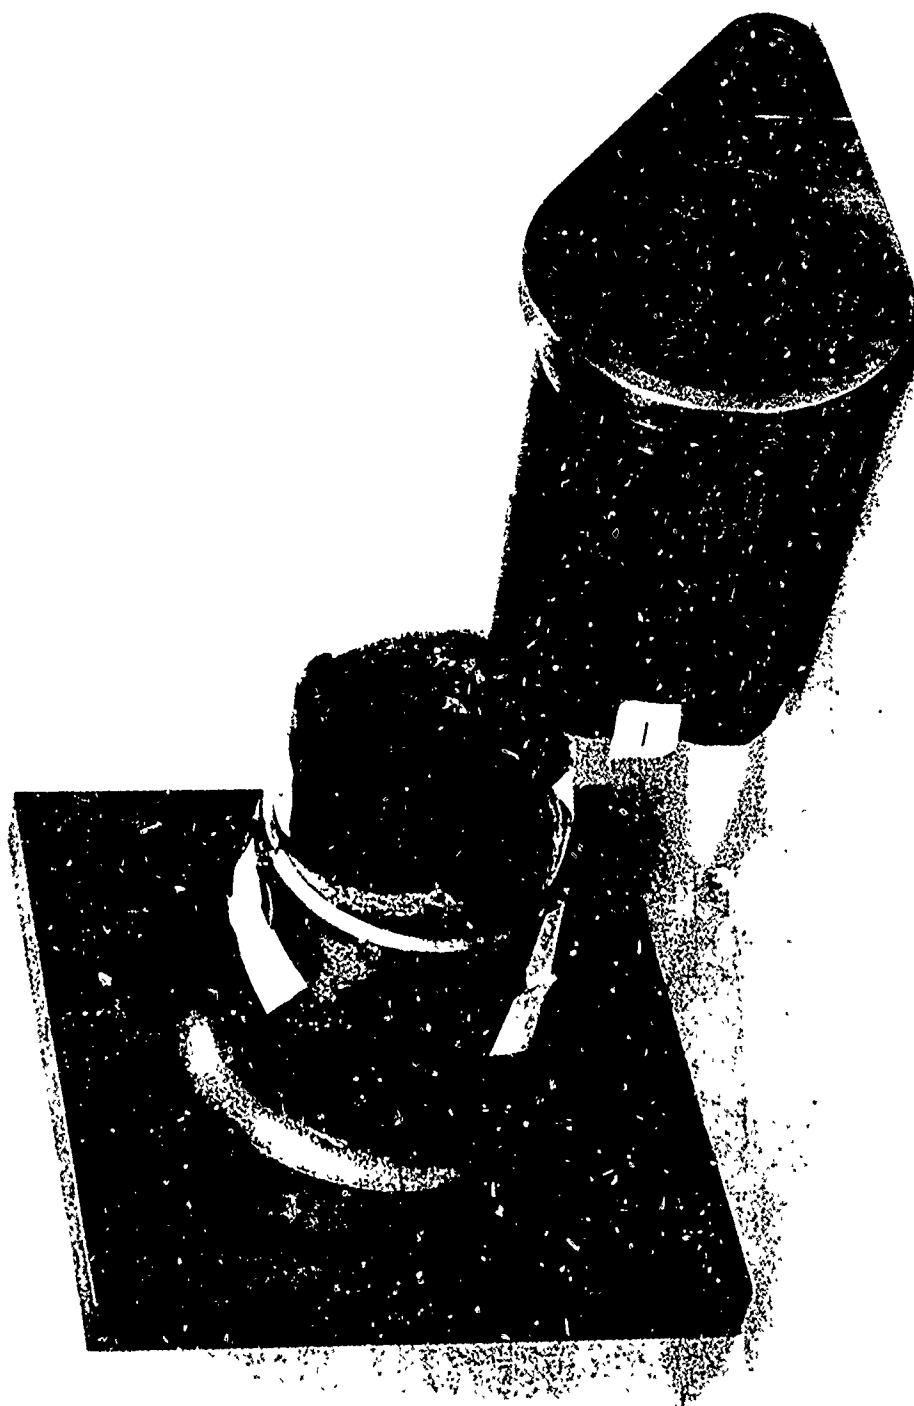
During the test the specimen failed by rupture of the cylinder in the region around Point **A**, Figures 5-78 and 5-79, at 13000 pounds. Therefore the cylinder sustained a load of 13/15 or 0.87 of the predicted value. This test also indicated that the loading lug joint was capable of supporting a shear stress in excess of 3360 psi.

A C-scan inspection of the composite cylinder indicated some possible regions of delamination within the cylinder wall as fabricated. These lapses in structural integrity might have had some influence on the specimen falling somewhat short of the target load. The details of the C-scan inspection are given in Figure 8-60.

Figure 5-79. Failed Cylinder Specimen, Boron-Epoxy Thirty-Two-Ply (Second Design)

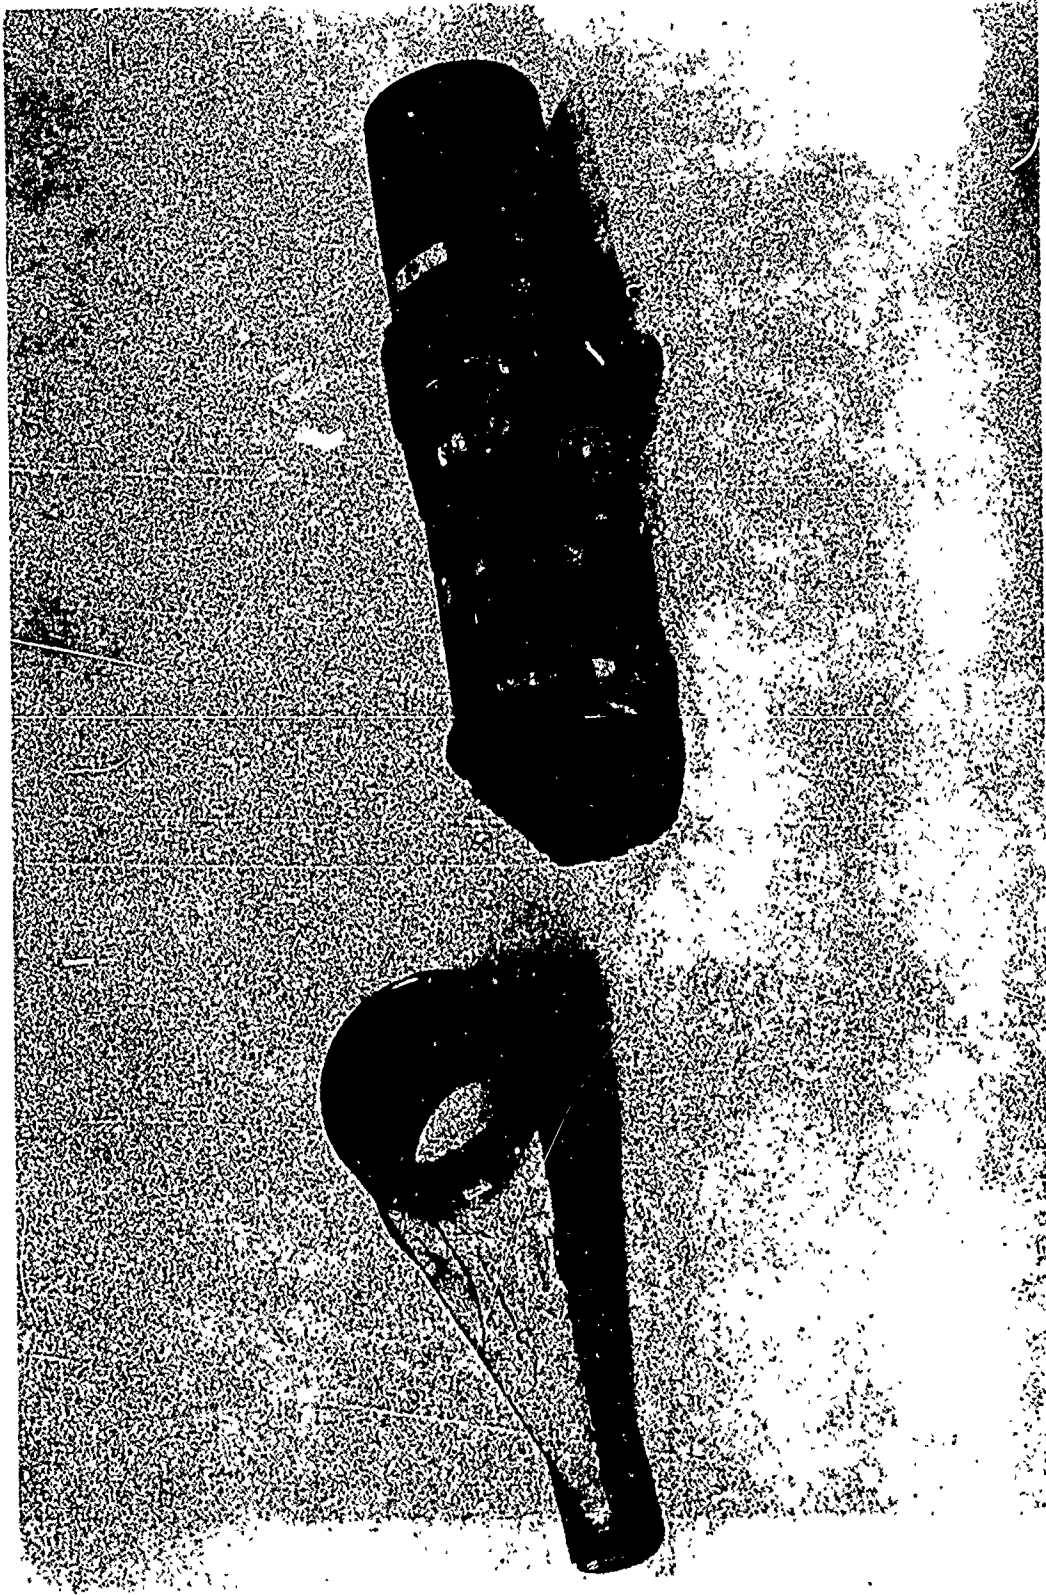
Figure 7-28. Failed Outer Cylinder (P-25190S)
