INSPECTION OF PAVEMENT GROOVING

Robert C. Gunkel

Army Construction Engineering Research
Laboratory
Champaign, Illinois

TECHNICAL REPORT NO. AFWL-TR-72-149

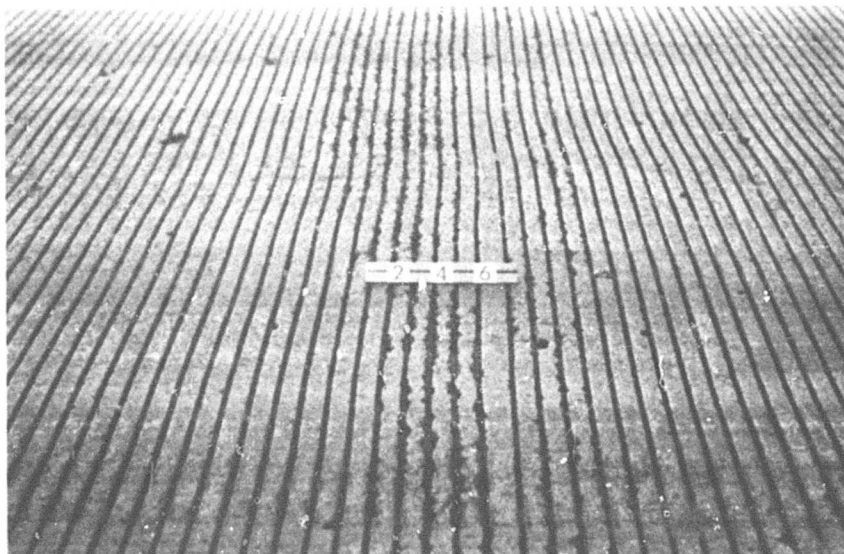
Figure 2. Kansas City Municipal Airport -- Deterioration
of AC grooving located near runway end (36)

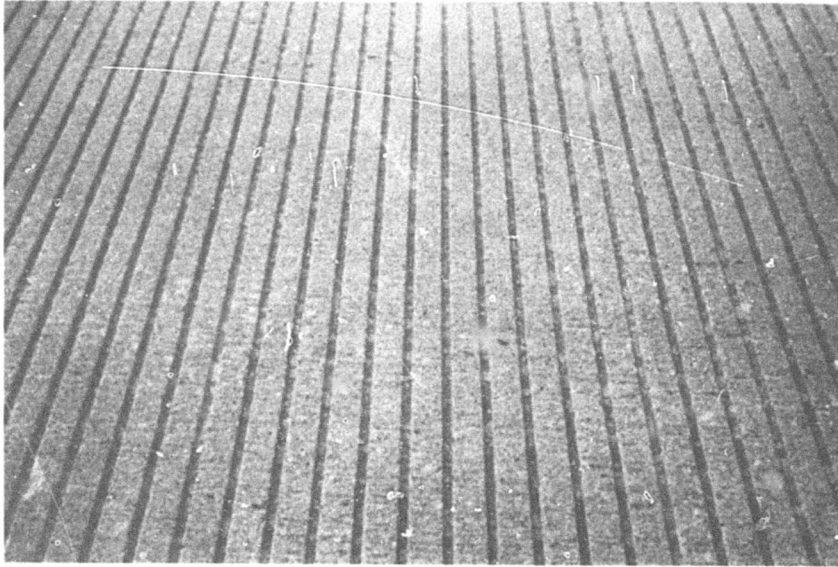
Figure 9. Chicago Midway Airport -- Excellent condition of grooving in southeast runway end.

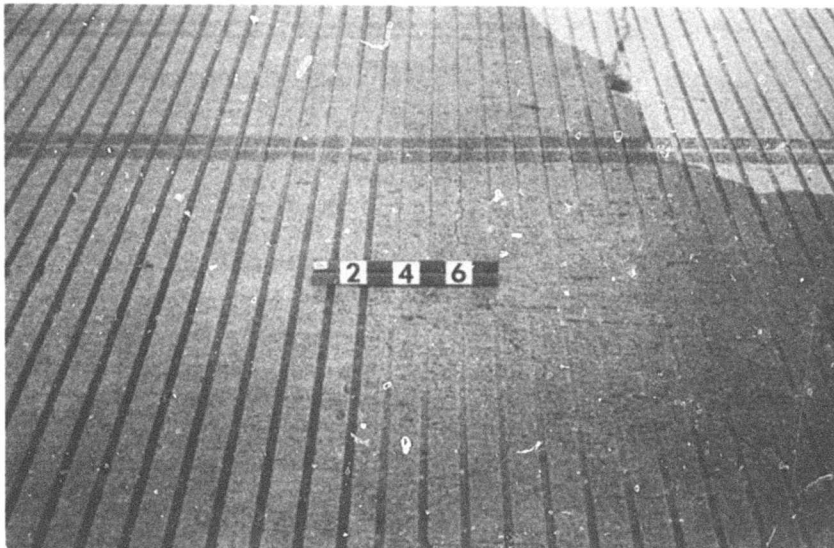
Figure 10. Chicago Midway Airport -- Deficiency in grooving due to low area in pavement surface.

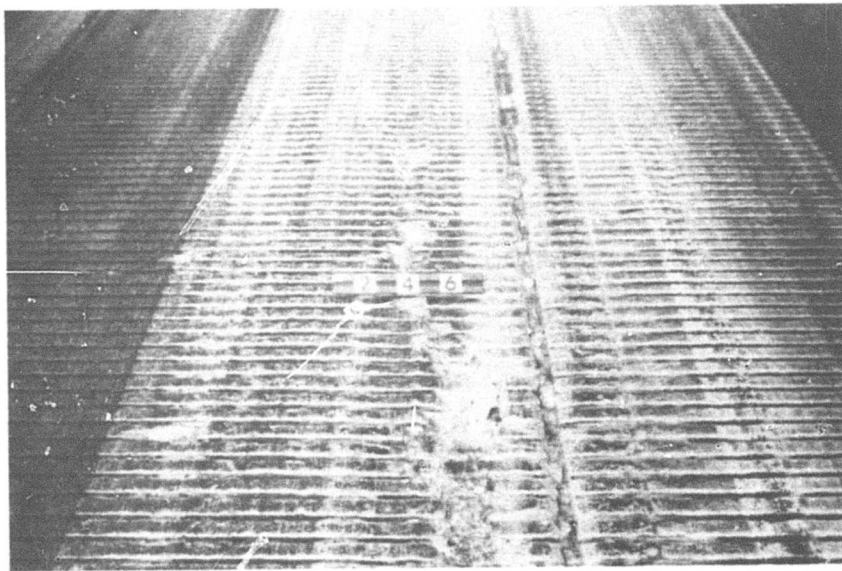
All of the pavement grooving observed at this airfield was in excellent condition (see Figures 7, 8, and 9). Tire marks were apparent in the touchdown areas, but there was little evidence of rubber deposits in the grooves. Several small areas of ungrooved pavement were observed where the grooving equipment had skipped over low places in the pavement surface (Figure 10). The continuously reinforced pavement had typical transverse cracks at closely spaced intervals, but there was little evidence of deterioration at intersections of the grooves with the cracks (Figure 11). A minor amount of surface voids were also noted (Figure 12). An extensive amount of spalling had occurred along the center longitudinal joint of the PCC pavement (Figure 13). This is

a structural problem which is not related to pavement grooving. Figure 14 shows a longitudinal joint spall repair made with a bituminous mixture.

Figure 13. Chicago Midway Airport -- Spalling along center longitudinal joint of runway.

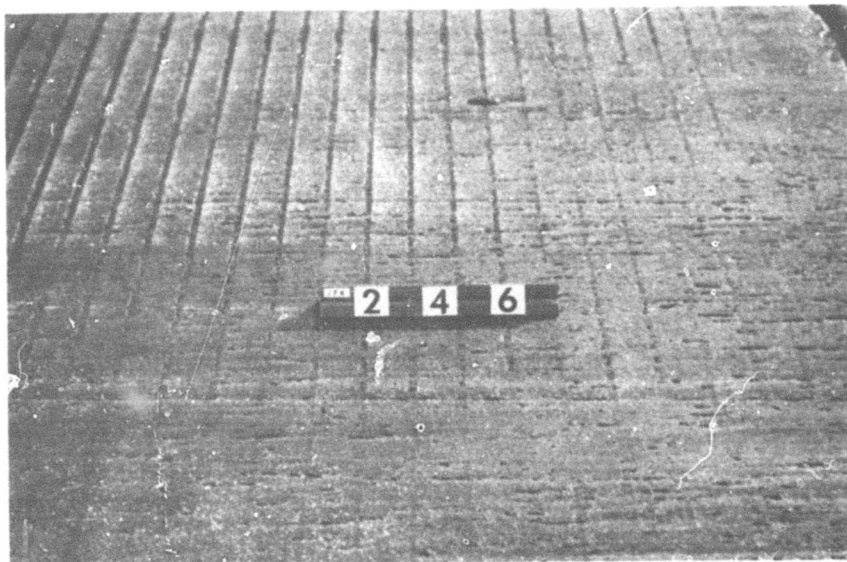
Figure 17. J. F. Kennedy International Airport -- Rubber accumulation completely filling grooves in touchdown area.
