TECHNICAL REPORT NO. 11738

INFRARED NON-DESTRUCTIVE  
ANALYSIS OF SOLID RUBBER  
ROAD WHEELS

FEBRUARY 1973

U.S. ARMY TANK AUTOMOTIVE COMMAND Warren, Michigan

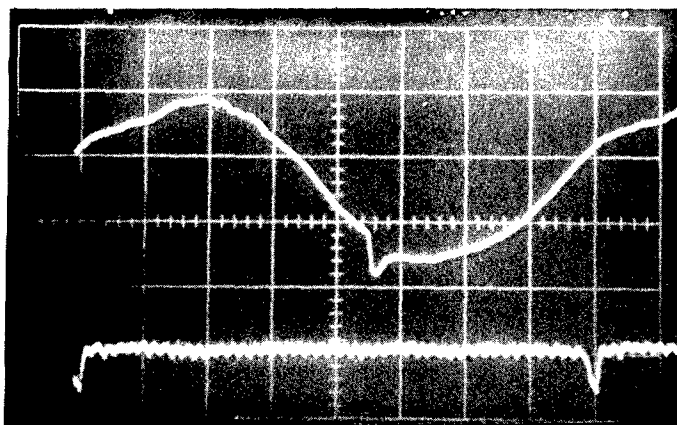
Test Wheel # 11  
Right Sidewall

Gross Unbalance (out of round)

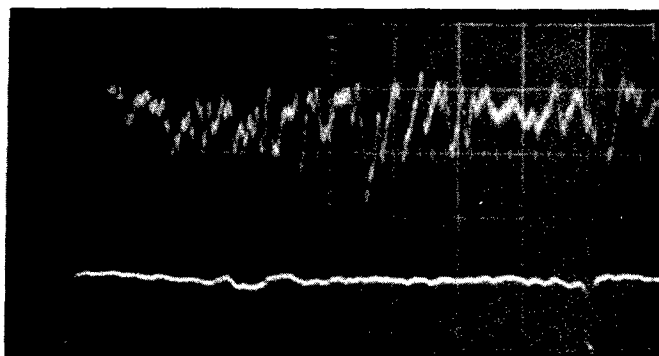
Test Wheel # 24  
Left Sidewall

Sidewall "Chunking"

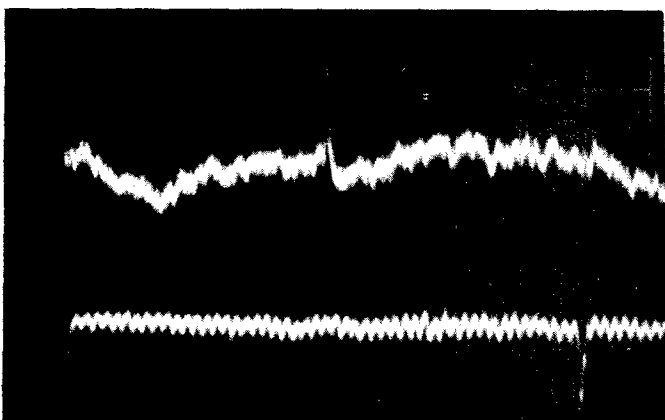
Test Wheel # 13  
Tread

Tread Cut at 180°

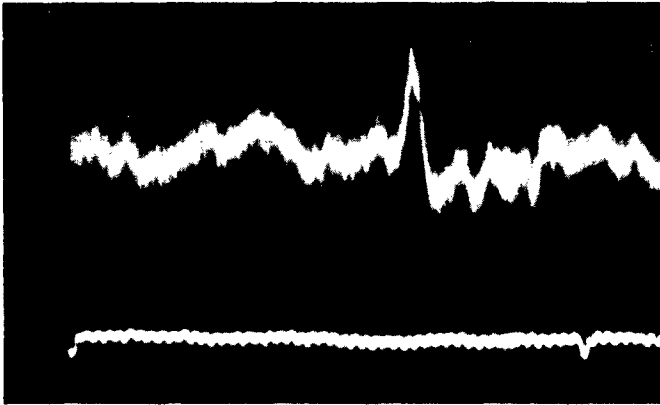
Test Wheel # 12  
Right Sidewall

Sidewall Cut at  $240^{\circ}$

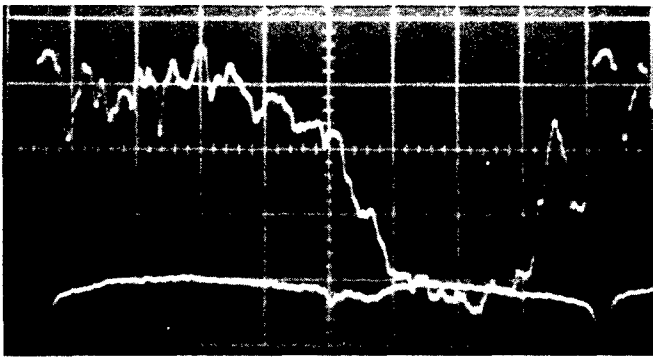
Test Wheel # 19  
Right Sidewall

Gross Unbond,  $220^{\circ}$  to  $310^{\circ}$ , 15 Square Inches Area

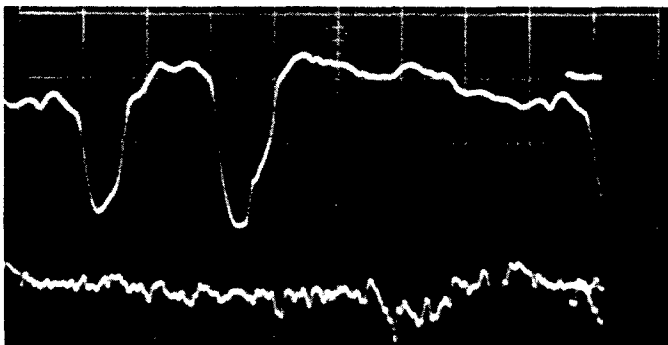
Test Wheel # 5

Minor Unbonds at  $60^{\circ}$  and  $150^{\circ}$ , 5 Square Inches  
Area Each Unbond

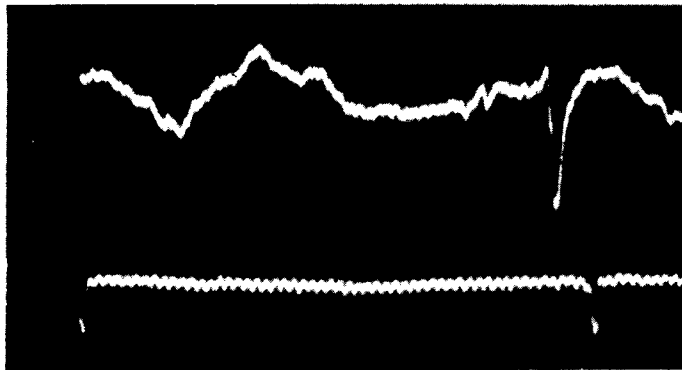
Test Wheel # 13

Small Unbond at 300°, 2 Square Inches Area

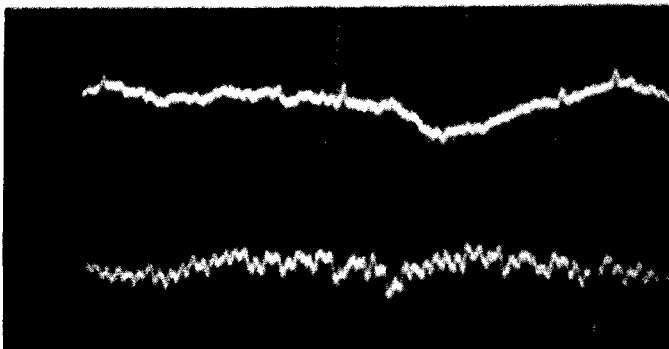
Test Wheel # 10

No Defects, Minimal Thermal Variations

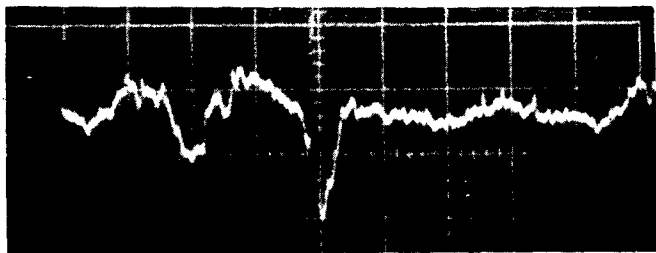
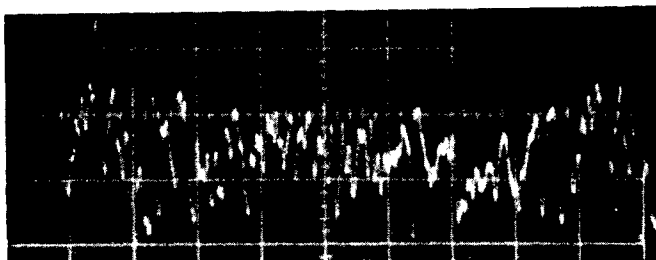
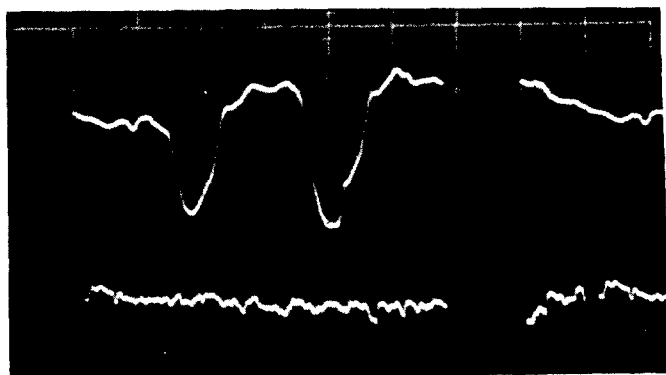
Figure 8 - Example of Thermal Transfer

Where large temperature differences are produced, there may be "thermal telegraphing" to adjacent areas. That is, in Figure 8 two defects located in the left shoulder/sidewall area produce such intense "cool" pulses that they are also seen in the right shoulder/sidewall area.

RIGHT SIDEWALL  
Transfer of Thermal  
Unbond Pattern To  
right sidewall area

TREAD  
Unbonds Not Detected

LEFT SIDEWALL  
Two Unbonds Located  
At 90° & 180° Each  
Unbond 4 Square Inches  
Area

Two Unbonds Located at 90° & 180° At  
Shoulder Edge of Left Sidewall

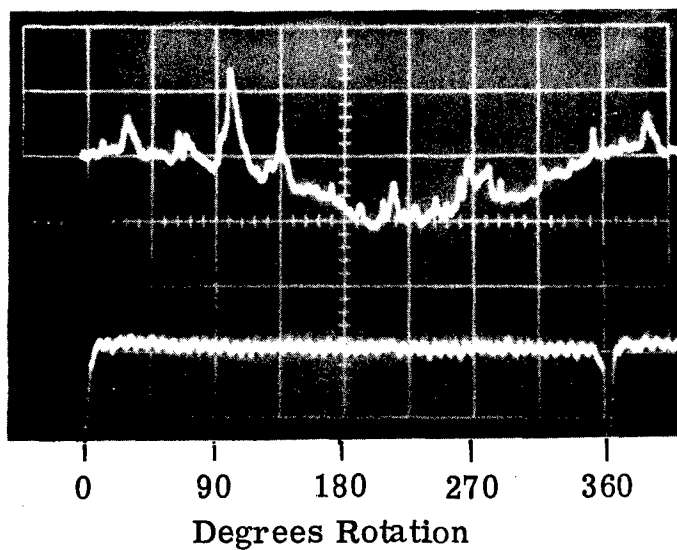
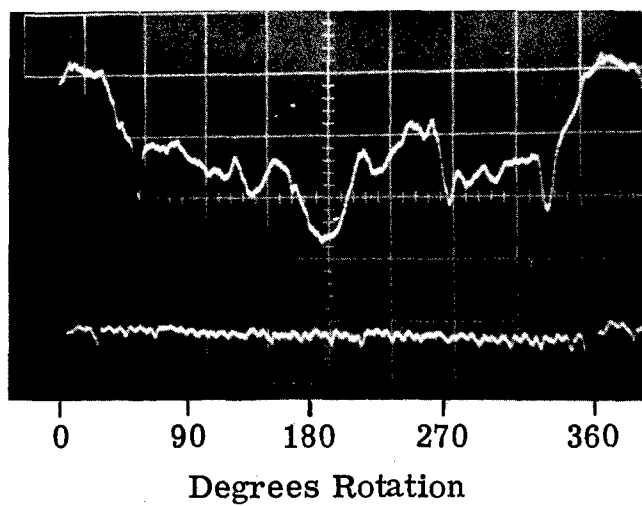
Figure 9 - Example of Active and Dormant Unbond Interface Defect

A more difficult interpretation is between a small thermally intense hot spot (pulse) and an equally intense cold pulse apparently both produced by an interface unbond. Based on examination of this type of unbond after stripping, it is concluded that "hot pulse" unbonds are growing in size and are in a high friction area. "Cold pulse" unbonds may be dormant and not increasing in size. In addition, "cold spots" may have been caused by a local effect such as solvent residue or foreign matter and after the initial unbonding may not spread beyond the effect size.

Small Active  
Heat Producing  
Unbond At  $95^{\circ}$

Moderate Size  
Dormant Unbond  
(Cold) at  $180^{\circ}$

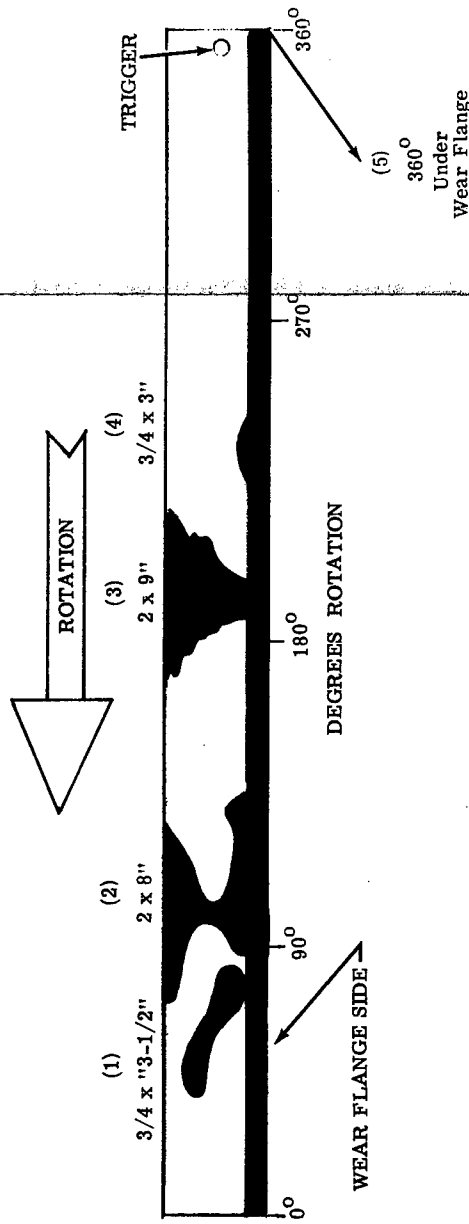
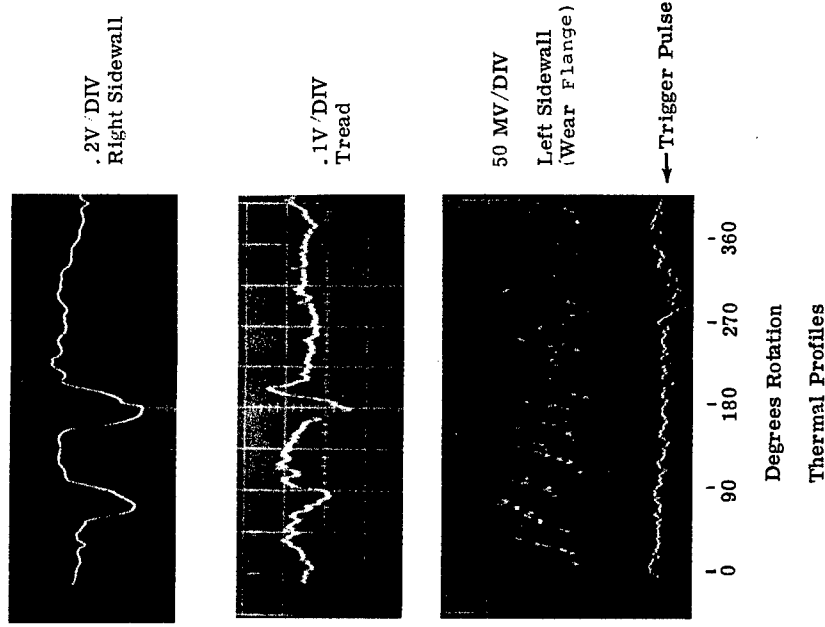
**Figure 10 - Stripped Rubber Tread Interface**

**Description of Defects: Separated Completely Over Wear Flange**

- (1) Unbond
- (2) Erosion
- (3) Unbond
- (4) Unbond
- (5) Unbond Along 300° Wear Flange

Erosion Caused By Road Debris  
Forced Past Wear Flange

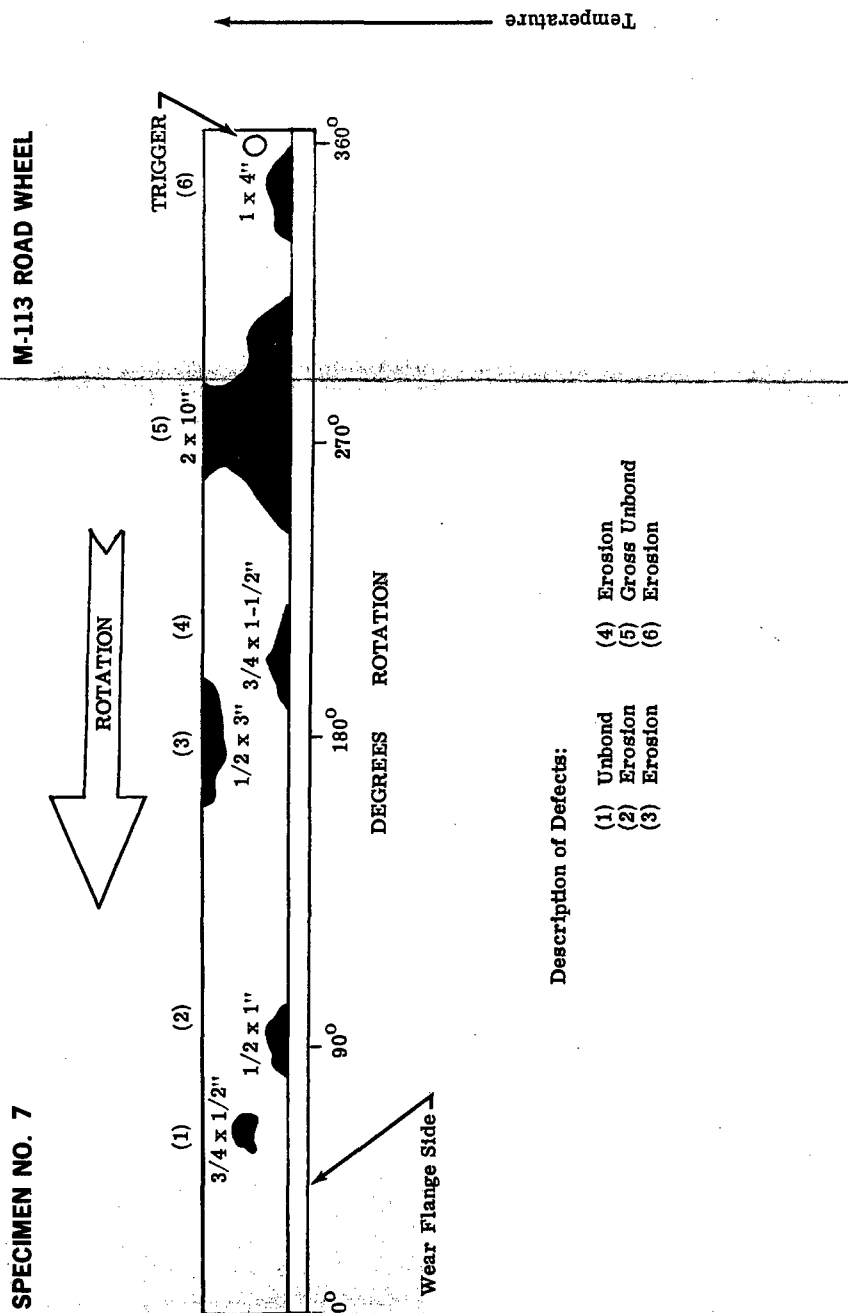
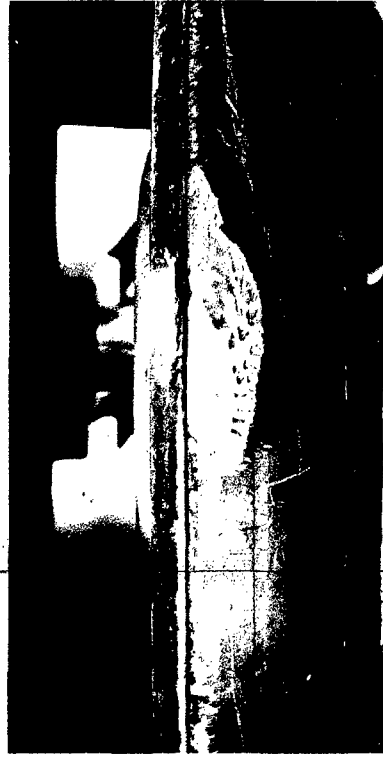
Figure 11 - Stripped Rubber Tread Interface

Erosion - Defect Location (3)

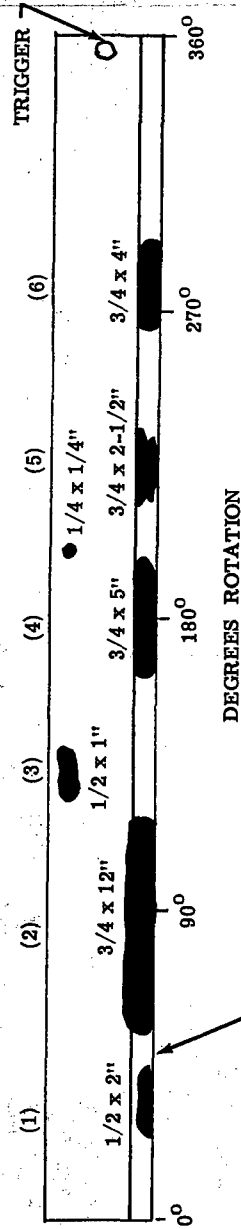
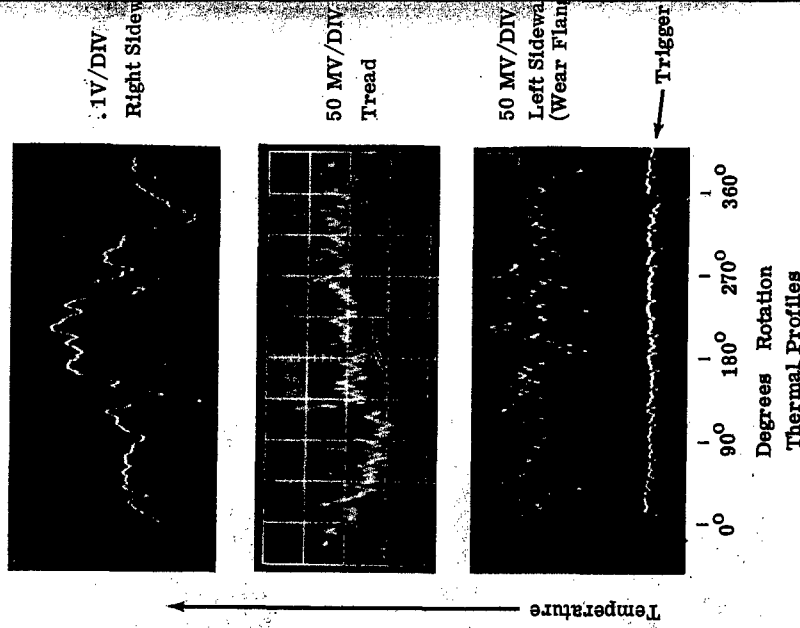
Figure 12 - Stripped Rubber Tread Interface

- (1) Unbond
- (2) Unbond Due To Adhesive Feathering
- (3) Track Guide Damage
- (4) Unbond At Wear Flange
- (5) Unbond At Wear Flange
- (6) Unbond At Wear Flange

Feathering of Adhesive Along Wear  
Flange (2)

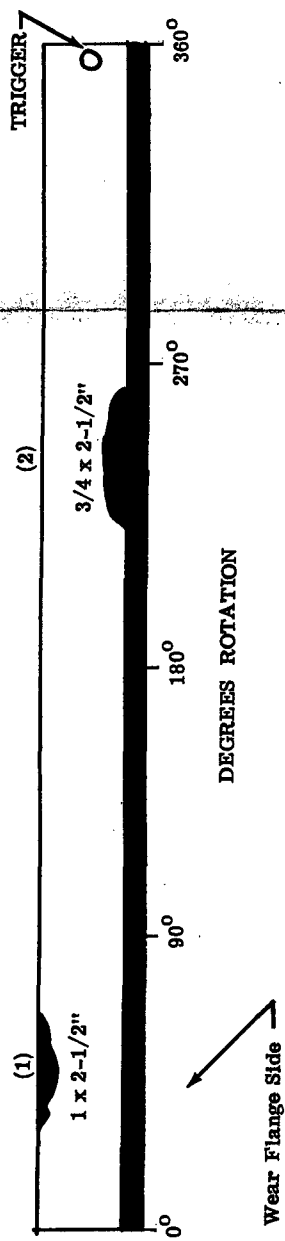
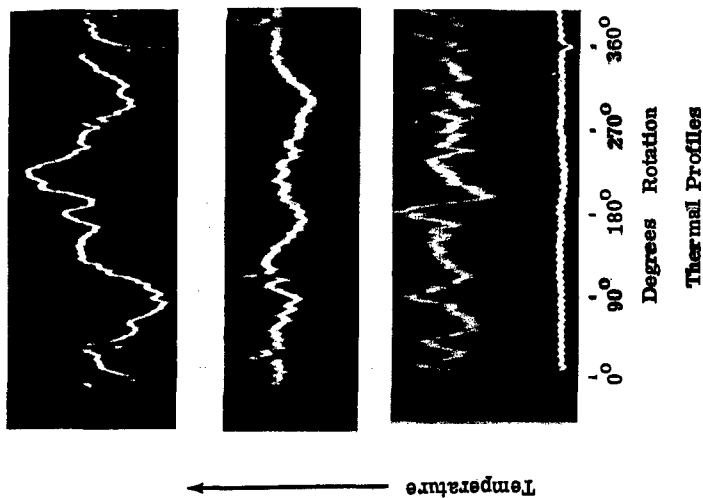
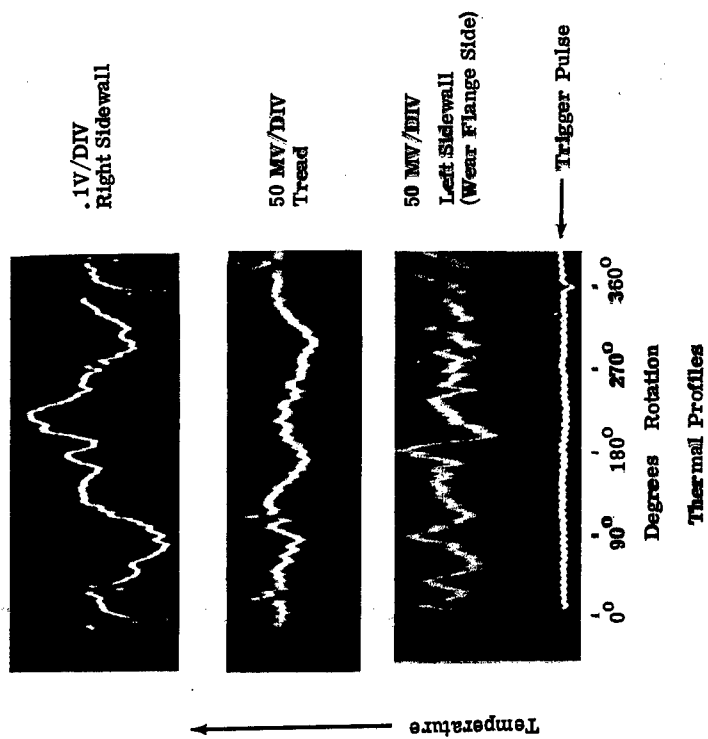
Figure 13 - Stripped Rubber Tread Interface

Unbond Along Length of Wear Flange

- (1) Unbond
- (2) Unbond

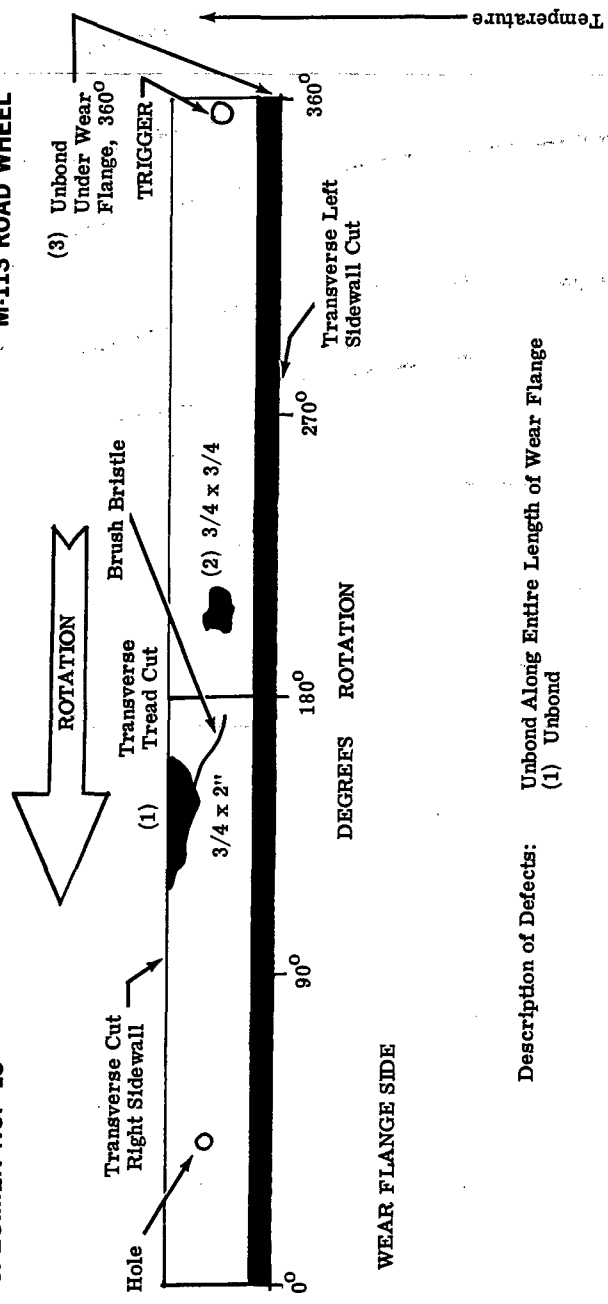
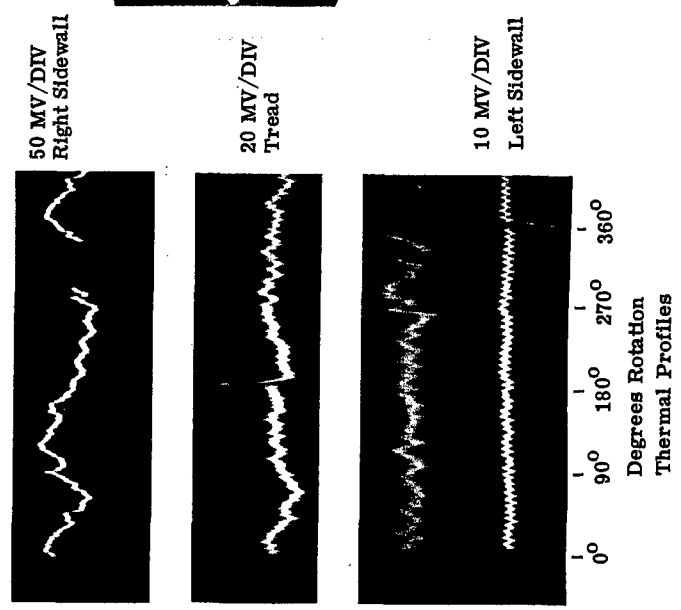
Figure 14 - Stripped Rubber Tread Interface

Description of Defects: Unbond Along Entire Length of Wear Flange (1) Unbond

Simulated Defects: Needle Hole - Acetone Injected At Interface (45°)  
Transverse Left Sidewall Cut (90°)  
Transverse Tread Cut (180°)  
Transverse Right Sidewall Cut (270°)

(3) Unbond Under Wear Flange, 360° TRIGGER

Brush Bristle (Hair) at 175°

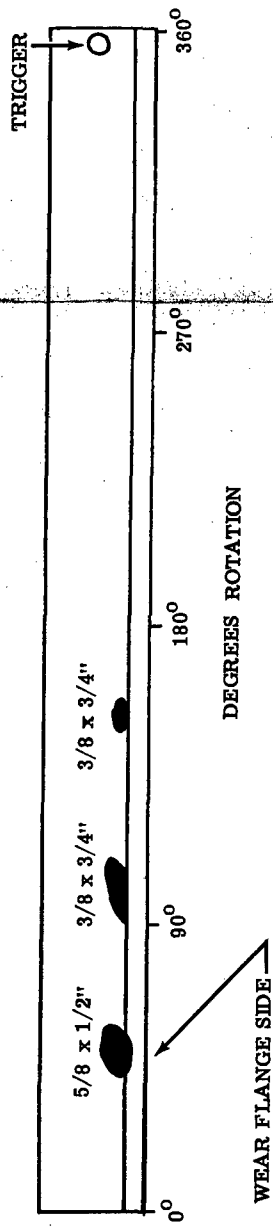
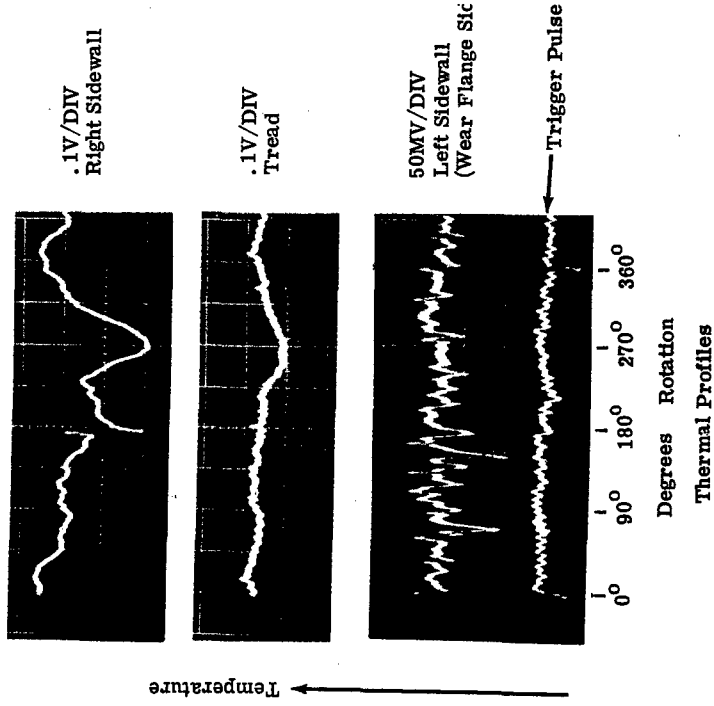
Figure 15 - Stripped Rubber Tread Interface

Description of Defects: All Defects Less Than 1 Sq. In.

Track Guide Damage

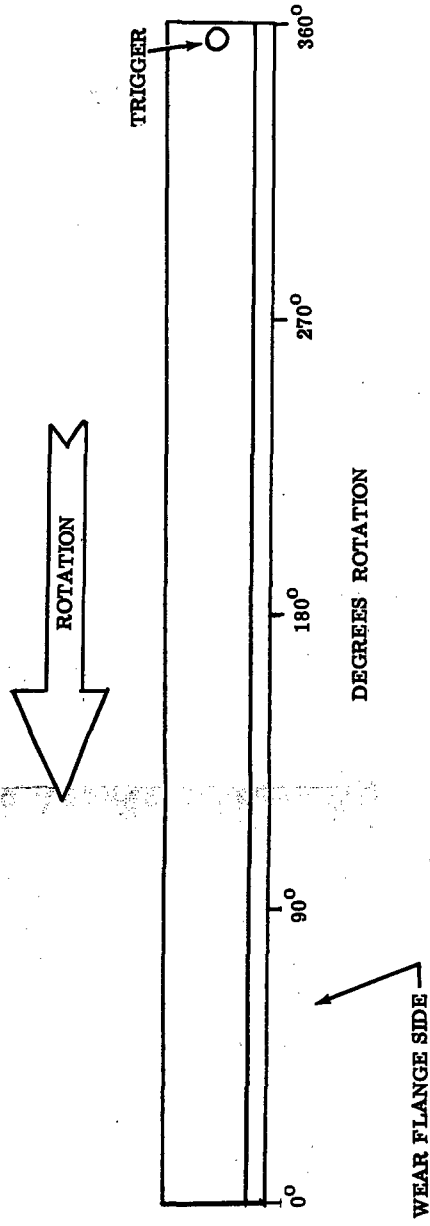
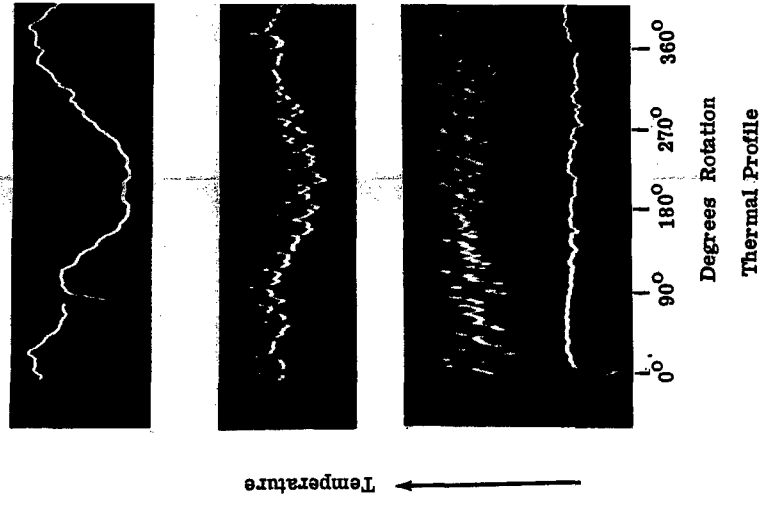
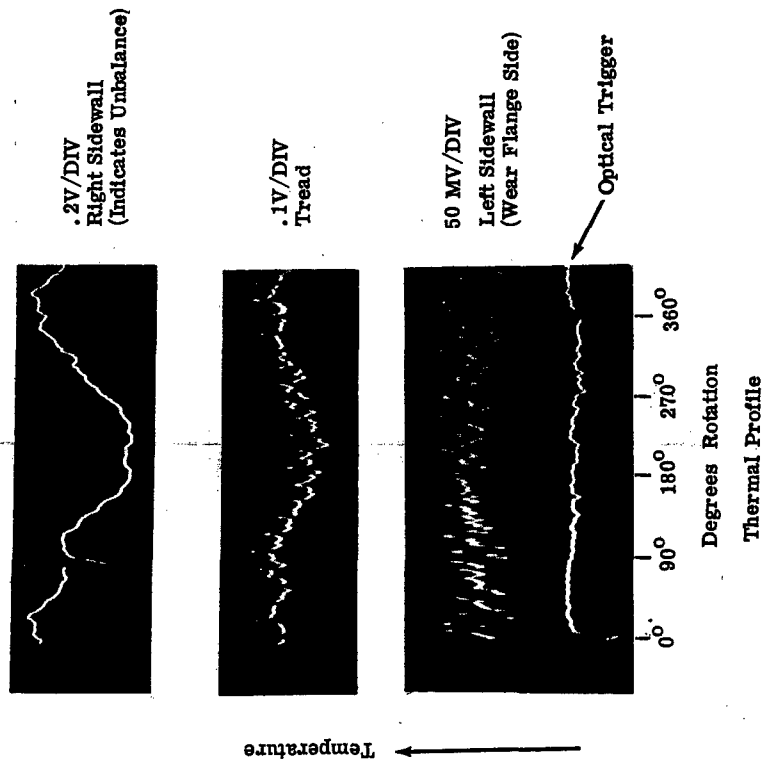
Figure 16

NO DEFECTS Wheel Out of Round (Gross Unbalance)

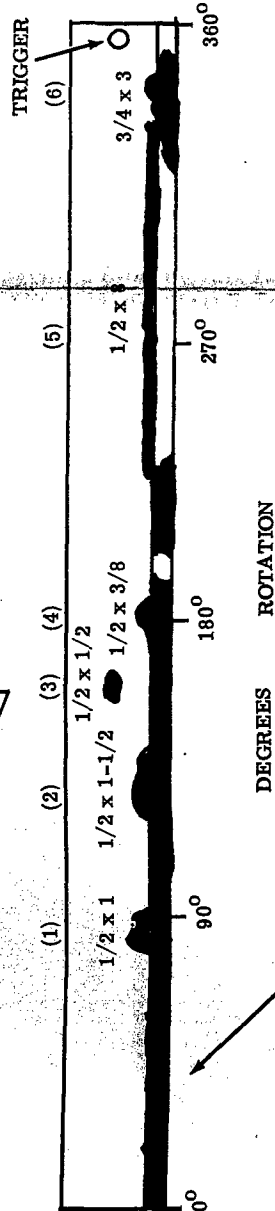
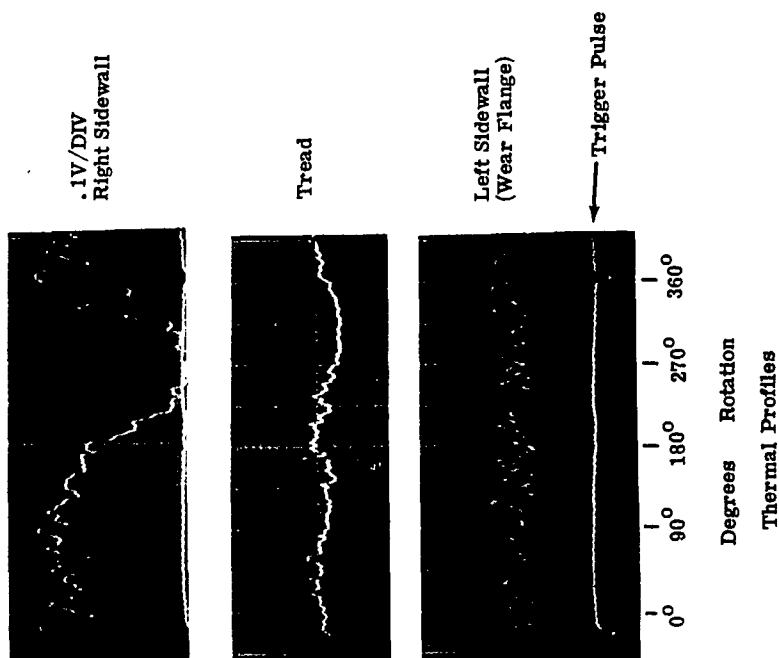
Figure 17 - Stripped Rubber Tread Interface

- (1) Unbond
- (2) Unbond
- (3) Track Guide Damage
- (4) Unbond
- (5) Unbond
- (6) Unbond

Track Guide Damage, Defect  
No. 2 and 3

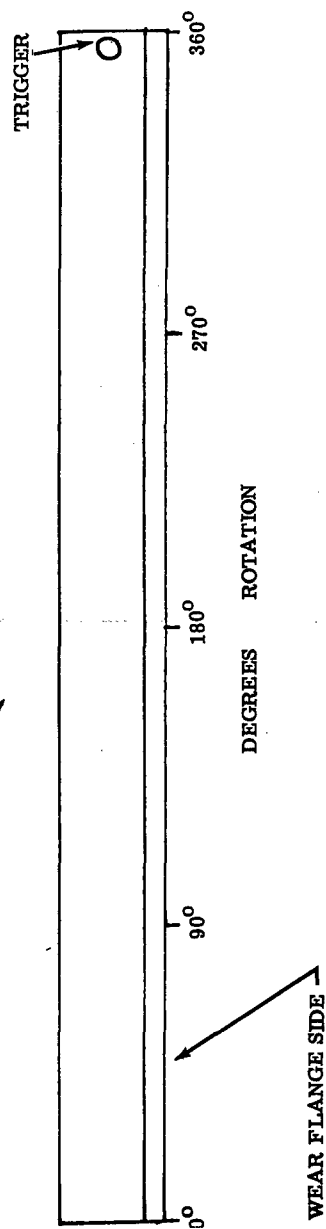
Figure 18 - Stripped Rubber Tread Interface

No Defects Developed During Drum Test

Feathering of Adhesive Along Wear Flange

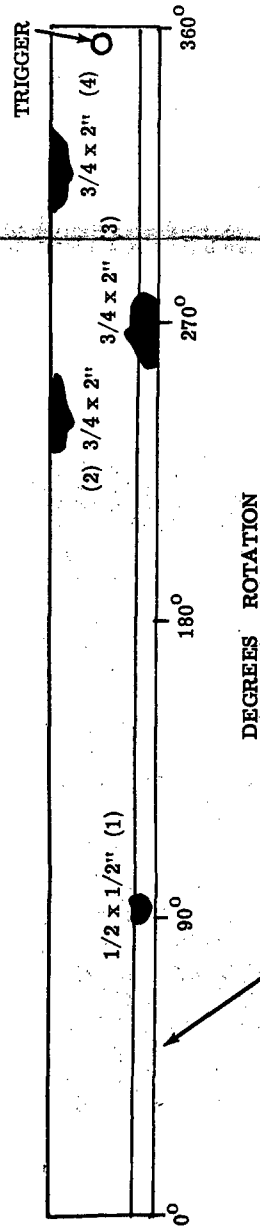
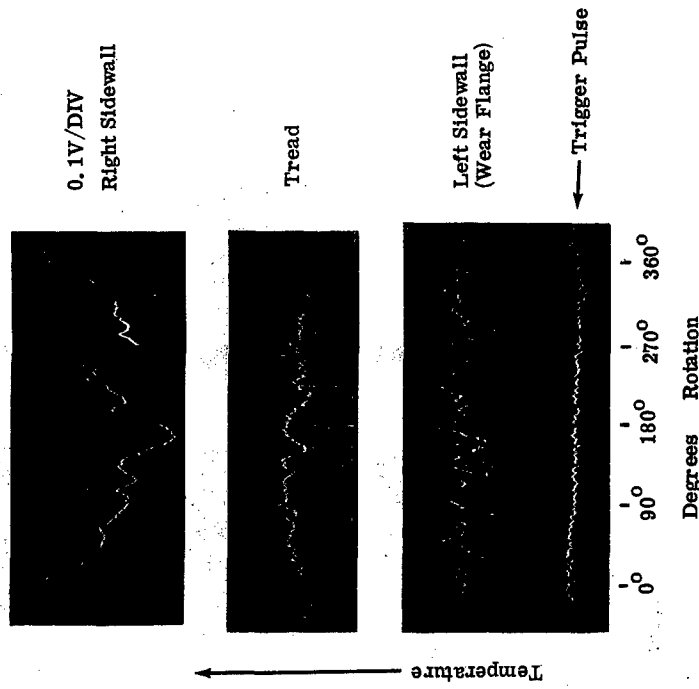
Figure 19 - Stripped Rubber Tread Interface

Description of Defects: (1) Erosion (3) Erosion  
(2) Unbond (4) Unbond

Erosion - Defect Location (1)

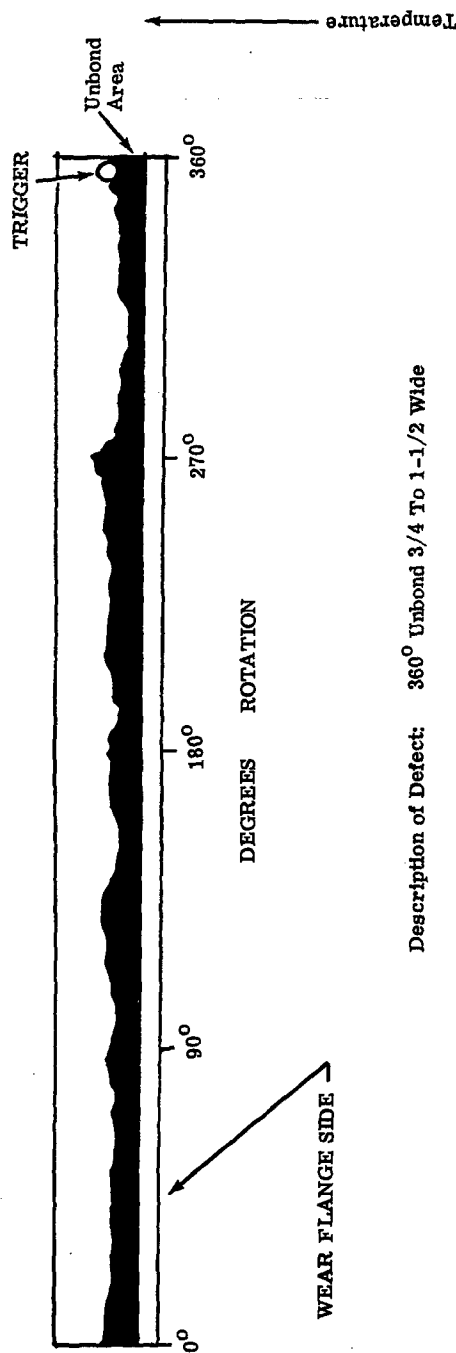
Figure 20 - Stripped Rubber Tread Interface

Description of Defect: 360° Unbond 3/4 To 1-1/2 Wide

Solvent Residue
