EVALUATION OF GOODYEAR MEDIUM-DUTY  
ALUMINUM HONEYCOMB LANDING MAT

Army Engineering Waterways Experiment Station

March 1973

MISCELLANEOUS PAPER S-73-8

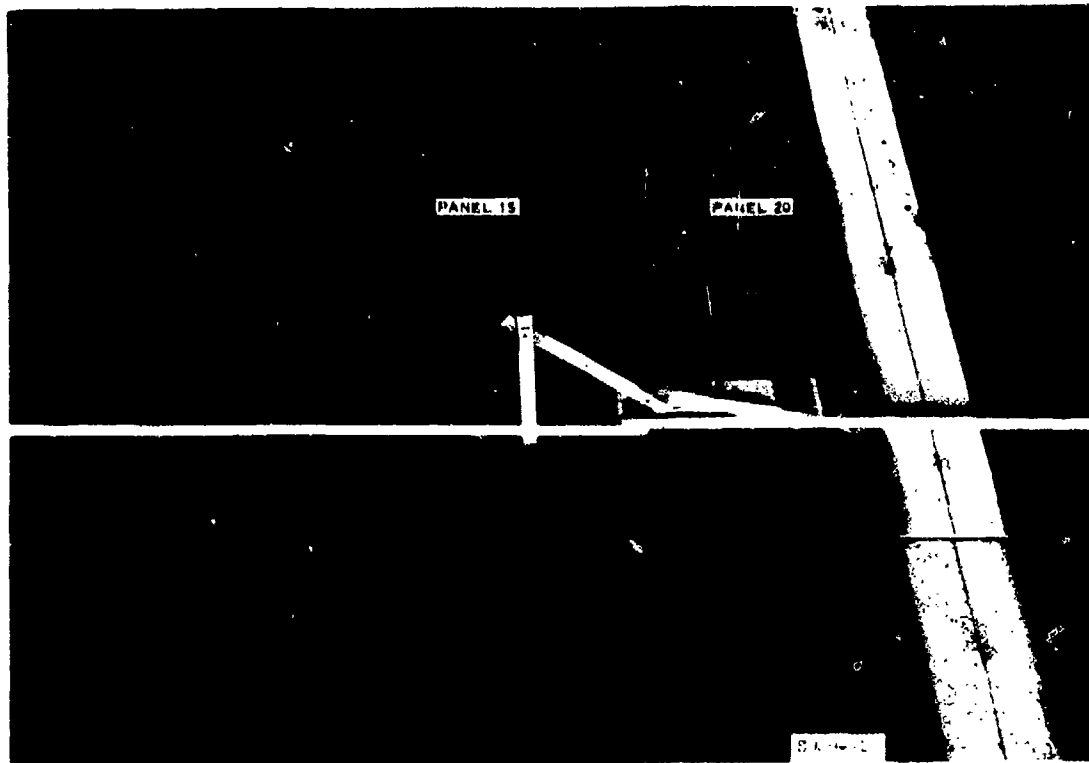
27. Traffic was applied using the load cart described in paragraph 16. After 180 coverages, panel 15 was considered failed due to a depression of approximately 43 by 7-1/2 in. parallel and adjacent to the male connector (photo 4). When the panel was removed from the test section, the surface subgrade strength under the panel was 3.8 CBR (table 1). The core had depressed 0.37 in. (maximum) along the male connector. In addition to the depression, a break 1-1/2 in. long had occurred at the corner of the male and underlap connectors. The bottom skin had broken at the male connector along the entire length of the panel. Photo 5 shows

Photo 4. Failed panel 15 showing depressed area after 180 coverages

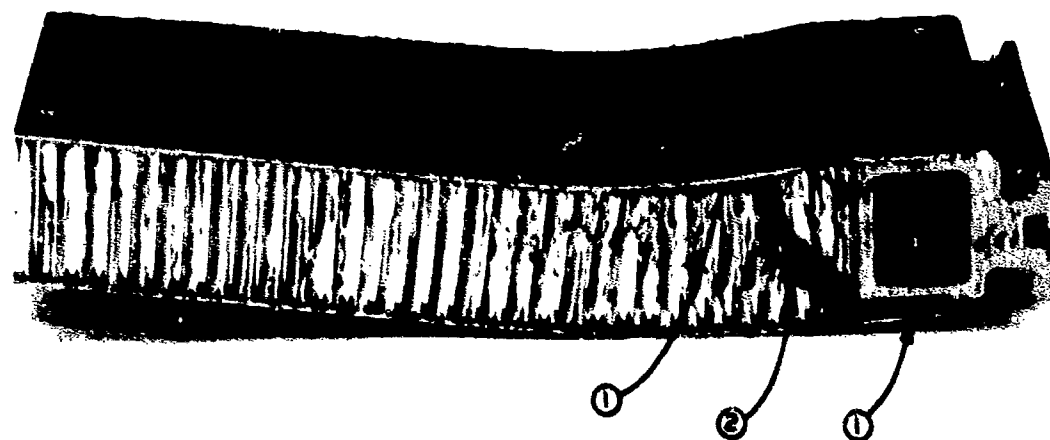
adhesive failure at the top and bottom skins and shear failure of the core of panel 15 after 180 coverages.

35. All panel failures were similar in the manner in which they initiated. The film adhesive was ordered by the fabricator in 48-in.-wide rolls and was cut to the length of the skins so that all required areas could be covered for bonding. However, the width of the adhesive as delivered was undersize by approximately 0.5 in., and a splice in the adhesive was required to assure 100 percent coverage. In some of the panels tested, it appeared that the adhesive had not been spliced (see the 0.5-in.-wide void area across the center of panel 3 in photo 6). Panel 18 was void of adhesive along the overlap connector (see photo 8), and a similar condition existed on panel 39 along the female connector. Failure of panels 3, 18, and 39 was attributed to the lack of splicing in the undersize fiber-film adhesive. None of the panels failed suddenly, however; and, after being excessively stressed or weakened, each survived several additional coverages before failure.

Photo 5. Adhesive failure ① and core shear failure ② of panel 15 after 180 coverages

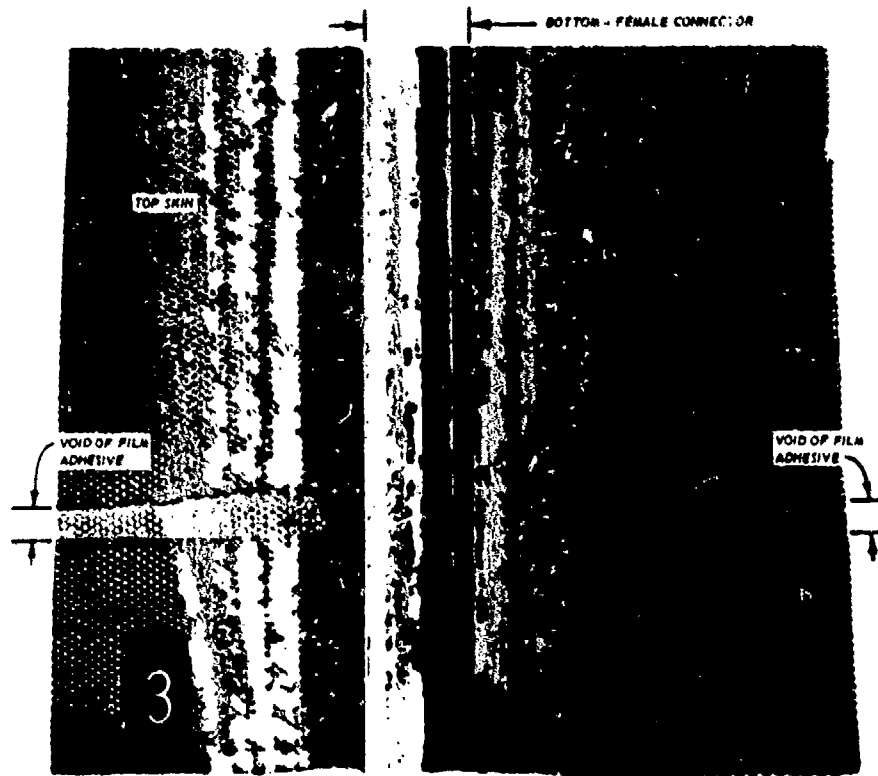
29. At 622 coverages, the test section was considered failed due to failure of panels 3, 15, 18, and 39, which represented more than 10 percent of the mats in the 100 percent traffic area; therefore, traffic was discontinued. Panel 3 was considered failed due to a depression of 0.38 in. (maximum) along the entire length of the female connector. Also, there were 1-in.-long breaks at right angles in the corner of the overlap and female connectors and 1-1/2-in.-long breaks at the underlap and female connectors. The bottom skin had broken along the female connector for the length of the panel, along the overlap connector for a distance of 3 in. and along the underlap connector for 7 in. A section of panel 3 with the top skin removed for inspection is shown in photo 6. Note the strip that was void of film adhesive (approximately 0.5 in. wide).

Photo 6. Section of panel 3 after 622 coverages with top skin peeled back to show internal parts

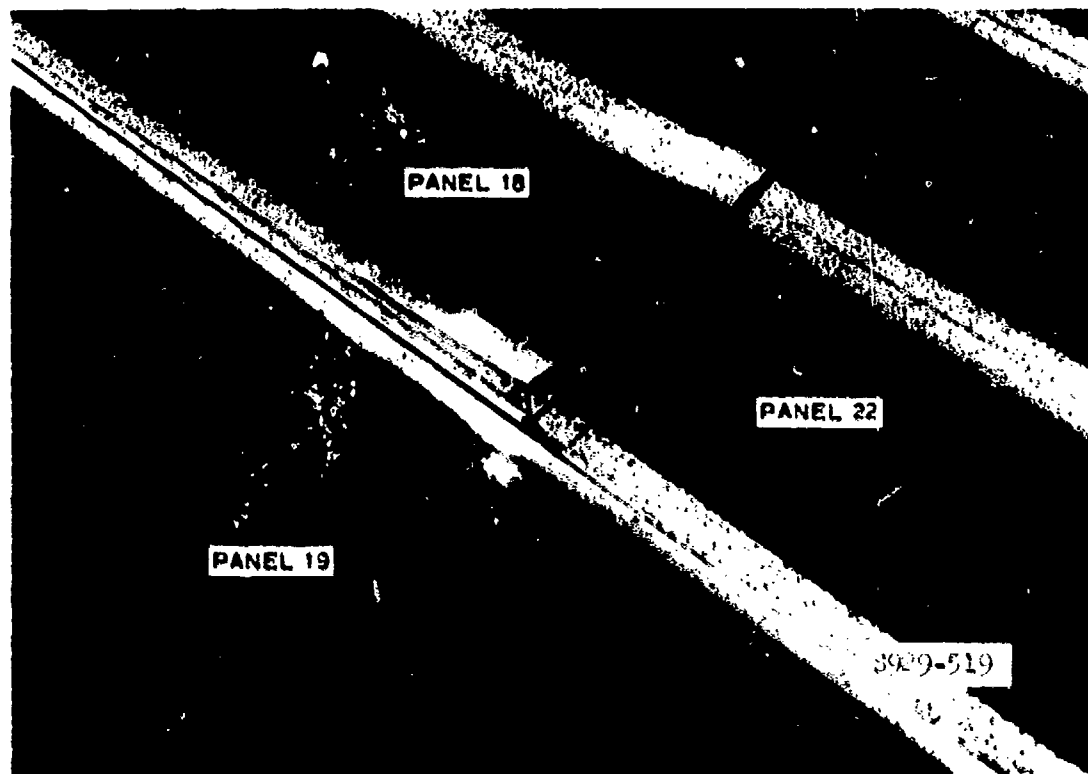
30. Panel 18 was considered failed due to a depression of 0.375 in. (maximum) along the male connector, beginning at the underlap corner. The adhesive bond between the top skin and the connectors had broken for 31 in. along the male connector and for 17 in. along the underlap connector. The bottom skin had separated along the male connector for the full length of the panel. Bottom-skin separation also extended along the underlap connector for 32 in. and along the overlap connector for 2 in. The top skin at the male/underlap corner had curled upward (photo 7). The panel was removed, and the top skin was peeled from the male/underlap corner area for examination (photo 8). In some areas, there were indications that the film adhesive had wrinkled during

fabrication, thus preventing the top sheet from being completely bonded to the core. The interior corner of the underlap connection had broken only on this panel.

Photo 7. Failure of panel 18 showing top-skin separation at underlap/male corner at 622 coverages

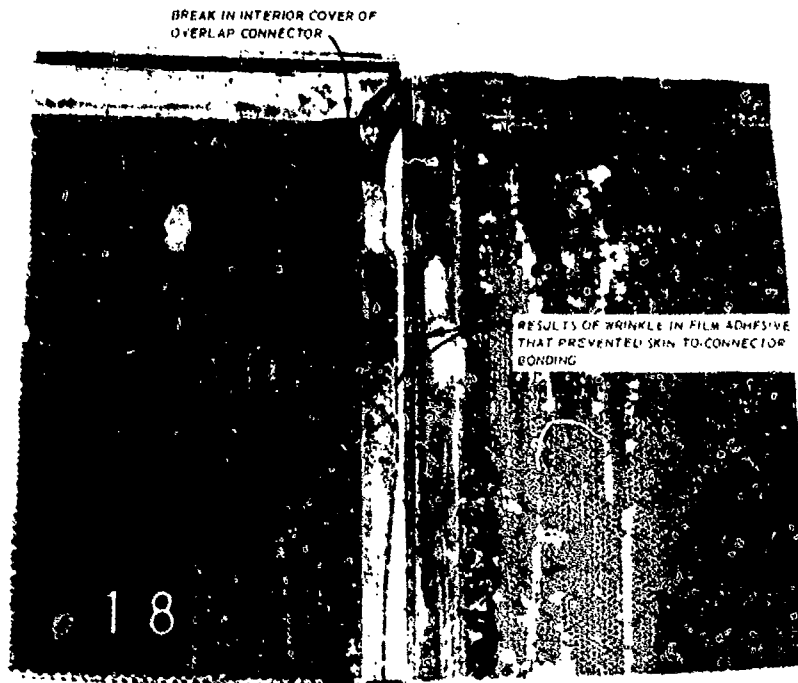
Photo 8. Section of panel 18 with top skin peeled  
back after 622 coverages

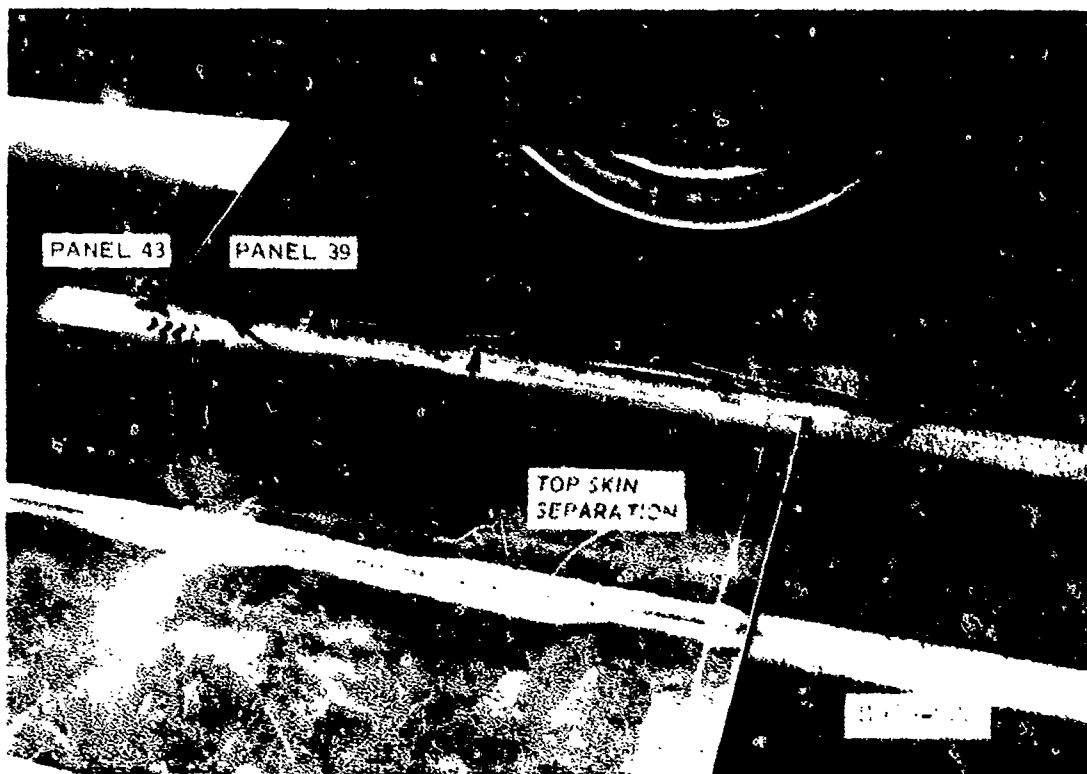
31. Panel 39 was considered failed due to a depression of 0.5 in. (maximum) along the female connector. The top-skin adhesive bond had broken for 34 in. along the female connector and for 2 in. along the underlap connector. A 48-in. separation had occurred between the bottom skin and the female connector, extending for 13 in. along the overlap connector and for 15 in. along the underlap connector. Photo 9 shows top-skin separation on panel 39 with the load wheel on the panel at 622 coverages. The panel had internal failures similar to those of panels 3 and 18 described in paragraphs 29 and 30, respectively (see photos 6 and 8).

Photo 9. Panel 39 under load wheel at 622 coverages

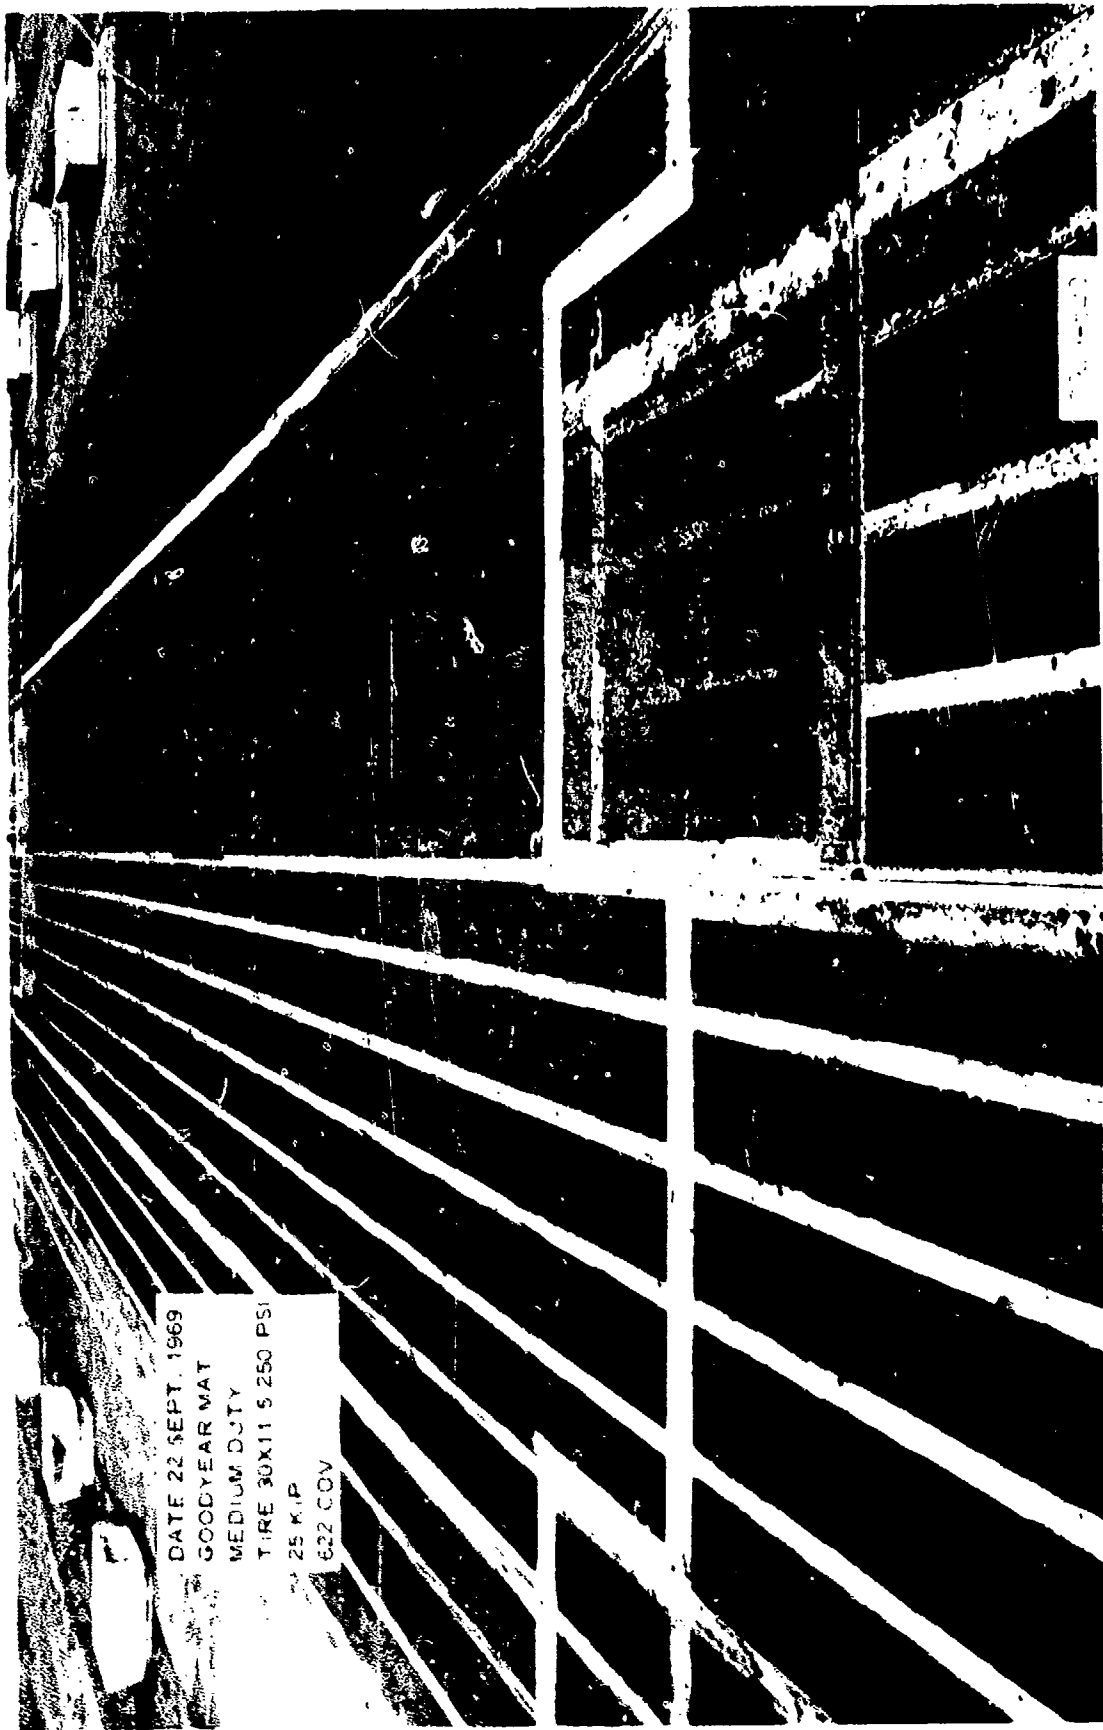
32. Except for the failed panels, the test section was in good condition at the conclusion of traffic (photo 10). CBR data were recorded at two locations (plate 1), and the rated CBR for the test section was 3.8 (table 1). Cross sections and longitudinal profiles at 0 and 622 coverages are shown in plates 4 and 5, respectively. Representative static deflection measurements at 0 and 622 coverages are shown in plate 6. Permanent longitudinal deformation along the center line of the traffic lane reached a maximum of approximately 1.1 in. and averaged 0.6 to 0.7 in. The maximum static deflection measured at 0 coverages was 0.8 in. at the joint of panels 30, 31, and 34; at 622 coverages, the maximum static deflection was 0.9 at the same location. The greatest increase in static deflection, 0.2 in., occurred at the joint of panels 27 and 31 (see plate 6).

Fig. 10. Test section after 20 days.
