EVALUATION OF KAISER MX19-B AND MX19-C
ALUMINUM HONEYCOMB LANDING MAT

MISCELLANEOUS PAPER S-73 II

G. L. Carr, D. A. Ellison

March 1973

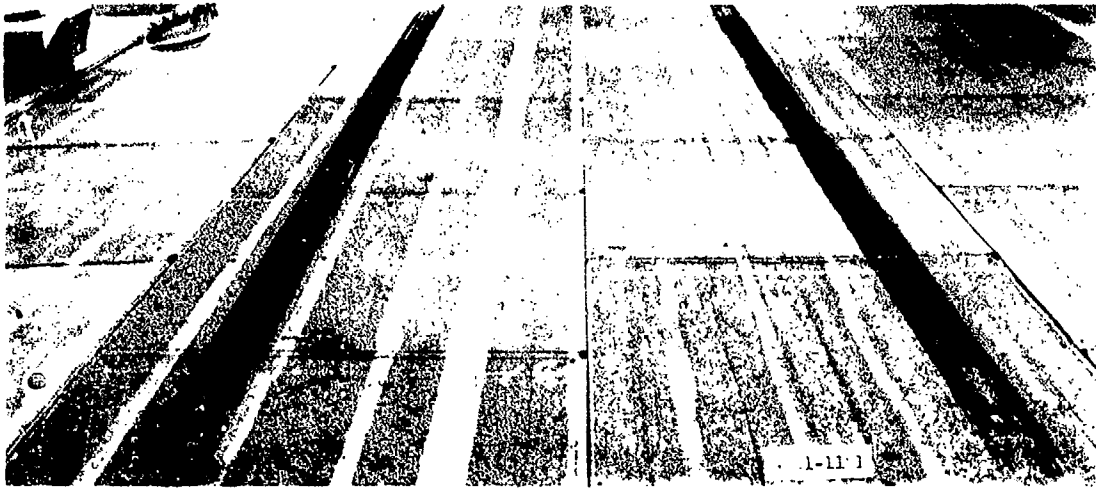
Photo 1. Skid marks on dry mat surface

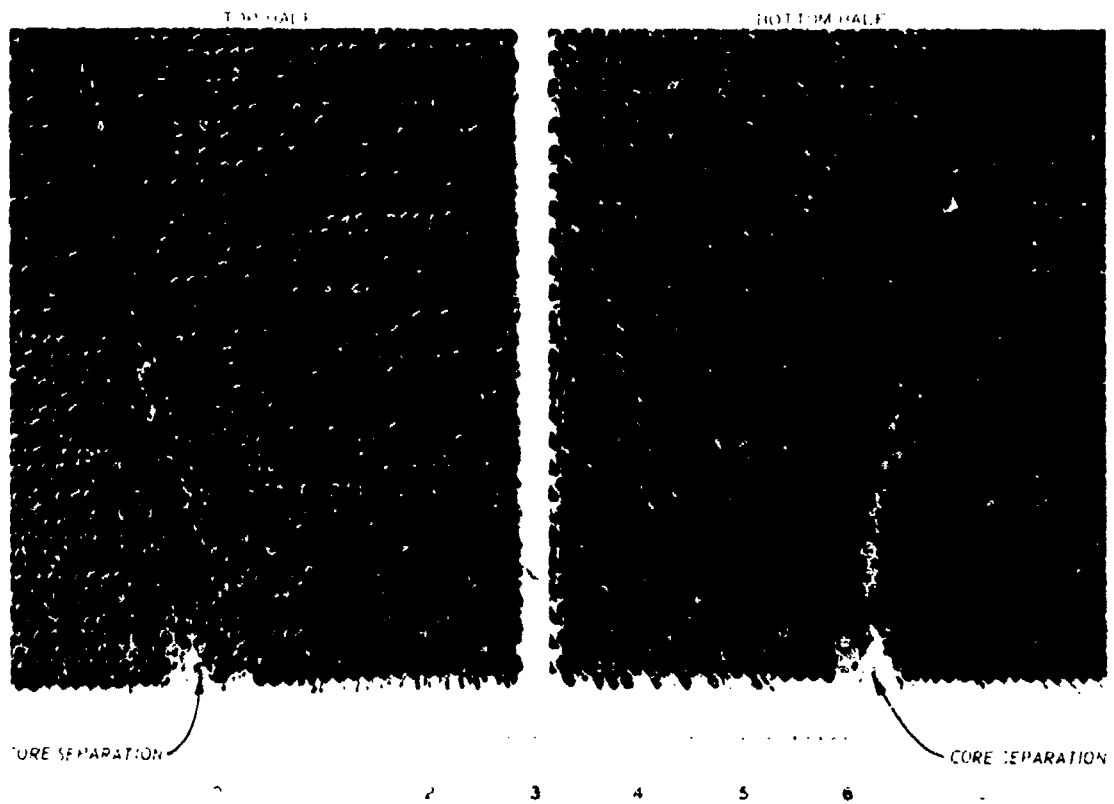
37. Item 1. The first panel failure occurred in the honeycomb core near the center of panel 39 at 1560 coverages. The failed core, dissected for inspection, is shown in photo 4. The second panel failure (panel 11) was caused by the trepanning operation performed during manufacture to check weld penetration. This failure began at 2480 coverages with a small crack 3-1/2 in. long perpendicular to the male connector at the point of trepanning (see photo 5). As traffic continued to 2692 coverages, this crack developed into a 12-in.-long break. This break had also progressed for 2-1/2 in. at the weld along the male connector. At 2756 coverages, panel 11 failed abruptly when the potting sheared along the male connector (photo 6), causing the bottom skin to tear as shown in photo 7.

Photo 4. Separation of core material in failed panel 39 (1560 coverages)

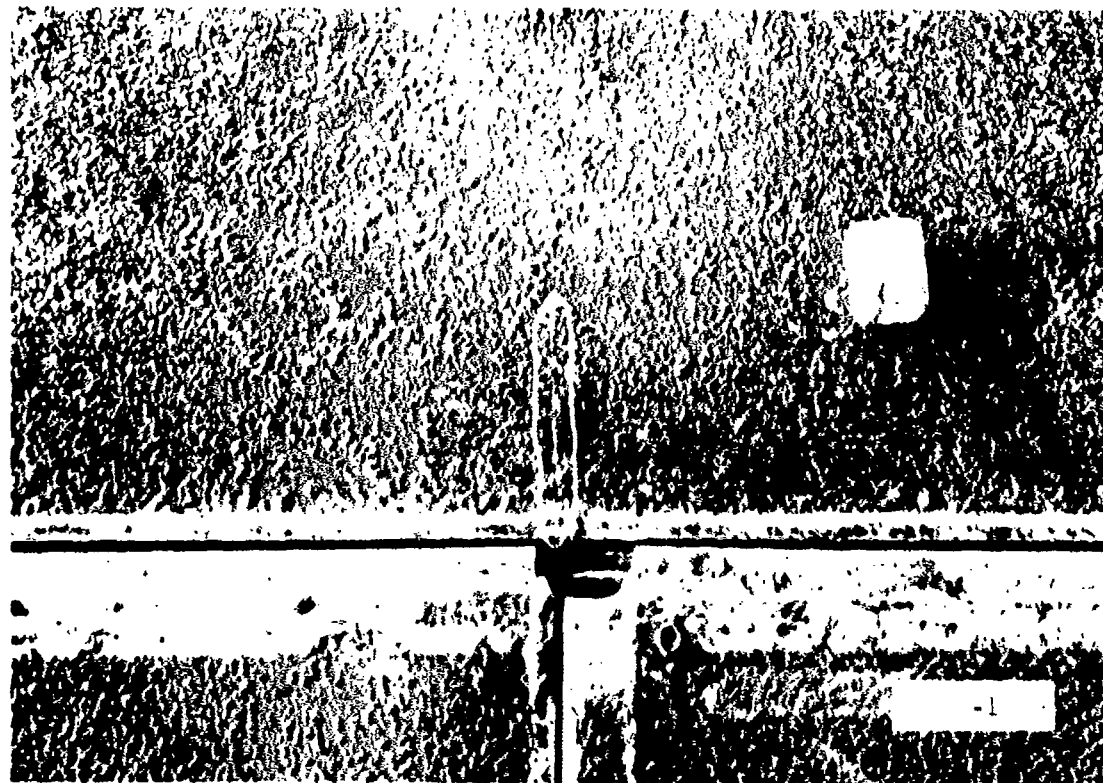
28. After 2480 coverages, a small crack had developed in panel 11 at the midpoint of the male connector (photo 5). The break originated at the point of trepanning and extended for approximately 3-1/2 in. toward the mat center. Traffic was continued until 2756 coverages had been completed. At that point, the break in panel 11 had progressed toward the center of the panel for 14-3/4 in., and a second break had occurred along the male connector (photo 6). Panel 11 was considered failed and was removed from the test section. Further examination of the panel revealed a 36-in.-long bottom-sheet break along the male connector (photo 7).

40. An analysis of the failure of panels 11, 43, and 67 revealed that the trepanning operation and the method and location of the operation had contributed to premature failure of these panels. The trepanning operation was located at the center of the connectors and was at a point of maximum stress concentration on the male and female connectors as adjacent panels transferred the load at these points. Weld inspections at the quarter point or at any other point, except where these maximum stresses were concentrated, would probably have prevented these failures. Also, the inspection notch (hole) should have been changed to a flat-bottom hole to ensure complete refilling of the hole with weld. These two types of weld inspection holes are shown in plate 8.

Photo 5. Break originating at location of trepanning on male connector of panel 11 (2480 coverages)

Premature failure of some of the panels, resulting from breaks along the sheet-to-male-connector welds, indicated that the location of treganning should be shifted from the center of connectors and that the shape of the notch formed during the procedure should be altered to permit complete refilling of the hole with weld.

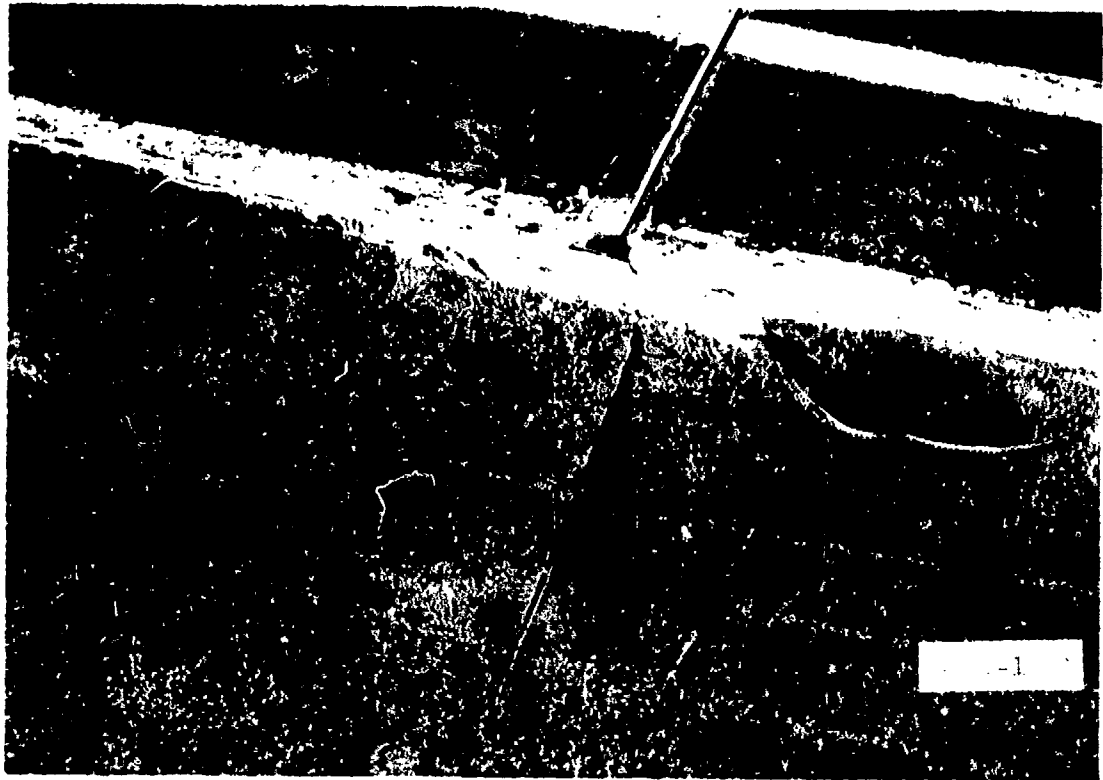
Photo 6. Failure of panel 11 after 2700 coverages

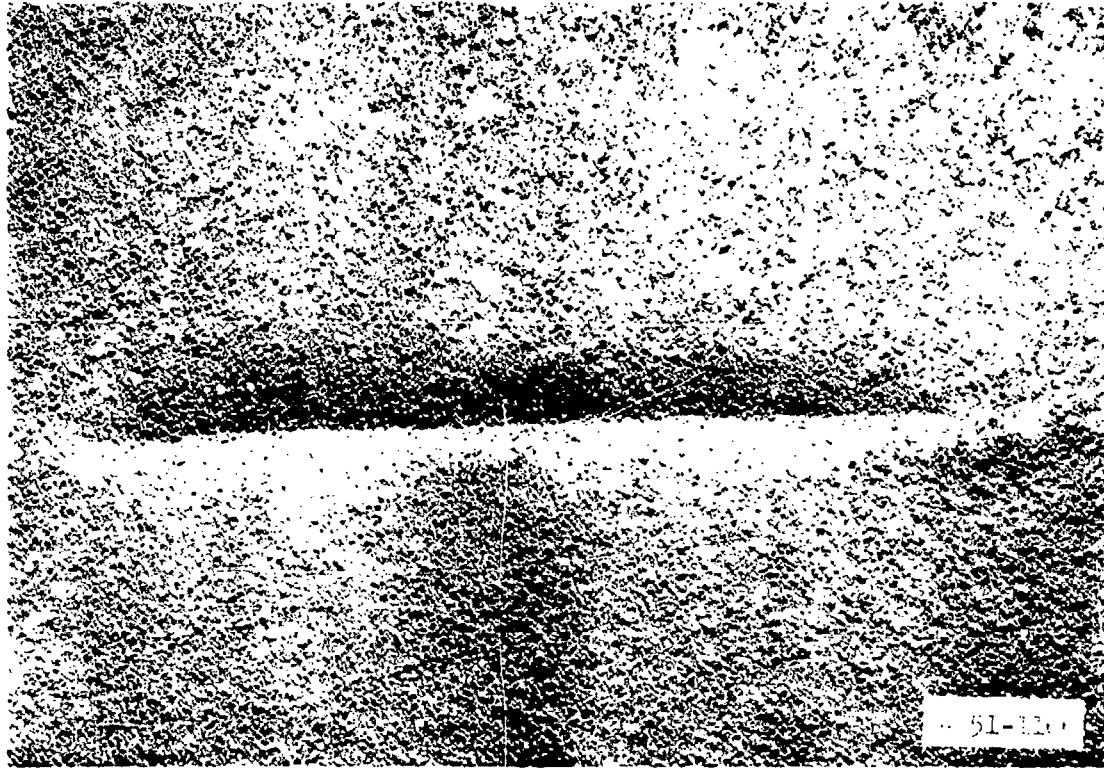
31. Item 2, MX19-B. Prior to the application of traffic, the surface of item 2 (modified female and male connections) was generally smooth (photo 9), and the average CBR of the subgrade was 4.0. After 170 coverages, a narrow 16-1/2-in.-long depression had developed in panel 47, perpendicular to the direction of traffic (photo 10). After ten additional coverages, this depression had increased to 33 in. in length and 11 in. in width. After 190 coverages, panel 47 was considered failed (photo 11).

Photo 10. Depression in panel 47 at 170 coverages

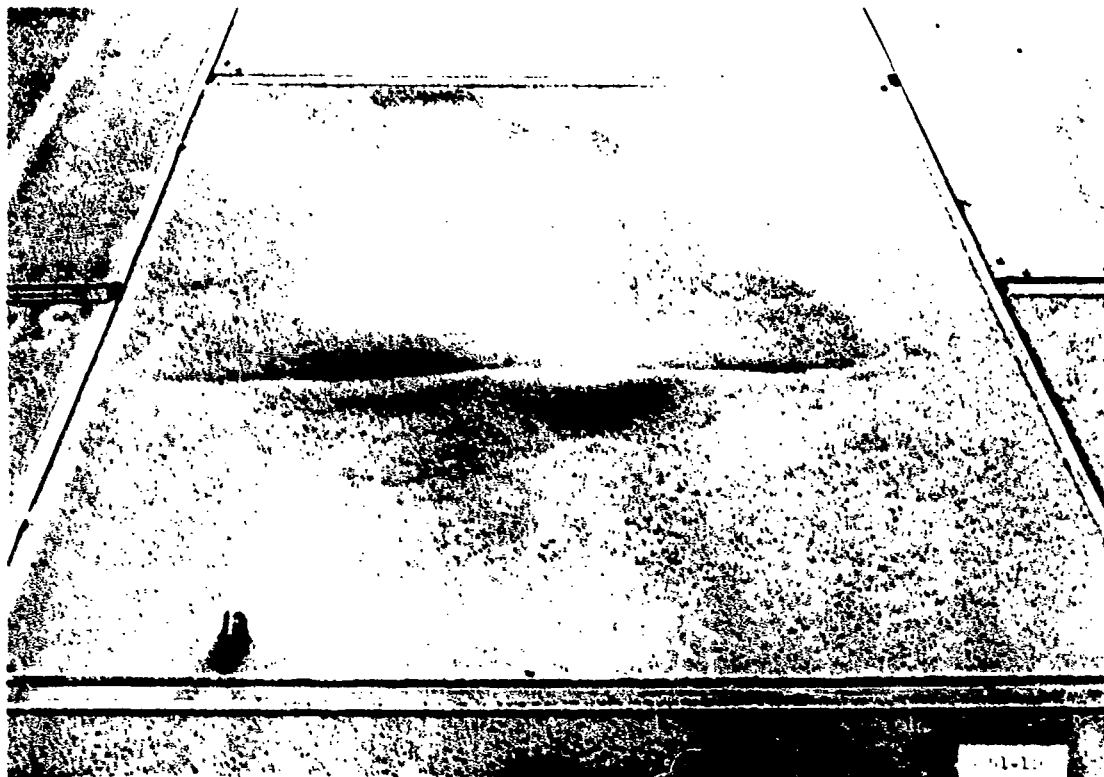
Photo 11. Failure of panel 47 after 190 coverages

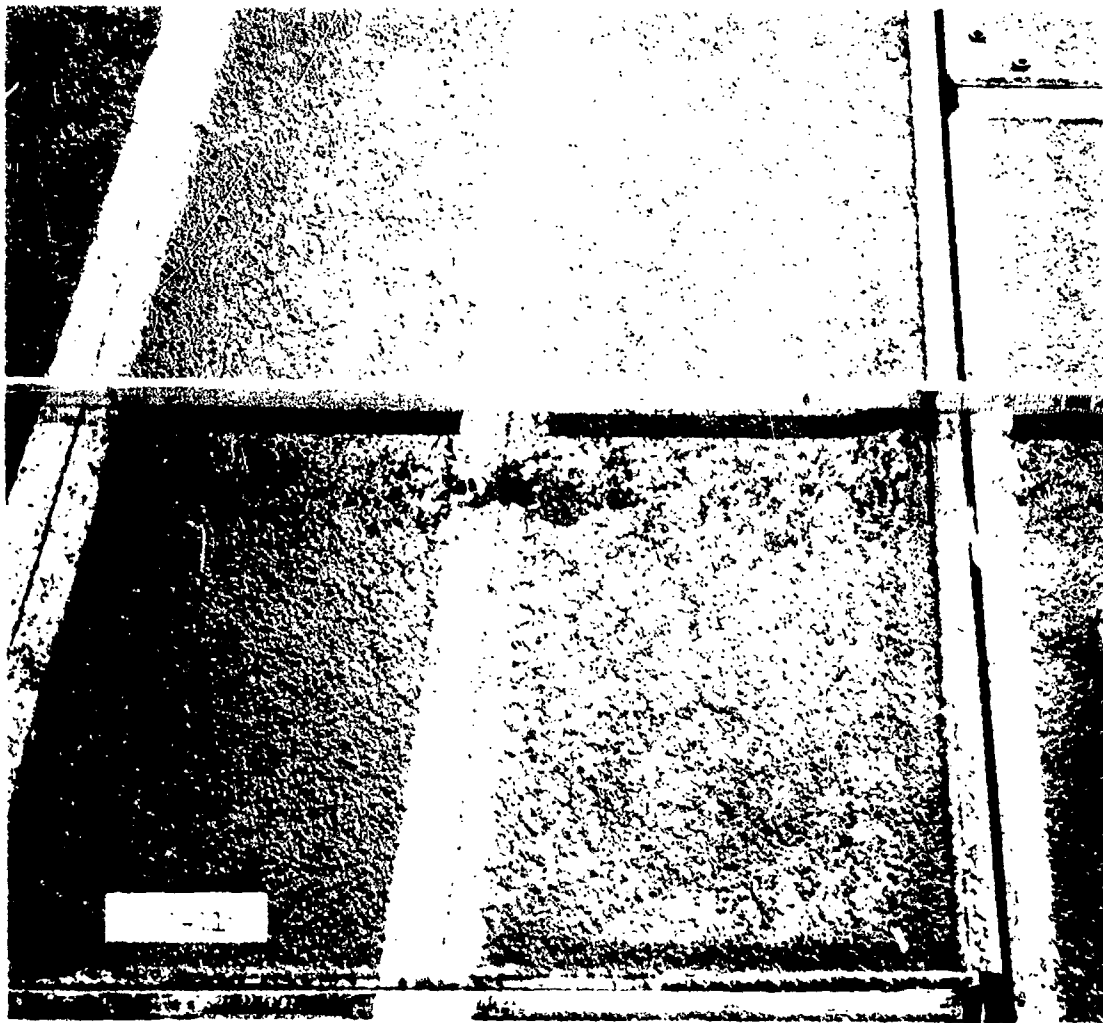
32. At 900 coverages, panel 66 had a 24- by 8-in. depression paralleling the direction of traffic along the female connector (photo 12). Panel 66 was considered failed and was removed from the test section and replaced with a new panel. Soil tests under panel 66 revealed that the CBR of the top 12 in. of the subgrade had increased to 6.0. Therefore, all panels were removed from the test section, and the subgrade was reprocessed. The strength of the reprocessed subgrade in item 2 averaged 3.9 CBR. Each panel was replaced in its original position, and traffic was resumed.

Photo 1. Failure of panel 66 after 900 coverages

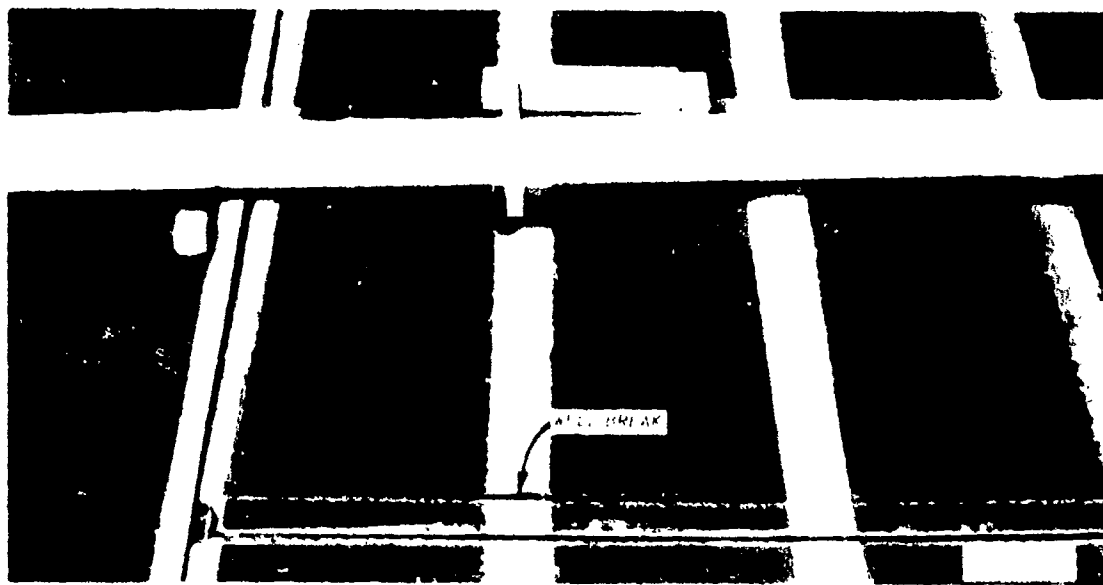
39. The third failure began after 948 coverages with a small depression in panel 78. By 1008 coverages, a severe depression had developed, along with an approximately 20-in. weld failure in the top skin along the overlap connector (photo 13). The bottom skin weld failed along the entire length of the overlap connector (photo 19).

Photo 2. Failure of panel 78 after 1000 coverages

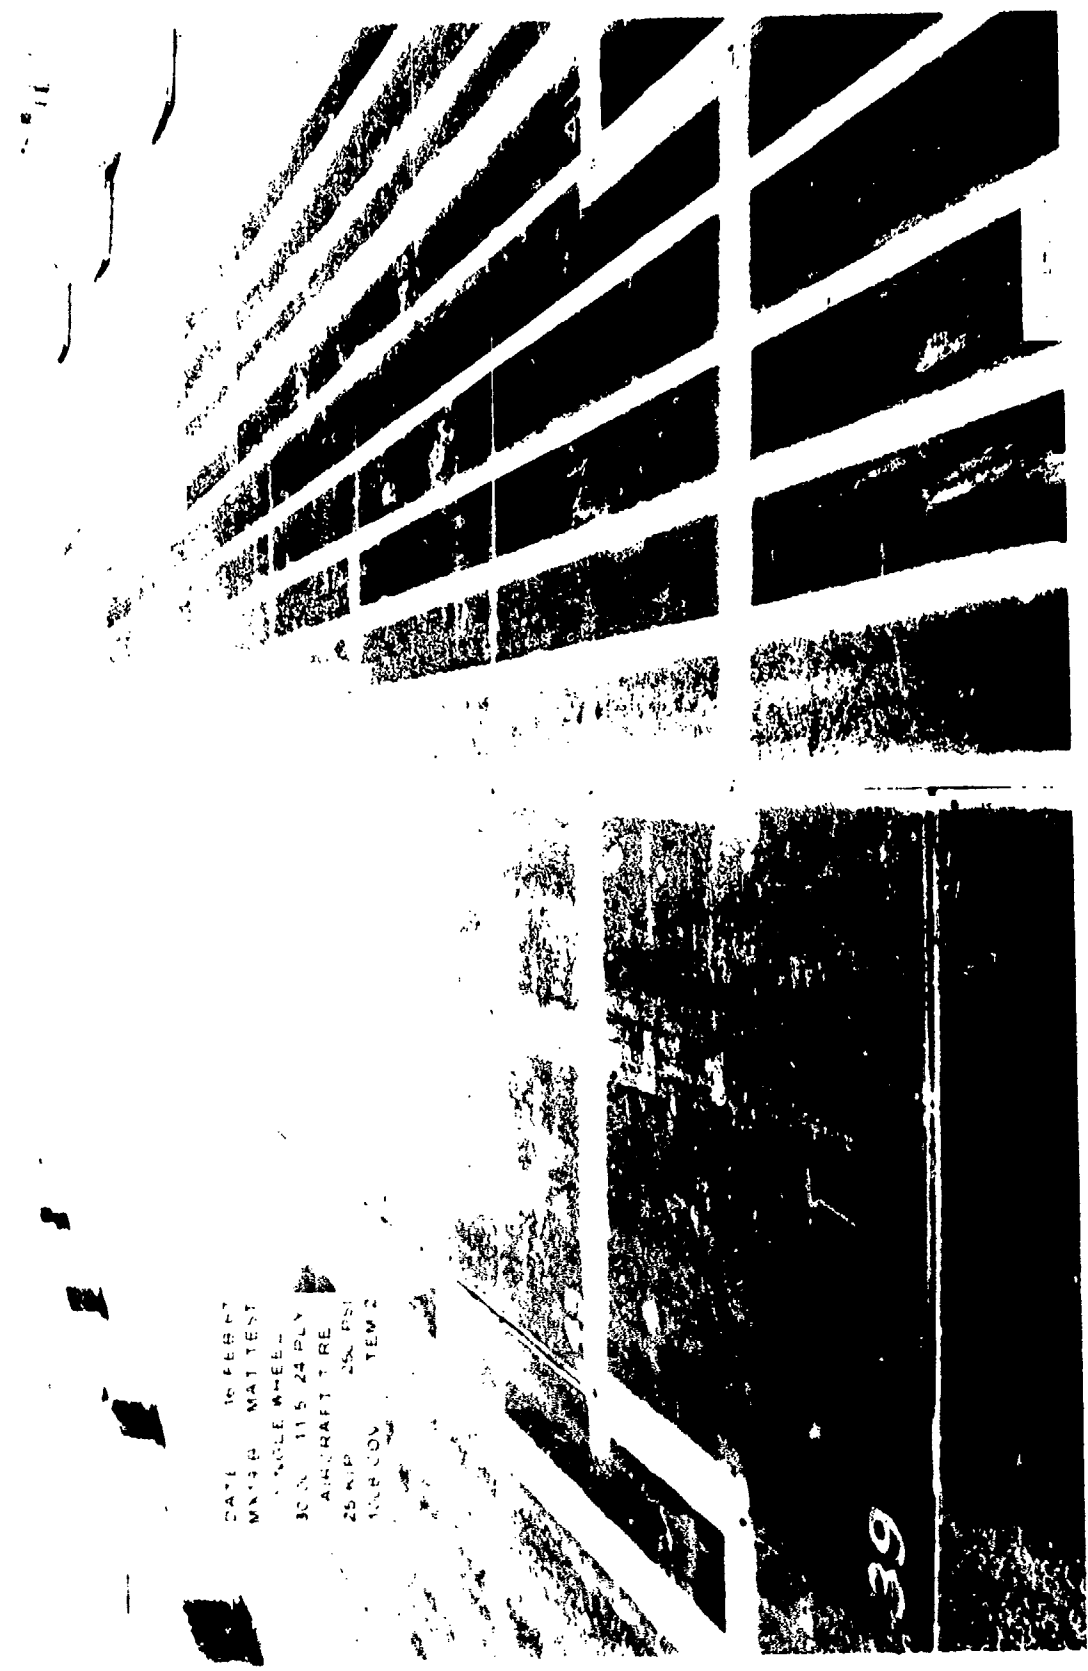
34. At this point, soil tests were performed under panels 70 and 78 (table 1). The general condition of item 2, other than panels 43 and 78, at 1008 coverages was good (photo 14). The maximum permanent deformation measured was 0.4 in. (plate 7), which occurred at 500 coverages, and the maximum static deflection was 0.7 in., measured at the joint of two panels at 1008 coverages (plate 5).

Photo 14. Item 2 after 1008 coverages

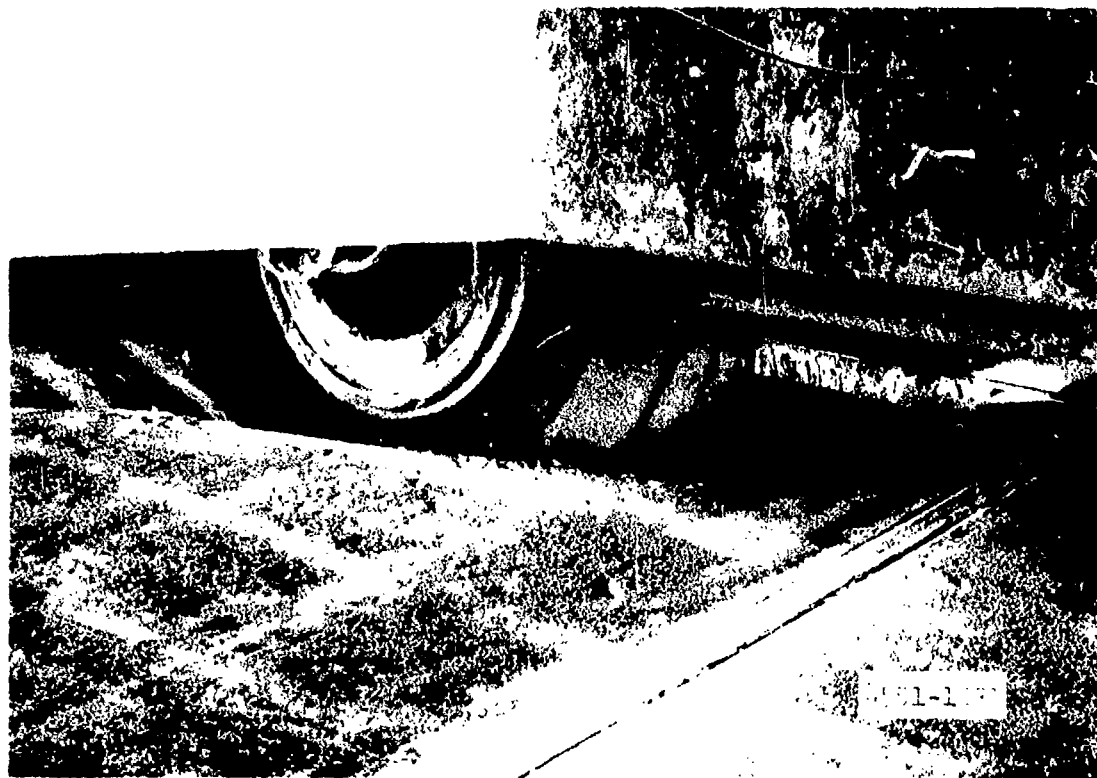
Photo 15. Collapse of panel 43 at 1306 coverages

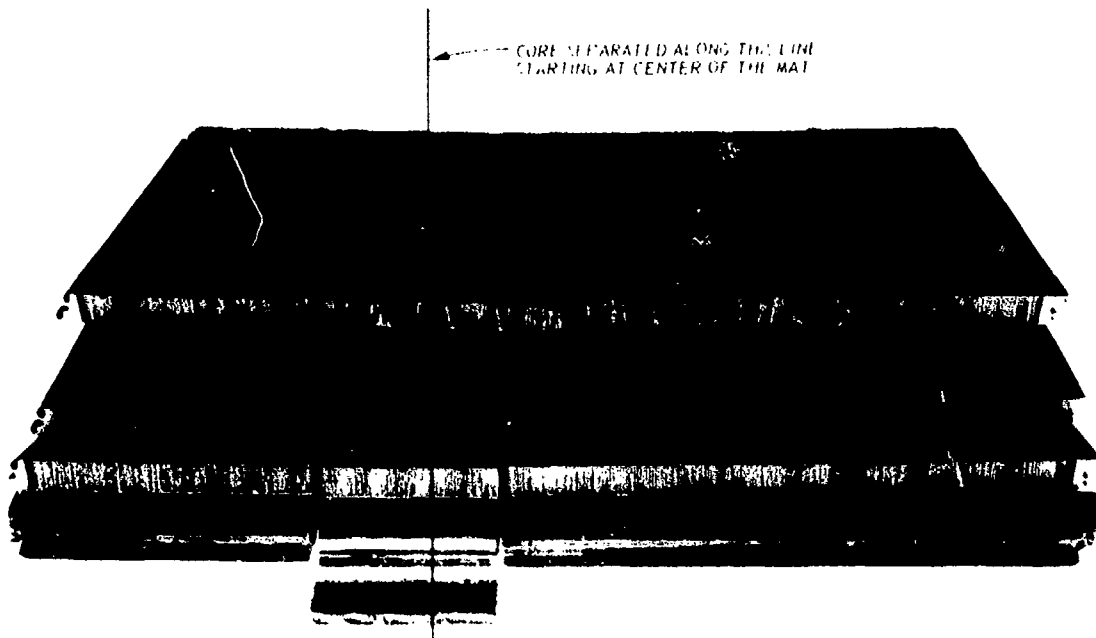
38. Item 2. The first panel failure occurred in the honeycomb core near the center of panel 47 at 190 coverages. This failure began as a small depression followed by a greater depression and separation of skin and core materials. Photo 17 shows the panel after being cut and dissected for an inspection of the core failure. The second panel failure (panel 66) also occurred as a depression in the core material approximately 24 in. long in a longitudinal direction and 8 in. wide in

Photo 17. Panel 47, dissected, showing core failure at 190 coverages

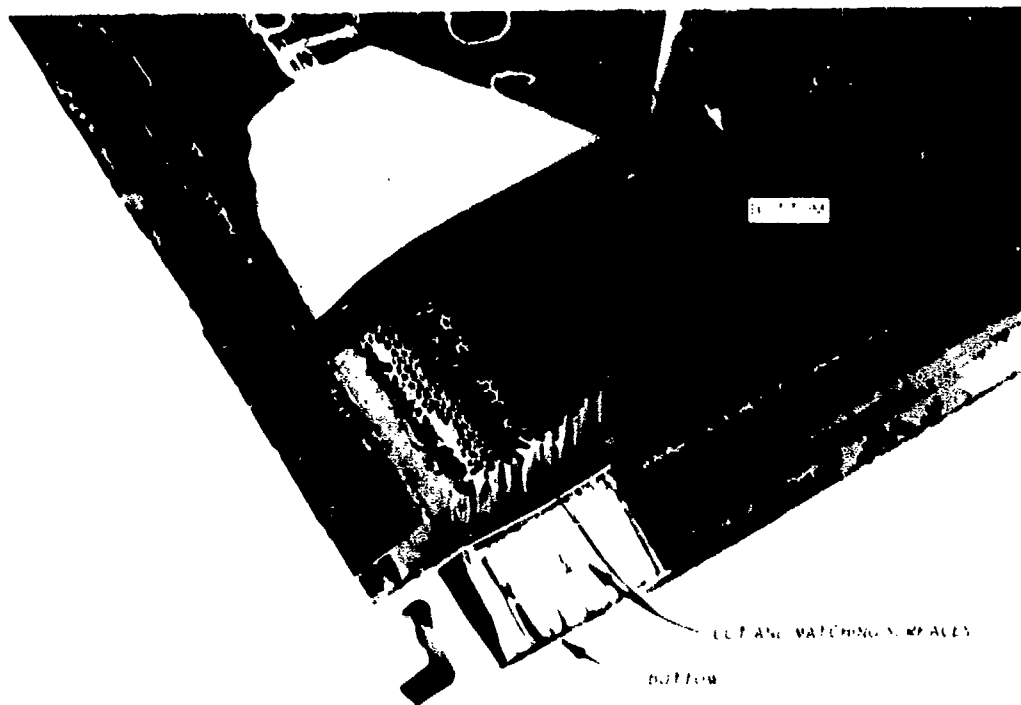
an area along the female connector (900 coverages). Photo 18 is a closeup view of panel 66, showing details of the failure. The maximum deformation measured in this panel was 0.15 in. After 948 coverages, panel 67 revealed signs of distress with a small crack at the center of the panel beginning at the male connector and progressing transversely, identical with the failure of panel 11 described in paragraphs 28 and 37. Panel 67 was removed for analysis. Failure was considered imminent, and this panel was replaced with a new panel.

Photo 18. Panel 66, dissected, showing core failure at 900 coverages
