STRENGTHENING OF KEYED LONGITUDINAL
CONSTRUCTION JOINTS IN RIGID PAVEMENTS

Army Engineer Waterways Experiment Station

TECHNICAL REPORT NO. AFWL-TR-72-174

March 1973

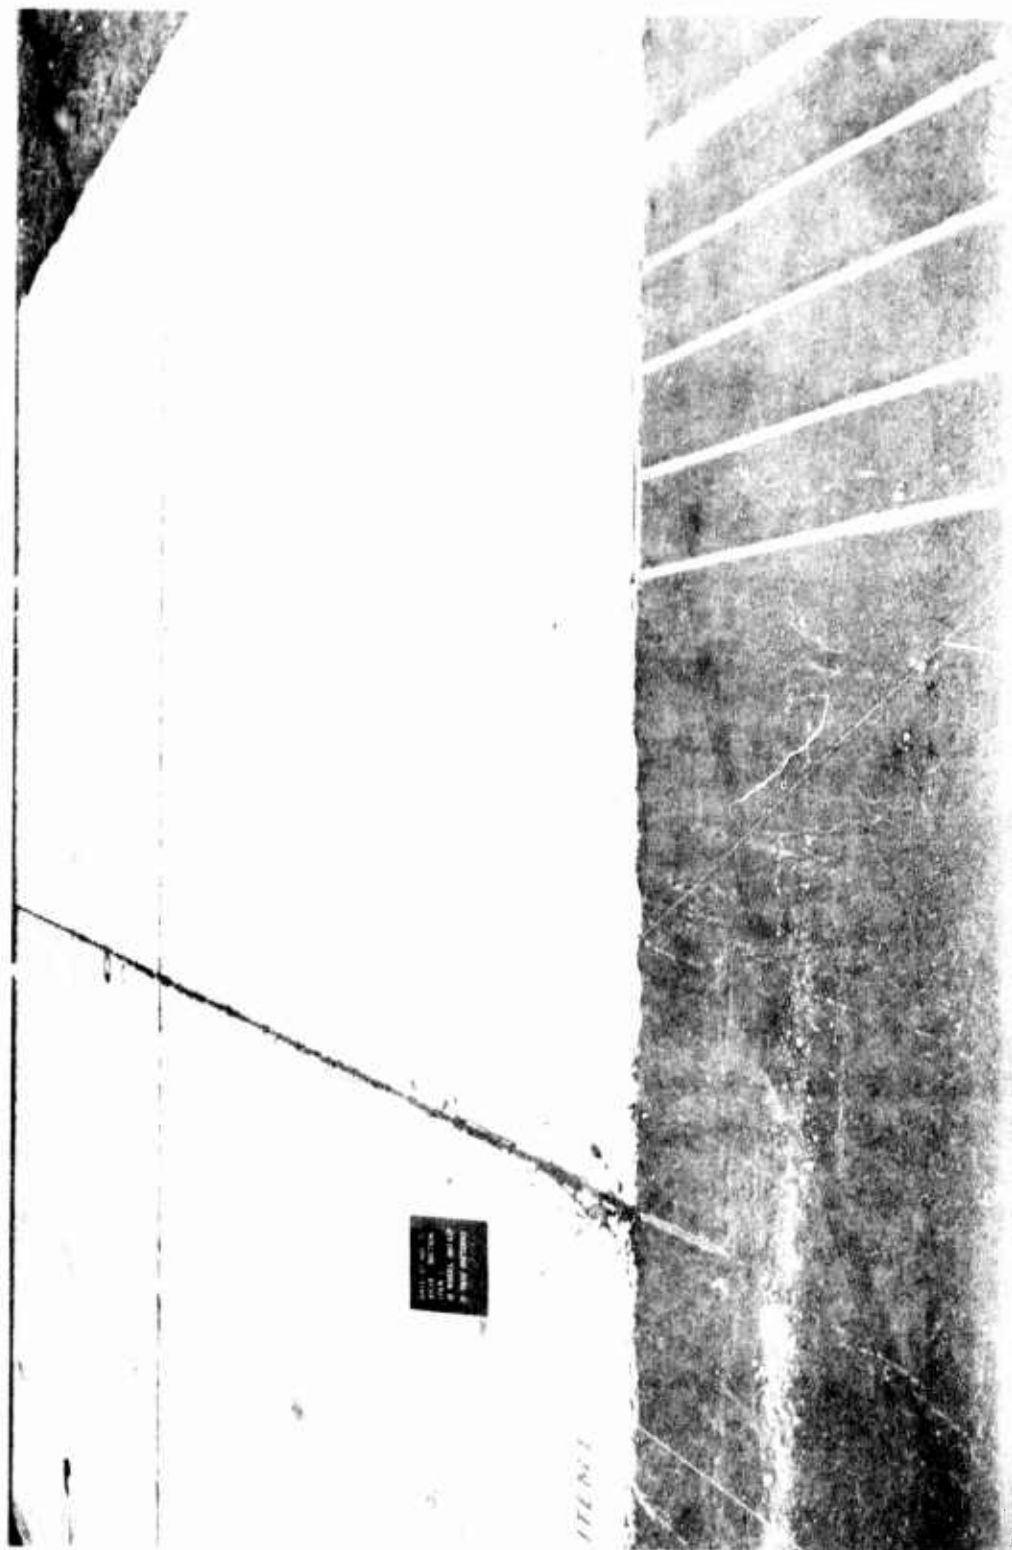
A general view of test item 1 prior to traffic is shown in figure 27. As can be seen in this photograph, both the southwest and northwest slabs contained longitudinal cracks prior to traffic. The crack in the southwest slab began at the west end of the item about 9 ft from the south free edge and ran approximately 13 ft longitudinally into the slab. The crack in the northwest slab began at the west edge of the item and ran 21 ft longitudinally through the center of the slab. Neither of these cracks was located inside the 200-in.-wide traffic lane.

Figure 27. General view of item 1 prior to test traffic.

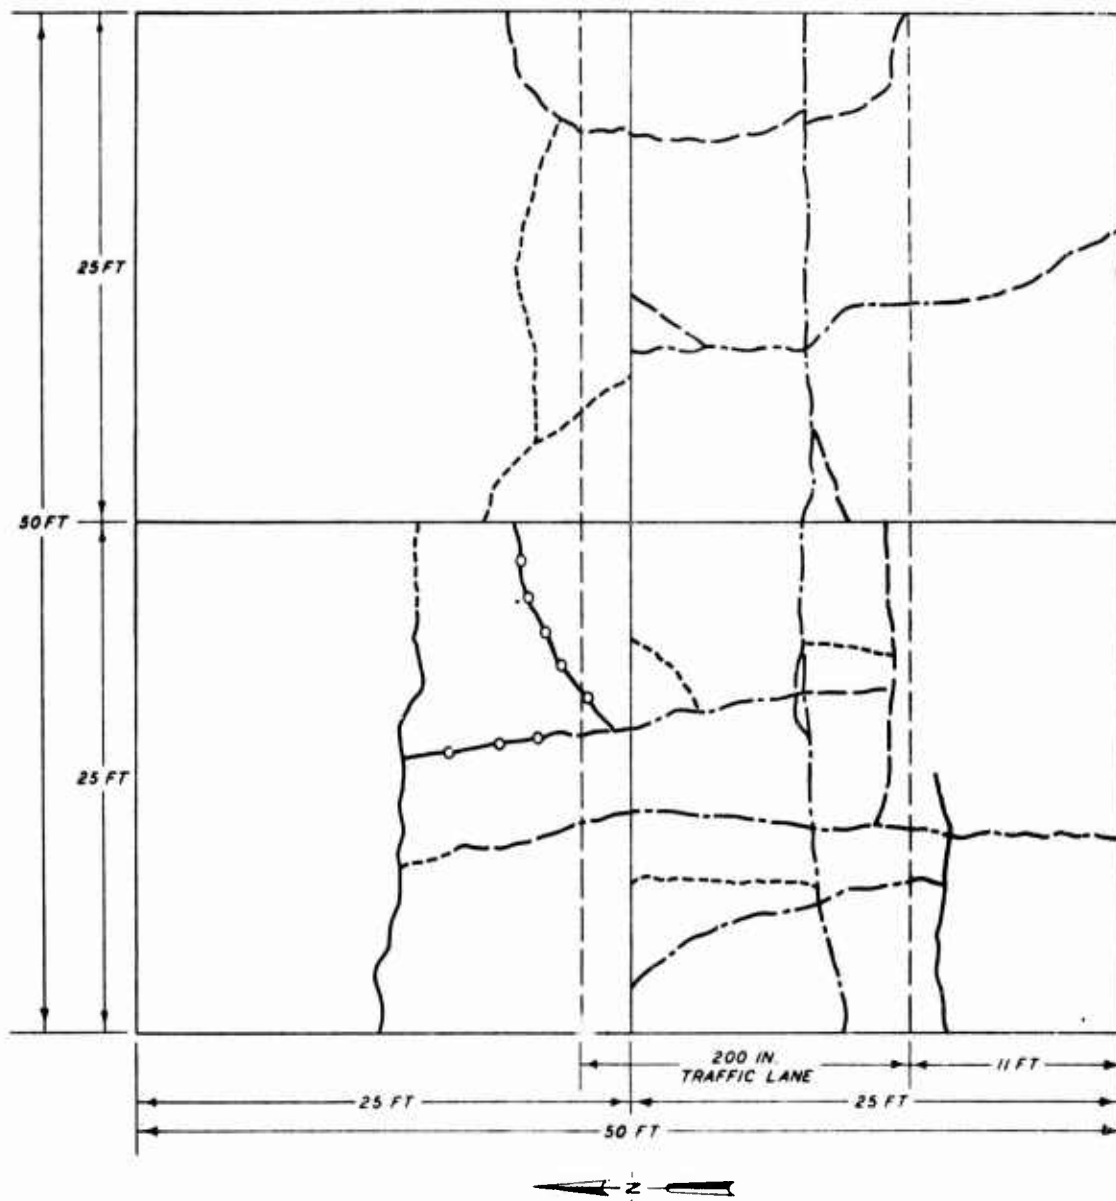
After one pattern of test traffic (16 coverages), flaking and spalling were evident along the edges of the existing cracks. Initial cracking due to test traffic occurred in the southwest slab at about 54 coverages. This cracking consisted of a 25-ft-long longitudinal crack about 10 ft south of the longitudinal construction joint and a transverse crack in about the center of the slab extending from the construction joint to the longitudinal crack. Between 54 and 144 coverages, cracks developed very rapidly in the two south slabs of the item. After 144 coverages, the surfaces of the southwest and southeast slabs were subdivided into 7 and 4 pieces, respectively, as shown in figure 28. Although the southwest slab met the shattered-slab failure criterion after 144 coverages, traffic was continued because the longitudinal construction joint was performing satisfactory.

A small, 5-ft-long, diagonal crack in the southeast slab was the only additional distress observed after 216 coverages. At the 344-coverage level, the transverse cracks detected at 144 coverages running approximately through the centers of the southeast and southwest slabs had extended to the south free edge of the pavement. Also at this time, there was a large half-moon-shaped crack located in the east end

Figure 32. Crack development in item 1 under 360-kip, 12-wheel-assembly traffic.

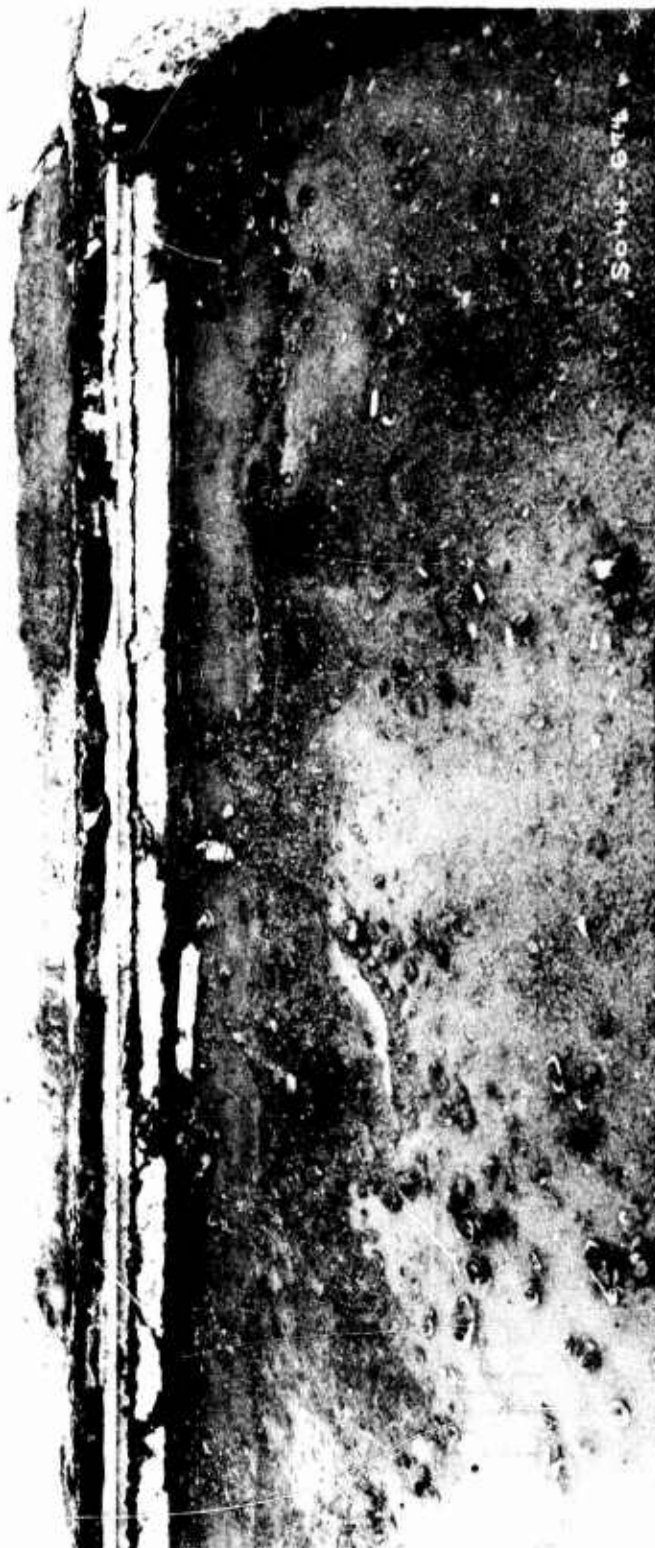
Figure 33. View of failed keyed longitudinal joint in item 1 after 688 coverages of the 360-kip, 12-wheel assembly.

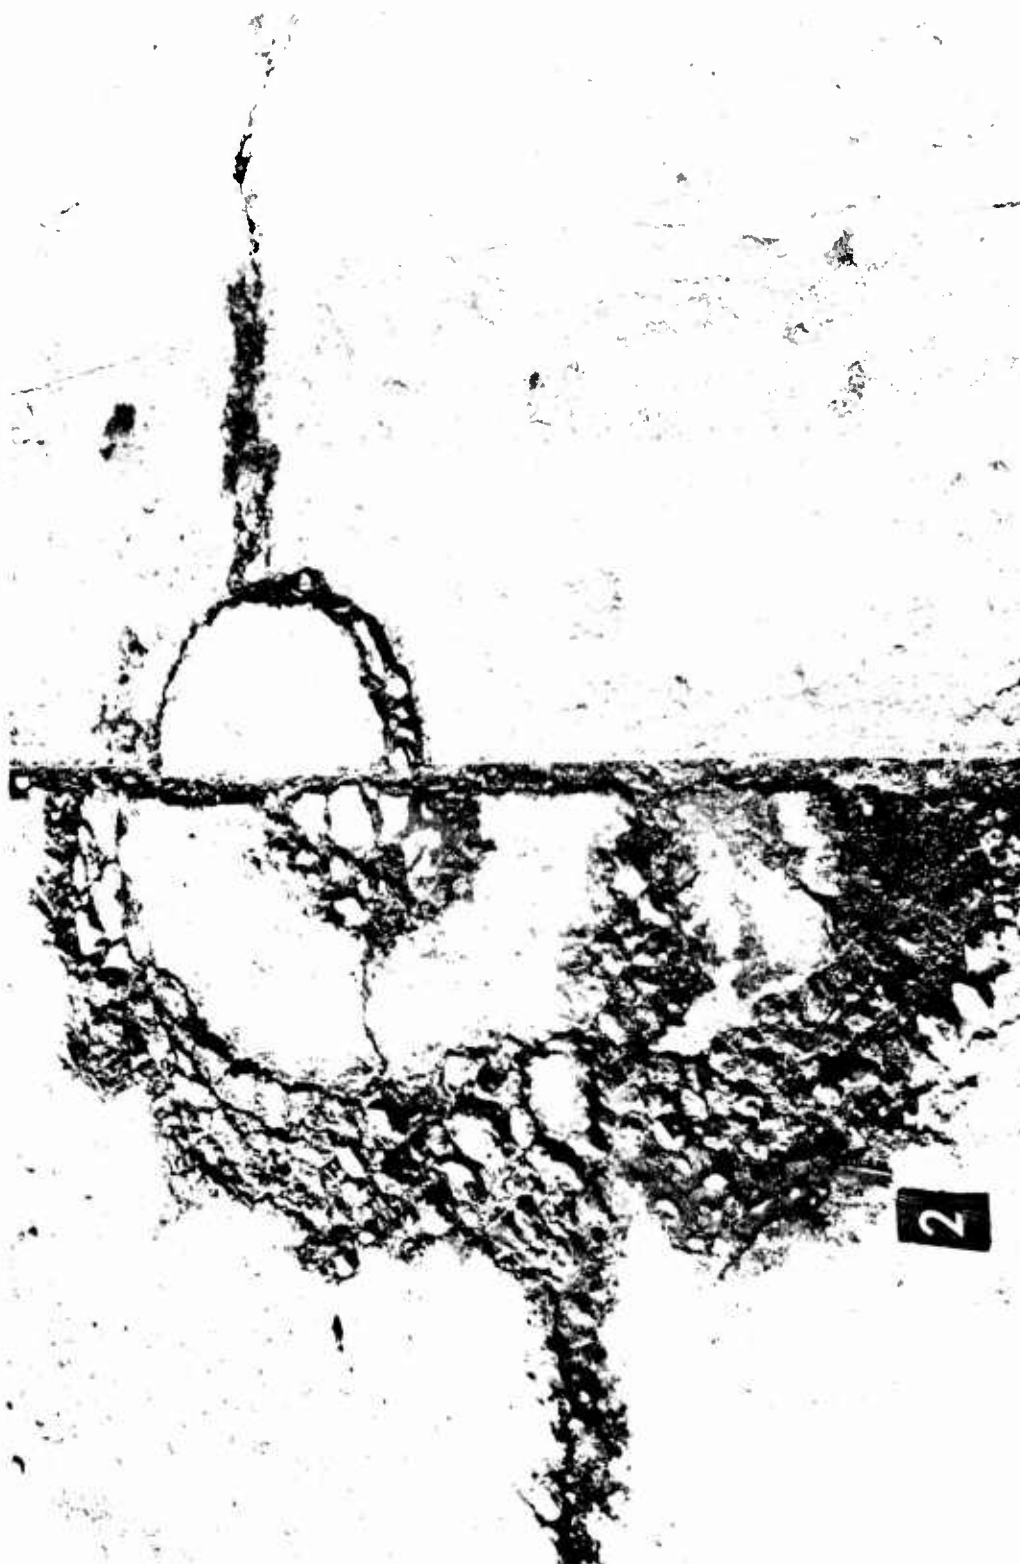
Figure 40. View of under-grouted joint in item 2, 360-kip, 12-wheel-assembly lane after 816 coverages.

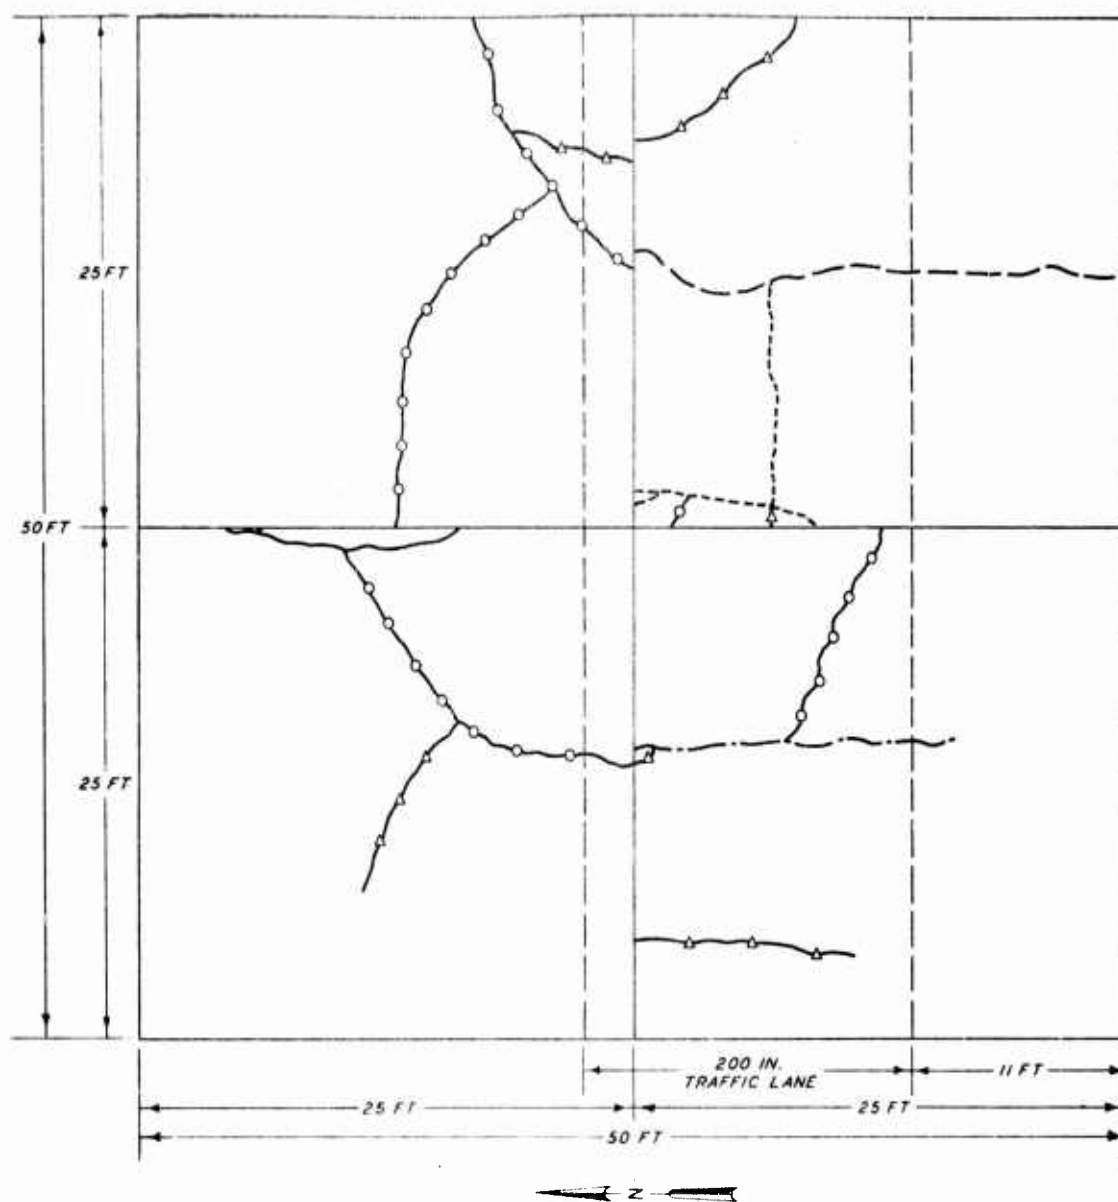
Figure 42. Crack development in item 2 under 360-kip, 12-wheel-assembly traffic.

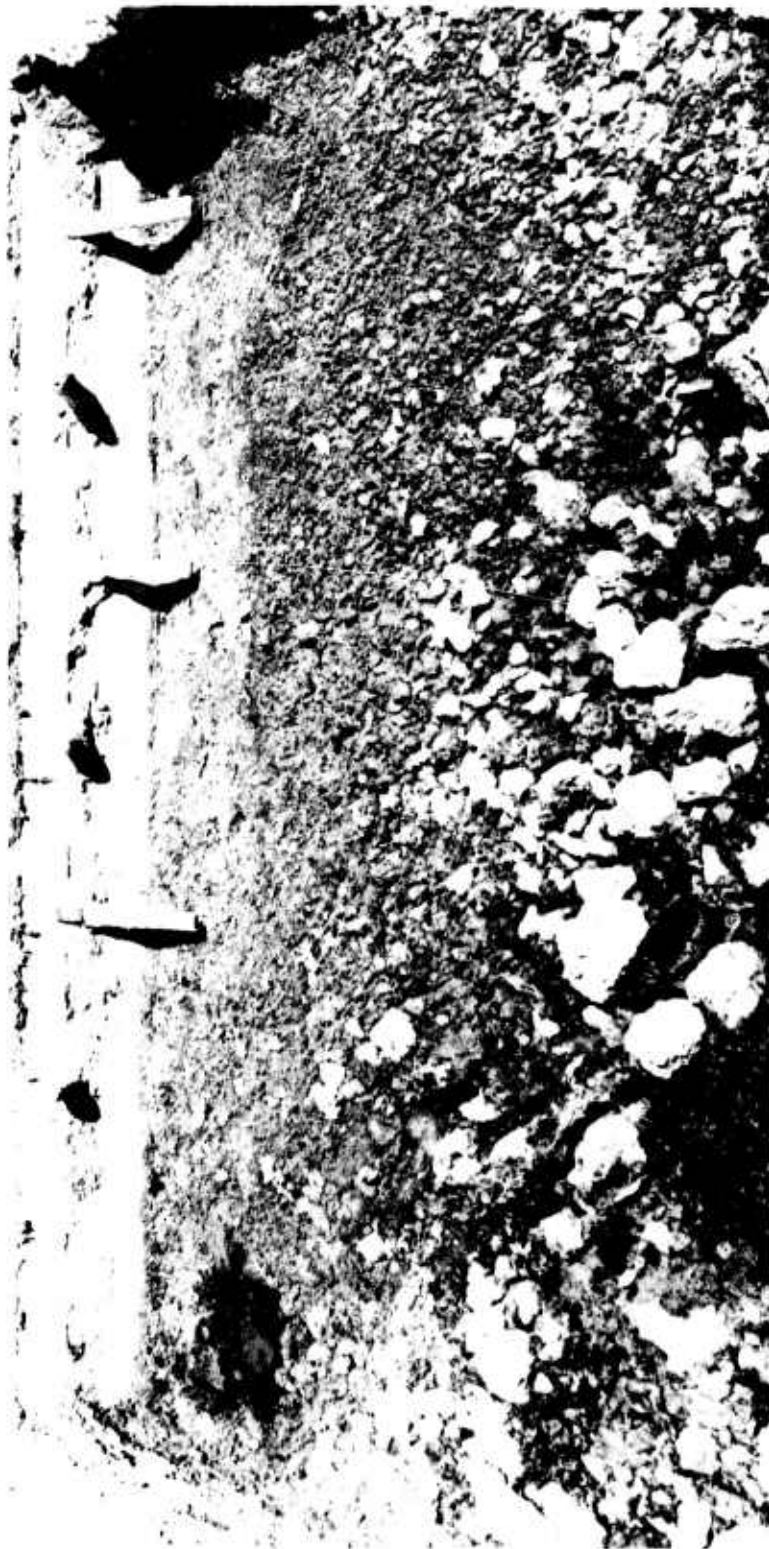
Figure 44. View of the longitudinal construction joint in item 2 strengthened by bonding bars at 45° angles (after 1676 coverages).

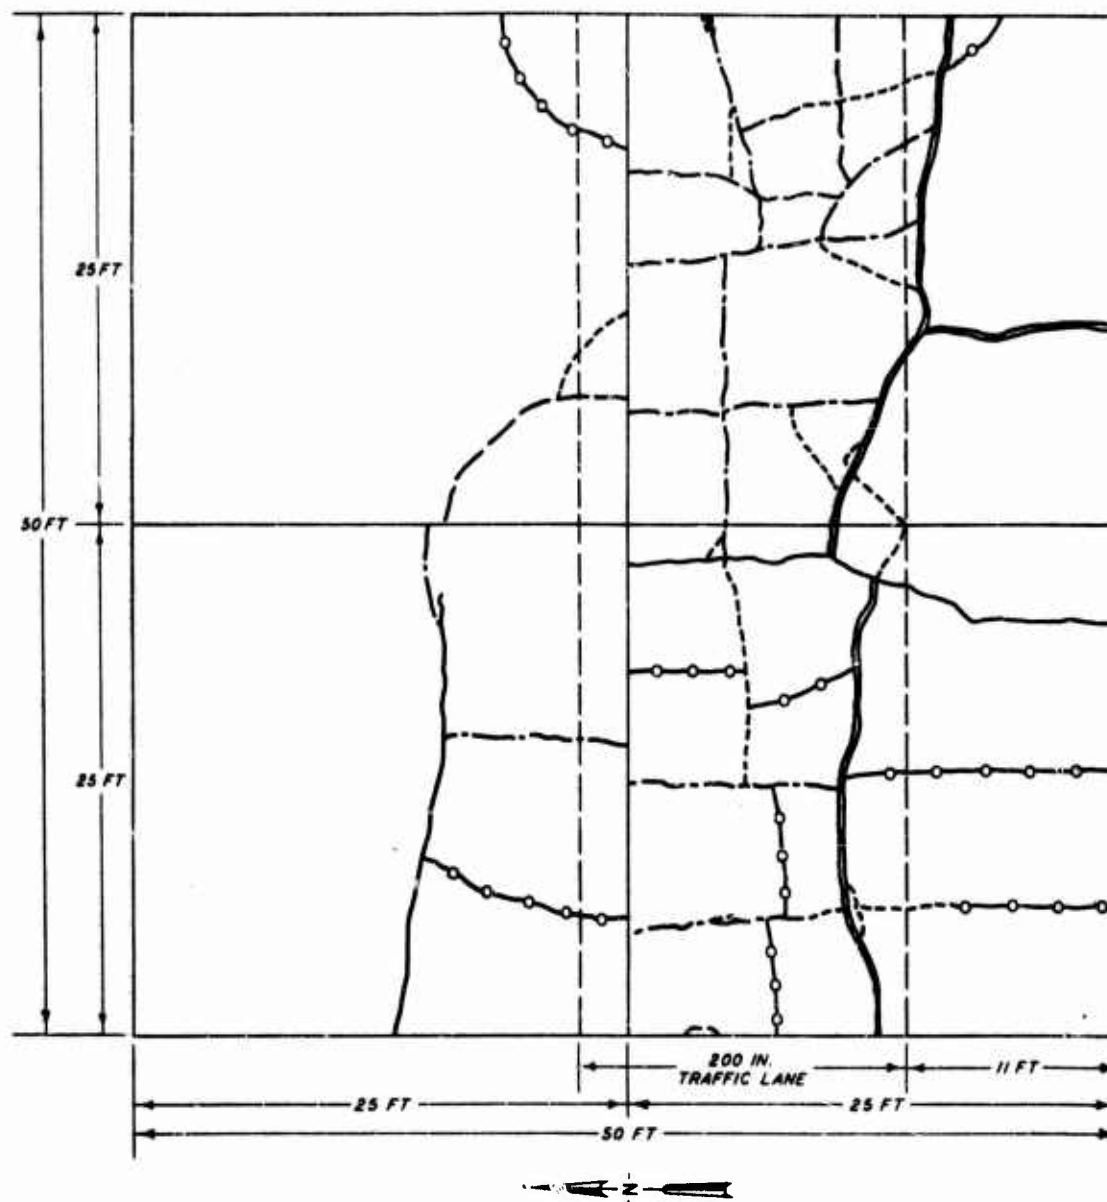
Figure 46. Crack development in item 3 under 360-kip, 12-wheel-assembly traffic.

As traffic was continued, several transverse and longitudinal cracks developed in the southeast and southwest slabs and the existing cracks, mainly transverse, were working. After 31.5 patterns (504 coverages), the east slab in the south lane was broken into 19 pieces and the west slab in the lane was subdivided into 5 pieces. The general condition of this item after 31.5 patterns is shown in figure 48. Figure 49 depicts the extent of flaking and spalling that had developed at the crack between the two south slabs at the 31.5 traffic pattern level. Only slight working of the other cracks was noticed at this time. During the next 12.5 patterns of traffic, two longitudinal and four transverse cracks developed in the southwest slab; 11-ft-long transverse crack running from the longitudinal construction joint in an existing longitudinal crack in the northwest slab was detected; and a corner break occurred in the northeast slab. An overall view of item 3 after 43 patterns (688 coverages) is shown in figure 50. As can be seen, severe spalling had occurred in several of the transverse cracks located in the two south slabs. A close-up of a typical spalled area after loose material was removed is shown in figure 51. Due to the severe spalling of several of the transverse cracks and the number of pieces into which the two south slabs had subdivided, test traffic was stopped after 43 patterns of traffic (688 coverages). At the end of traffic, both slabs in the south lane were subdivided into more pieces than that constituting shattered-slab failure. The progression of cracking with traffic is shown in figure 46. The doweled longitudinal construction joint performed very well during test traffic; it was rated as in satisfactory condition at the end of traffic.

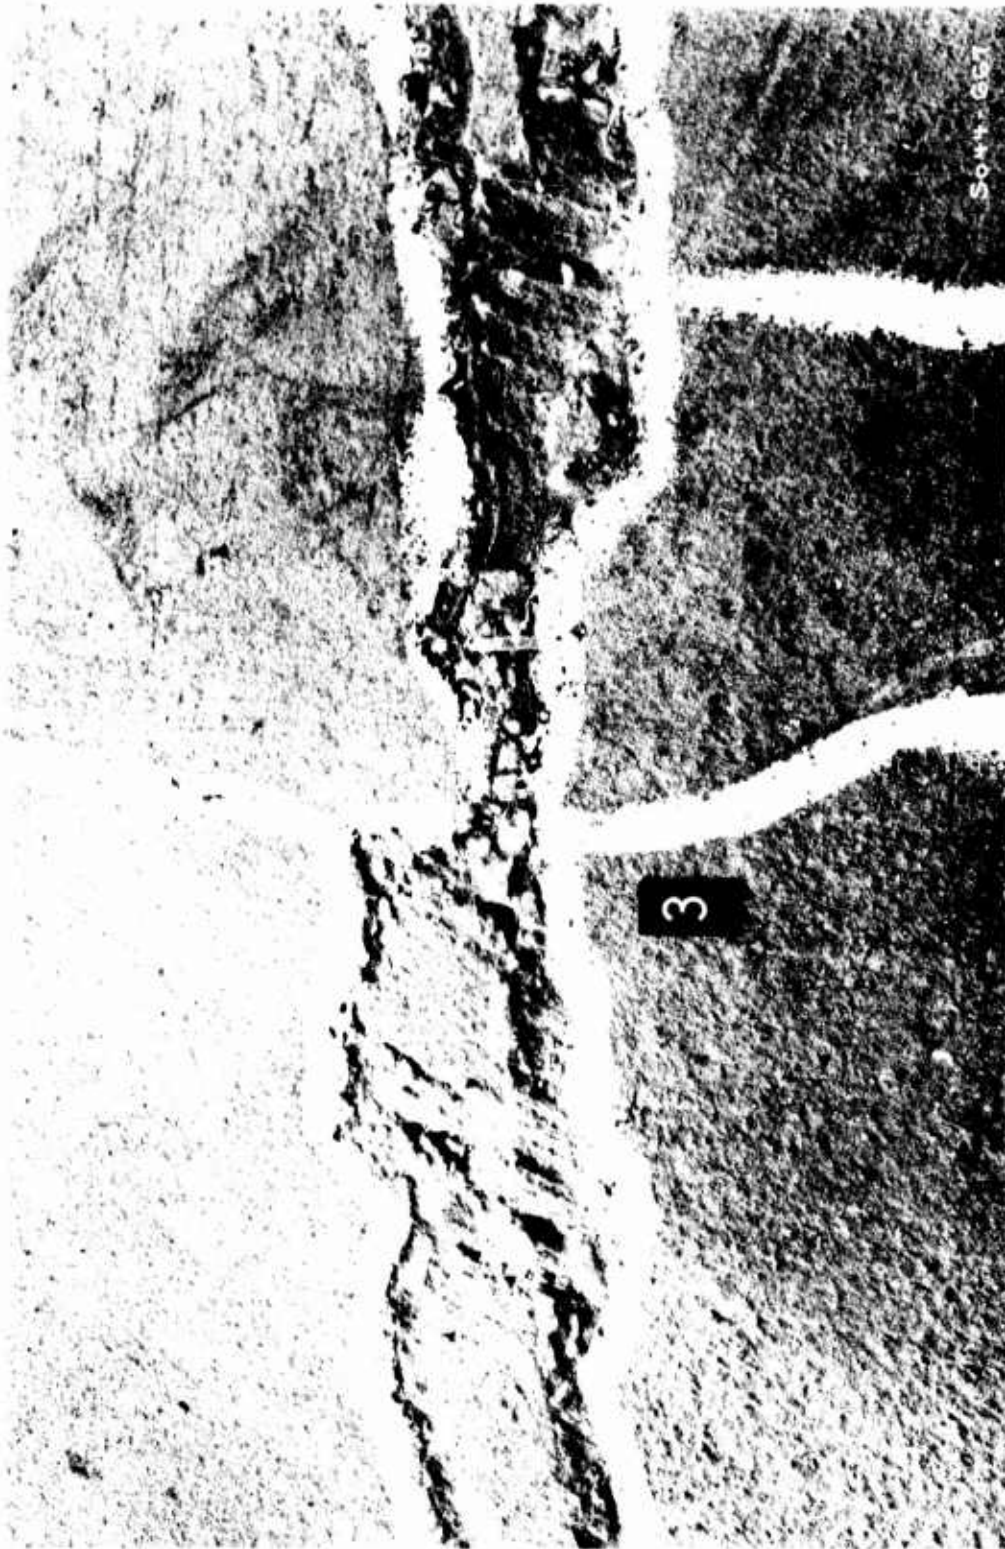
Figure 49. Spalling and flaking along cracks in item 3, 360-kip, 12-wheel-assembly lane after 504 coverages.

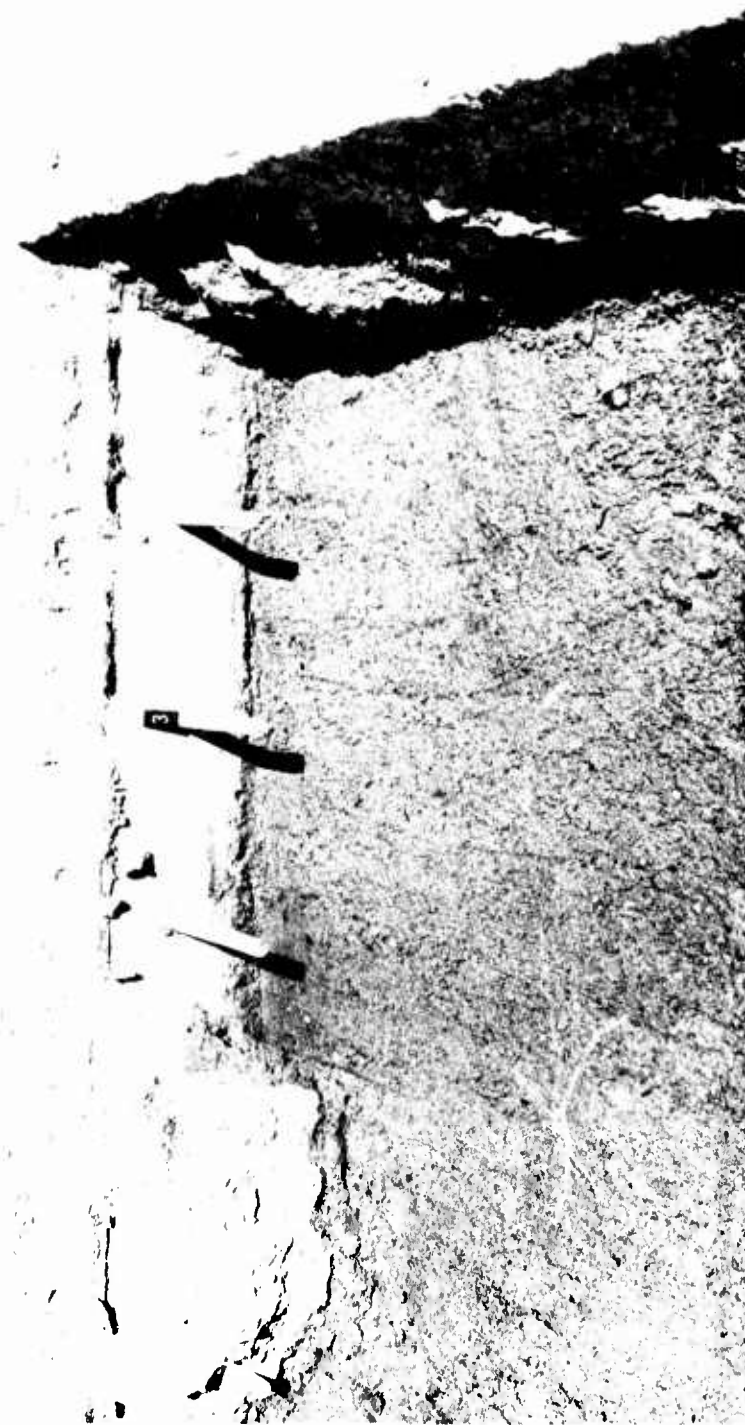
Figure 53. View of doveled longitudinal construction joint in item 3, 360-kip, 12-wheel-assembly lane after 688 coverages prior to overlaying and 5008 coverages after overlaying.

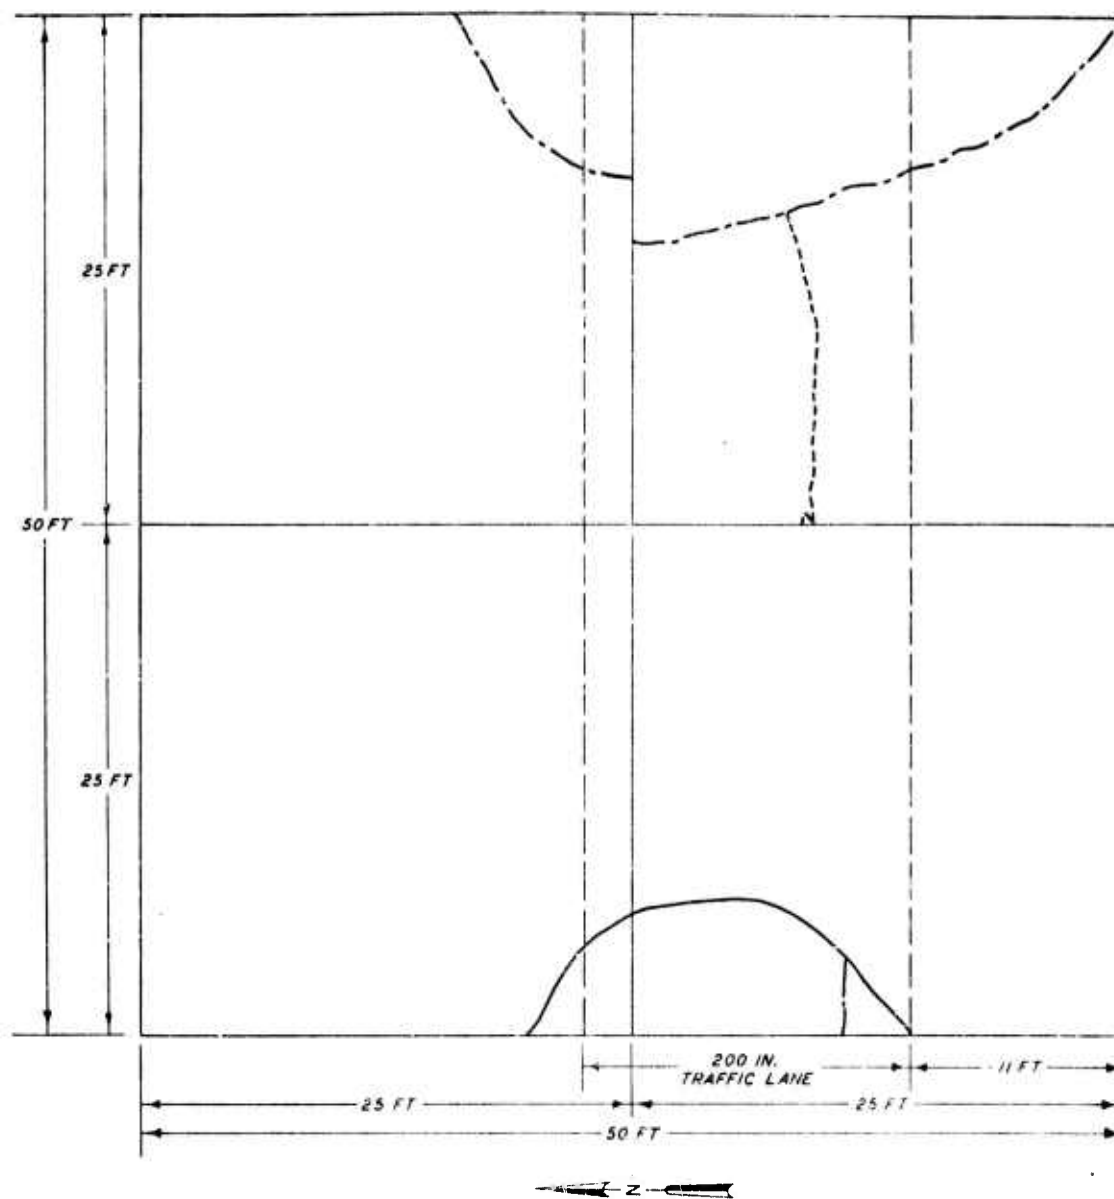
Figure 56. Crack development in item 4 under 360-kip, 12-wheel-assembly traffic.

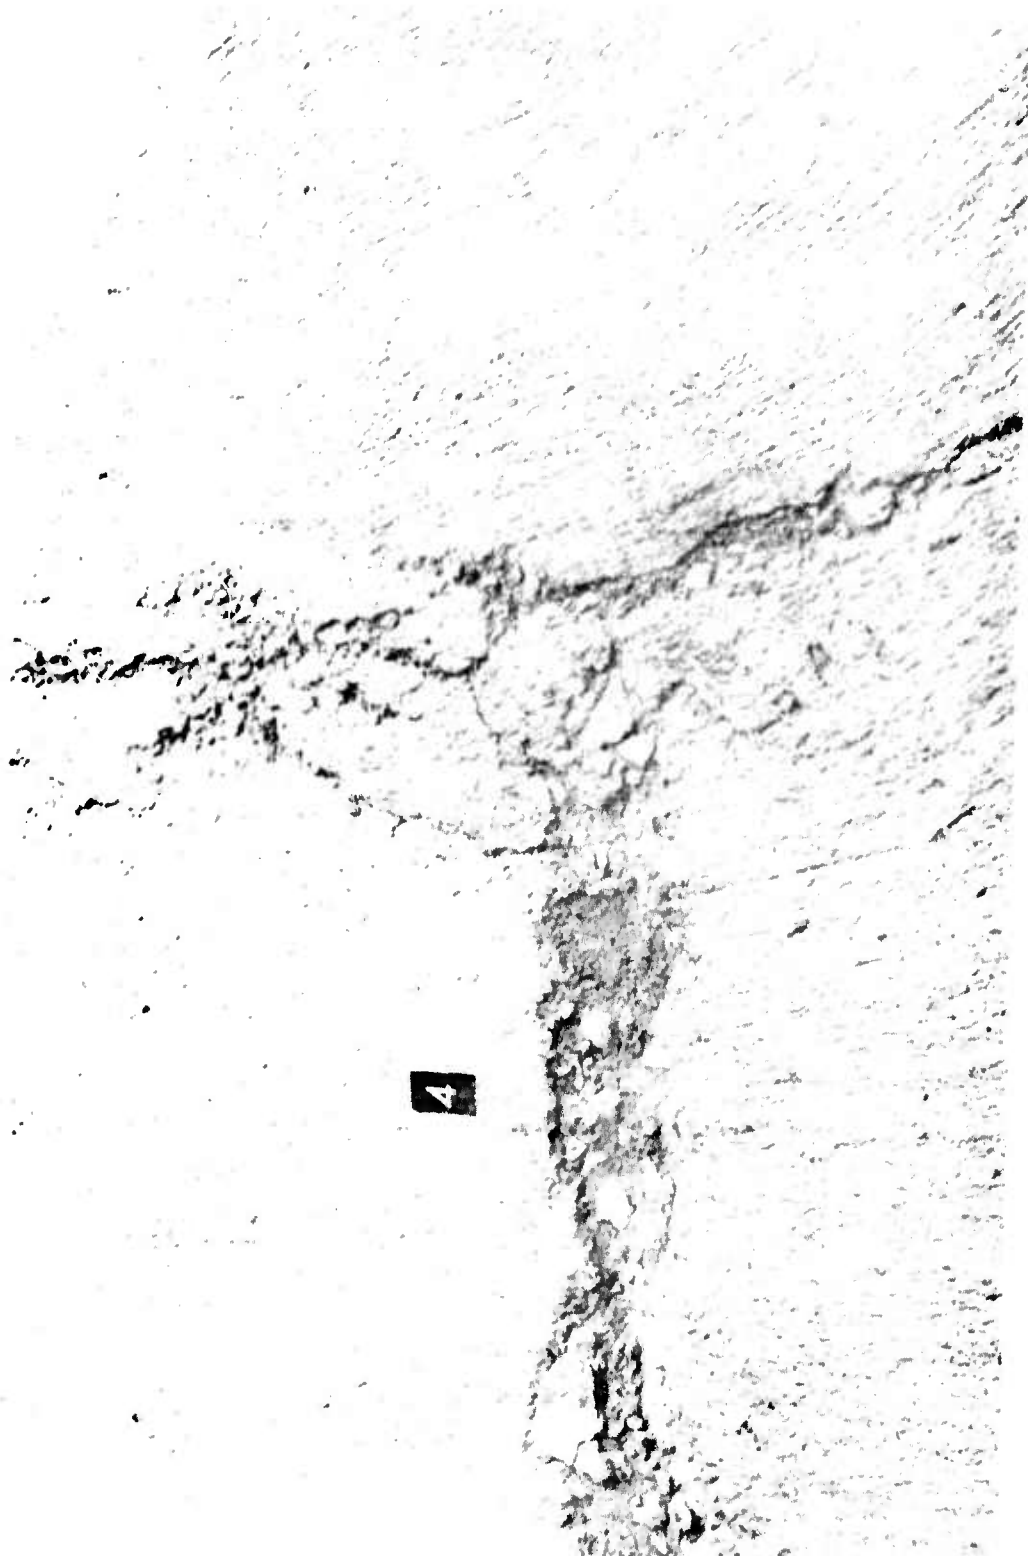
Figure 71. Spalling and flaking along the cracks in item 4, 166-kip, twin-tandem-assembly lane after 950 coverages.

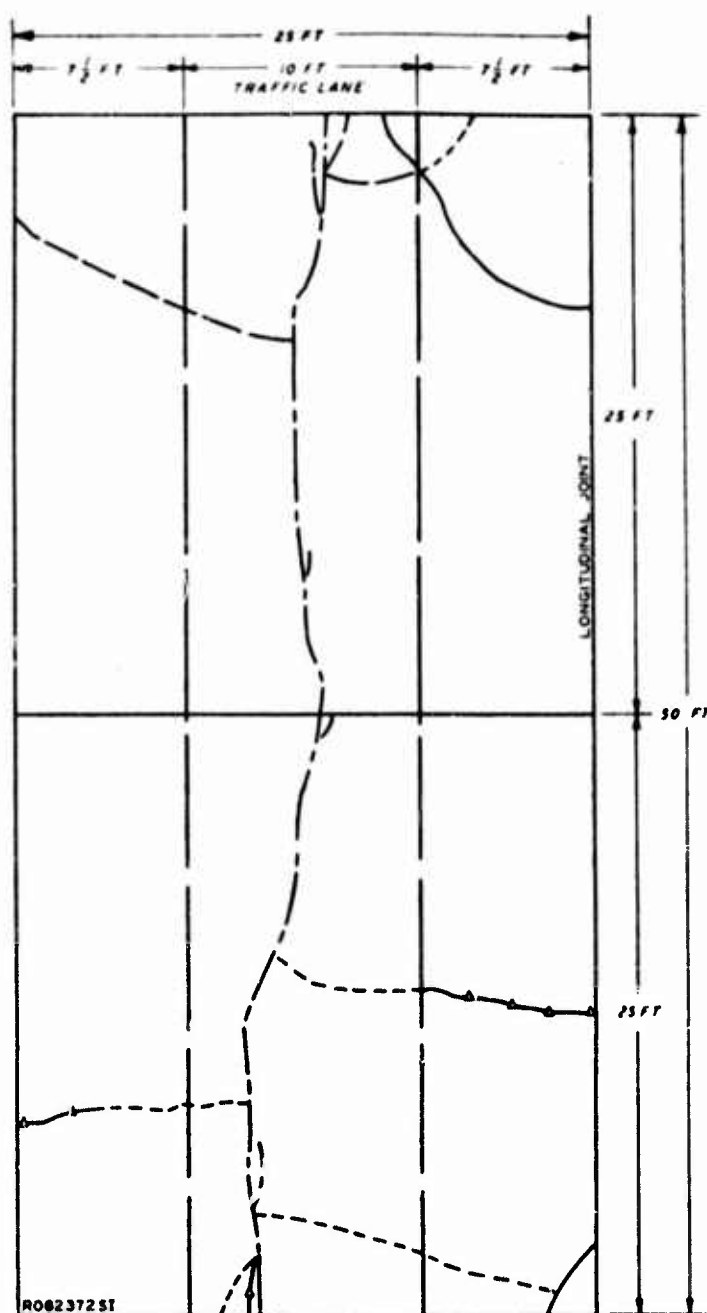
Figure 72. Crack development in item 4 under 166-kip, twin-tandem-assembly traffic.
