ANALYSIS OF HYDROPHONE SUPPORT STRUCTURE
AFTER 52-1/2 MONTHS EXPOSURE AT A DEPTH
OF 5270 FEET IN THE BARKING SANDS TEST
RANGE, KAUAI, HAWAII

James F. Jenkins

Naval Civil Engineering Laboratory
Port Hueneme, California

Technical Note N-1267

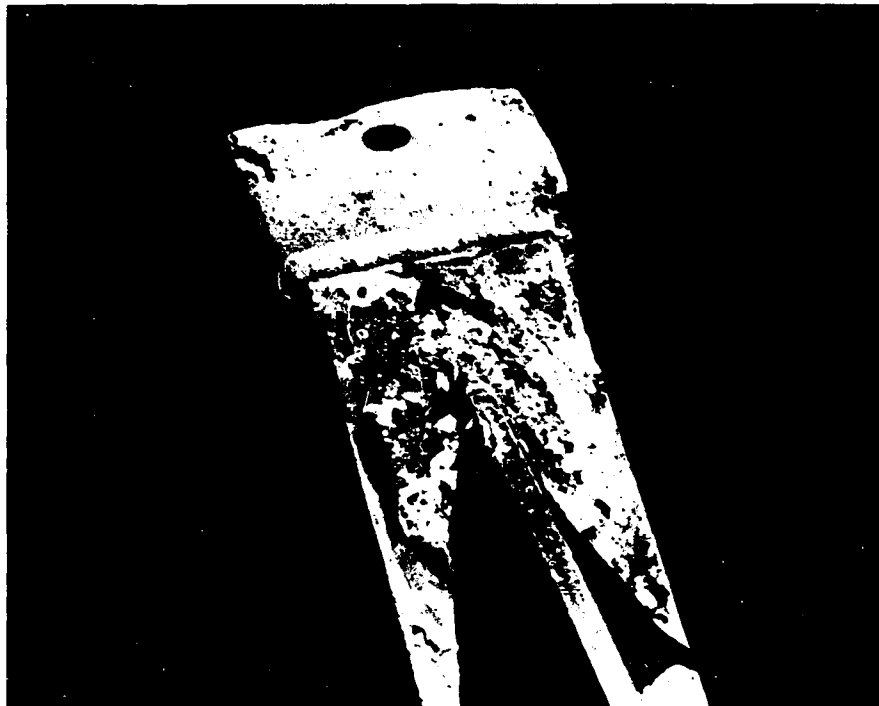
with accelerated attack in the heat affected zone adjacent to the weld bead is shown in Figure 6. Metallographic examinations of joint sections showed that the corrosion of the weld beads was intergranular.

There was a continuous precipitate of Mg_2Al_3 at the grain boundaries of the weld bead. In the heat affected zone adjacent to the weld bead there was a thin layer where Mg_2Al_3 had precipitated adjacent to the grain boundaries to form a continuous network. Intergranular corrosion was noted in this zone. Attack in the heat affected zone of some joints was up to .086" deep.

Another area where crevice corrosion had resulted in significant damage was under the compound used to cover the welds on the structure. This compound was applied in an attempt to minimize attack at these areas. However, as shown in Figure 6, attack under the compound was more severe than at adjacent areas.

Figure 6. Weld attack at base ring clip.

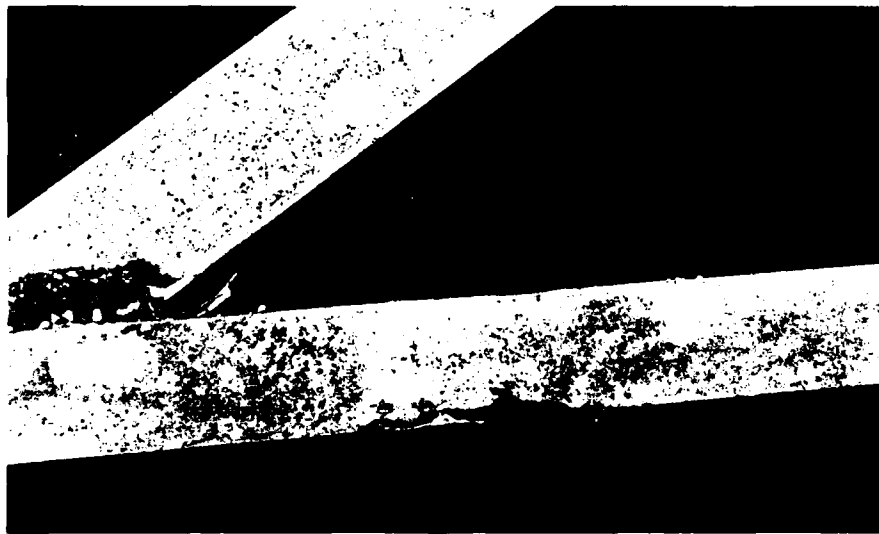
Pitting attack on boldly exposed areas of some components of the structure resulted in structurally severe damage. The most severely pitted components were the base ring braces and the yoke. Pitting of the base ring braces, as shown in Figure 7, initiated at the edges of the members and had progressed up to 1" into them at several areas. Metallographic inspection of the base ring brace channel and bar did not show any continuous precipitate at the grain boundaries. The corrosion was transgranular. The clips at the ends of the braces where the base ring was attached were also severely corroded as shown in Figure 6. This attack also initiated at the edges of the clips. Metallographic inspection of sections of these clips revealed a continuous network of Mg_2Al_3 precipitated at the grain boundaries and the usual attendant intergranular attack. The severity of the attack on the base ring braces can be partially attributed to the exposure of the braces to the bottom sediments.

Figure 7. Pitting on base ring brace.

1. Complete isolation of dissimilar metals must be achieved. Inspection of assembled structures to assure isolation is recommended.
2. Elimination of contact between the bottom sediments and any aluminum structural members is recommended.
3. Elimination, by design, of any unnecessary crevices is recommended.
4. The continued use of 5086 aluminum alloy as the most corrosive resistant aluminum alloy is recommended. However, 5086 alloy in the as extruded (H-111) condition is preferred to other conditions where intergranular precipitation and its associated accelerated attack is possible.

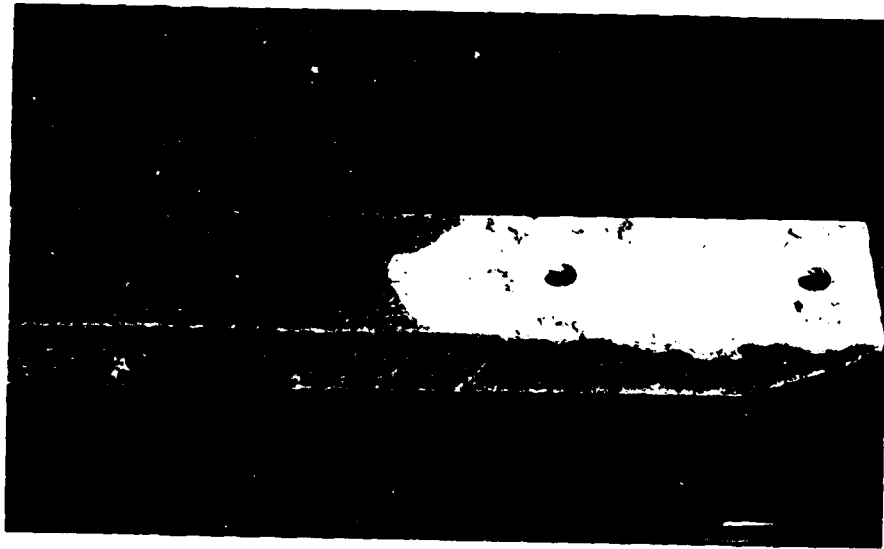
At all points on the structure where there were crevices, crevice corrosion was found. In most areas the attack was not severe. However, in other areas the attack was significant. The area most adversely affected by crevice corrosion was the point where the base ring braces were attached to the mast. Even though the crevices at this joint were sealed with room temperature vulcanizing silicone rubber compound some seawater entered the crevices. This resulted in attack such as shown in Figure 9. In this area the attack was up to .095" deep. Metallographic inspection of sections from this area showed that the channel sections at the base-ring-brace to mast joints had corroded transgranularly. The microstructure of the uncorroded material was typical of as extruded (H-111)

Figure 9. Crevice attack on base brace.

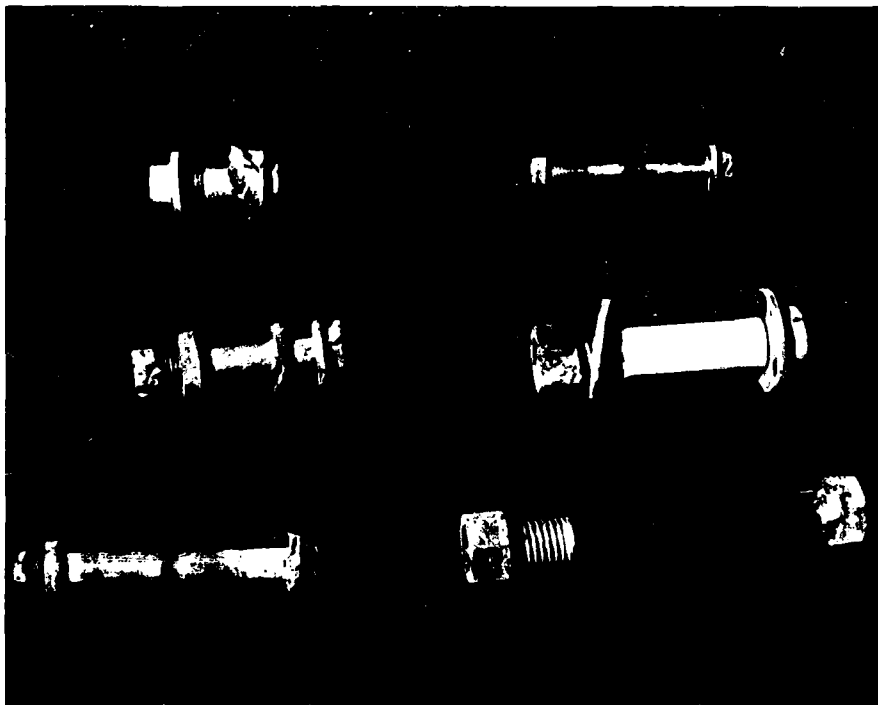
The Nickel-Copper alloy 400 fasteners used to assemble the structure, as shown in Figure 11, were not significantly attacked. The only attack noted other than a slight tarnish was slight crevice attack under the heads and on the threads of a few fasteners. This attack was structurally insignificant. The PVC base ring and couplings as well as the various non-metallic insulating sleeves and washers used on the structure were not significantly affected by their exposure at depth. Damage to the base ring was mechanical, and as evidenced by the lack of fouling on the damage-exposed surfaces, and probably occurred during recovery.

Figure 11. Fasteners and insulators.
