THRESHOLD DAMAGE IN RADOME MATERIALS
BY DISCRETE WATER IMPACT (BALLISTICS
RANGE INVESTIGATION)

Naval Ordnance Laboratory
White Oak, Maryland

13 February 1973

NOLTR 73-34

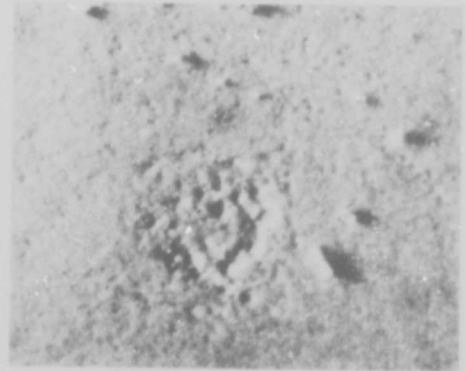
MODERATE PITTING

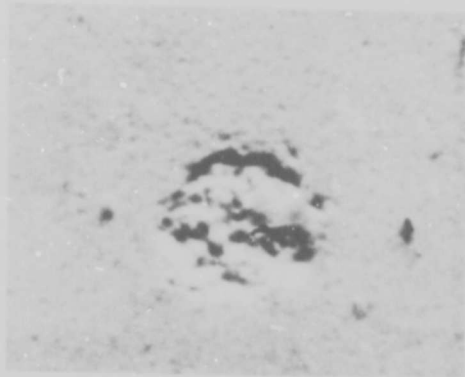
IRREGULAR CRATER

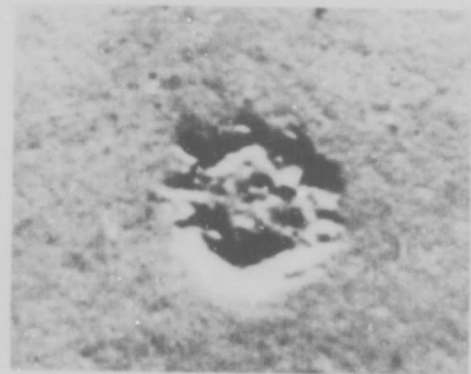
The 1.2mm drop size in untreated SCFS indicated no visible damage below approximately 1,300 feet per second while some pitting always appeared above 1,500 feet per second. As velocity was increased with the 1.2mm drops, pitting became heavier and more general over the impact area. Above approximately 2,100 feet per second, definite craters appeared over the extent of the impact area (~1mm in diameter). The floors of these craters were irregular or generally flat in contour. With the exceptions noted, above approximately 2,600 feet per second, the craters always showed a ringed depression around their periphery with a hump or raised section in the center. The general nature of these damaged characteristics is indicated in Figures 3, 4, and 5.

RINGED CRATER

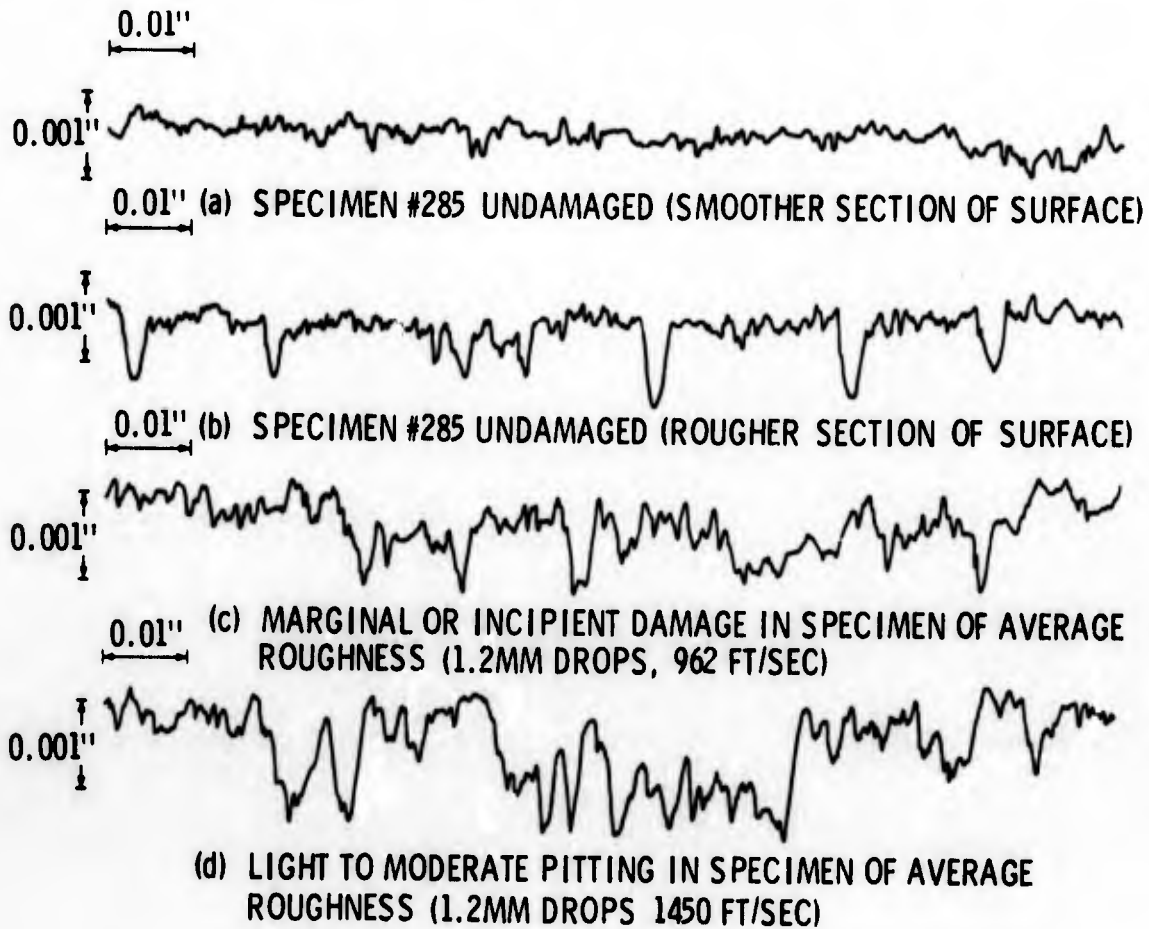
FIG. 4 SURFACE PROFILES IN SLIP CAST FUSED SILICA
(UNTREATED MATERIAL - VARIATIONS IN ORIGINAL SURFACES)
COMPARED WITH INCIPIENT DAMAGE)

Typical results for untreated SCFS are presented in Figures 3, 4, and 5. This material was developed and characterized by Georgia Institute of Technology, references 1, 6, and 7. Three distinct thresholds were apparent. Early damage appeared as very small pits appearing at random locations within the impact area. This damage characteristic appeared to be somewhat dependent upon smoothness of original surface and variation in individual specimens (see Figure 4). The general data were well ordered and consistent, however, when consideration of experimental scatter and repeatability was taken into account. The results can be summarized in a plot such as Figure 5. Here the damage characteristics or regimes are indicated as influenced by velocity and drop size, while the thresholds as influenced by individual specimen and experimental scatter are shown as bands between areas of different damage characteristics. The trends indicated in Figure 5 were repeated for several series of specimens and included samples from three lots of material. The total number of specimens fired at each condition is not sufficient for meaningful statistical evaluation, however, and additional firings would be necessary to provide statistical data for this material. The data repeat well enough, however, within the limits shown in Figure 5, to be considered significant and representative. In one or two cases at each drop

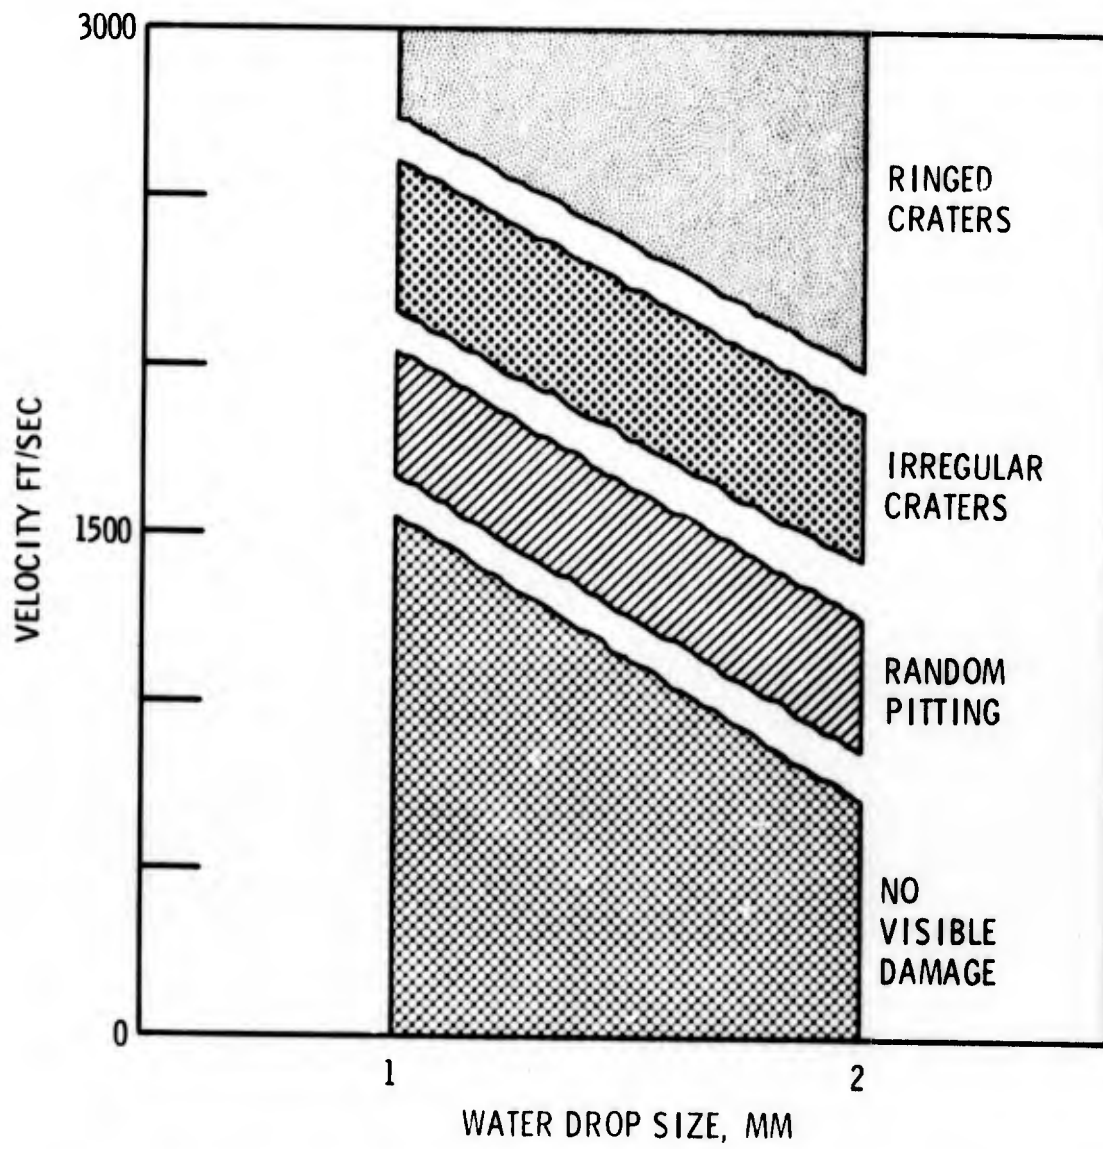
FIG. 5 DAMAGE THRESHOLDS IN UNTREATED SCFS

size, a ringed crater formation did appear at lower velocities than indicated in Figure 5. The infrequency of this result and the fact that it was not repeated when additional shots were made under the same conditions led to the preliminary conclusion that a particularly weak spot in the material was the reason for such inconsistency.

The preliminary results with 2mm drops were similar to those for the smaller drops in that the same sequence and type of damage patterns appeared. A definite effect of drop size is apparent, however, since all thresholds appeared at lower velocities with the larger drops. This support results from several experiments, indicating that damage increases with drop diameter at a given velocity beyond the simple increase in impact area.

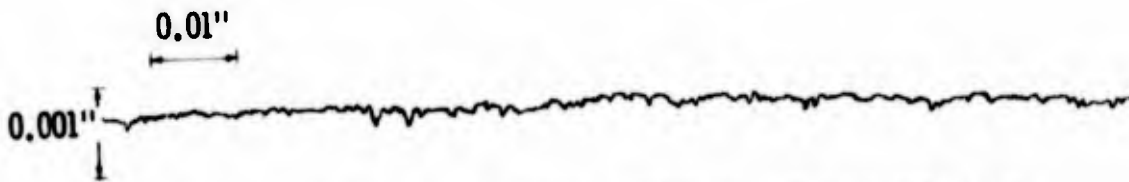
(a) SPECIMEN #12 UNDAMAGED MATERIAL (TREATED MATERIAL)

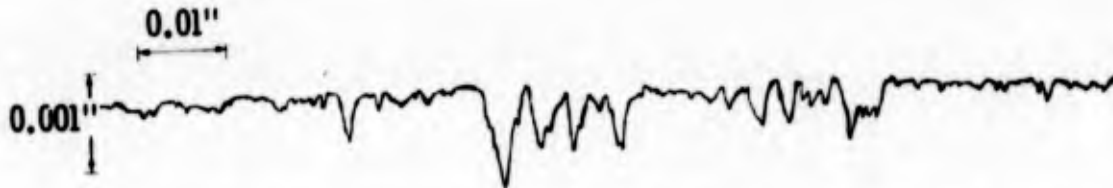
Figure 6 indicates the lower threshold or pitting damage in the treated or impregnated material. Comparison with Figure 4 indicates that the incipient damage threshold appears to be raised of the order of 500 to 1,000 feet per second by the treatment. The material lots were different in these cases and the possibility of differences in material strength cannot be discounted until more firings are completed on the same material lot. There does seem to be an increase in impact resistance in the treated specimens, however. It is important to mention that the material did not appear to accept or retain the impregnant uniformly over its entire surface. The areas of deeper or more dense impregnation appeared more resistant than those more lightly impregnated. This resulted in a wider threshold "belt" or more scatter in defining damage characteristics. All of the few specimens fired at both drop sizes did show the increased resistance to damage, however.

(c) SPECIMEN #348 LIGHT PITTING (1.2 MM DROPS, APPROX. 2000 FT/SEC) (TREATED MATERIAL)

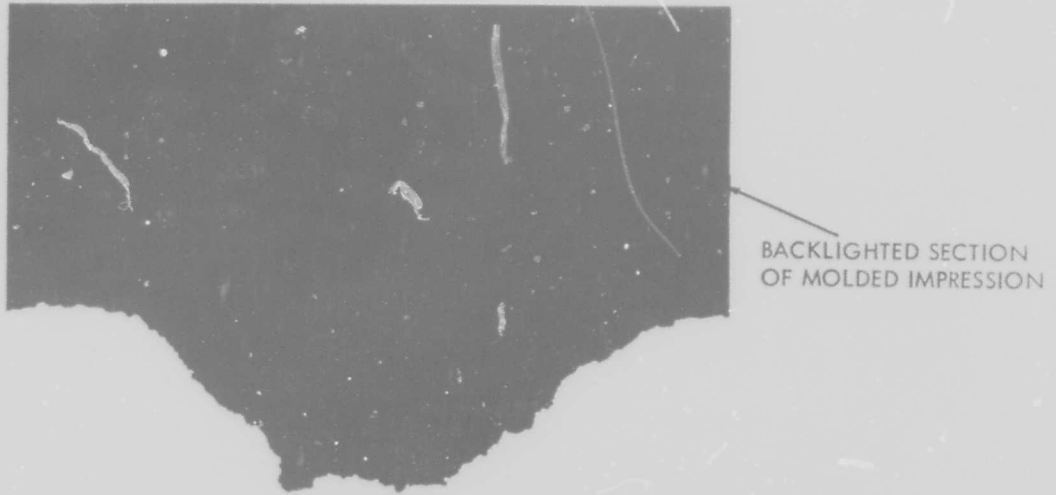
FIG. 10 PROFILE OF DEEP CRATER IN CARBON MATERIAL—MOLDED IMPRESSION TECHNIQUE

The evaluation of larger scale surface damage and crater characterization can be economically and quickly measured when scanning microscopes or computerized densitometers are not available by the method illustrated in Figures 9 and 10.

In this technique, a high stability molding compound can be used to take male impression models of the crater or damage area. These molds, after curing, can be cut into thin sections and a standard type shop comparator used to make tracings or photographs to the appropriate magnification. The material used for the moldings shown was G. E. Dimethyl RTV-41, a silicon rubber molding compound. Linear shrinkage in these materials can be kept to $\sim .2 - .5$ percent, and, therefore, accurate data on crater shape and volume are easily obtainable.

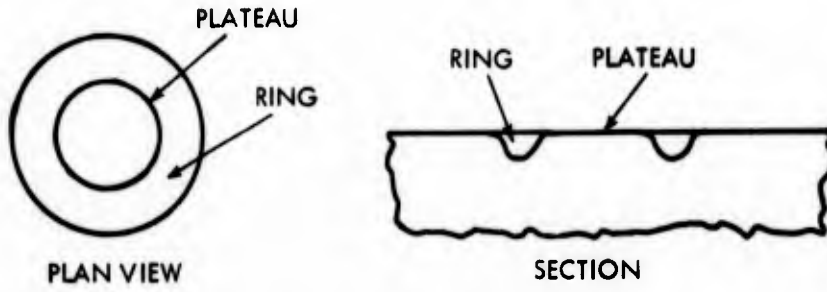
FIG. 11a WATER IMPACT, PLEXIGLAS, VELOCITY < 1500 FT/SEC

The general characteristics of the impact site are the same at lower velocities as those found with several materials. A permanent deformation of the Plexiglas surface is formed consisting of a central plateau surrounded by a depressed annular ring (see Figure 11a).

In the range from 1,200 to 1,600 feet per second, the damage appears similar to the previous sketch, but diameter of the damage site is greater for the water impact (~1mm ring for water, ~1/2mm for water in wax).

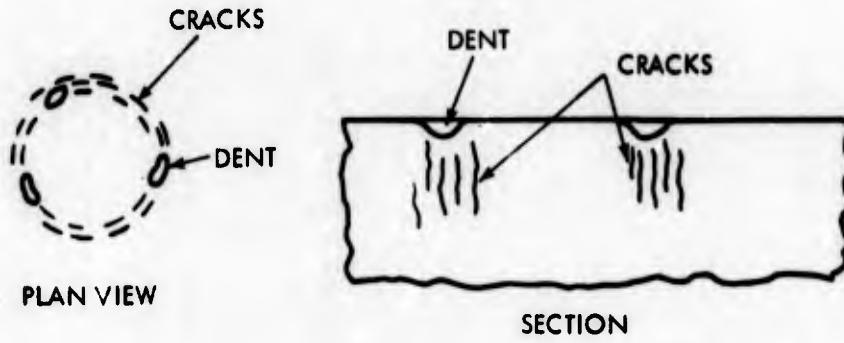
FIG. 11b WATER IMPACT, PLEXIGLAS, 1600 - 2500 FT/SEC

In the velocity range from 1,600 to 2,200 feet per second, the damage site appears to go through a significant transition for water impact. The characteristic ring depression no longer appears, but significant cracking (probably subsurface) appears with occasional small dents or depressions on the surface. This is indicated in Figure 11b. The depth and characteristics of the subsurface cracks are approximated since the method of examination used in preliminary evaluations does not define them accurately.

The diameter of the cracked regions at the higher velocities appears slightly smaller in diameter in some cases than the depressed rings at velocities just below the transition value.

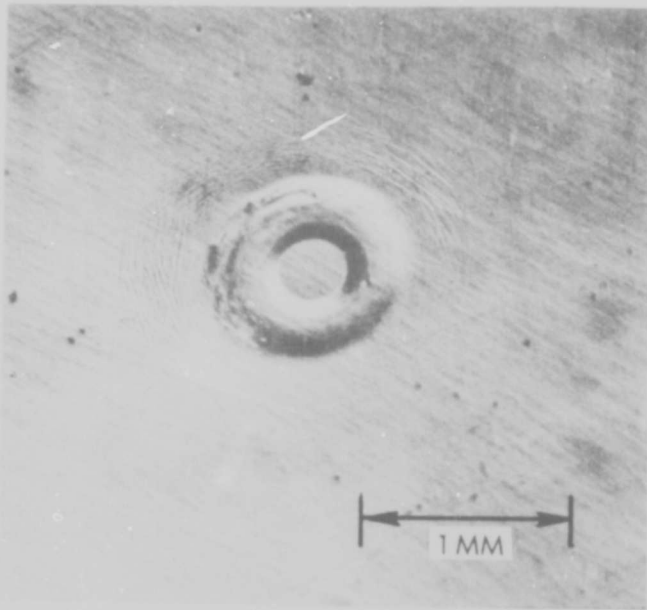
SHOT 295

NOTE: CRACKING OUTSIDE IMPACT SITE
NON CIRCULAR APPEARANCE IS
DUE TO LIGHTING EFFECTS

FIG. 11c PLEXIGLAS IMPACTED BY 1MM WATER DROP -976 FT/SEC

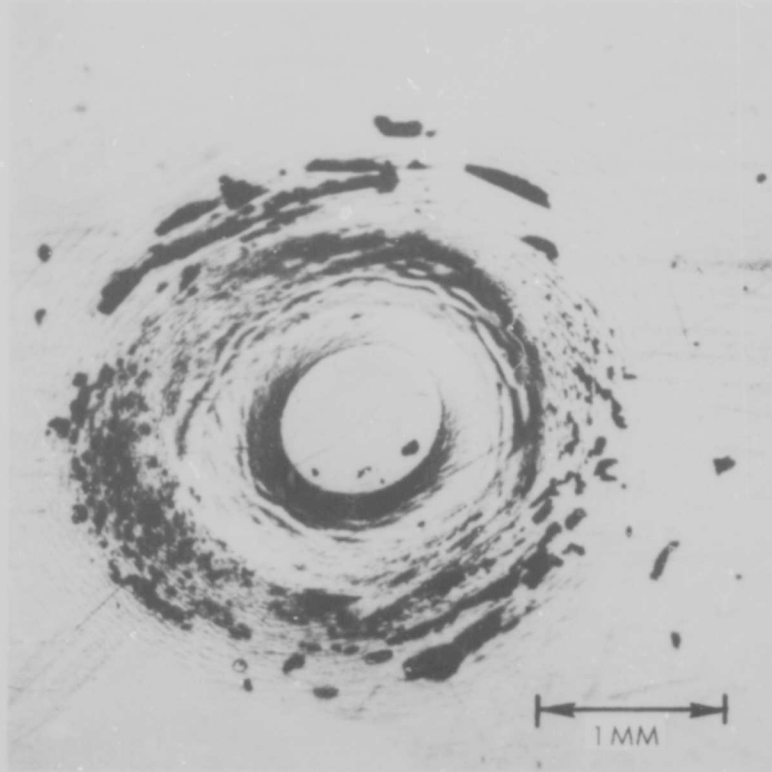
SHOT 286

NOTE: CRACKING OUTSIDE IMPACT SITE

FIG. 12 PLEXIGLAS IMPACTED BY 2MM WATER DROP - 1000 FT/SEC [EST]

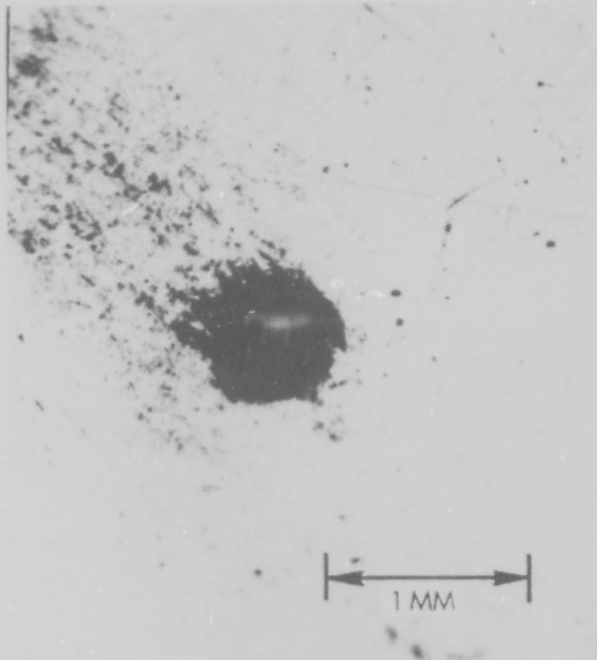
SHOT 299

NOTE: WAX DEPOSIT

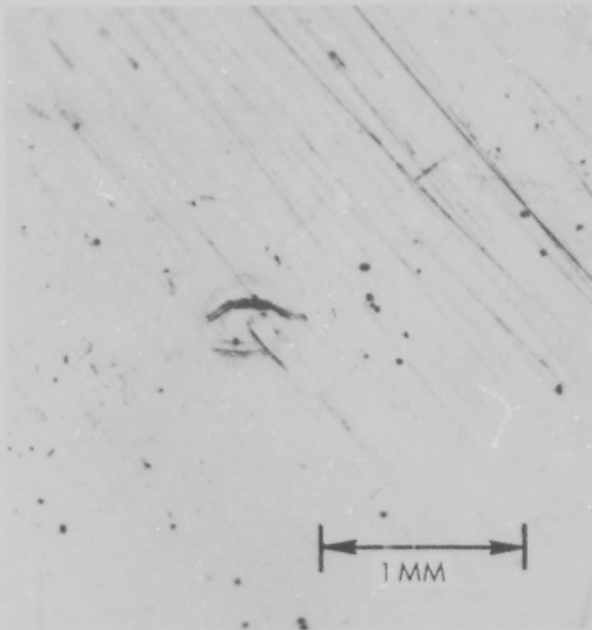
SHOT 299

NOTE: WAX REMOVED. IMPRESSION NOT
SIMILAR TO PURE WATER IMPACTS

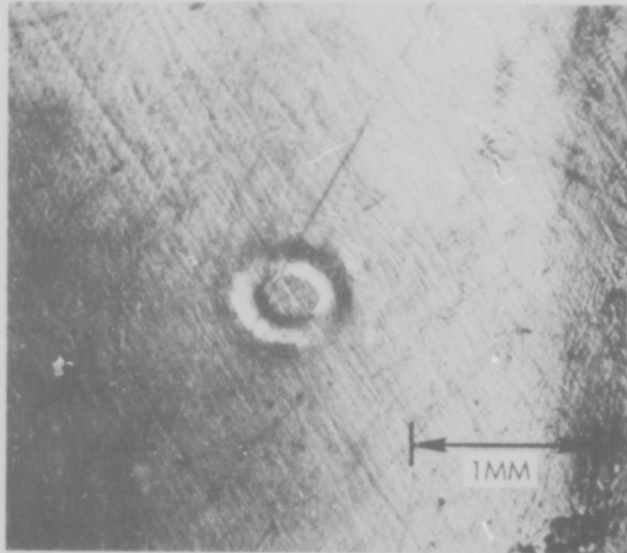
SHOT 301

The damage sites with water in wax do not appear to go through this transition for the velocities investigated. The ringed depressions and plateau damage site continue to appear with velocities above 2,000 feet per second.

NOTE: IMPRESSION SHOWS SOME CHARACTERISTICS
OF WATER IMPACT AT LOWER VELOCITIES
SMALLER IMPACT AREA NO EVIDENCE OF
CRACKING
