INVESTIGATION OF THERMAL FATIGUE IN
NON-TUBULAR REGENERATIVELY COOLED
THRUST CHAMBERS. VOLUME II

AFRPL-TR-73-10
VOLUME II

FINAL REPORT
VOLUME II

ROCKETDYNE DIVISION, ROCKWELL INTERNATIONAL
6633 Canoga Avenue, Canoga Park, California

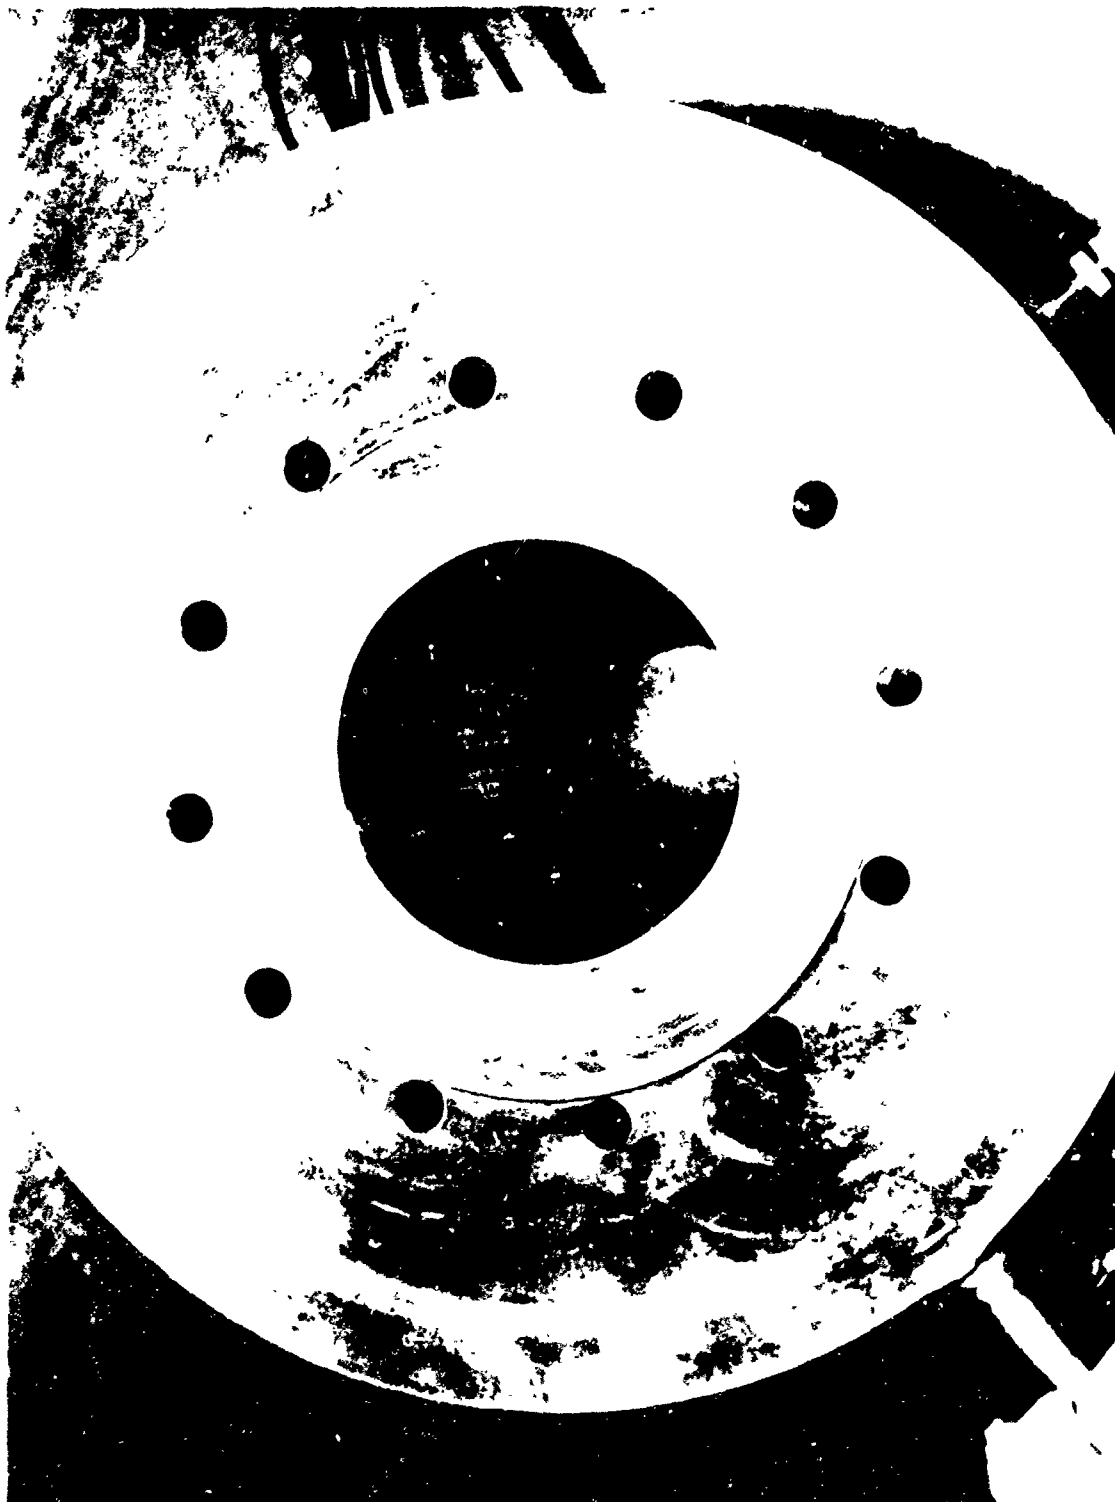
The nickel chamber was then installed on the test stand. A series of checkout tests were run and cyclic tests initiated. After approximately 50 cycles, a facility malfunction again occurred which resulted in destruction of the chamber. The chamber is shown post-test in Fig. 29. Although the cyclic life demonstration was not completed on this chamber, 50 cycles were accumulated prior to the malfunction. There were no thermal cracks on the chamber, indicating that this material can be used for chambers having a reasonably long life requirement.

Figure 29. Nickel-200 Chamber Post-Test

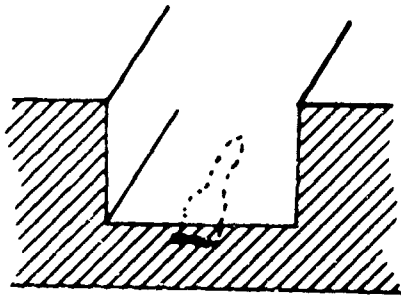
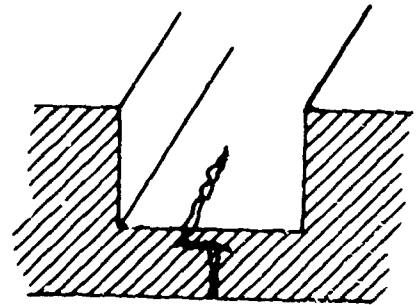
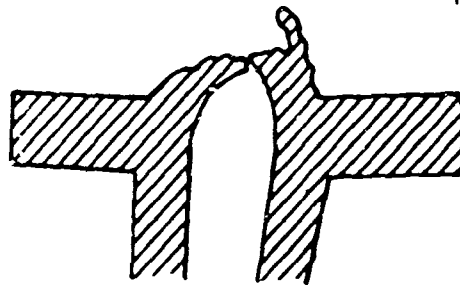
STRINGER INITIATED CRACK EXPOSED BY BENDING
ENTIRE CRACK SURFACE BLACKENED BY HOT GAS

Figure 52. Evolution of a Stringer Crack
