EVALUATION OF REDESIGNED XW18 MEMBRANE
AND ACCESSORIES

Army Engineer Waterways Experiment Station
Vicksburg, Mississippi

May 1973

TECHNICAL REPORT S-73-3

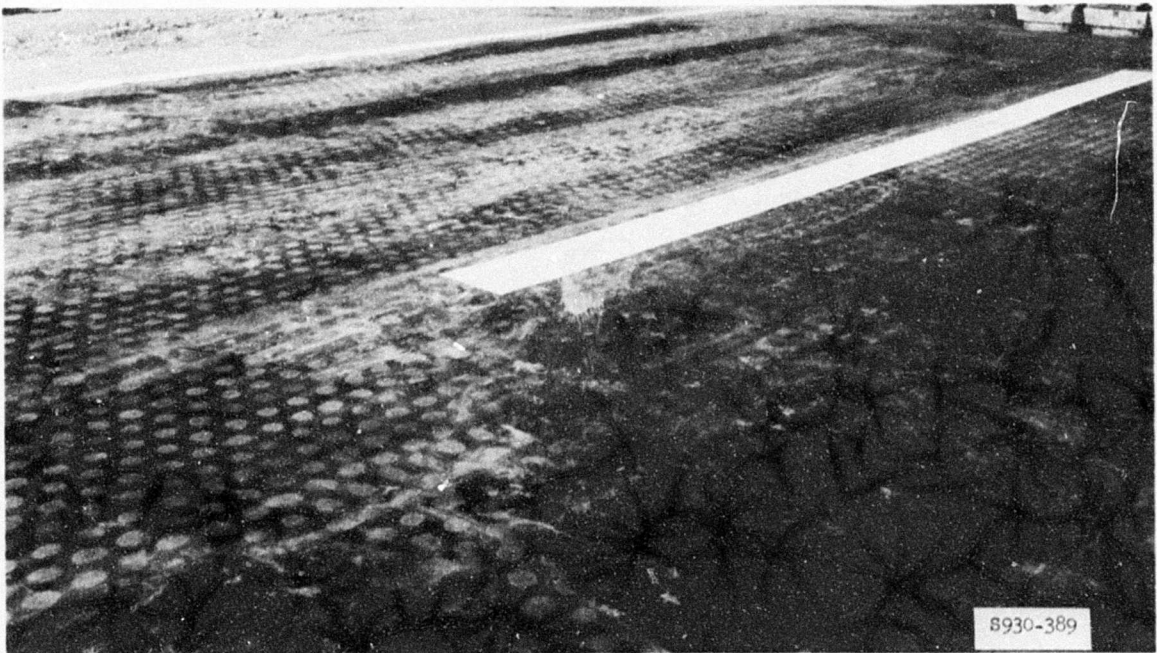
33. An examination of the surface after the skid tests revealed that approximately 36 percent of the nonskid compound was removed after the dry skids (photo 12) and approximately 23 percent was removed after the wet skids (photo 13). Cross sections of the surface made at 6-ft intervals and a center-line profile of a rut caused by a typical skid are shown in plate 6.

Photo 13. Nonskid removed after wet skid on XW18 membrane section 2

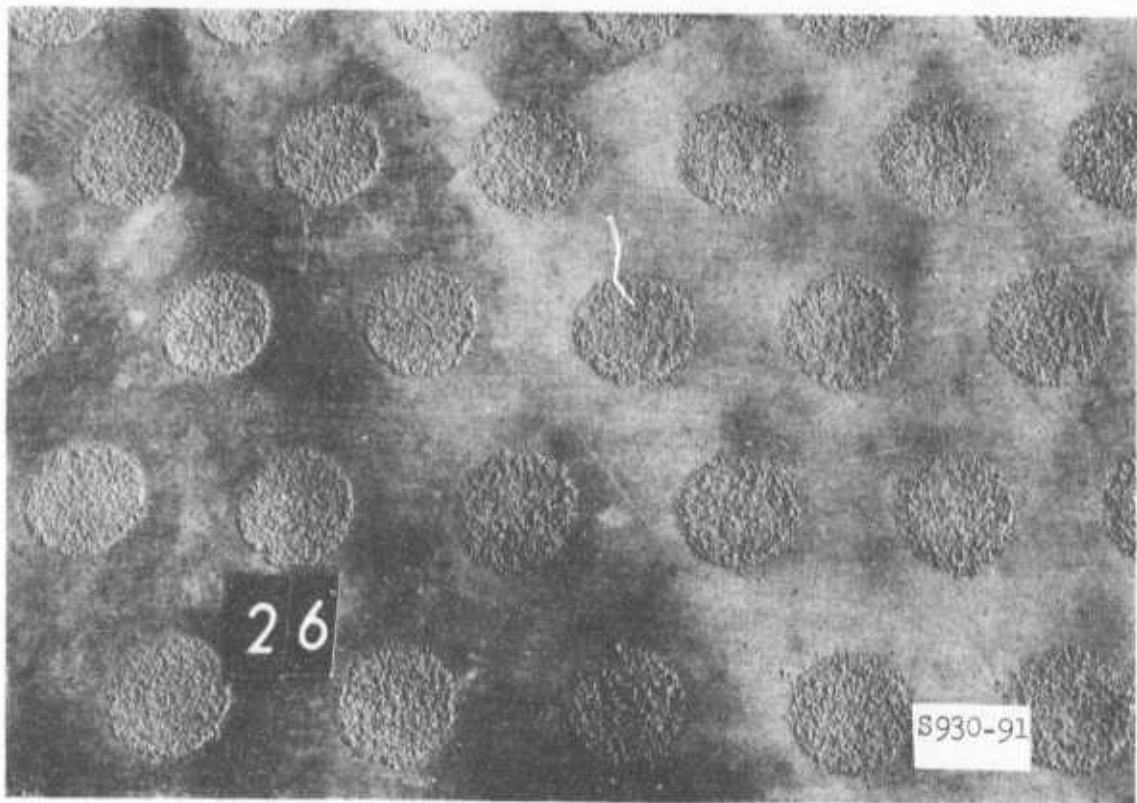
31. Test section 2. Photo 8 shows the general condition of the membrane surface prior to the skid tests. Partial cracking and flaking of the nonskid coating occurred in isolated areas (photo 9).

Photo 8. Condition of nonskid coating on XW18 membrane section 2 prior to skid tests

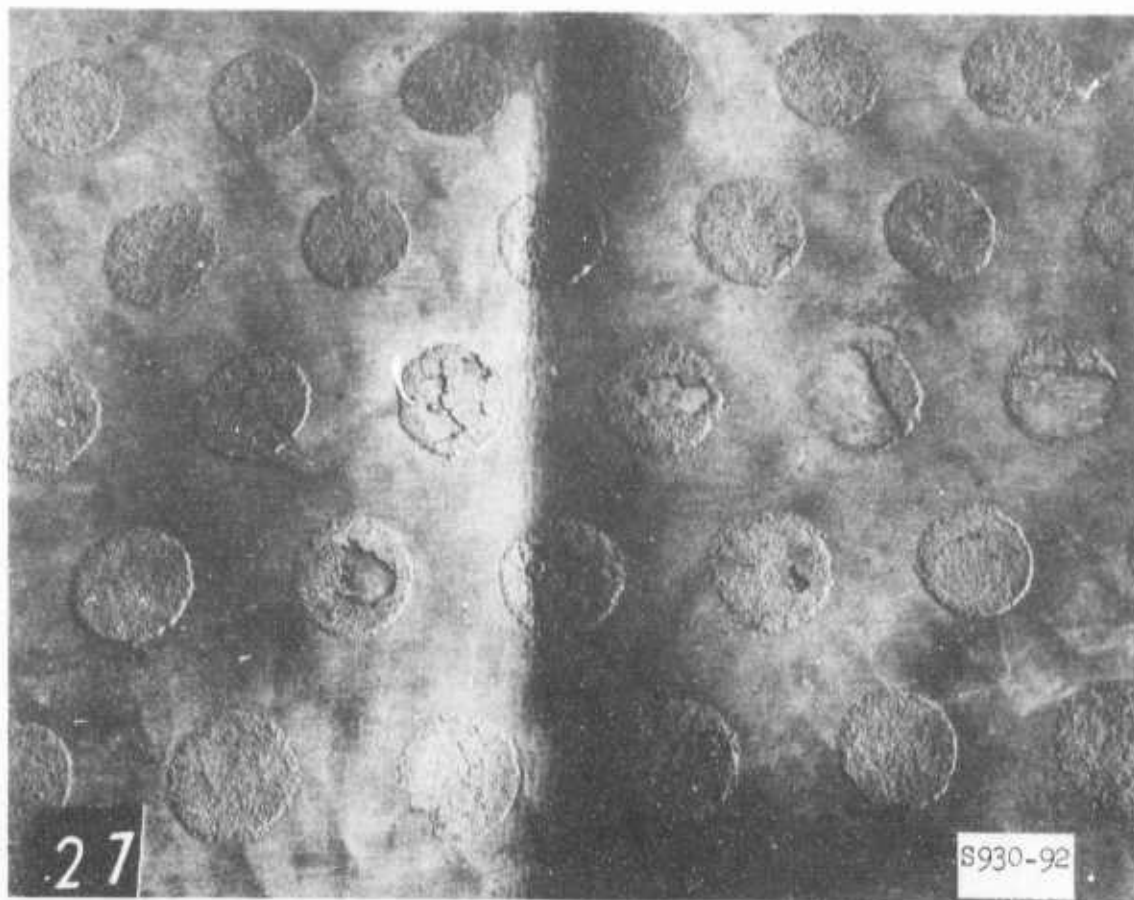
Photo 9. Cracking and flaking of nonskid coating on XW18 membrane section 2 due to effects of accordion folding

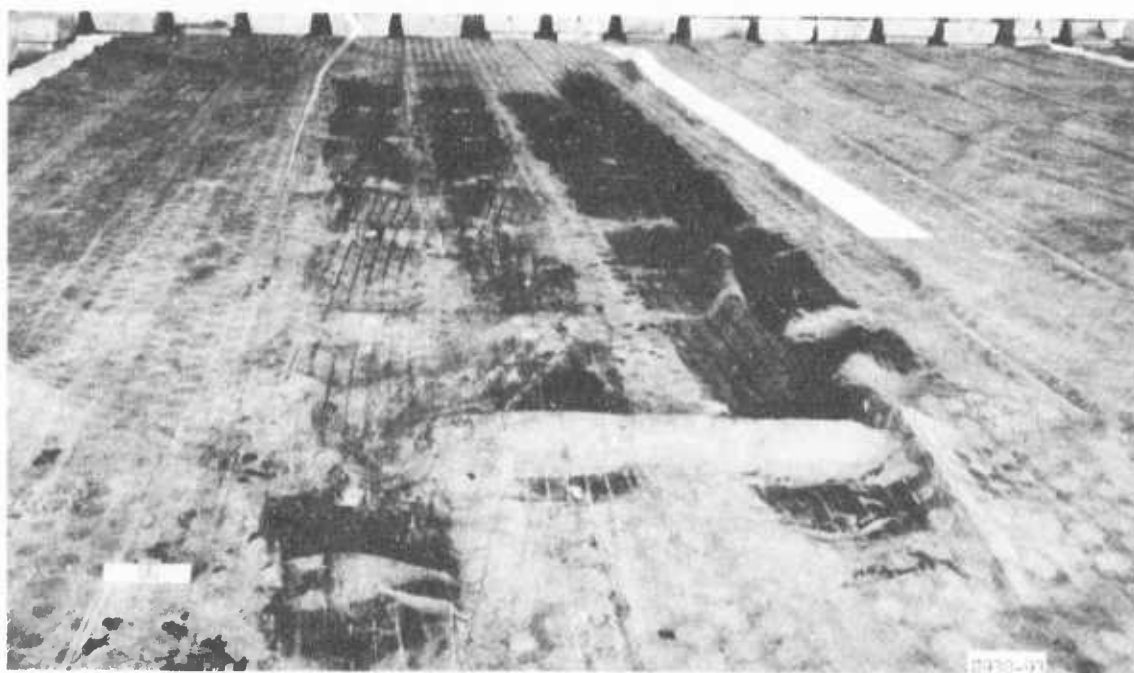
32. Photo 10 shows XW18 membrane test section 2 after four dry skids, and photo 11 shows the section after four wet skids. The average rated braking conditions for the dry and wet skids were 0.74 and 0.50, respectively (table 3), corresponding to dynamic coefficients of friction of 0.59 and 0.45, respectively.

Photo 10. Condition of XW18 membrane section 2 after four dry skids

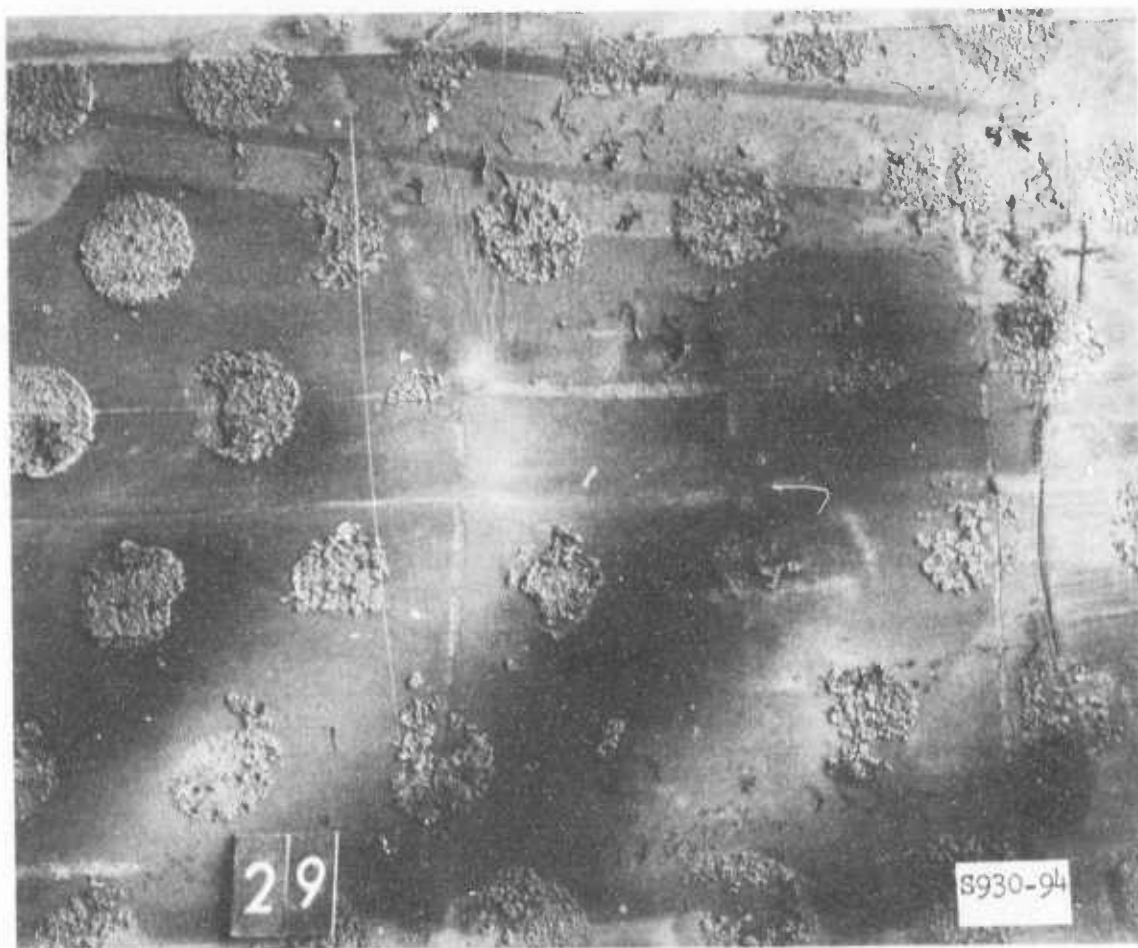
Photo 12. Nonskid removed after dry skid on XW18 membrane section 2

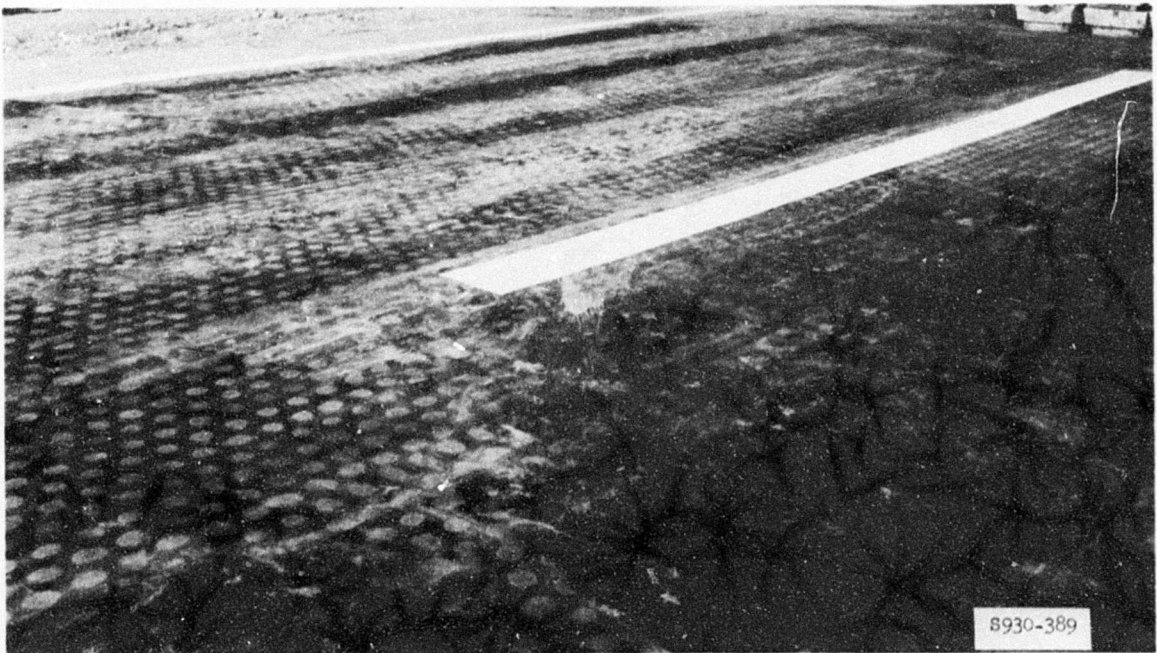
35. The condition of XW18 membrane test section 3 after four dry and four wet skids (photo 14) was similar to that described for test sections 1 and 2. The average rated braking conditions for the dry and wet skids were 0.72 and 0.50, respectively (table 3), corresponding to dynamic coefficients of friction of 0.63 and 0.41, respectively.

Photo 14. Condition of XW18 membrane section 3 after four wet and four dry skids

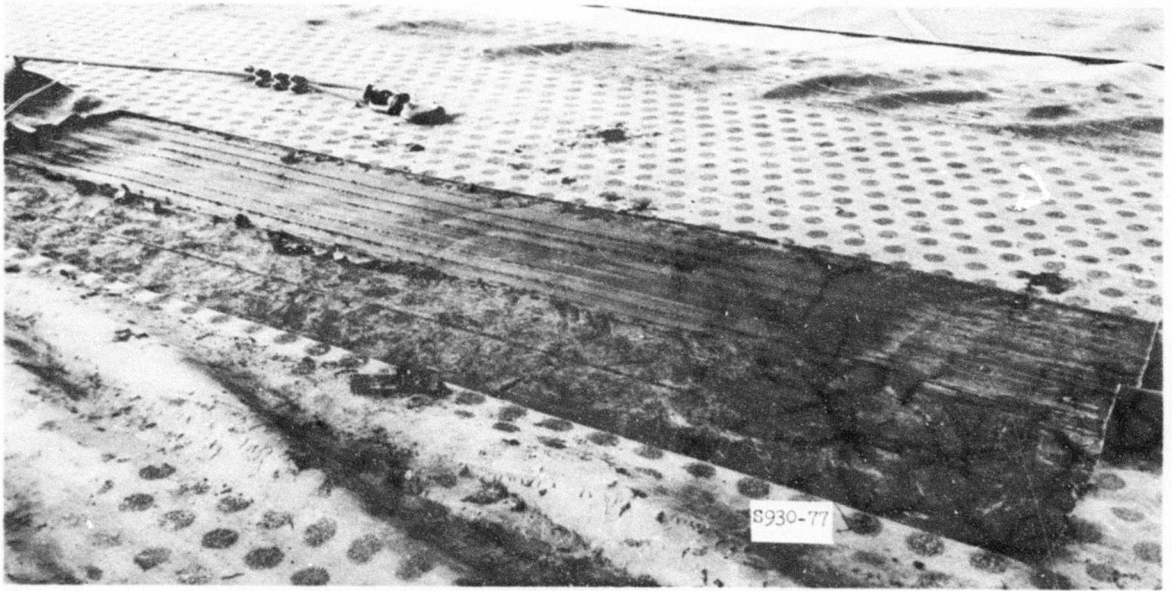
- b. Run 2. After the second repetitive skid across the same area of run 2, only small amounts of neoprene had been stripped from the surface (photo 18). No top-ply failures occurred at this time as they had on run 1. No change in the condition of the membrane was evident following the third repetitive skid. However, during the fourth skid, the membrane failed after the tire had skidded a distance of approximately 2 ft. The failure extended completely across the run (approximately 4 ft) and was 12 ft long (photo 19). As is evident in photo 19, rutting of the subgrade was negligible.

Photo 19. Failure of run 2 of XW18 membrane section 1

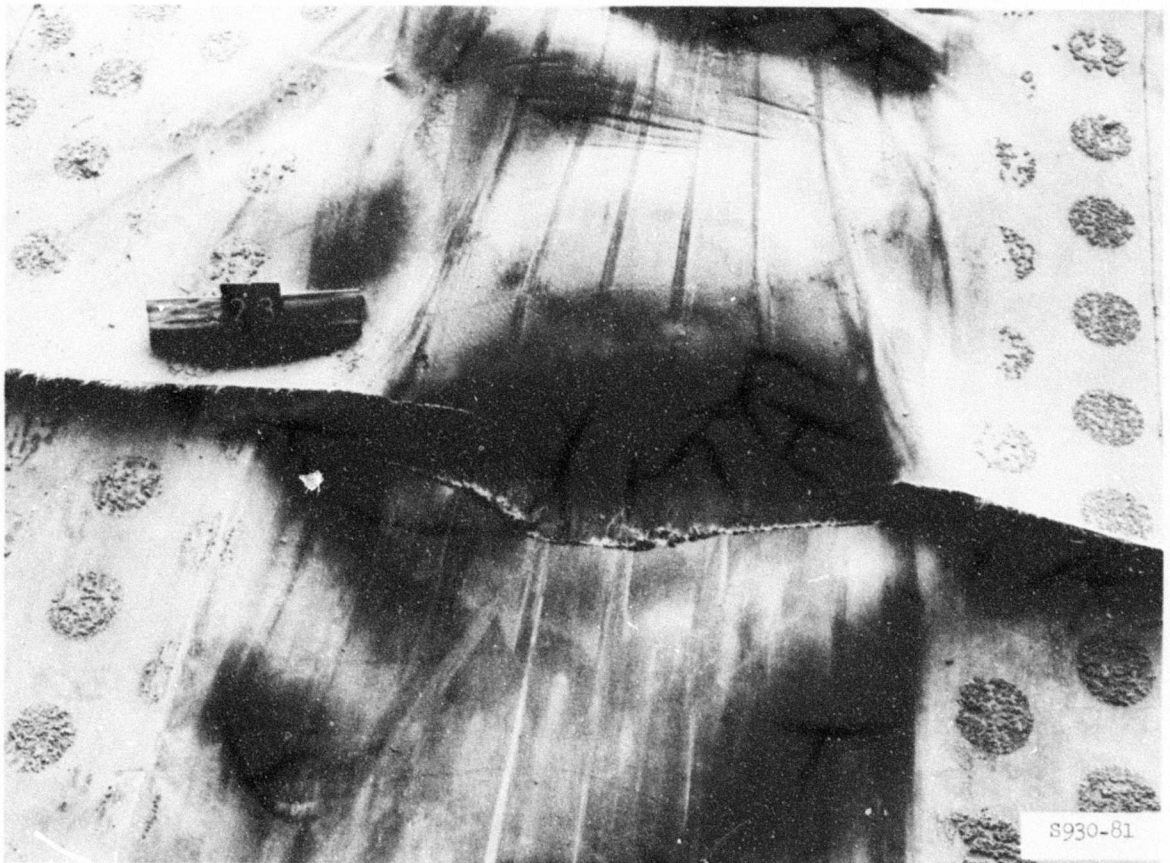
- c. Run 3. Top-ply fabric failures occurred at two places in run 3 after the second repetitive skid. These types of failures increased in number during subsequent skids. During the fifth repetitive skid, complete failure of the membrane occurred after a skid of approximately 2 ft. The failed area was 16 ft wide and 6 ft long (photo 20).

Photo 20. Failure of run 3 of XW18 membrane section 1

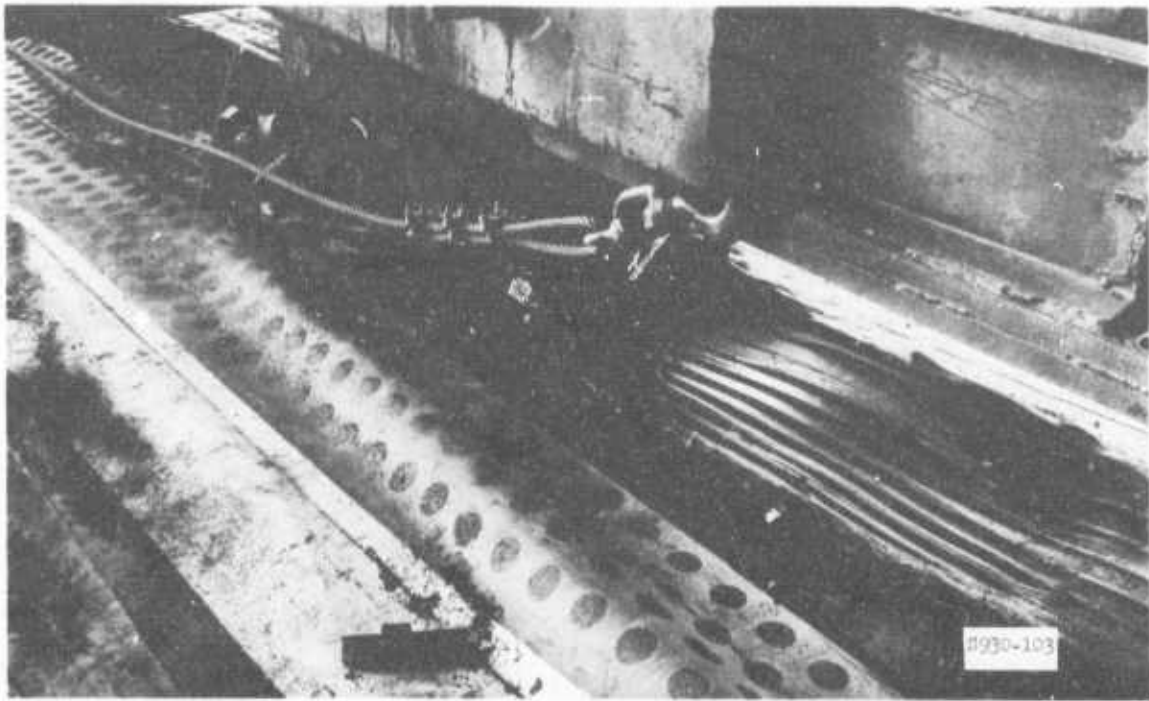
- a. Run 1. Top-ply failures occurred after two repetitive skids and increased in number and severity during subsequent skids. Complete failure of the membrane occurred approximately 2 ft after the initiation of the eighth skid in an area 4 ft wide and 9 ft long (photo 21). As is shown in photo 21, rutting of the subgrade was somewhat more severe than during previous tests. Cross sections of the surface taken at 6-ft intervals and a center-line profile of the rut caused by the skidding are shown in plate 9.

Photo 21. Failure of run 1 of XW18 membrane section 2 after eight repetitive skids

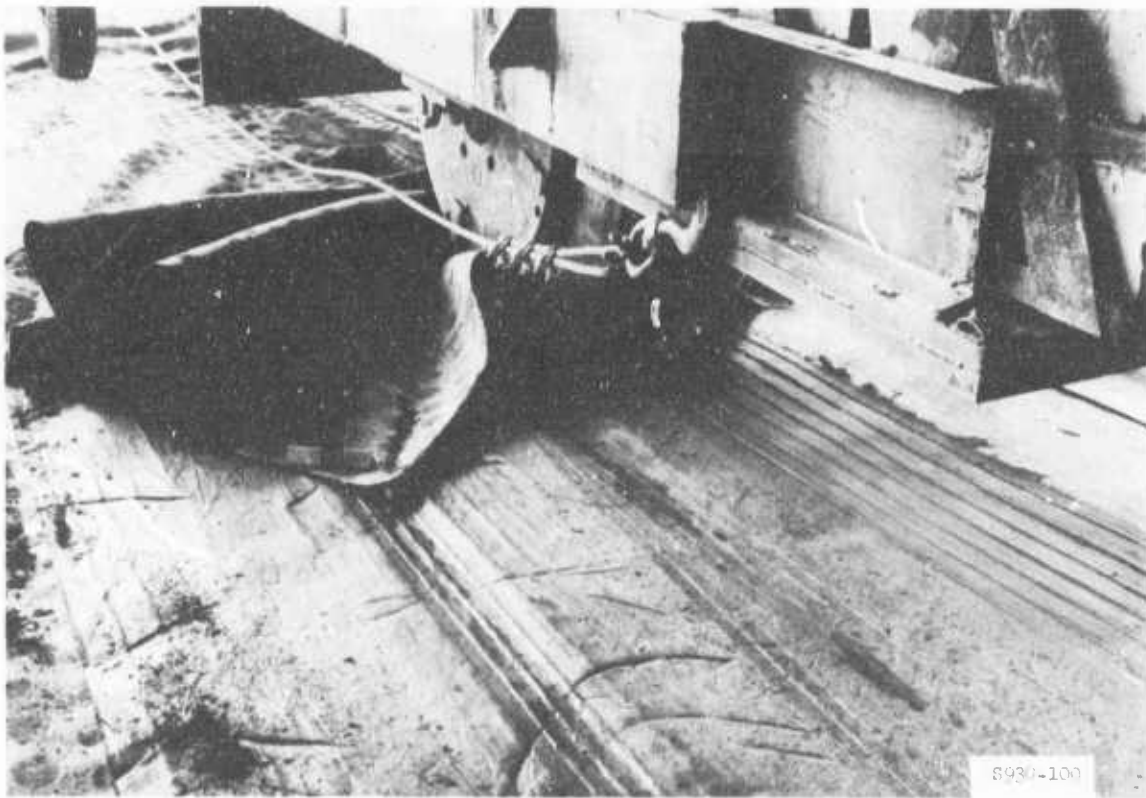
- b. Run 2. Three repetitive skids over the same area of run 2 were required to completely fail the membrane. The area of failure extended across two runs of the membrane (approximately 7-1/2 ft) and was 8 ft long (photo 22). The failure developed before the test wheel began to skid, and it occurred in an area where no top-ply failures had been observed previously.

Photo 22. Failure of run 2 of XW18 membrane section 2 after three repetitive skids

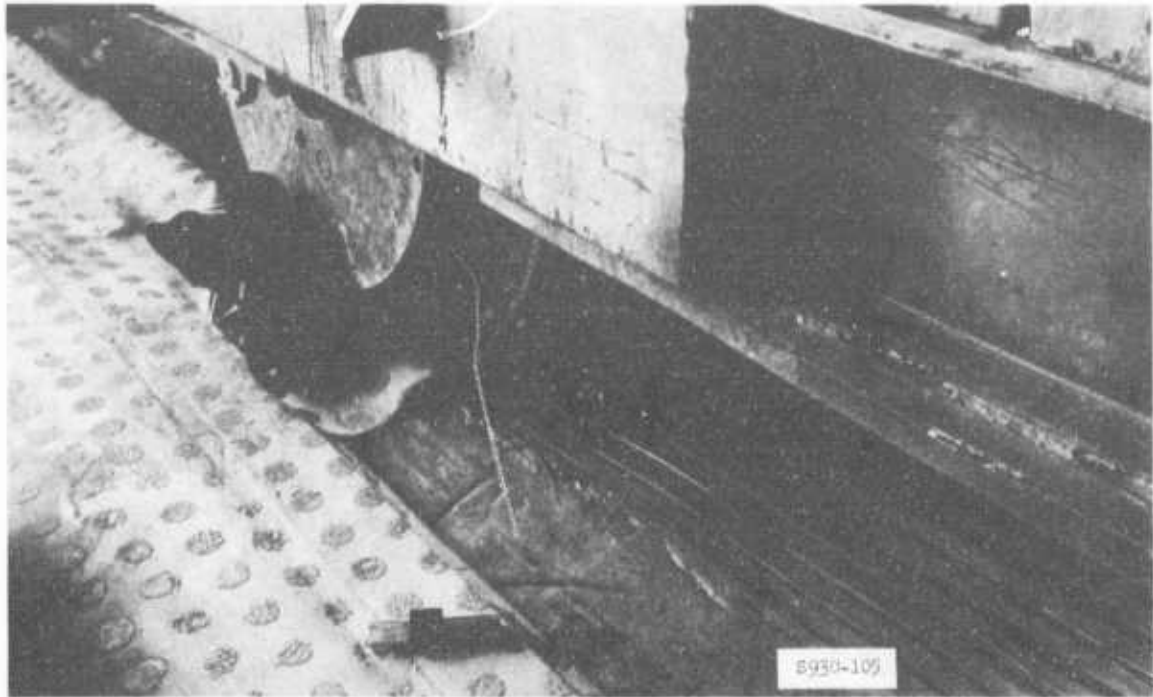
area that had been weakened by such failures. After six repetitive skids, the membrane failed completely in a 7-1/2-ft-wide by 8-1/2-ft-long area (photo 23).

Photo 23. Failure of run 3 of XW18 membrane section 2 after sixth repetitive skid

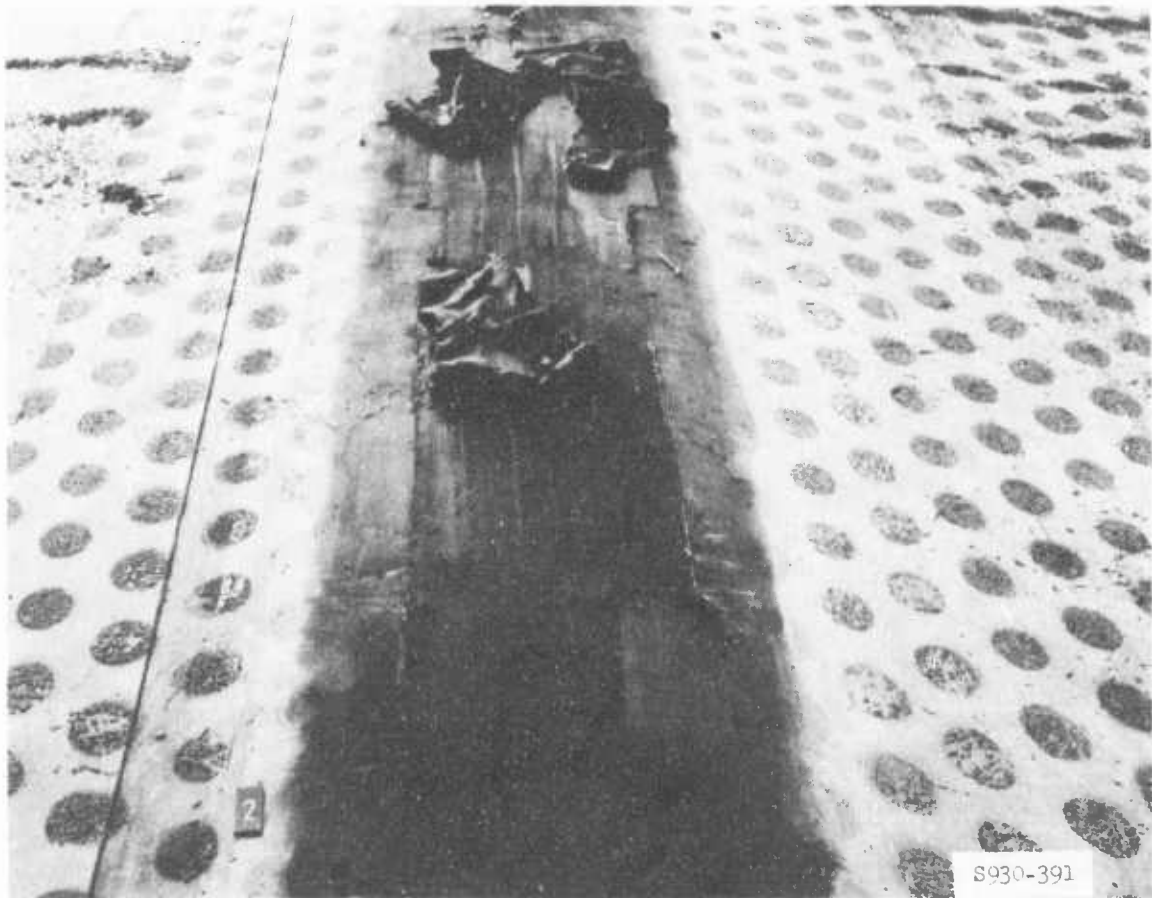
- a. Run 1. Top-ply failures occurred during the third skid and increased in number during subsequent skids (photo 24). In an area where the membrane had been weakened by these failures, complete failure of the membrane occurred 3 ft after the beginning of the seventh skid. The area failed was 4 ft wide and 8 ft long (photo 25). Cross sections of the surface taken at 6-ft intervals and a center-line profile of the rut caused by the skidding are shown in plate 10.
- b. Run 2. Top-ply failures occurred after three repetitive skids. During the eighth skid, several second-ply failures occurred (photo 26), leaving the membrane with only half of its original strength. Complete failure of the membrane occurred during the tenth skid. The area failed was 4 ft wide and 8 ft long (photo 27). As is shown in plate 11, rutting of the subgrade was quite severe.

Photo 24. Condition of run 1 of XW18 membrane section 3 after six repetitive skids

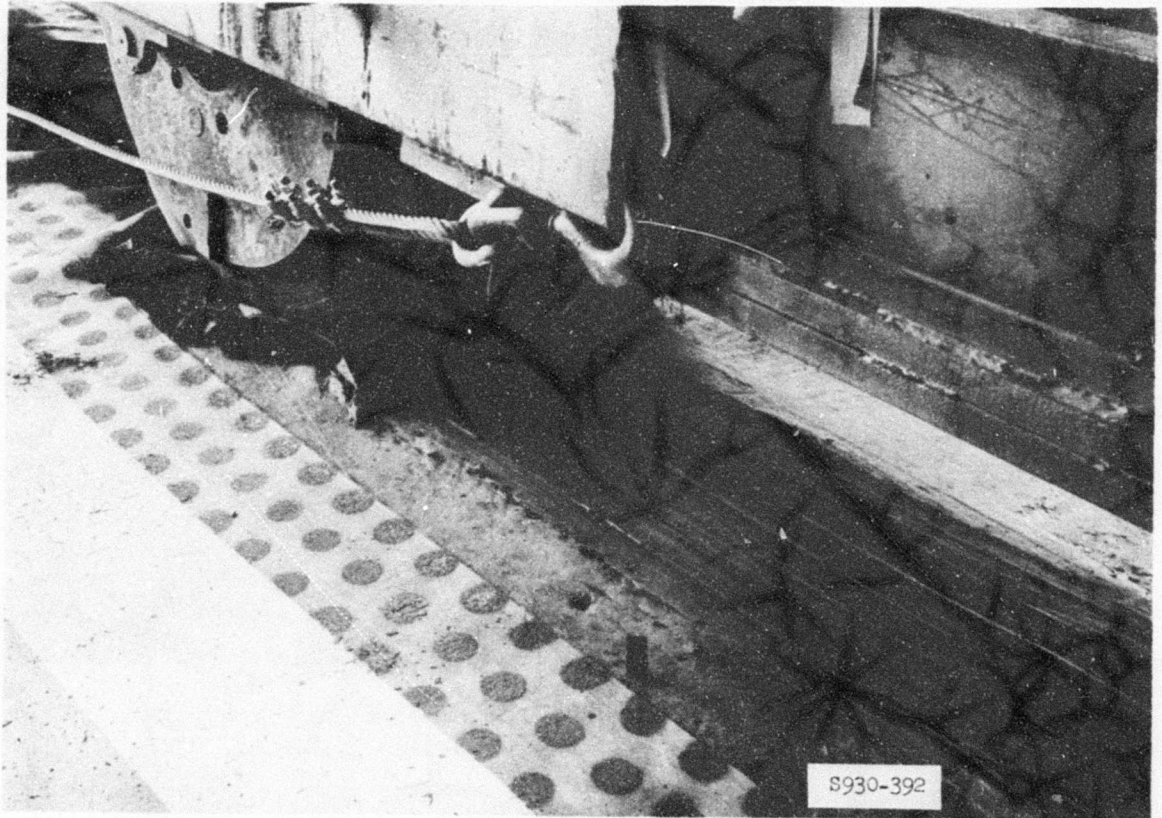
Photo 25. Failure of run 1 of XW18 membrane section 3 after seven repetitive skids

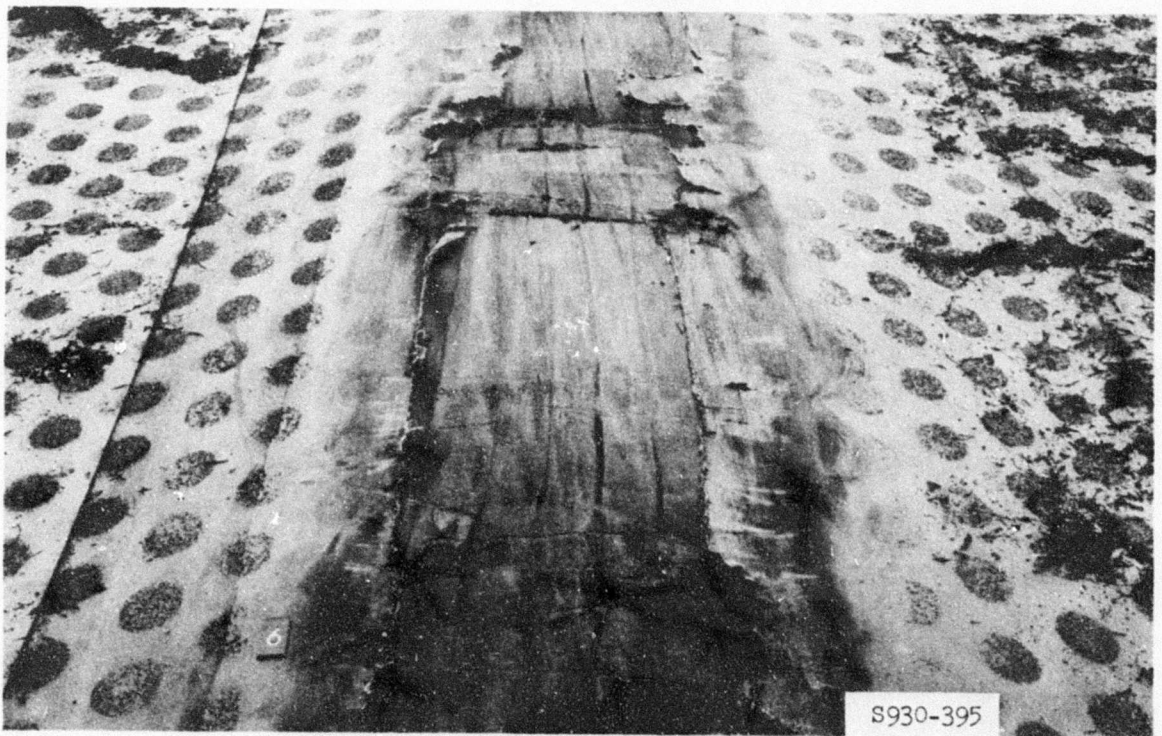
Photo 26. Second-ply fabric failures on run 2 of XW18 membrane section 3 after eighth repetitive skid

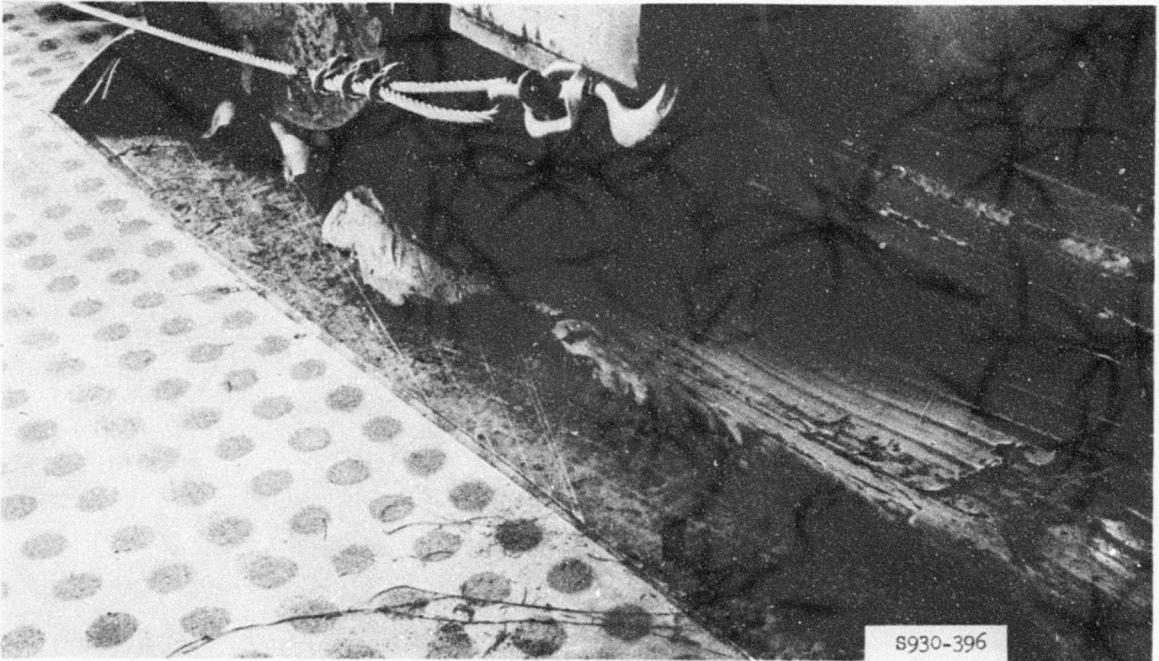
Photo 27. Failure of run 2 of XW18 membrane section 3 during tenth repetitive skid

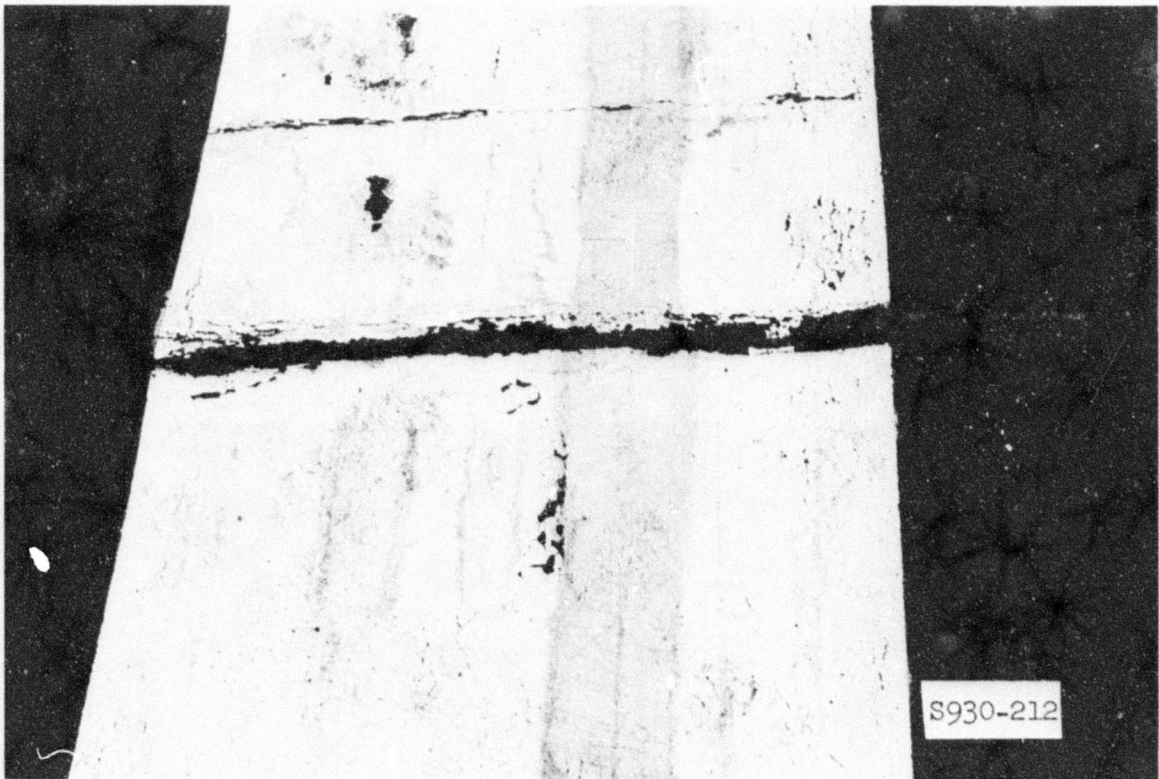
Photo 46. Heavy wear on edges of folds in surfacing caused by test wheel (100 coverages on test section 1)

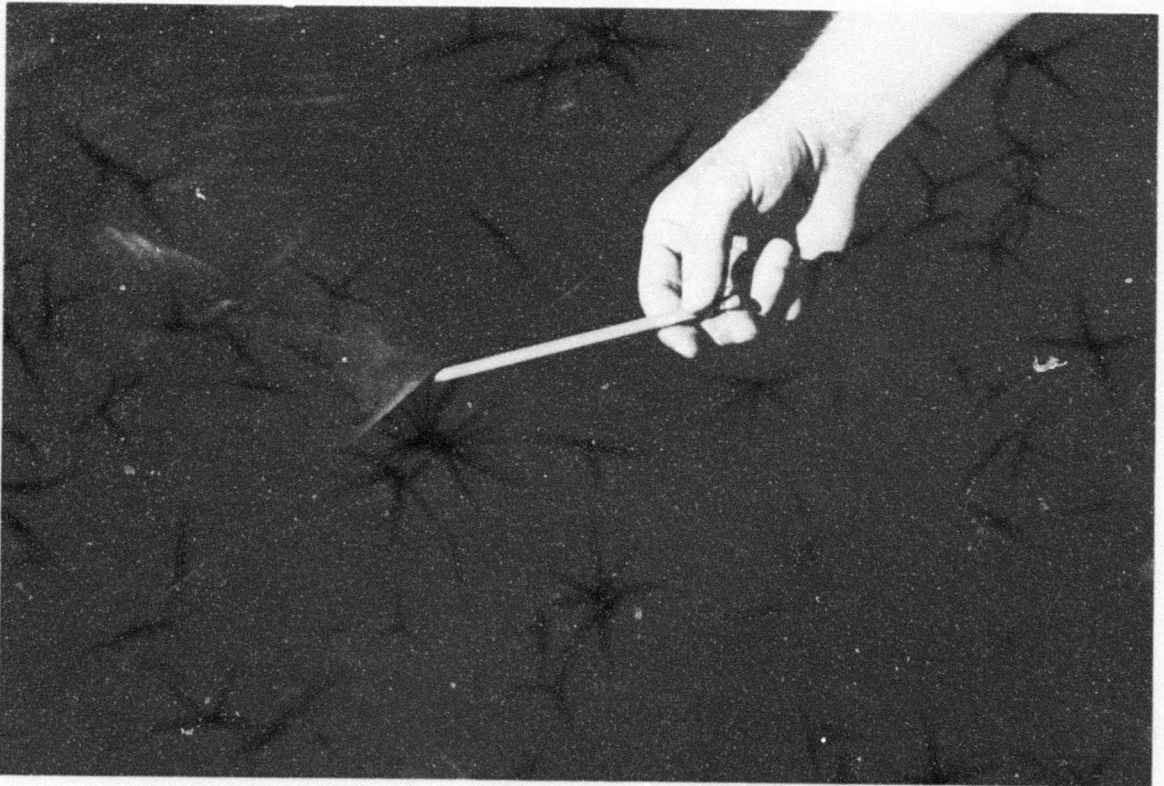
Photo 47. Edge of 3-ft-wide reinforcing strip on adhesive construction joint worked loose by test wheel (100 coverages on test section 1)

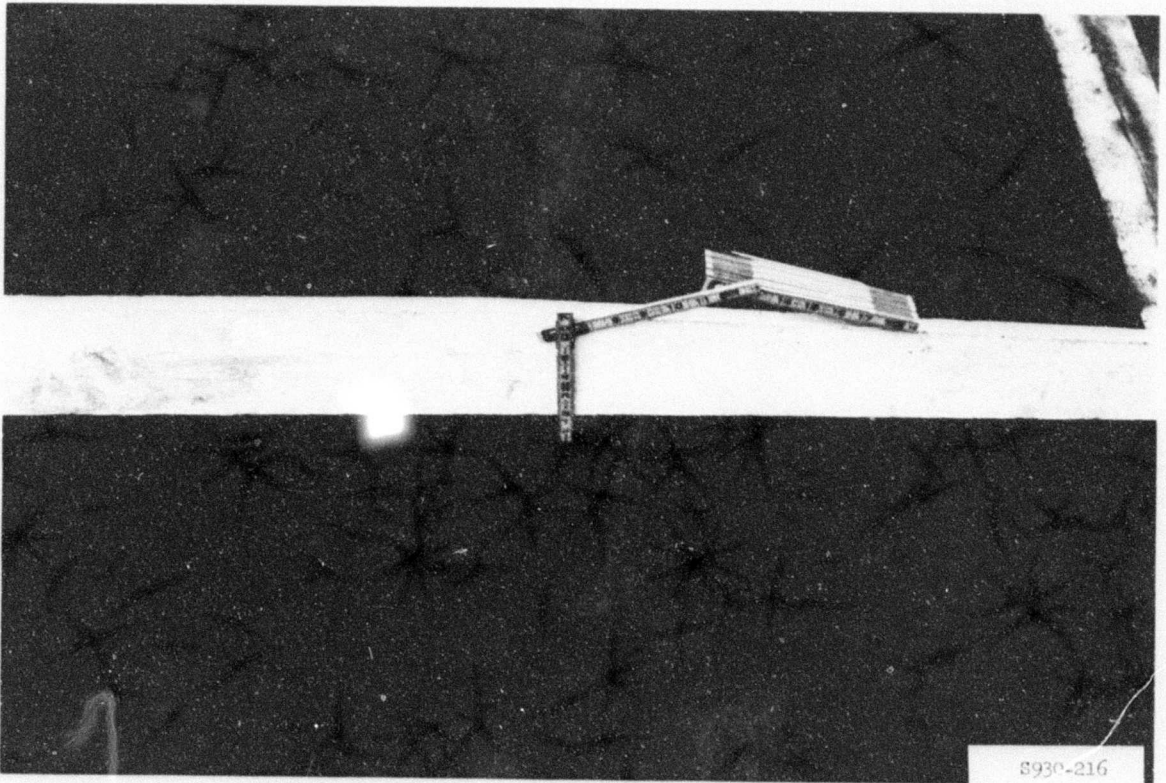
Photo 48. Two-in. rutting of subgrade after 150 coverages (test section 1, sta 0+75)

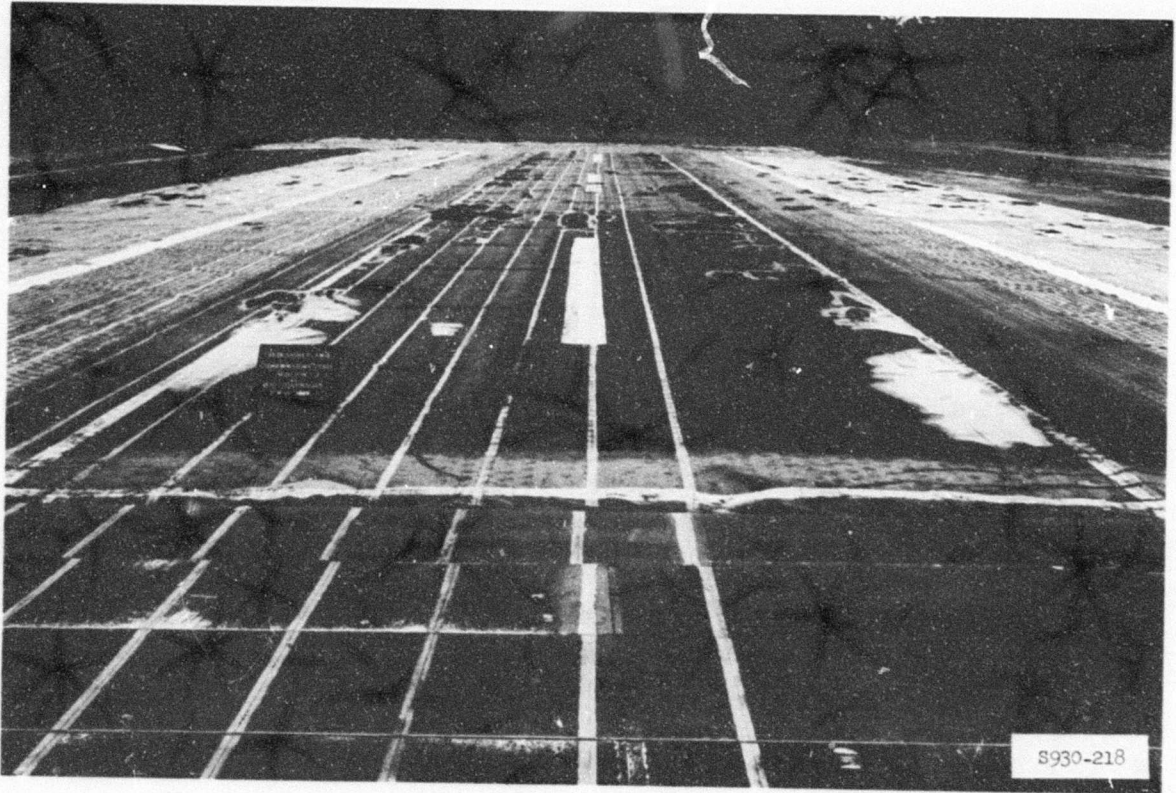
Photo 49. General condition of test section 1 after 200 coverages

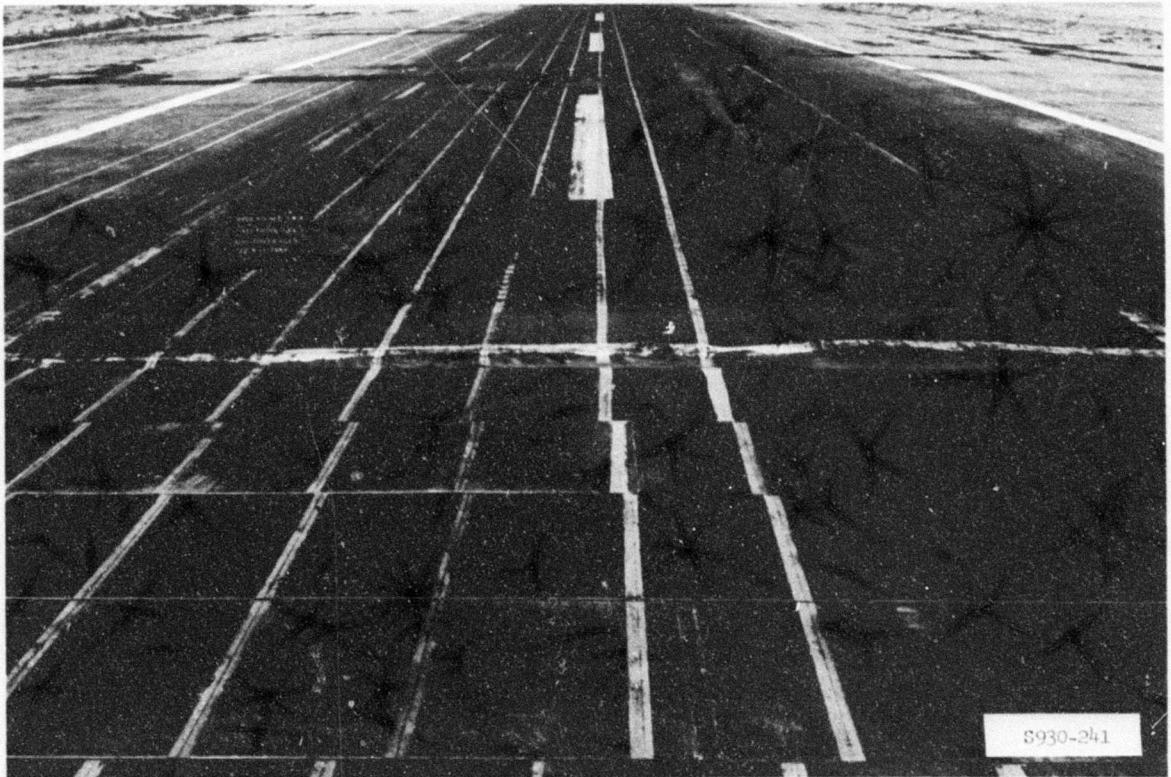
Photo 52. General condition of test section 1 after 400 coverages

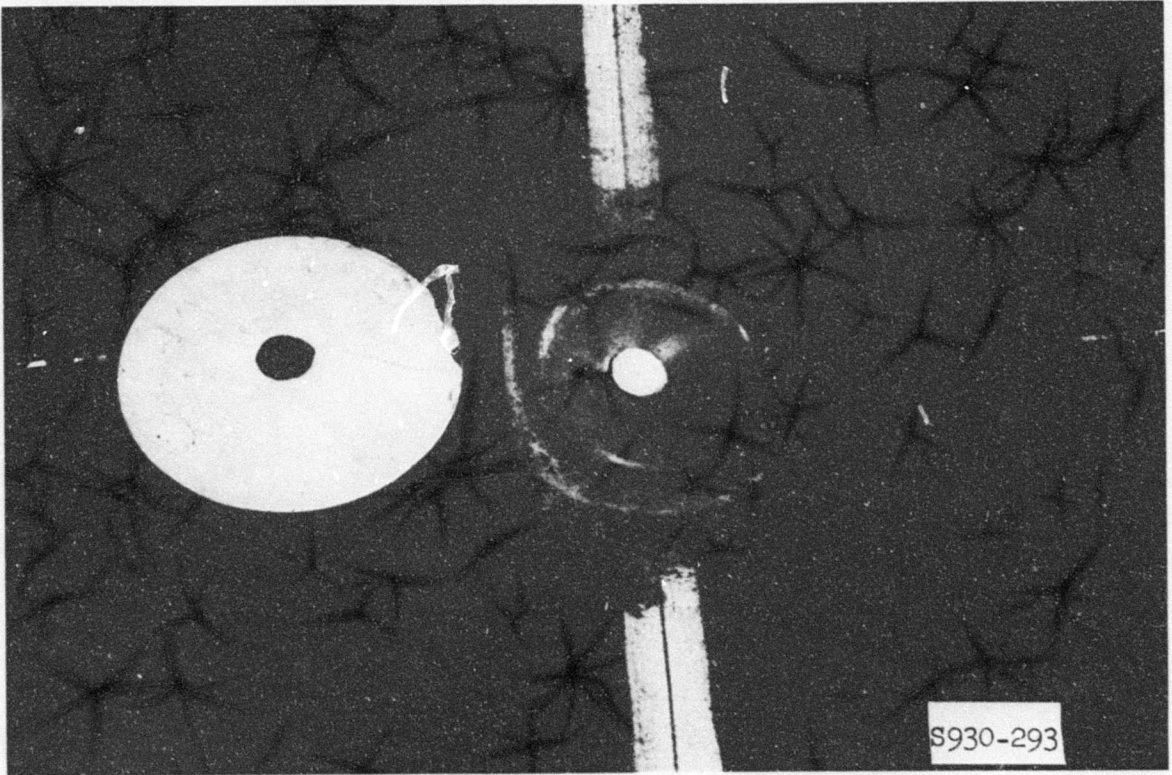
Photo 53. Failure of steel anchor at joint between sheets 2 and 3 of section 1 after 522 coverages

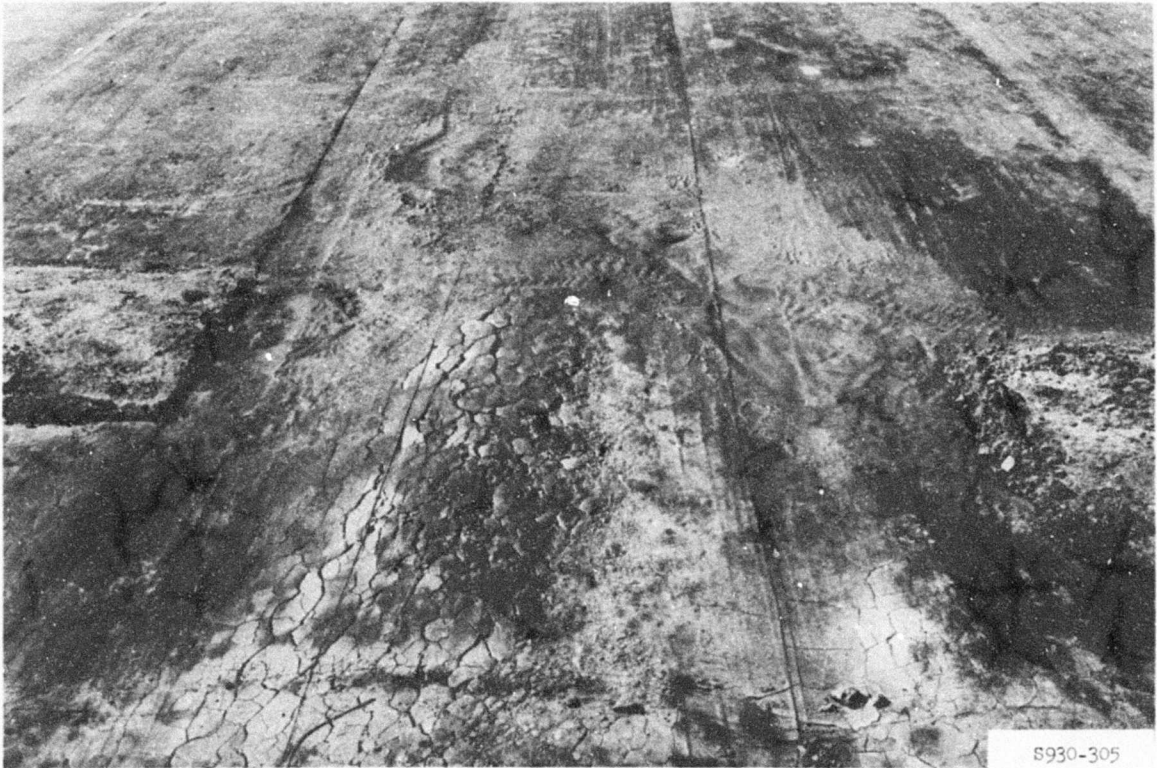
Photo 59. Condition of lean clay subgrade of test section 1, sta 1+05, after 538 coverages

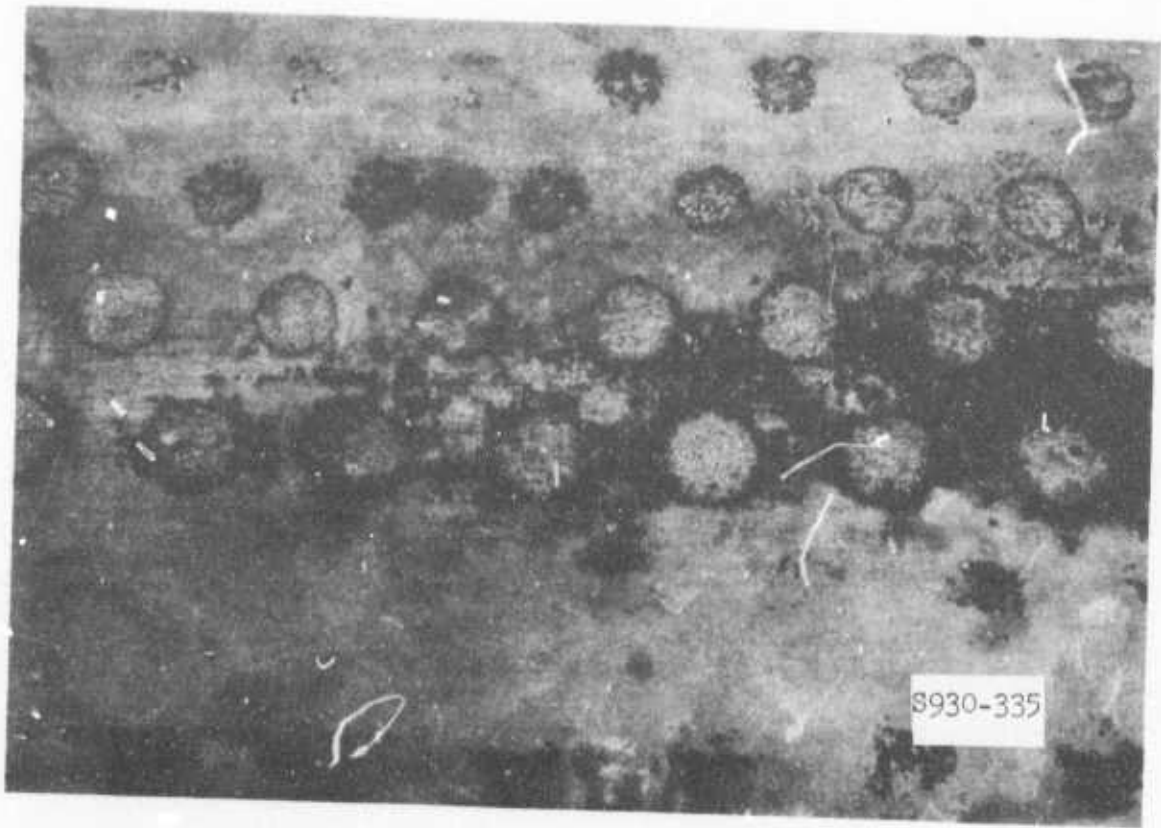
Photo 75. Severe wear of neoprene coating on sheet 1 of test section 1
(1200 coverages)

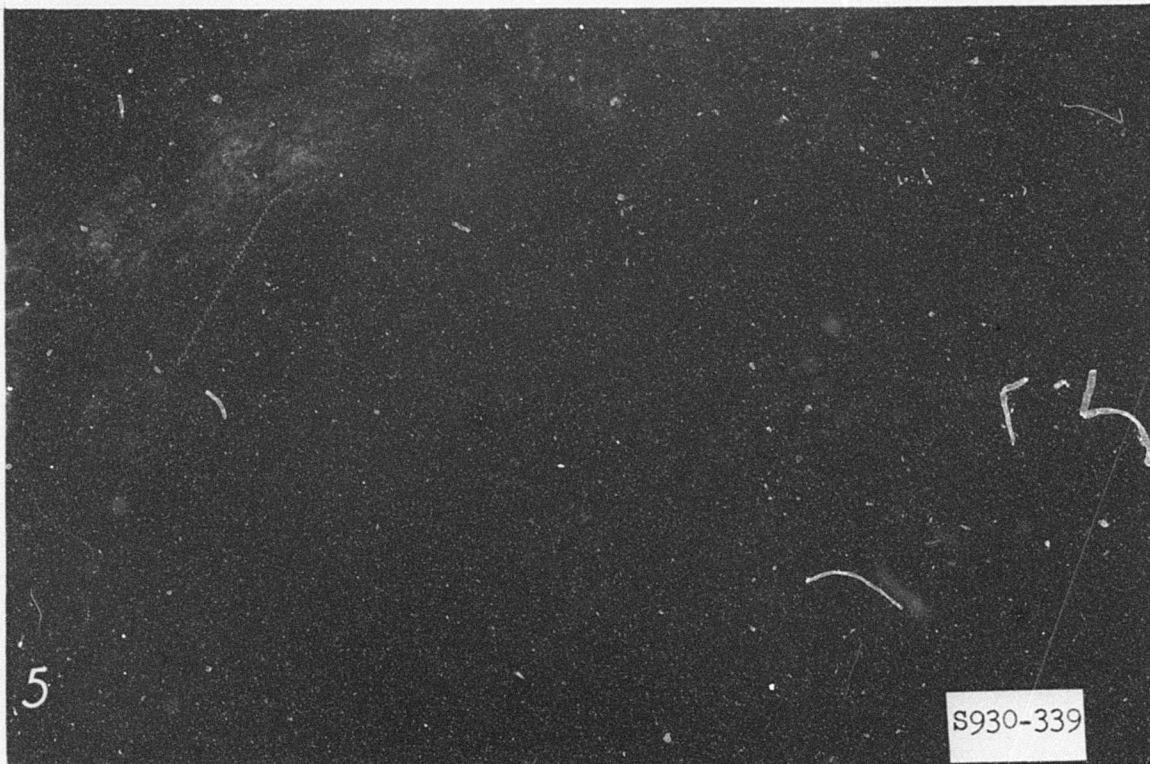
Photo 77. Typical wear on membrane sheet 3A of test section 1 after 662 coverages (1200 total coverages on test section)
