EVALUATION OF REDESIGNED XW18 MEMBRANE
AND ACCESSORIES

Army Engineer Waterways Experiment Station
Vicksburg, Mississippi

May 1973

TECHNICAL REPORT S-73-3

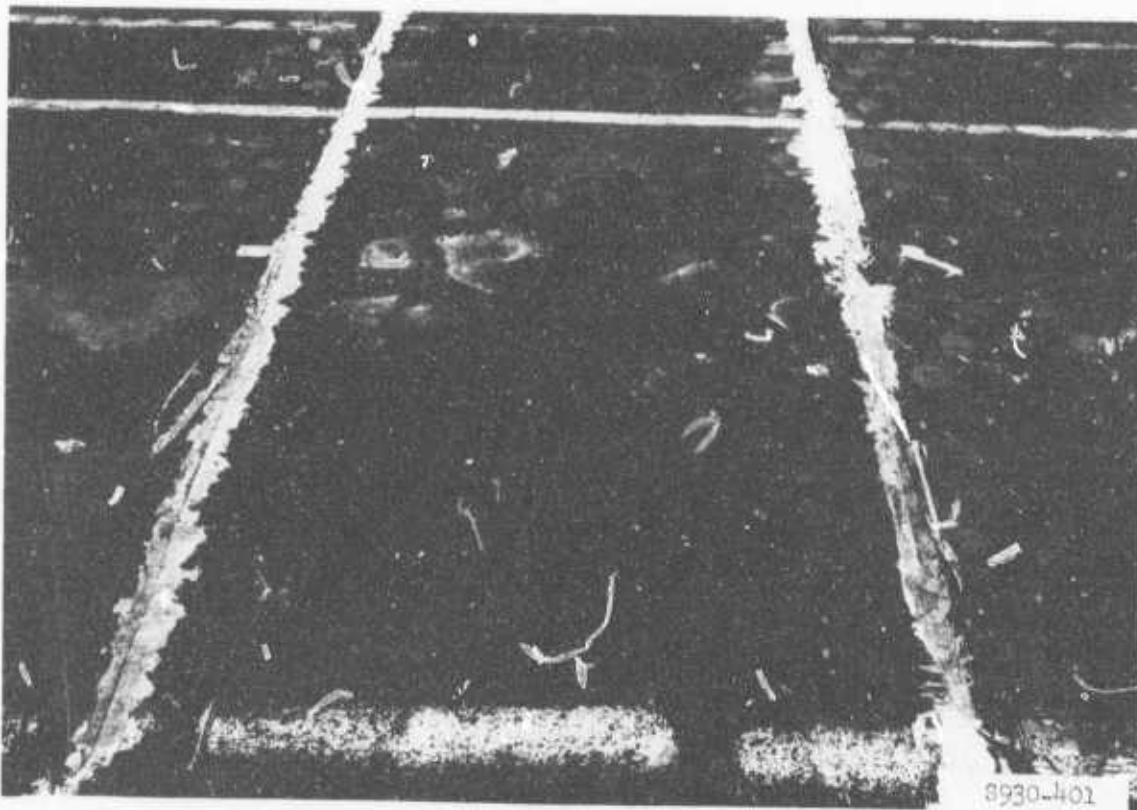
82. The 3-ft-wide cover strip on the joint between the two sheets was in good condition (photo 84). Only minor repair had been required

Photo 84. General condition of 3-ft-wide reinforcing strip after
600 coverages on test section 2
