CERAMIC MATERIALS IN ROLLING CONTACT BEARINGS

NORTON COMPANY

PREPARED FOR
NAVAL AIR SYSTEMS COMMAND

FINAL REPORT
Contract N00019-72-C-0299
January 3, 1972 to February 3, 1973

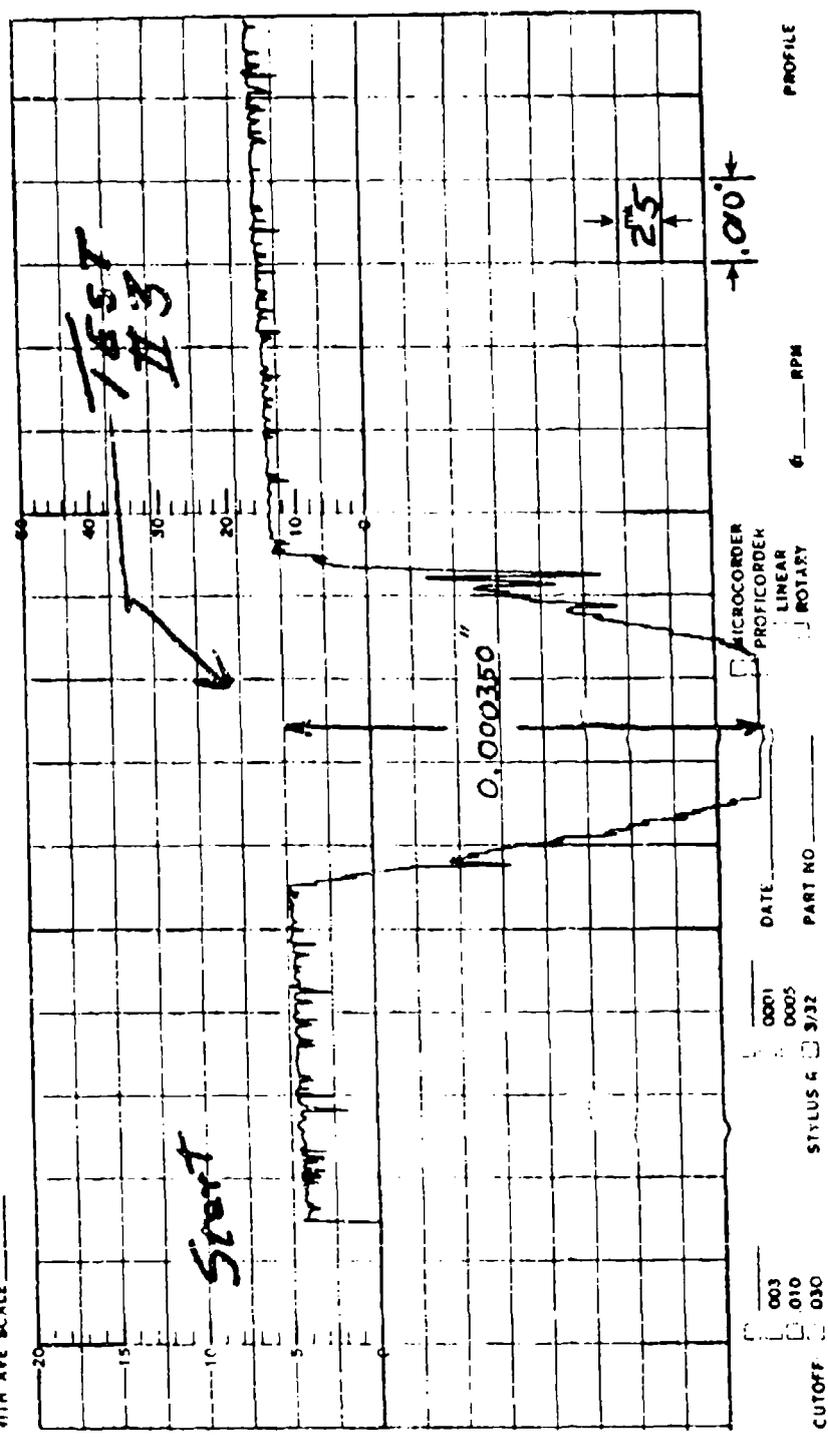
The aluminum oxide tests were generally suspended due to crushing in the ceramic contact area. Figure 5 shows a linear proficorder chart of aluminum oxide rod #1 across the contact area. Note the deep groove caused by the crushing. Compare this trace with that across an M-50 steel specimen shown in Figure 6. Because of this crushing encountered at light loads no attempts were made to run aluminum oxide at 800,000 psi Hertz stress.

FIGURE 5
Linear Proficording Across Test Track on AD999 Aluminum Oxide Bar #1

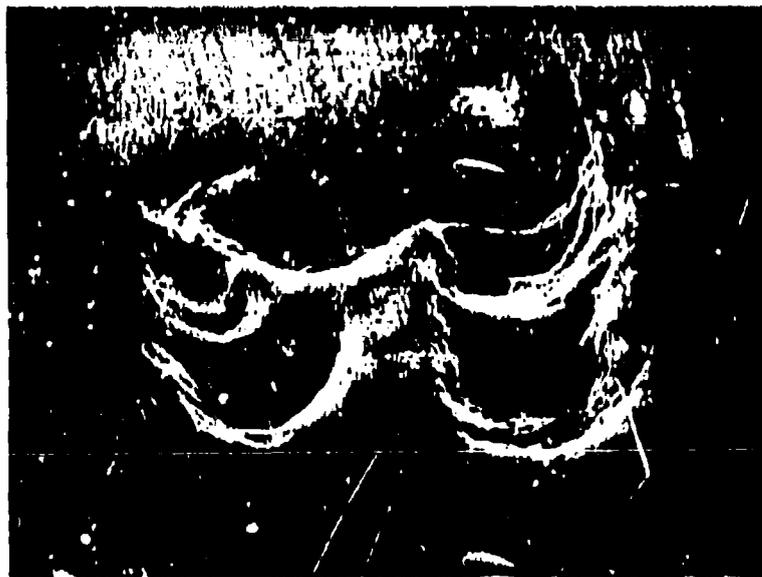
FIGURE 23 Wear spall on Rod FM-1. 75X SEM

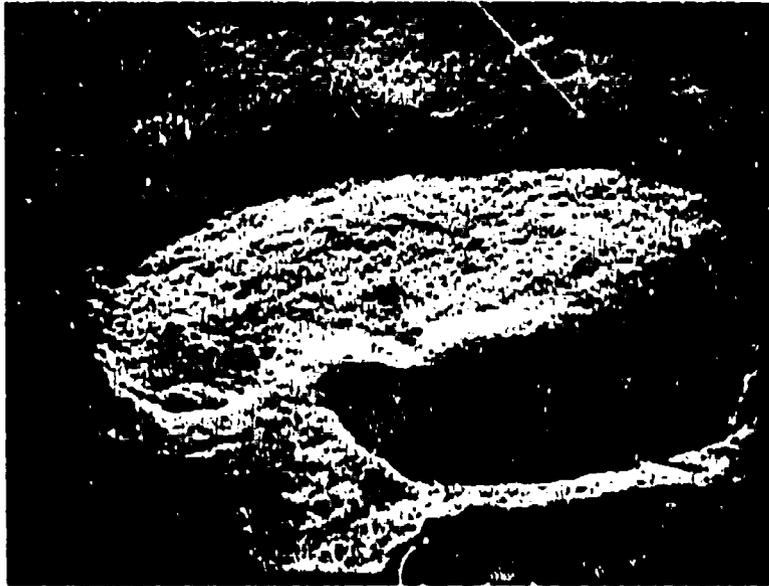
The first mode is shown in Figure 24. The dimpled region just below the center of the photograph was found to possess an inclusion rich in Mg and Al as determined by the electron probe. It is maintained that the crack of the spall was initiated at the inclusion as a result of a stress concentration there. Inclusions of similar composition have been found in other studies of HS-110 silicon nitride material. The apparent point of fracture initiation of the spall surfaces were often examined with the electron

FIGURE 24 Wear spall on rod FM-3. 200X SEM
Failure believed to have been initiated from
inclusion just below center.

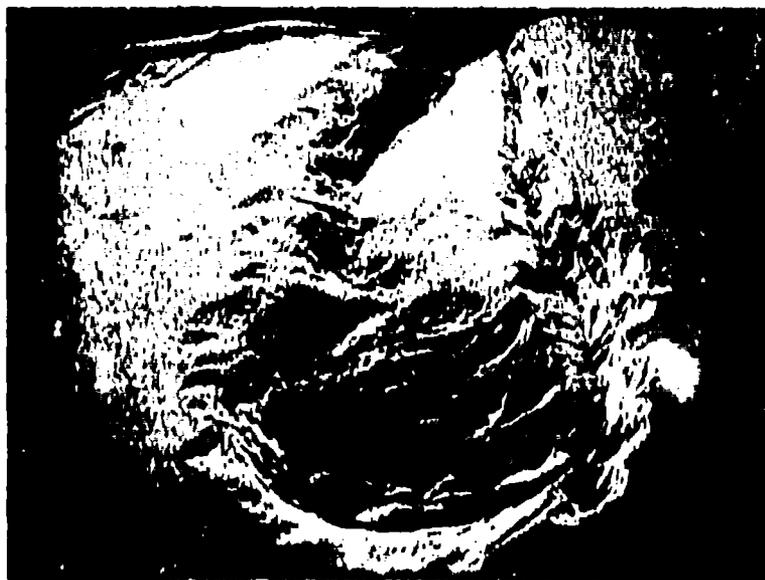
FIGURE 26 Wear spall on Rod #8. 100X SEM
Failure believed to have been initiated
from boundary crack.

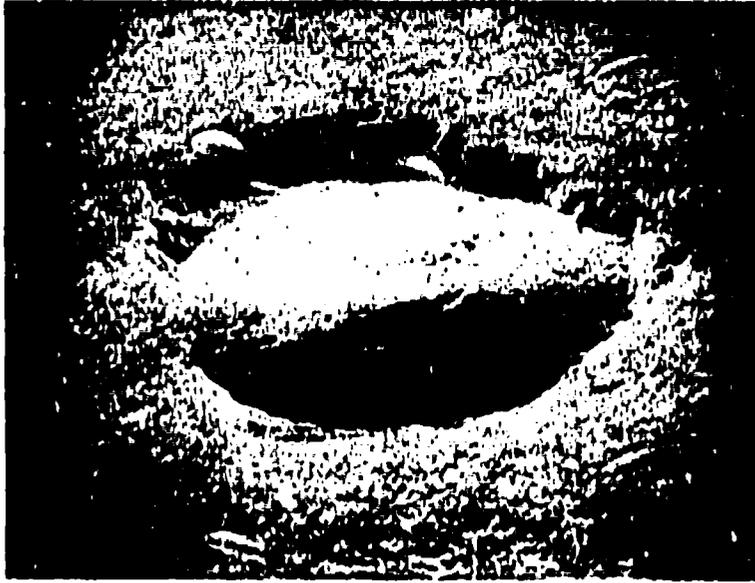
FIGURE 28 Wear spall on Rod #13. 150X SEM
Note presence of large pits in the
load track.

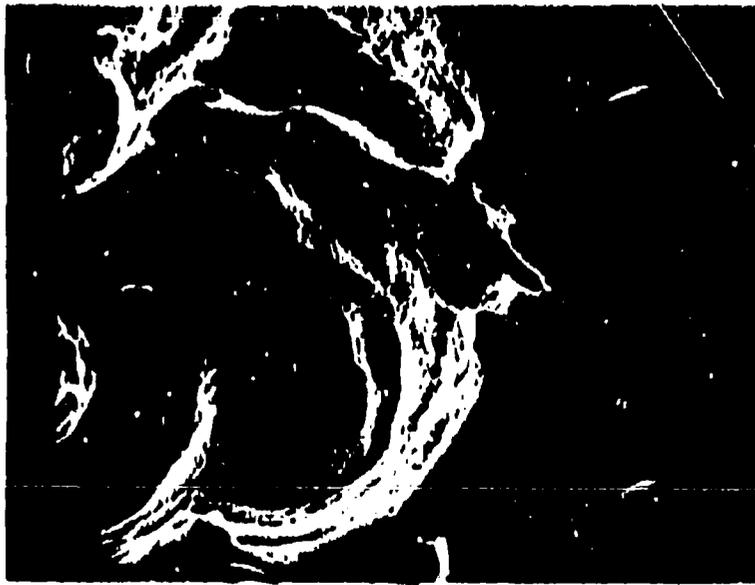
FIGURE 29 Higher magnification of RBS portion of
spall in Figure 25 showing structure
of boundary cracks. 200X SEM
