EVALUATION OF STRUCTURAL LAYERS IN FLEXIBLE  
PAVEMENT

ARMY ENGINEER WATERWAYS EXPERIMENT STATION

MISCELLANEOUS PAPER S-73-26

May 1973

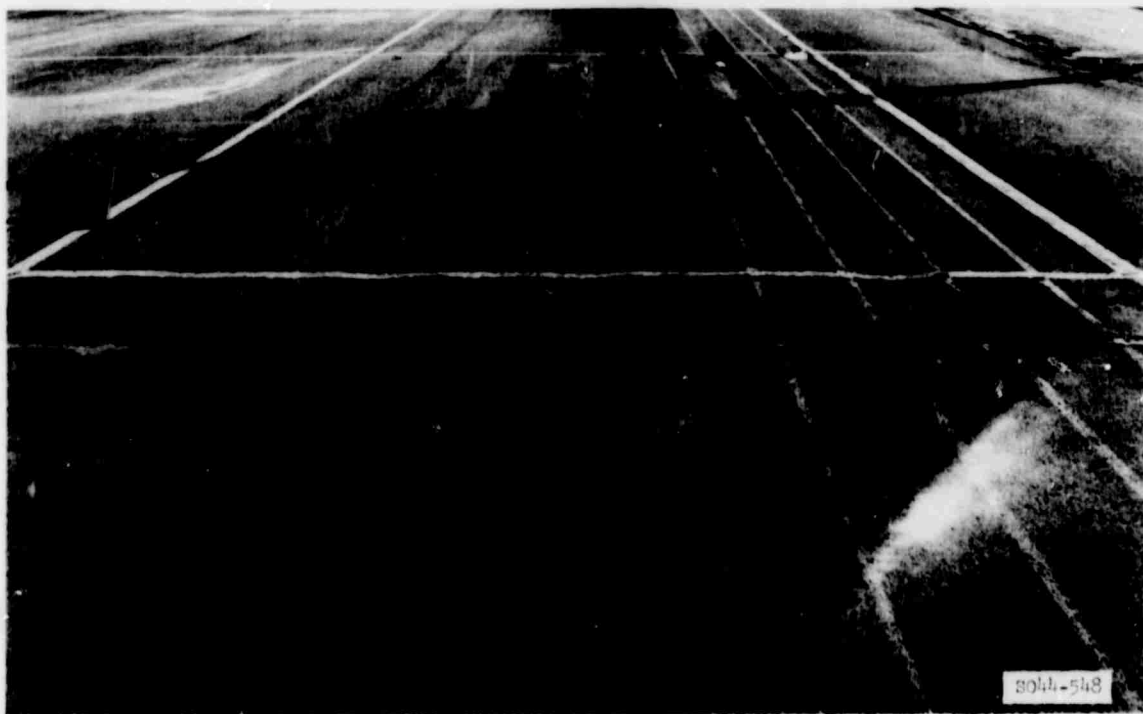
Photo B2. General view of item 1, lane 1, at failure (after 198 coverages of 360-kip, 12-wheel assembly)

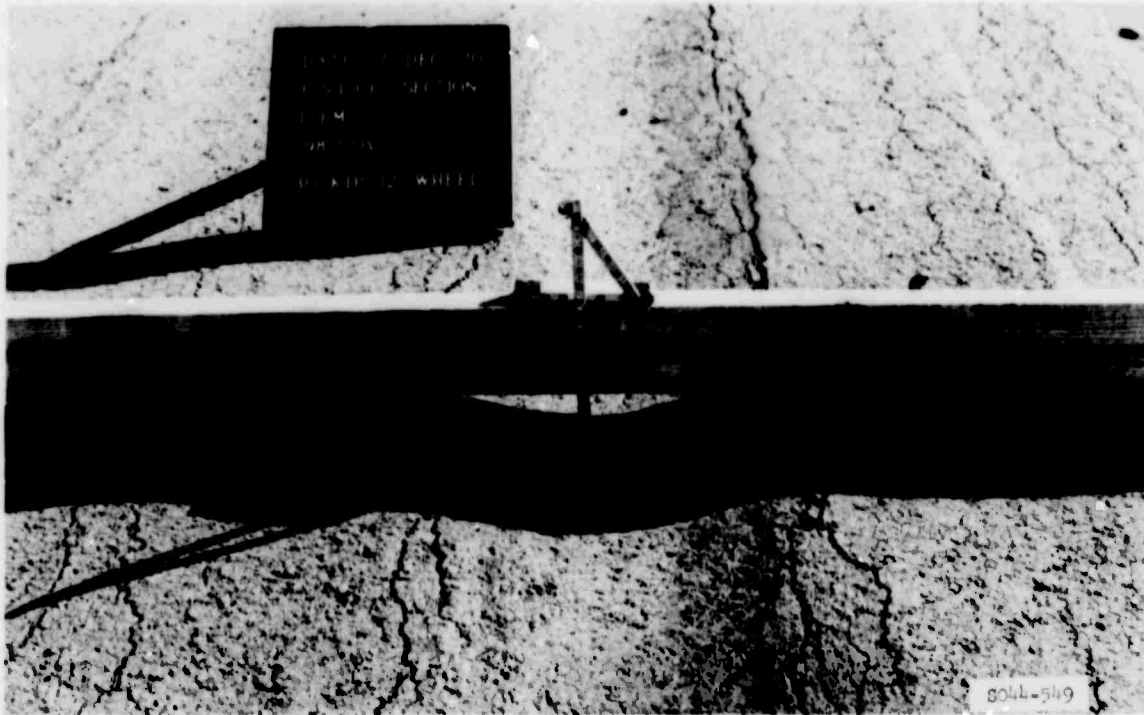
Photo B3. View of the severe cracking in item 1, lane 1, at failure

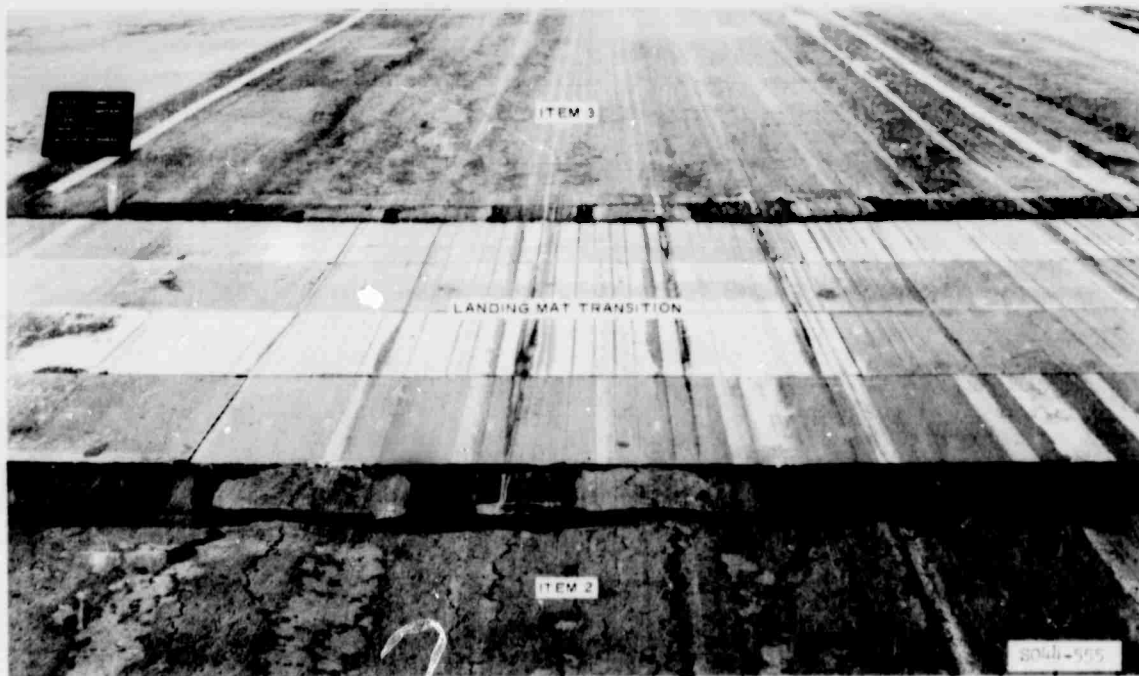
Photo B8. General view of item 3, lane 1, after 1509 coverages of 360-kip, 12-wheel assembly. Note cracks in item 2 in foreground

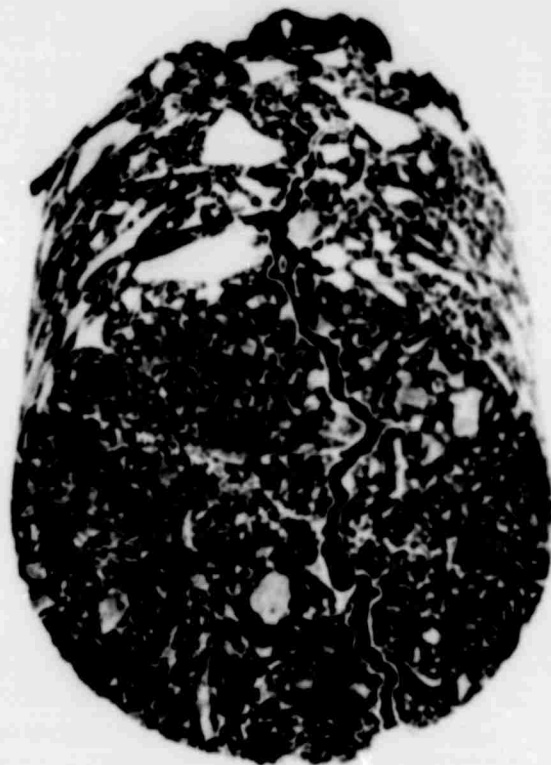
Photo B10. One-in.-deep crack in core from 100 percent coverage zone of item 3, lane 1 (after 2744 coverages of 360-kip, 12-wheel assembly)

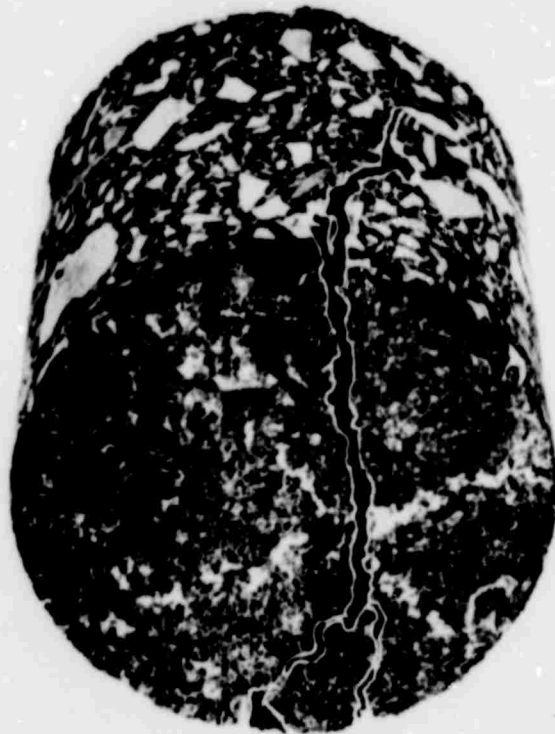
Photo B11. Core taken at construction joint in item 3, lane 1 (after 27 $\frac{1}{4}$  coverages of 360-kip, 12-wheel assembly). Crack depth about 1- $\frac{3}{4}$  in.

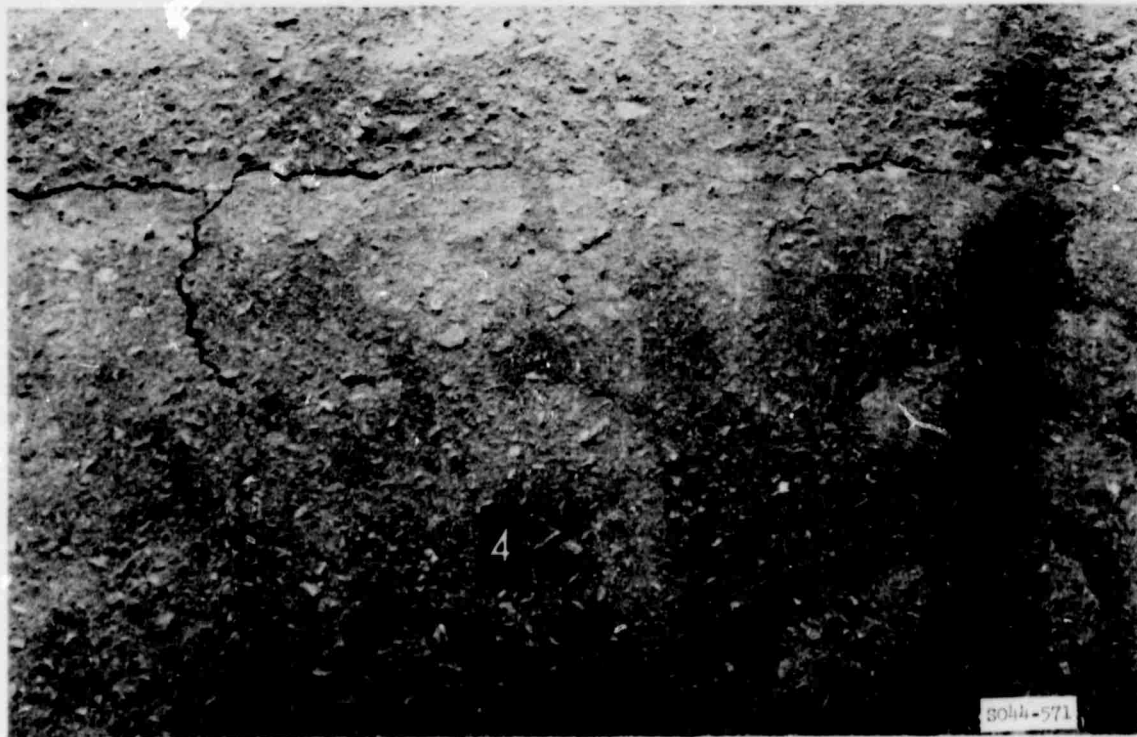
Photo B14. Small cracks extending from construction-joint crack in item 4, lane 1, after 10,406 coverages of 360-kip, 12-wheel assembly

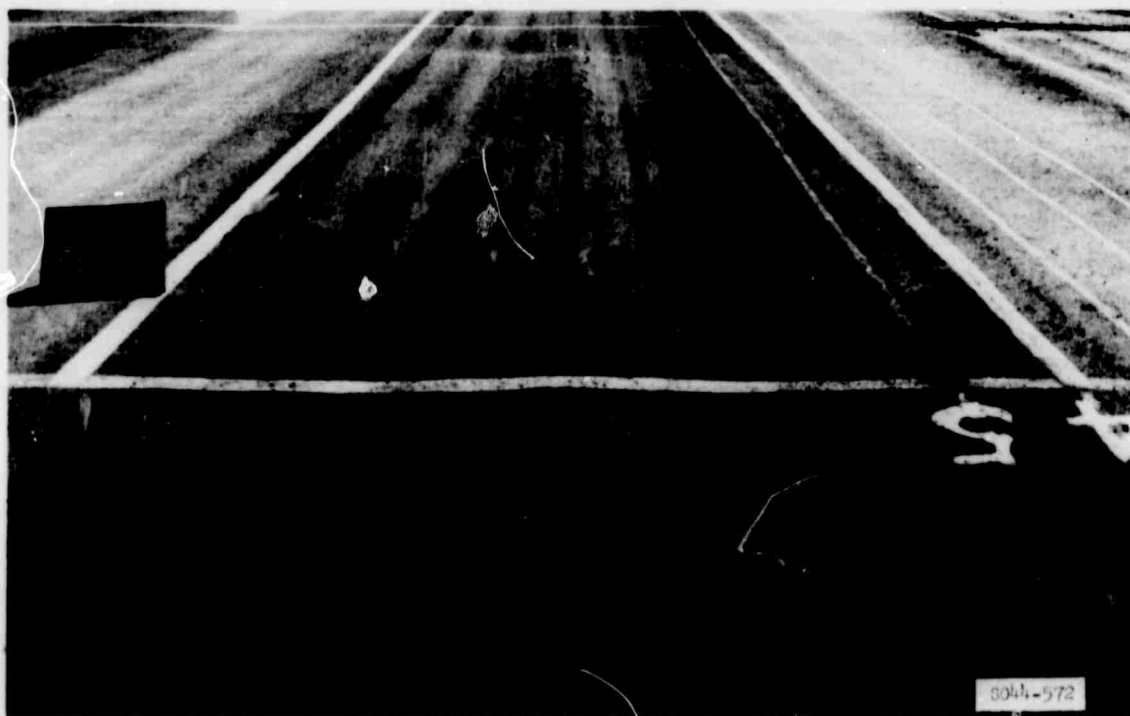
Photo B16. General view of item 1, lane 2, at failure (after 140 coverages of 160-kip, twin-tandem assembly)

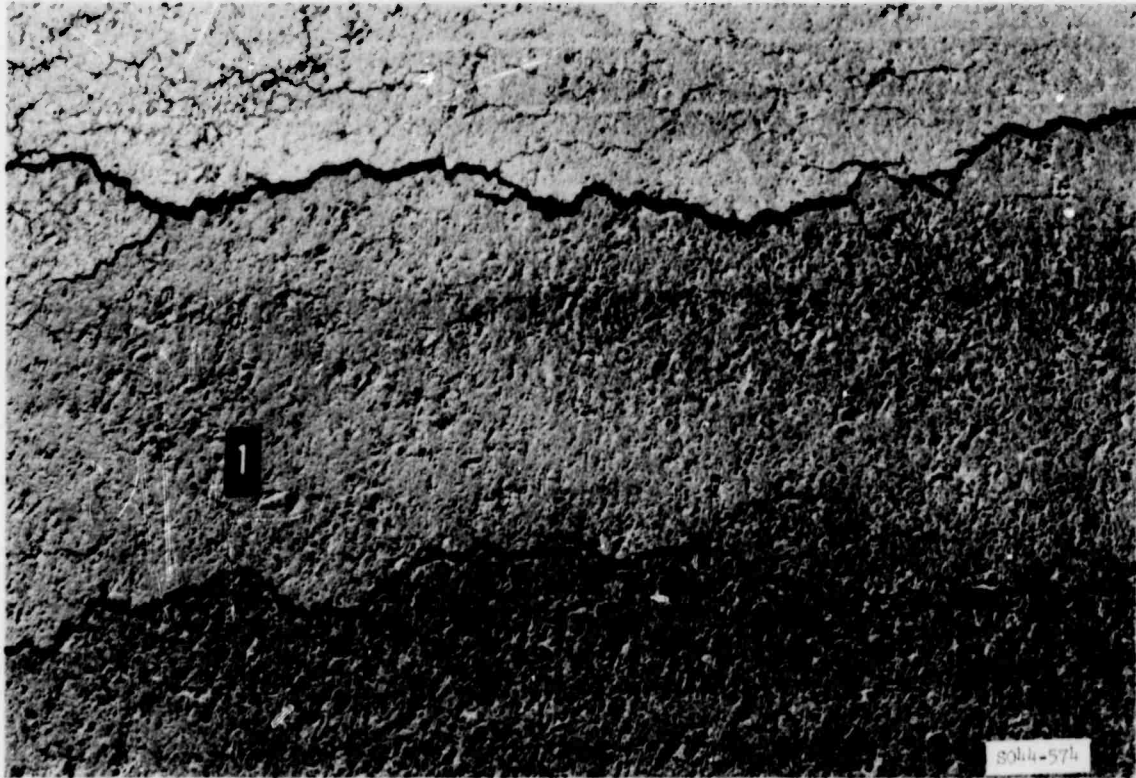
Photo B17. Close-up of cracks in 100 percent coverage zone in item 1, lane 2, at failure (after 140 coverages of 160-kip, twin-tandem assembly)

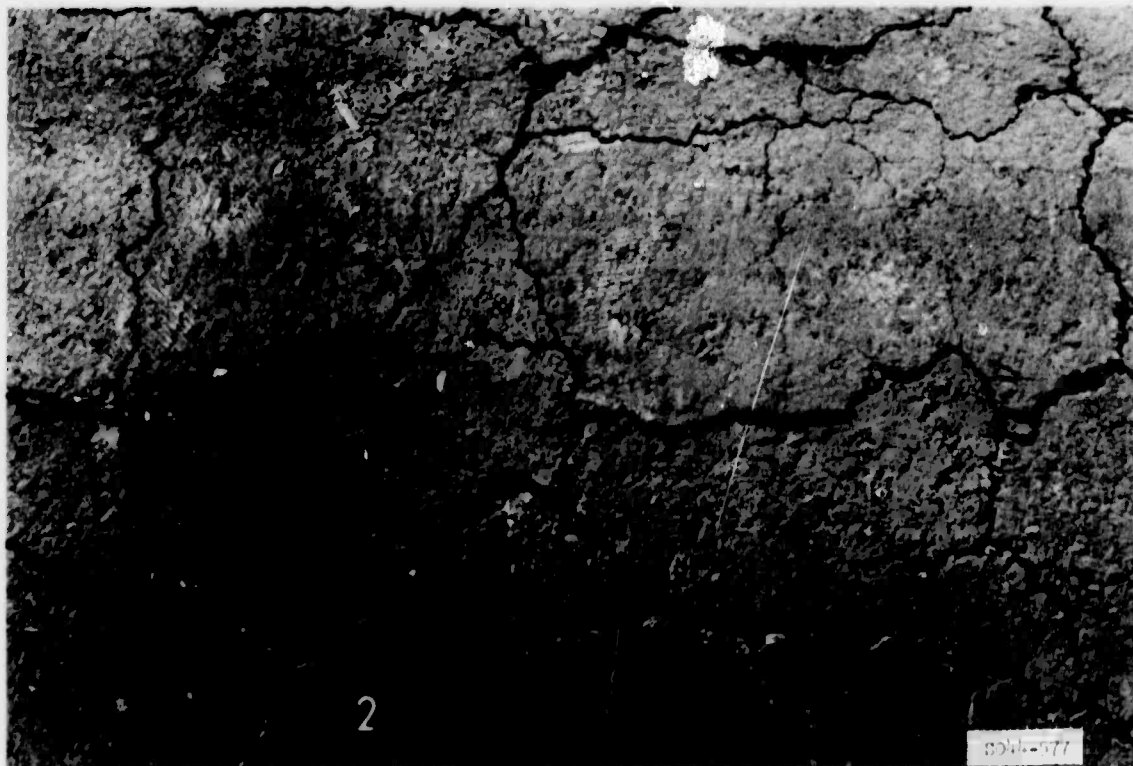
Photo B19. 1/4-in.-wide alligator-type cracking in 100 percent coverage zone of item 2, lane 2, at failure (after 1000 coverages of 160-kip, twin-tandem assembly)

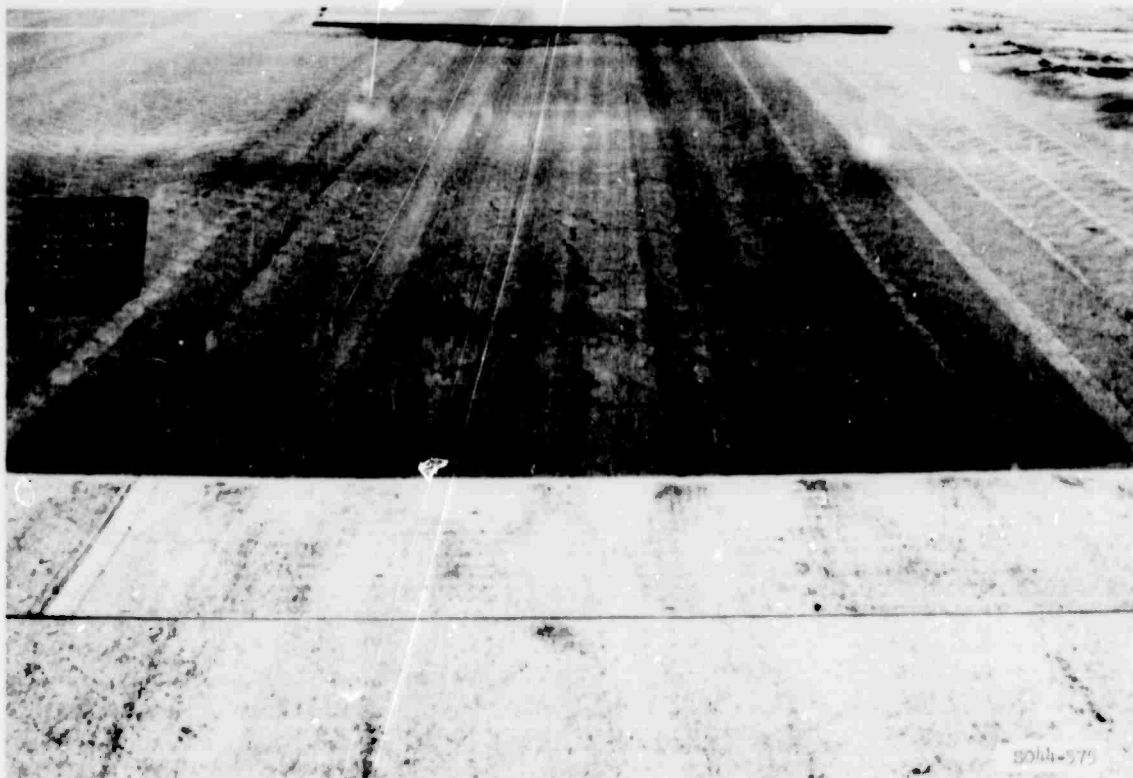
Photo B20. General view of item 2, lane 2, at failure (after 1000 coverages of 160-kip, twin-tandem assembly)

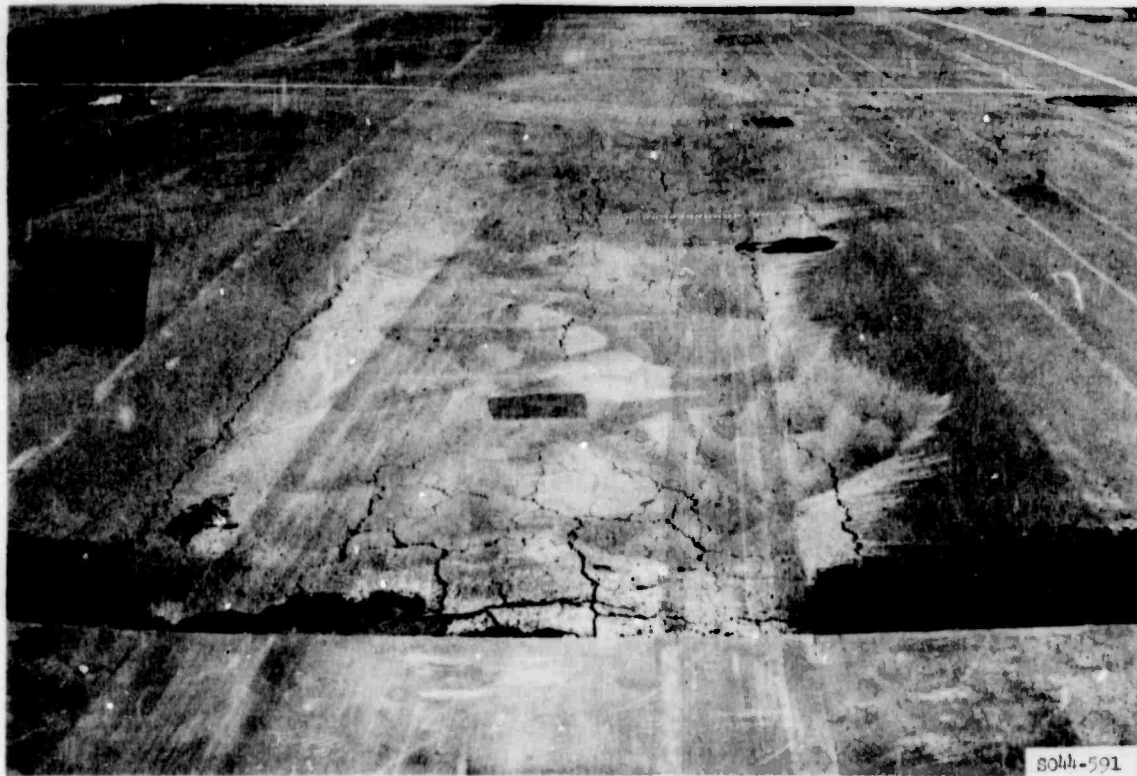
Photo B24. General view of item 3, lane 2, at failure (after 890 coverages of 200-kip, twin-tandem assembly)

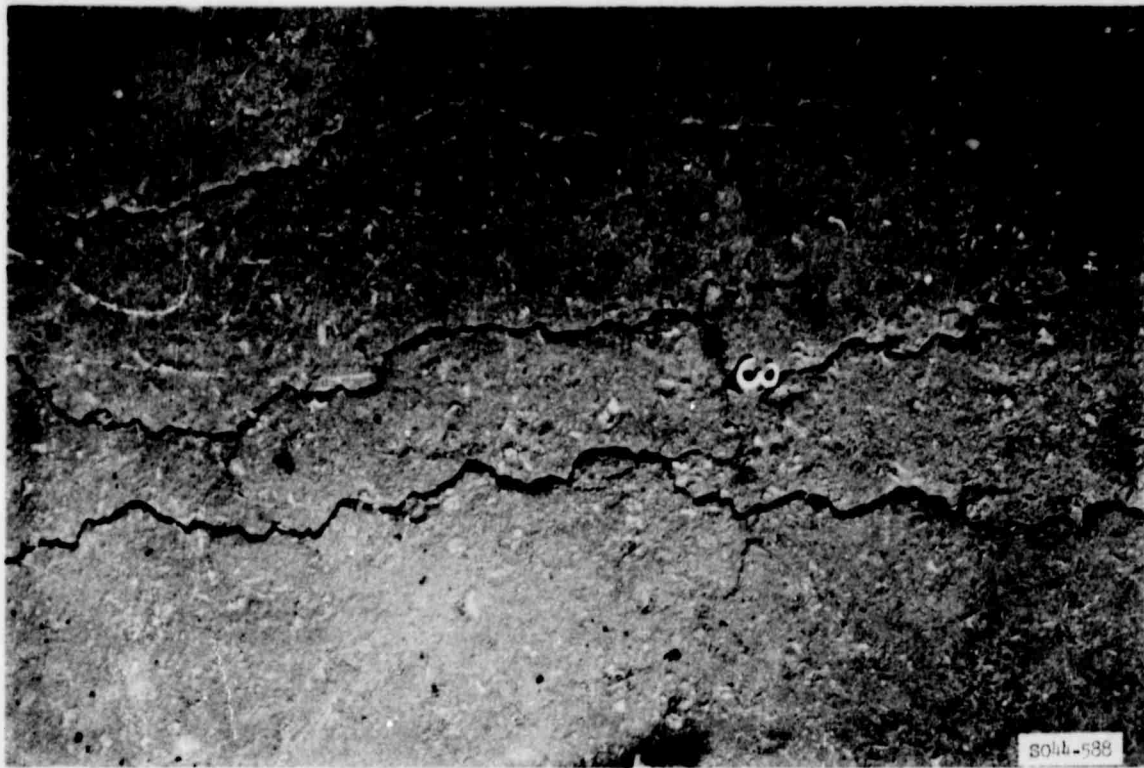
Photo B25. Close-up of cracks in 100 percent coverage zone in item 3, lane 2, at failure

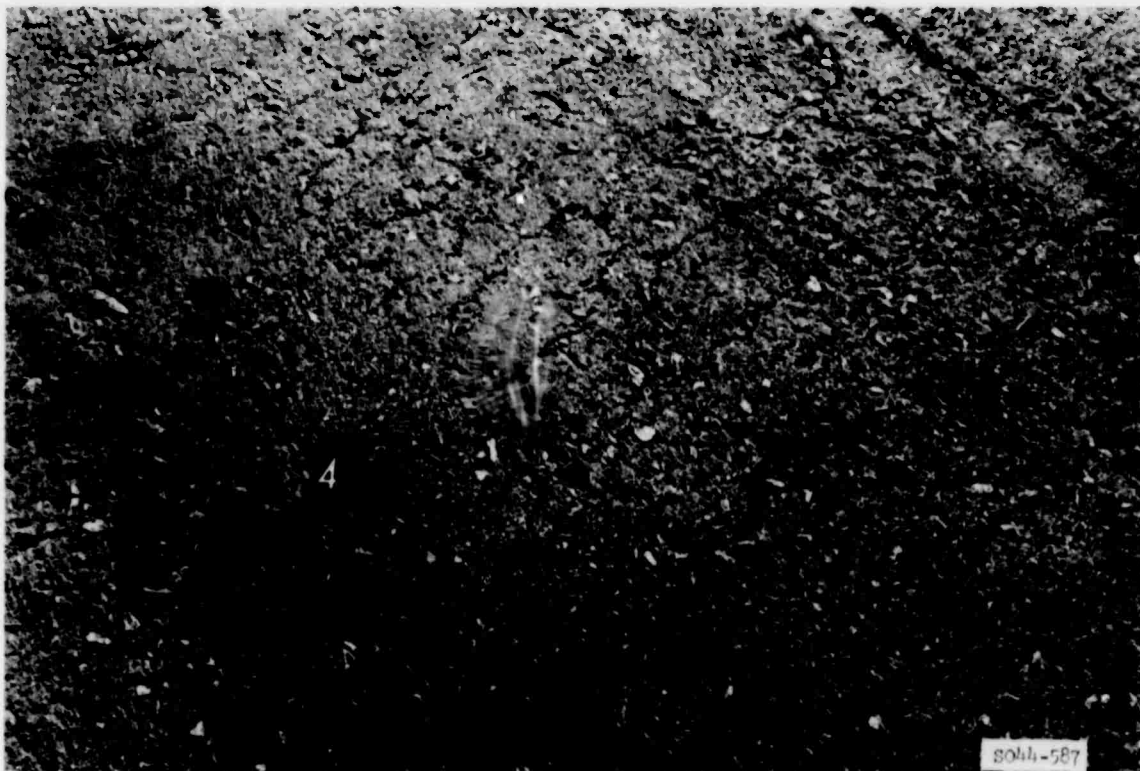
Photo B26. Small hairline cracks transverse to direction of traffic in item 4, lane 2, after 560 coverages of 200-kip, twin-tandem assembly

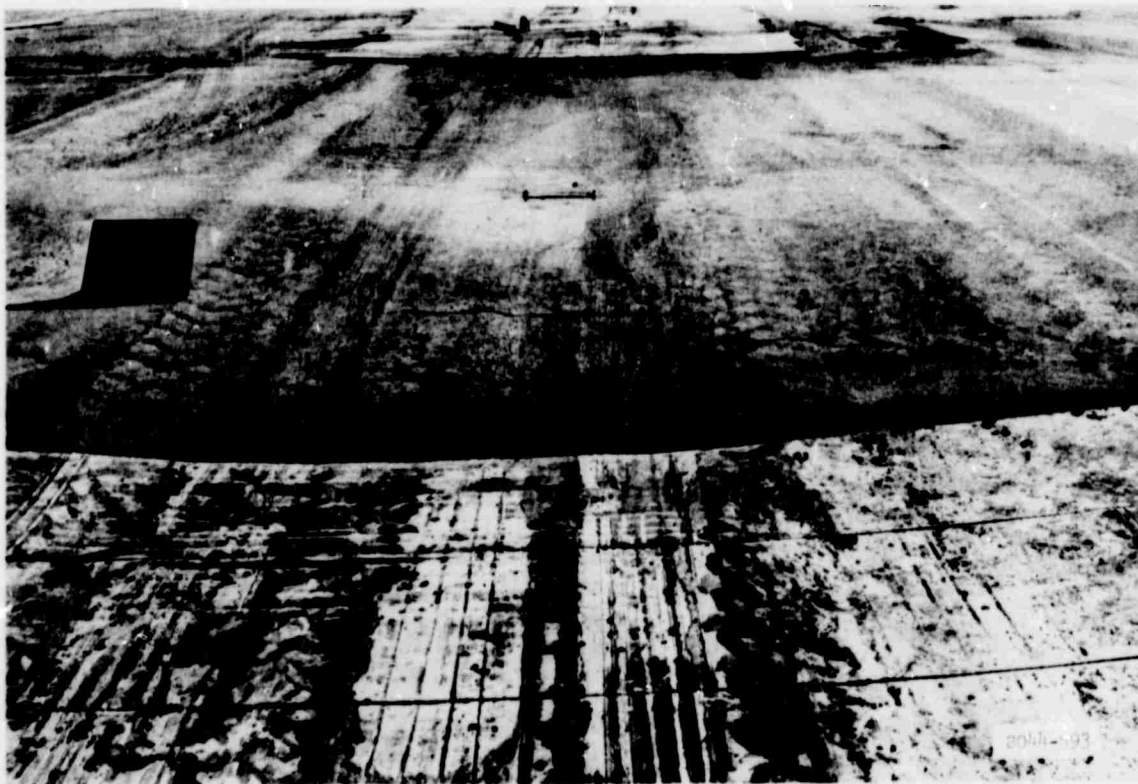
Photo B27. General view of item 4, lane 2, at failure (after 1810 coverages of 200-kip, twin-tandem assembly)

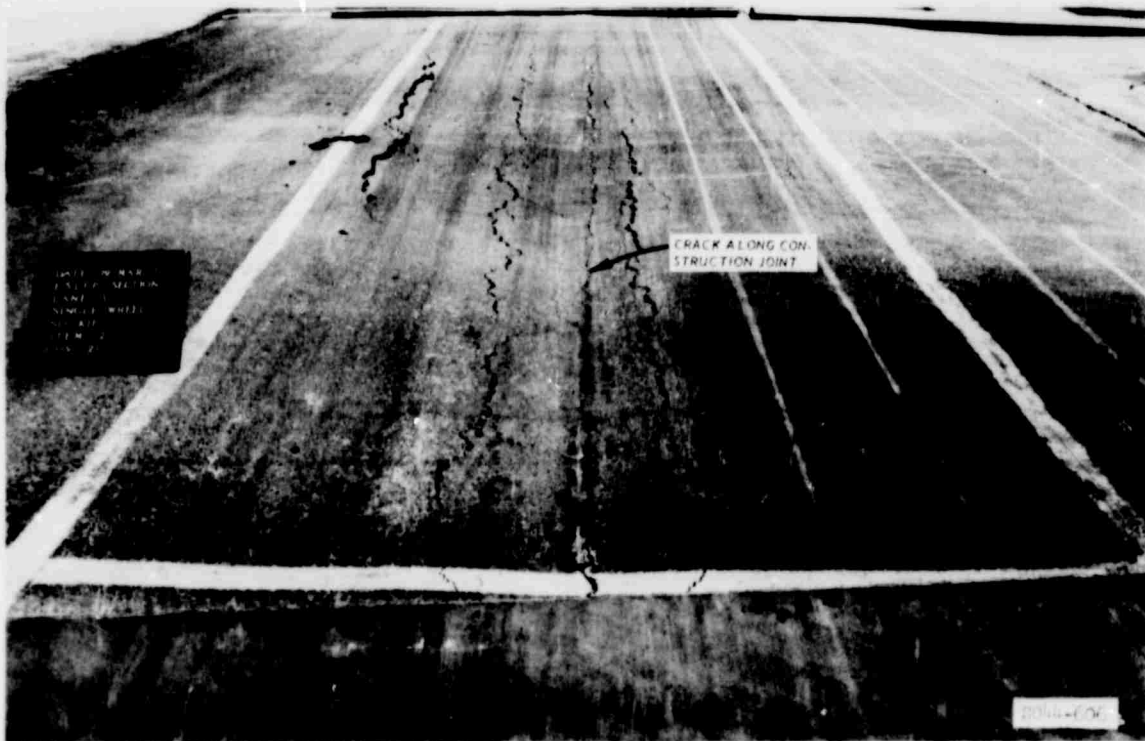
Photo B32. General view of item 2, lane 3, after 120 coverages  
of 50-kip, single-wheel assembly

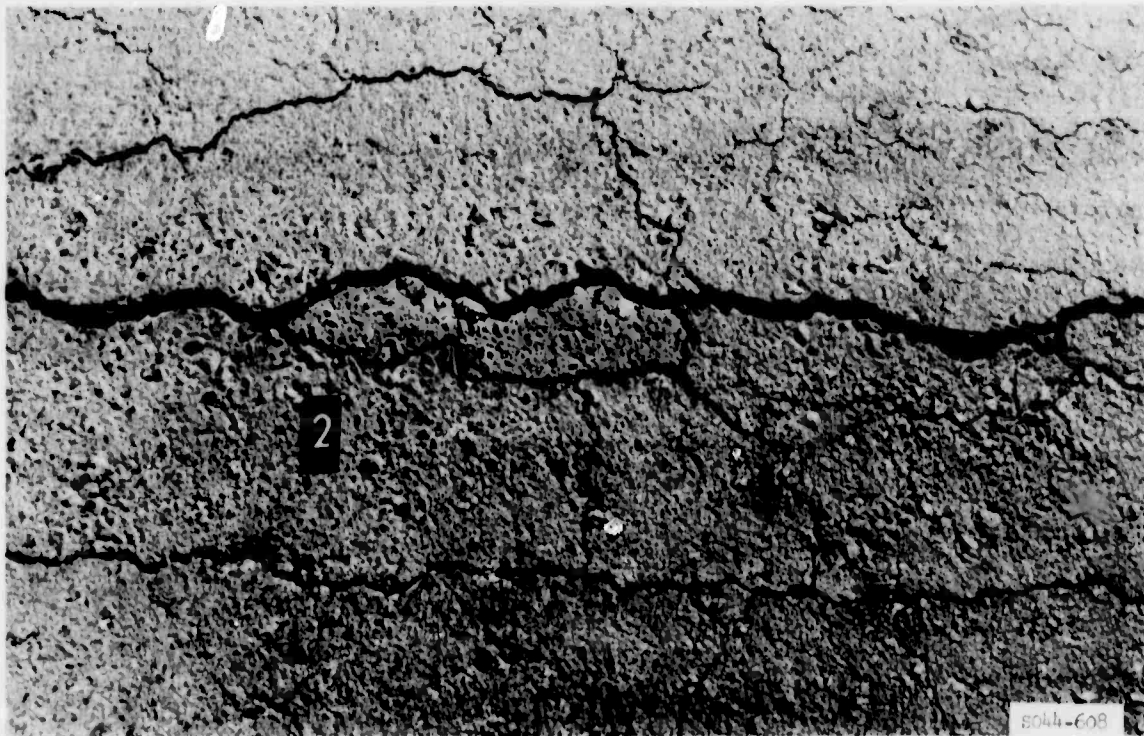
Photo B33. Close-up of severely cracked pavement in 100 percent coverage zone of item 2, lane 2, after 120 coverages of 50-kip, single-wheel assembly

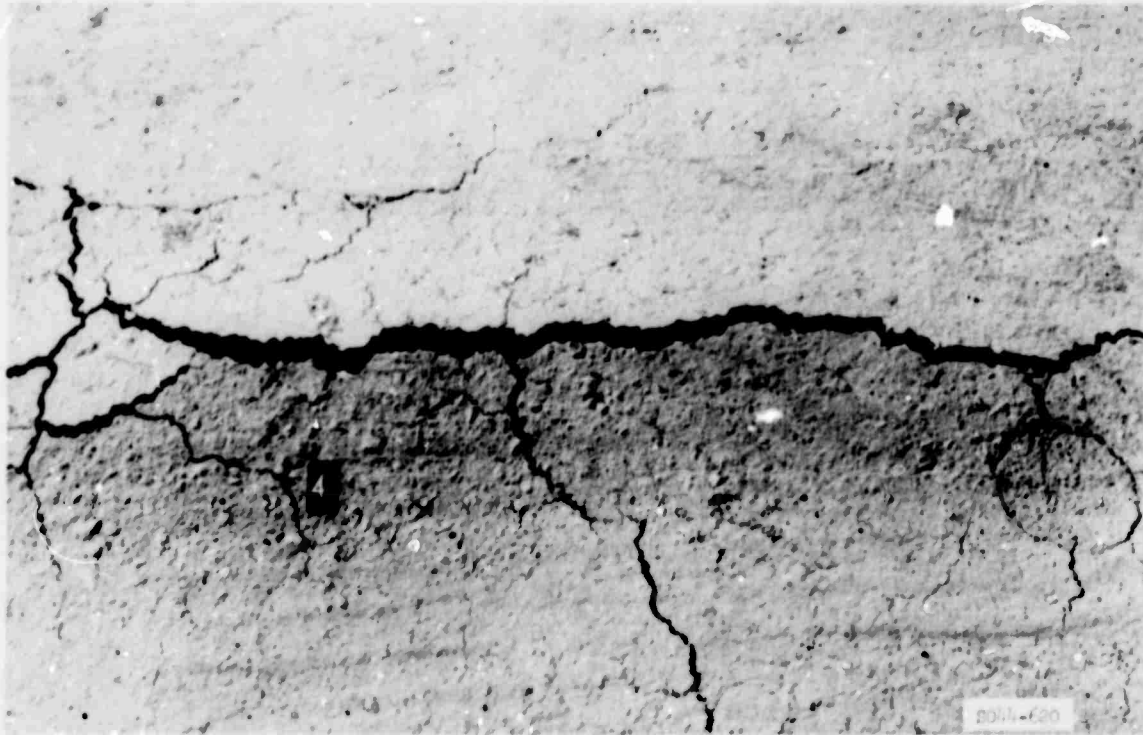
Photo B39. Severe cracking in the 100 percent coverage zone of item 4 at failure (after mixed traffic)
