STRENGTHENING OF KEYED LONGITUDINAL CONSTRUCTION
JOINTS IN RIGID PAVEMENTS

ARMY ENGINEER WATERWAYS EXPERIMENT STATION

Report No. FAA-RD-72-106

AUGUST 1972
FINAL REPORT

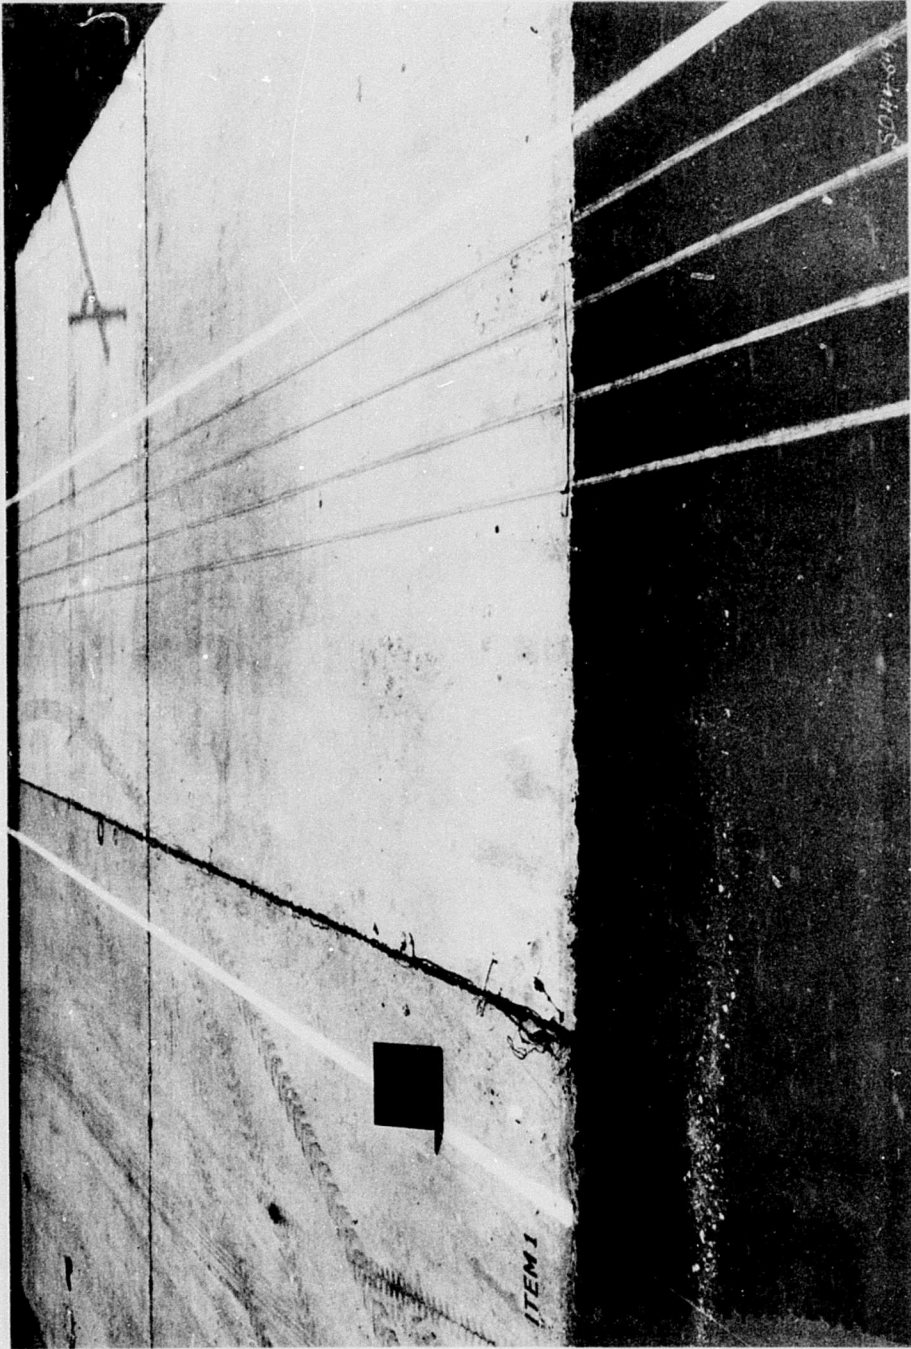
A general view of test item 1 prior to traffic is shown in figure 27. As can be seen in this photograph, both the southwest and northwest slabs contained longitudinal cracks prior to traffic. The crack in the southwest slab began at the west end of the item about 9 ft from the south free edge and ran approximately 13 ft longitudinally into the slab. The crack in the northwest slab began at the west edge of the item and ran 21 ft longitudinally through the center of the slab. Neither of these cracks was located inside the 200-in.-wide traffic lane.

Figure 27. General view of item 1 prior to test traffic.

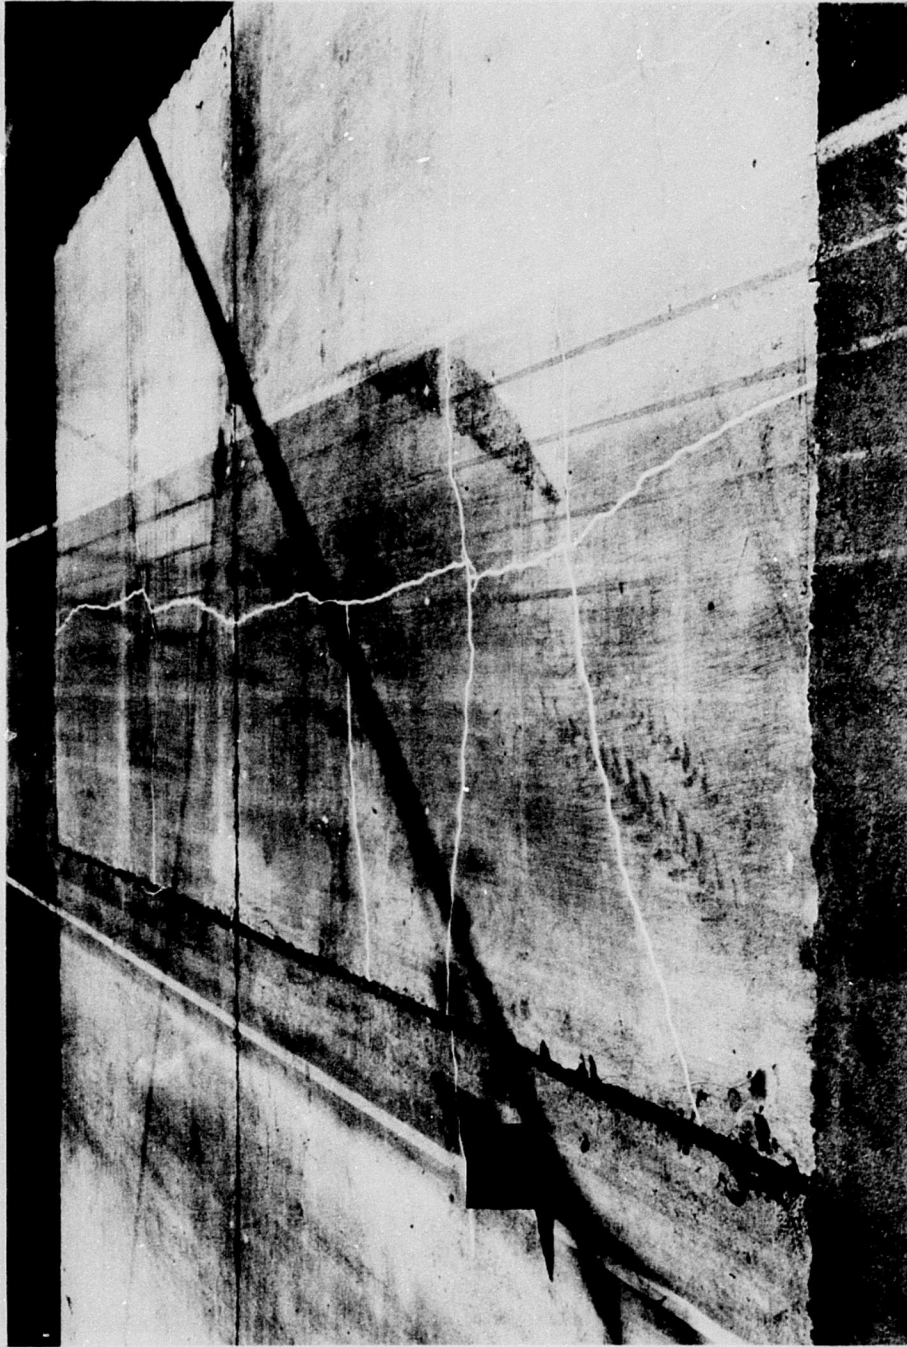
Figure 28. Item 1, 360-kip, 12-wheel-assembly lane after 144 coverages.

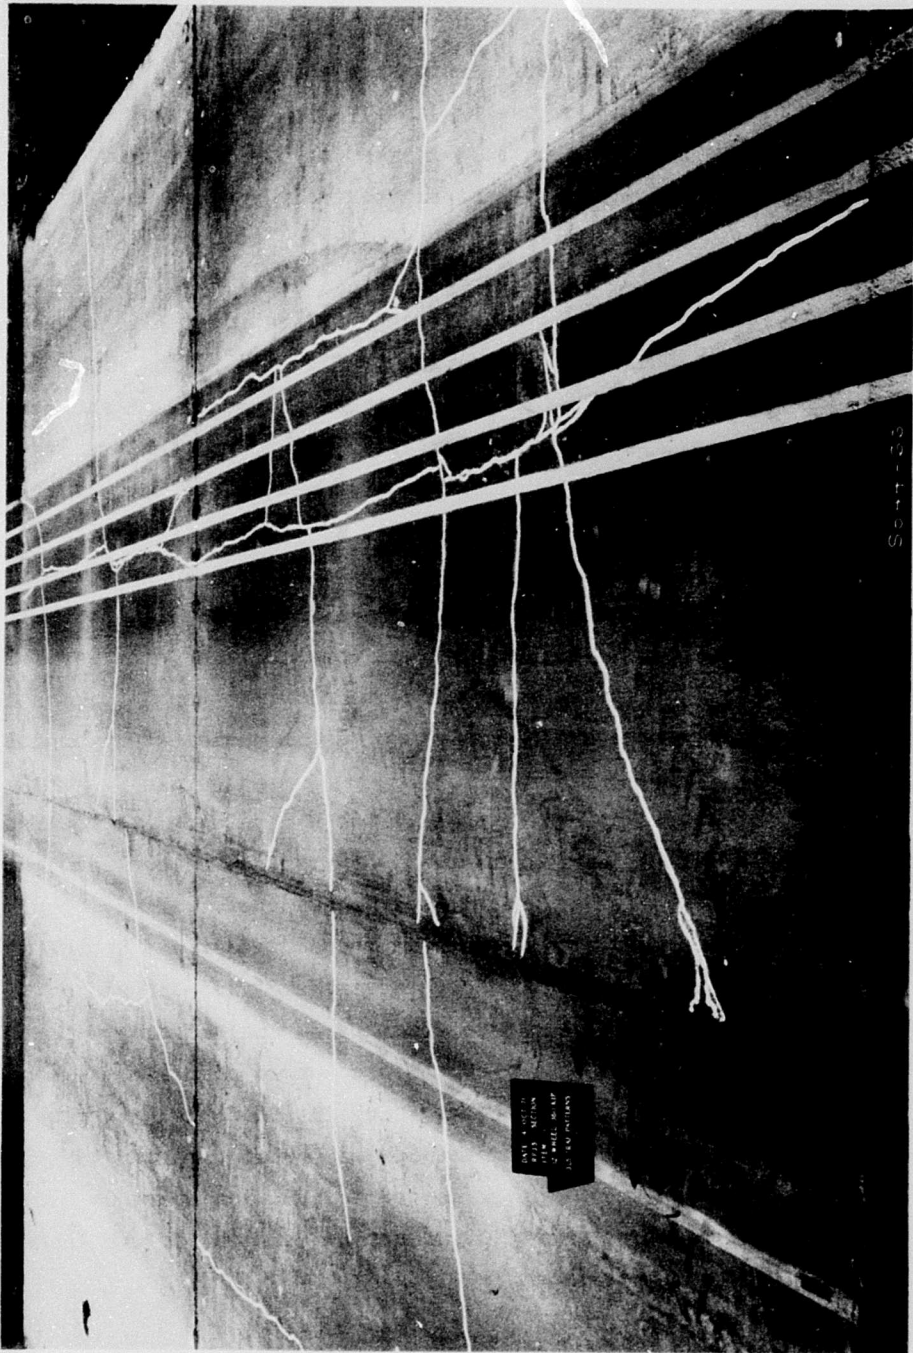
of the item. Additional surface cracking had developed in both of the north slabs and in the southwest slab after 504 coverages. Figure 29 depicts the crack pattern in this item after 504 coverages. Several of the cracks in the southwest slab were severely spalled and raveled. Traffic was stopped after 43 traffic patterns (688 coverages) due to the severe faulting of the keyed longitudinal construction joint, as well as the shattered-slab failures of both south slabs and the item was rated as failed. Figure 30 indicates faulting of $3/8$ to $1/2$ in. after 688 coverages at the construction joint between the southwest and northwest slabs. An overall view of the item after 688 coverages is shown in figure 31; the progression and extent of cracking due to test traffic is shown in figure 32. After traffic was discontinued, a portion of the southwest slab adjacent to the keyed construction joint was removed to confirm the joint failure. As can be seen in figure 33, the bottom half of the keyway of the keyed longitudinal construction joint was failed. The longitudinal construction joint containing the dowel bars on 12-in. centers in the eastern half of the item was in satisfactory condition at the end of traffic.

Figure 29. Item 1, 360-kip, 12-wheel-assembly lane after 504 coverages.

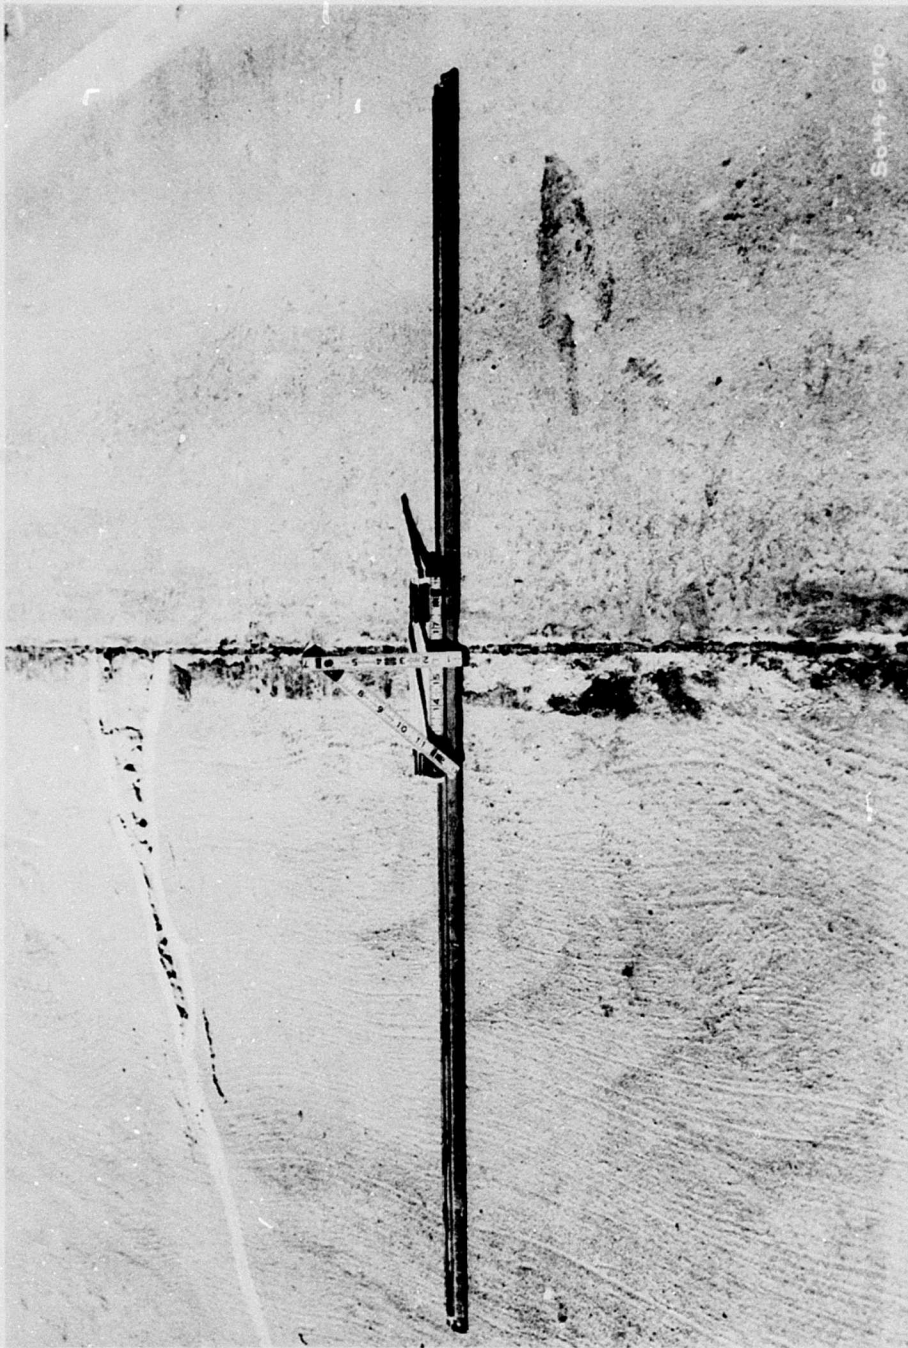
Figure 30. Faulting of longitudinal construction joint in item 1 after 688 coverages.

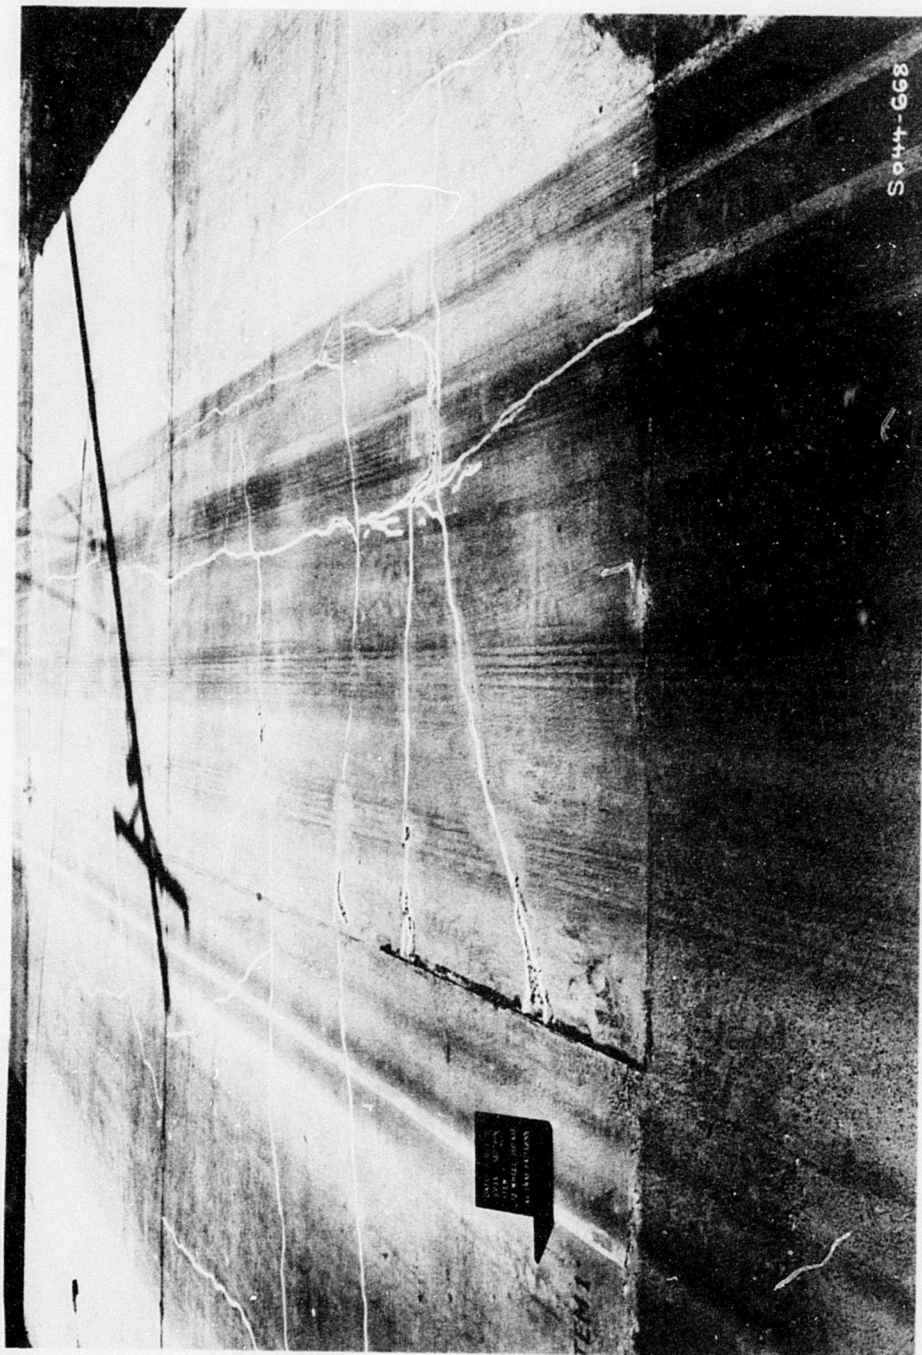
Figure 31. General view of item 1, 360-kip, 12-wheel-assembly lane after 688 coverages.

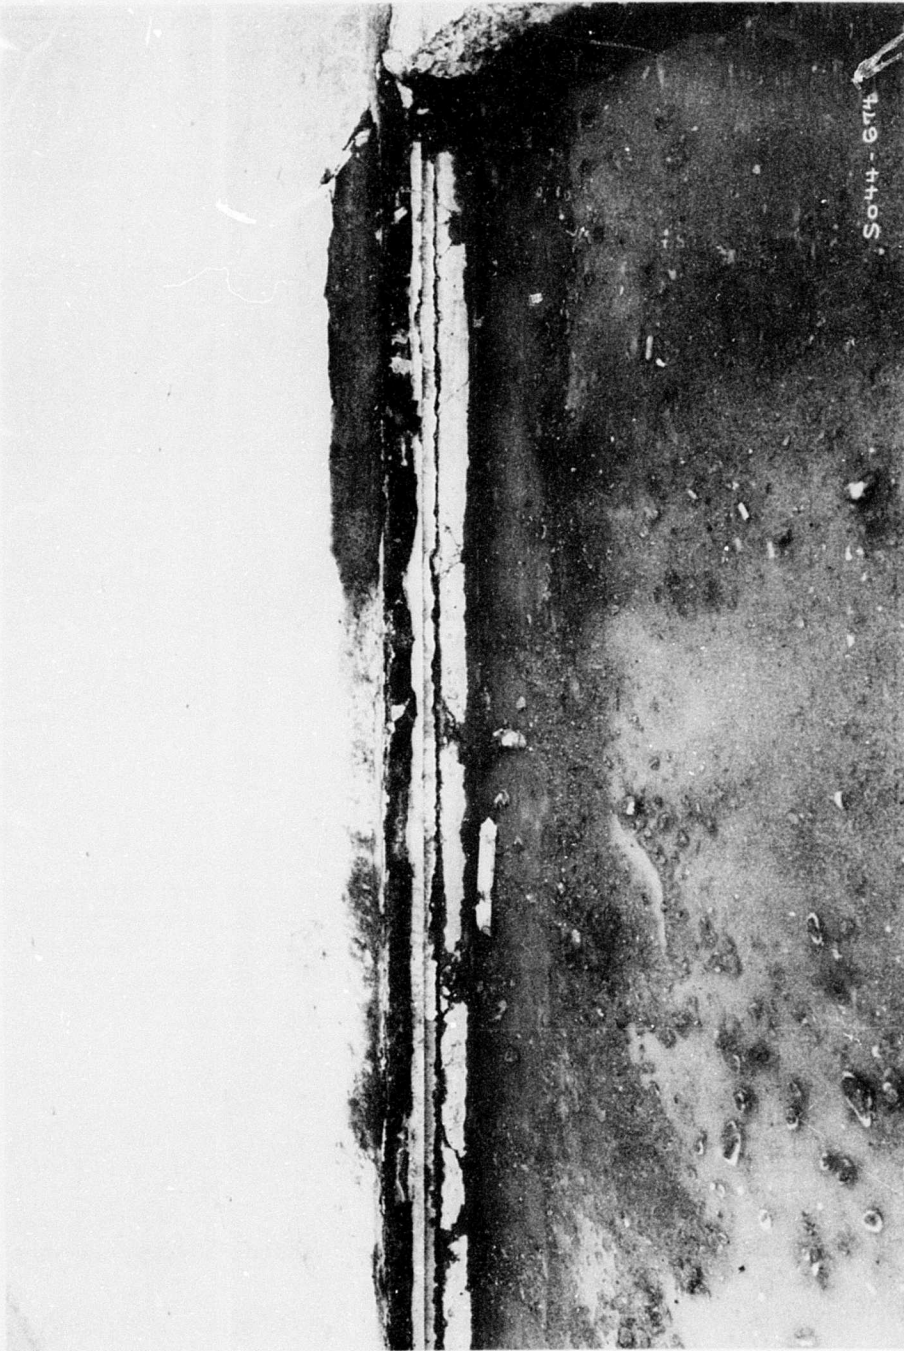
Figure 33. View of failed keyed longitudinal joint in item 1 after 688 coverages of the 360-kip, 12-wheel assembly.

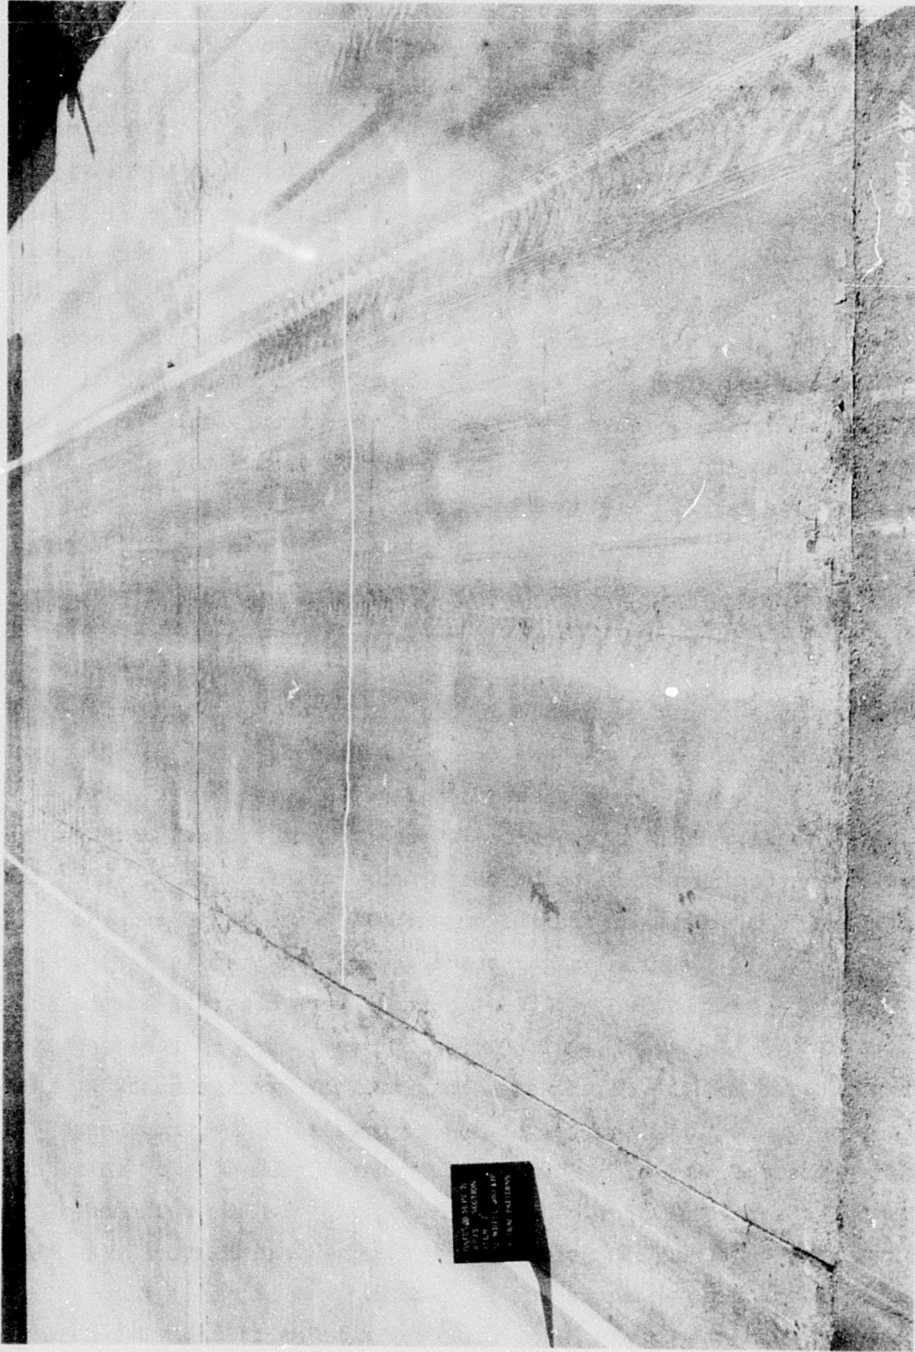
Initial cracking occurred during the ninth traffic pattern (144 coverages). This consisted of a transverse crack, which began at the longitudinal construction joint and ran about 15 ft across the southwest slab, as shown in figure 36. After 21.5 traffic patterns (344 coverages), the transverse crack in the southwest slab had progressed across the slab and a transverse crack was also detected going across the southeast slab. Both south slabs in this item were essentially halved by these cracks. Each of the three types of longitudinal construction joint strengthening seemed to be performing satisfactory at this time. After 10 more patterns of traffic or a total of 31.5 patterns, a slight amount of flaking occurred along the edges of the transverse cracks in the two south slabs. Two additional cracks were observed in the southeast slab at the 504 coverage level (31.5 patterns). One of these cracks was a corner break and the other was a longitudinal crack connecting the transverse crack that occurred at 344 coverages to the transverse weakened-plane contraction joint. The general condition of this item after 504 coverages is depicted in figure 37. The strengthened longitudinal construction joint was performing satisfactorily at this time; however, flaking and spalling such as that shown in figure 38 had occurred around all of the 8-in.-diam cored holes filled with sanded grout.

Figure 36. Initial crack in item 2, 360-kip, 12-wheel-assembly lane after 144 coverages.

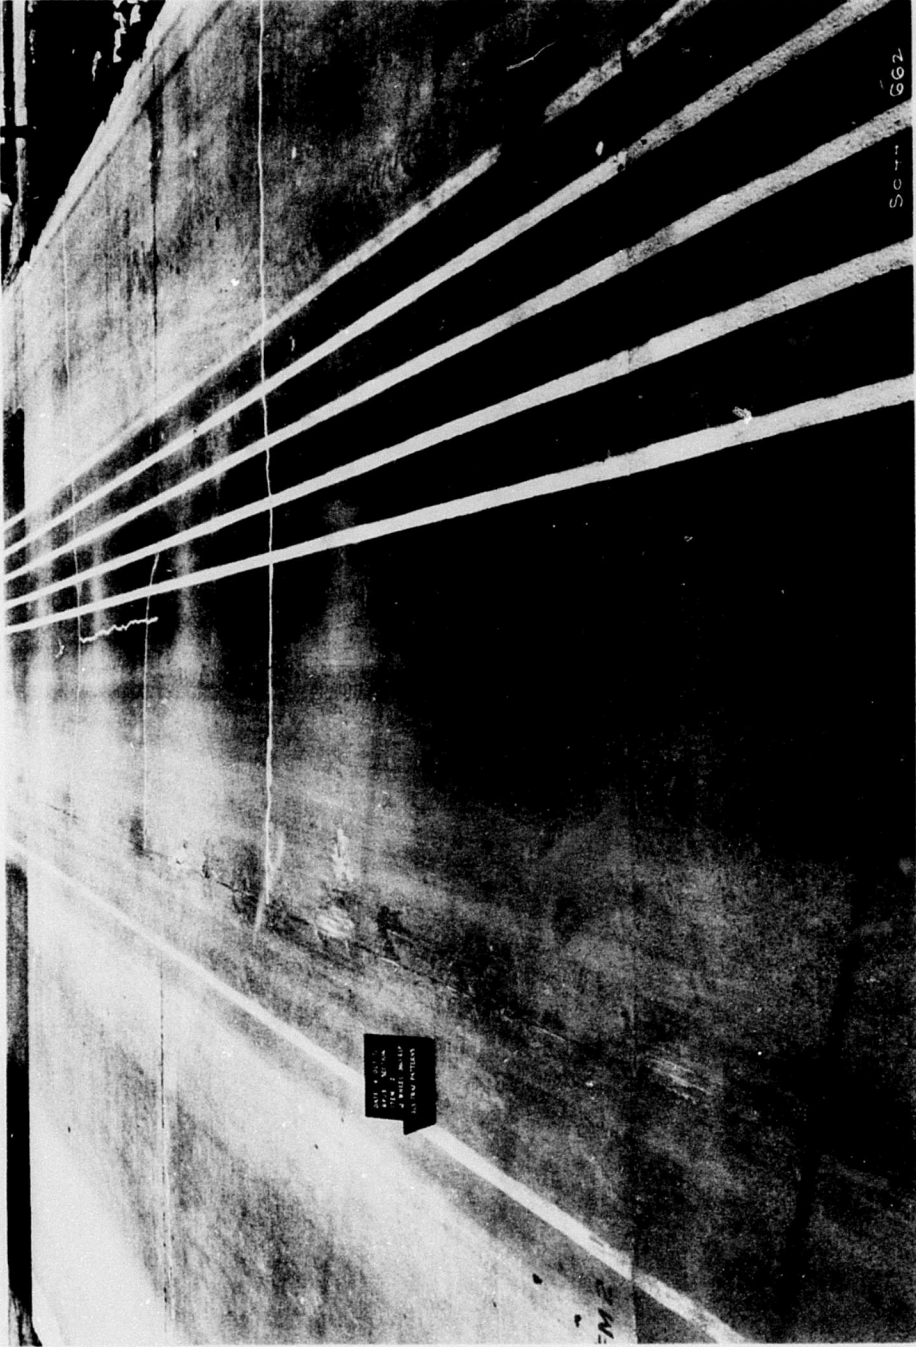
Figure 37. Item 2, 360-kip-assembly lane after 504 coverages.

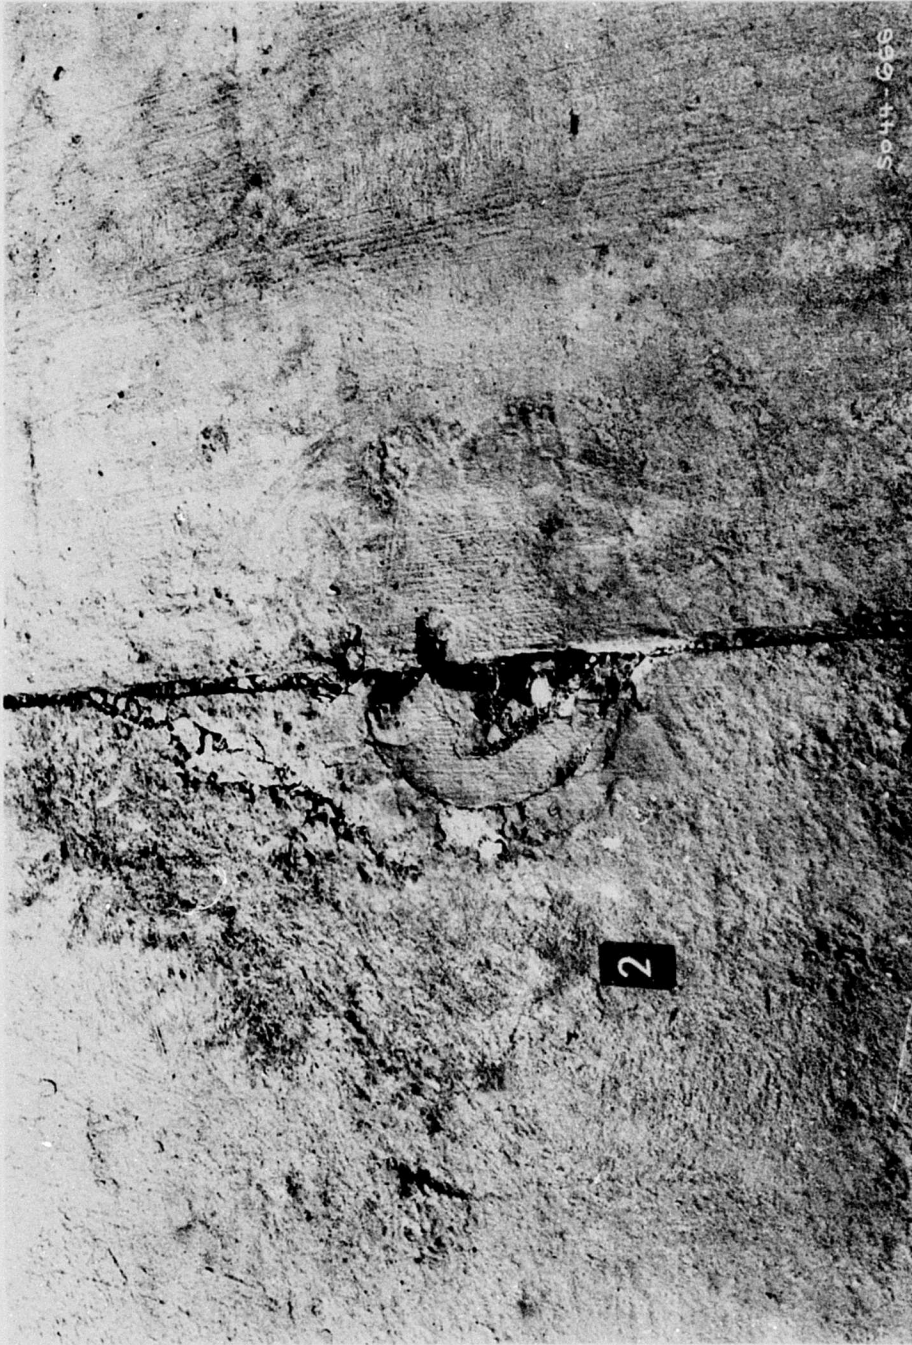
Figure 38. Flaking and spalling around the 8-in.-diam access holes filled with sand-cement grout (after 504 coverages).

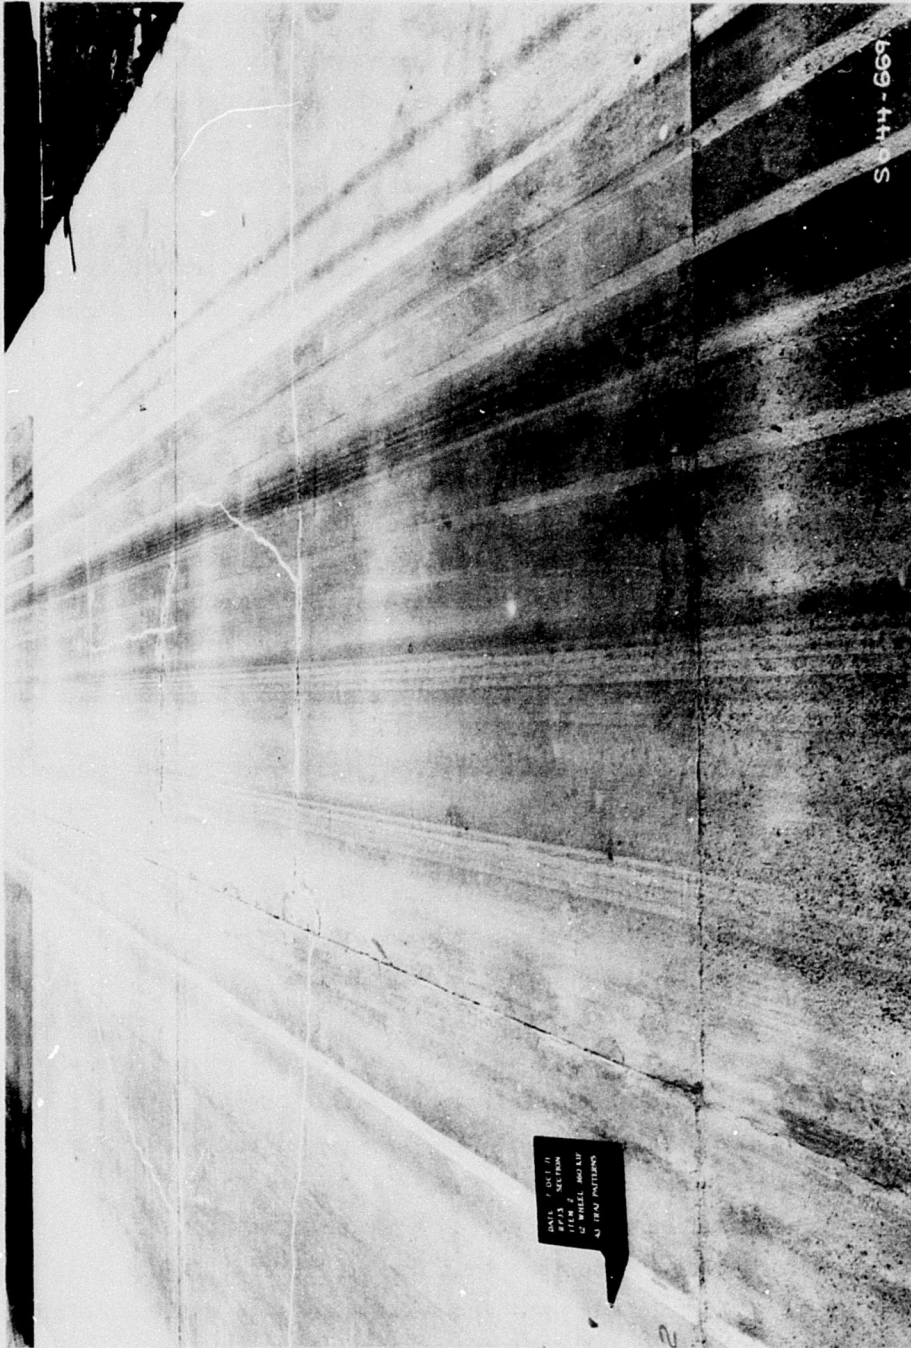
Figure 39. General view of item 2, 360-kip, 12-wheel-assembly lane after 688 coverages.

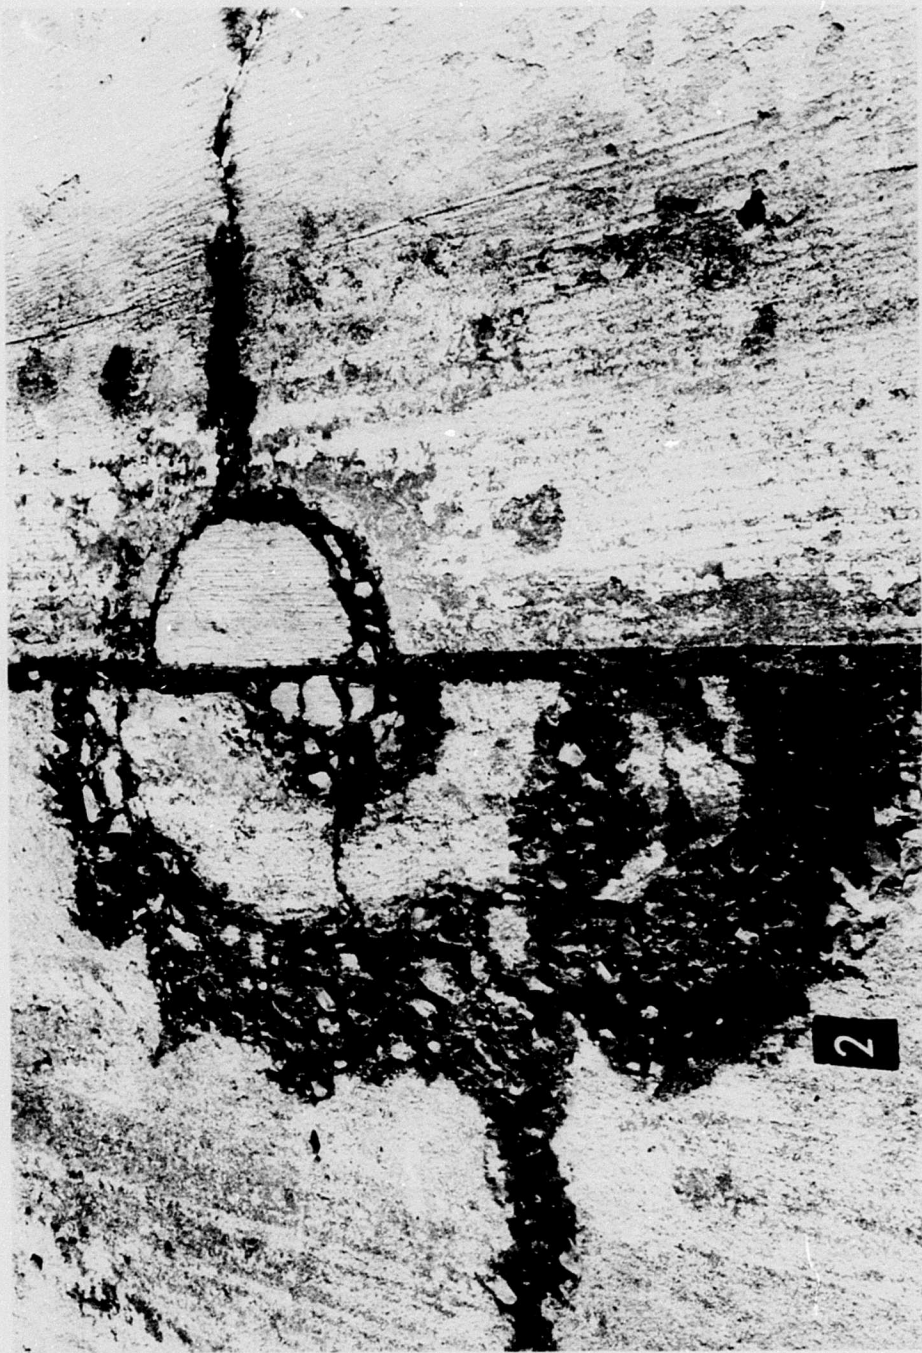
Figure 40. View of under-grouted joint in item 2, 360-kip, 12-wheel-assembly lane after 816 coverages.

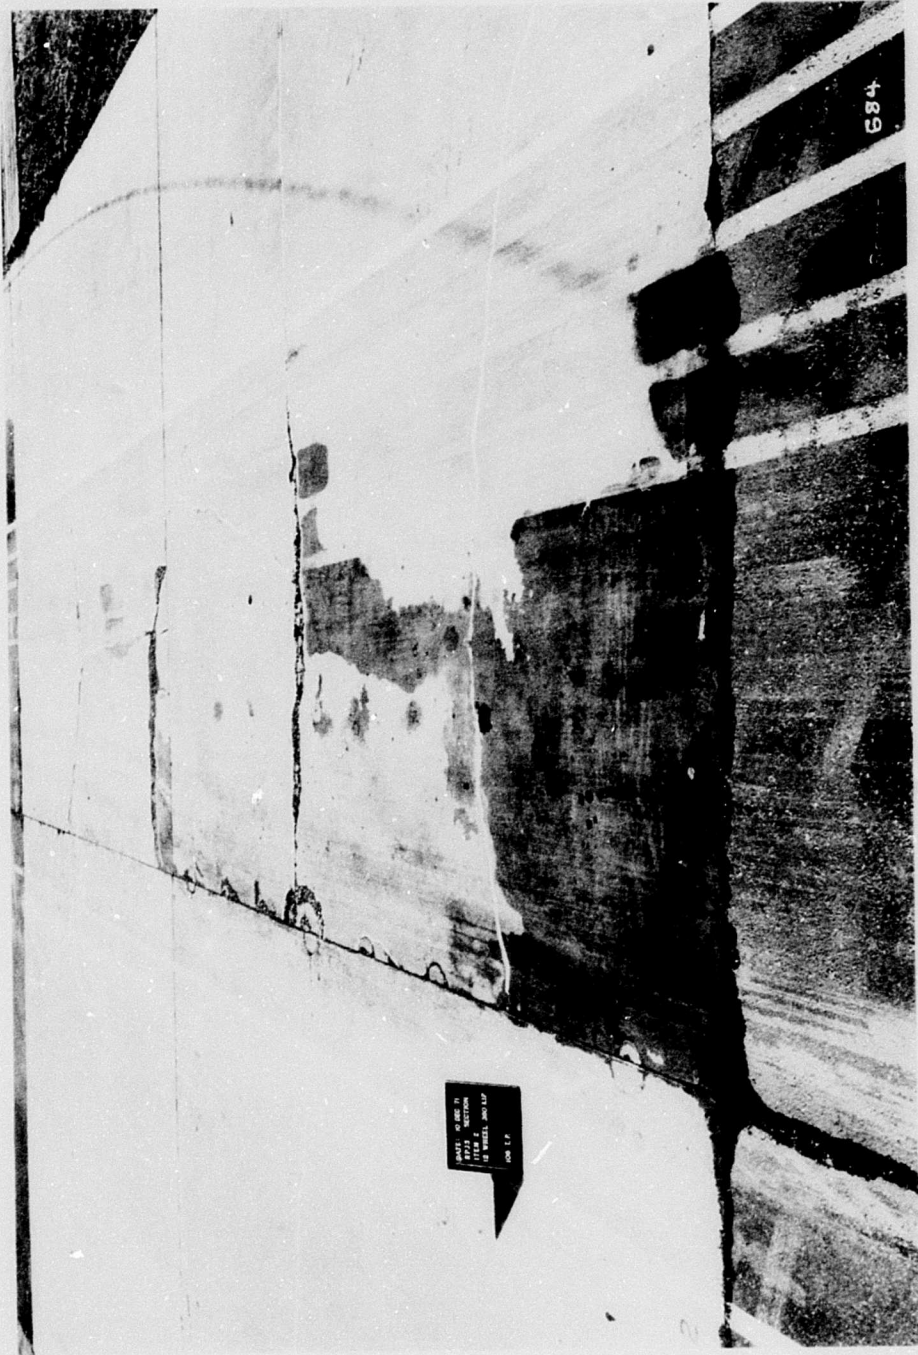
Figure 41. Item 2, 360-kip, 12-wheel-assembly lane after 1696 coverages.

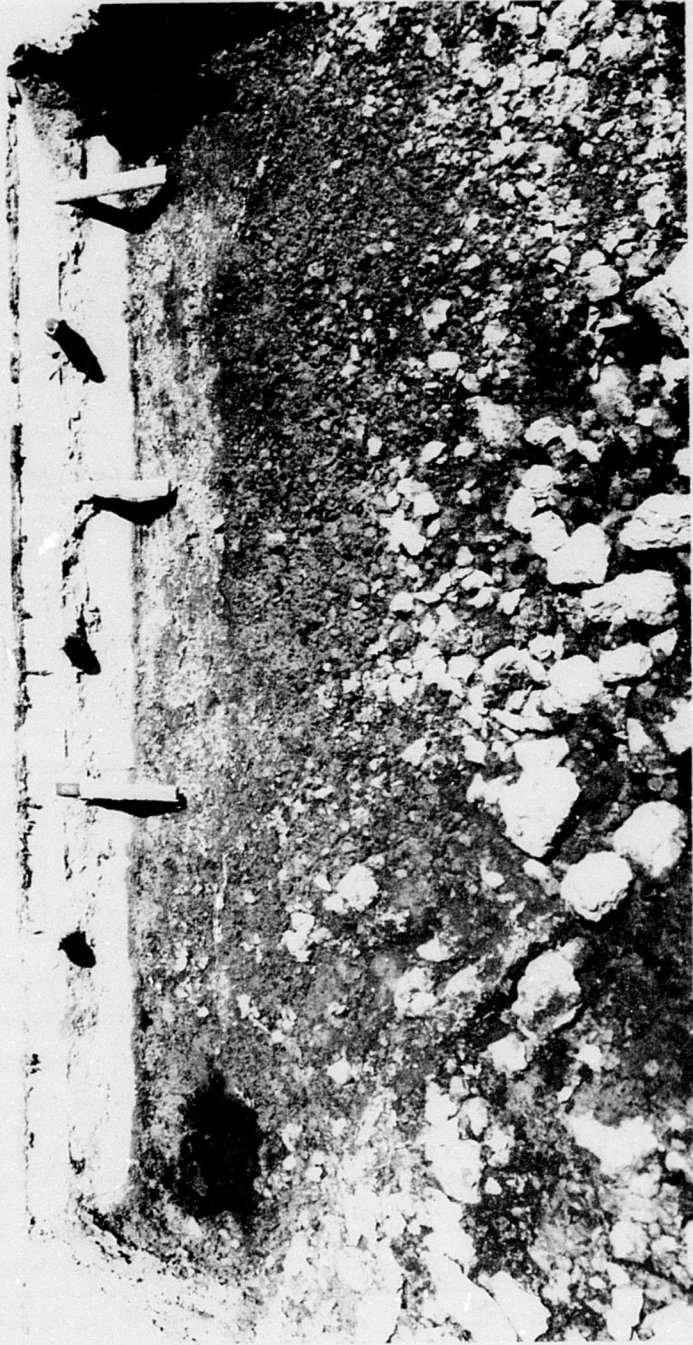
Figure 44. View of the longitudinal construction joint in item 2 strengthened by bonding bars at 45° angles (after 1676 coverages).

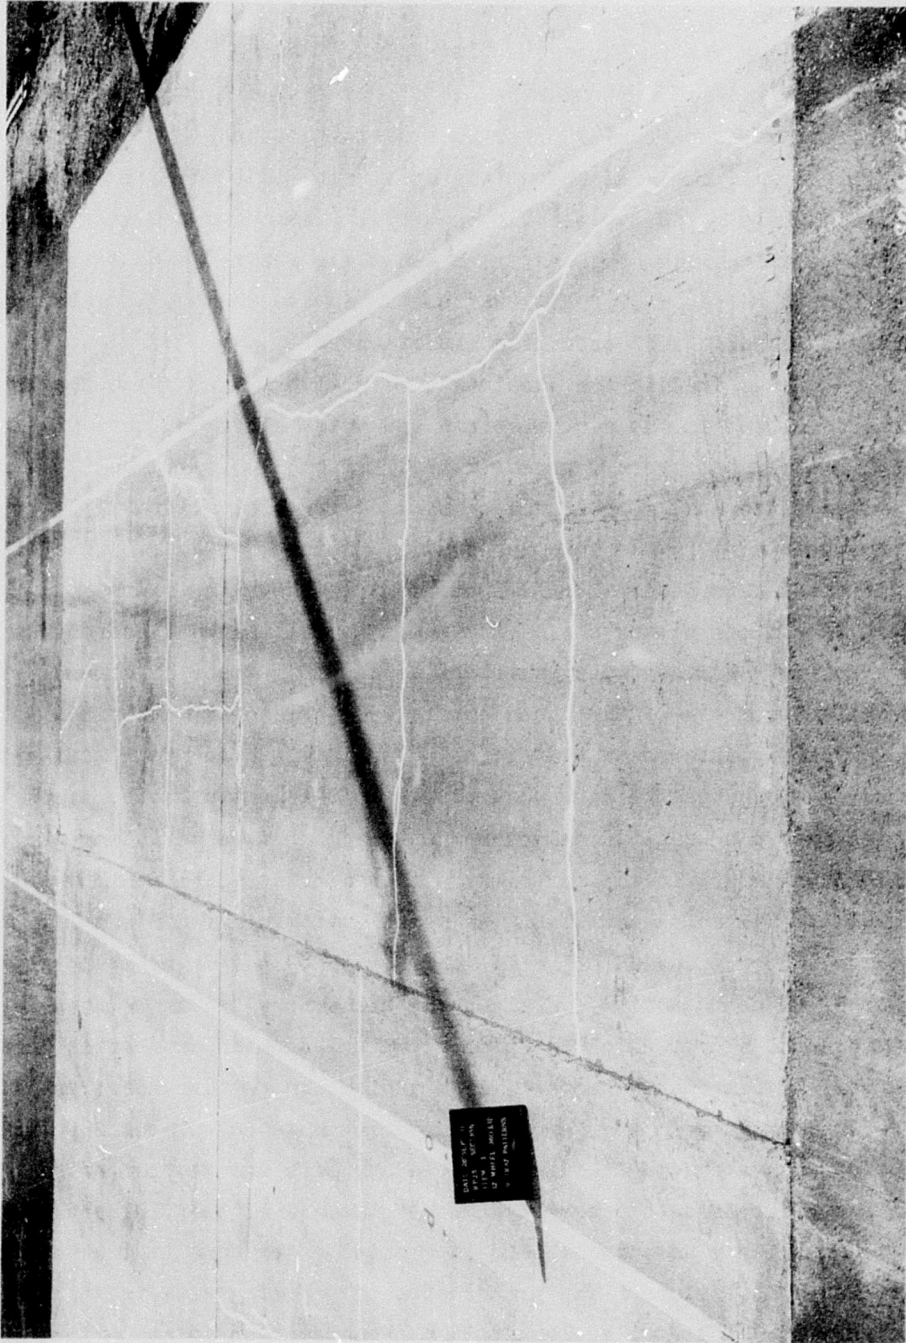
Figure 47. Item 3, 360-kip, 12-wheel-assembly lane after 144 coverages.

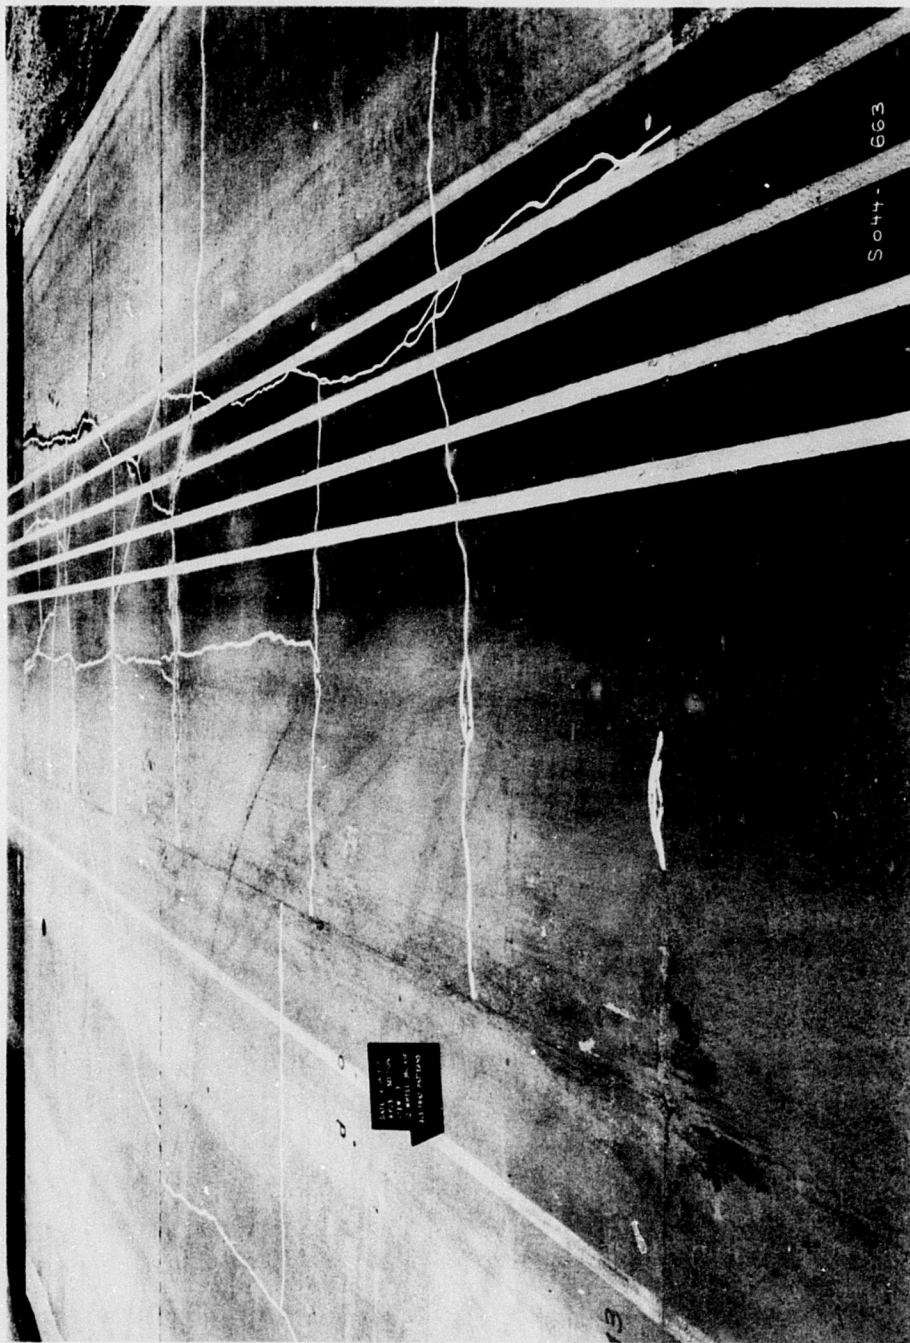
Figure 48. Item 3, 360-kip, 12-wheel-assembly lane after 504 coverages.

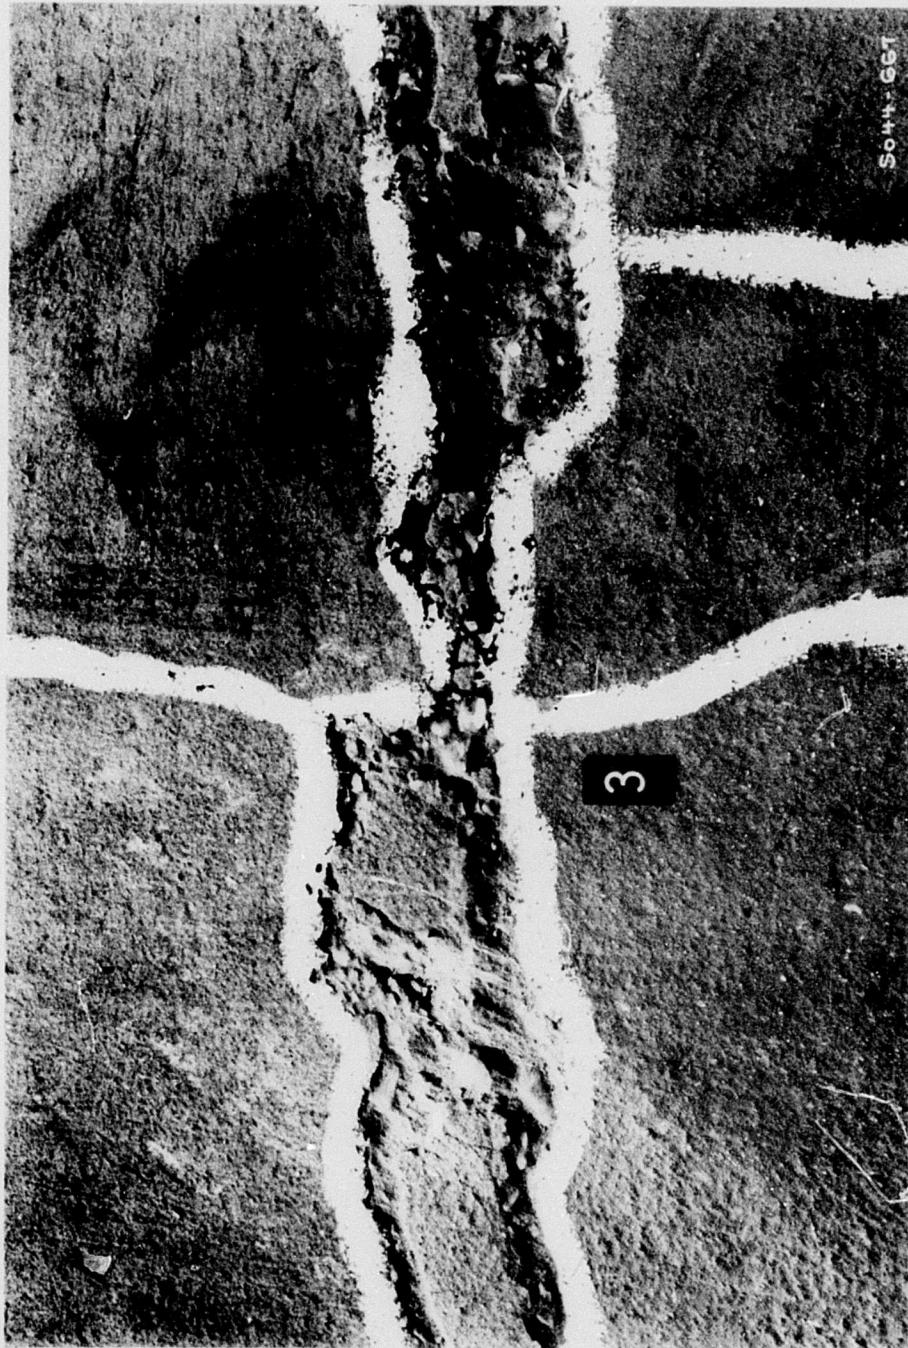
Figure 49. Spalling and flaking along cracks in item 3, 360-kip, 12-wheel-assembly lane after 504 coverages.

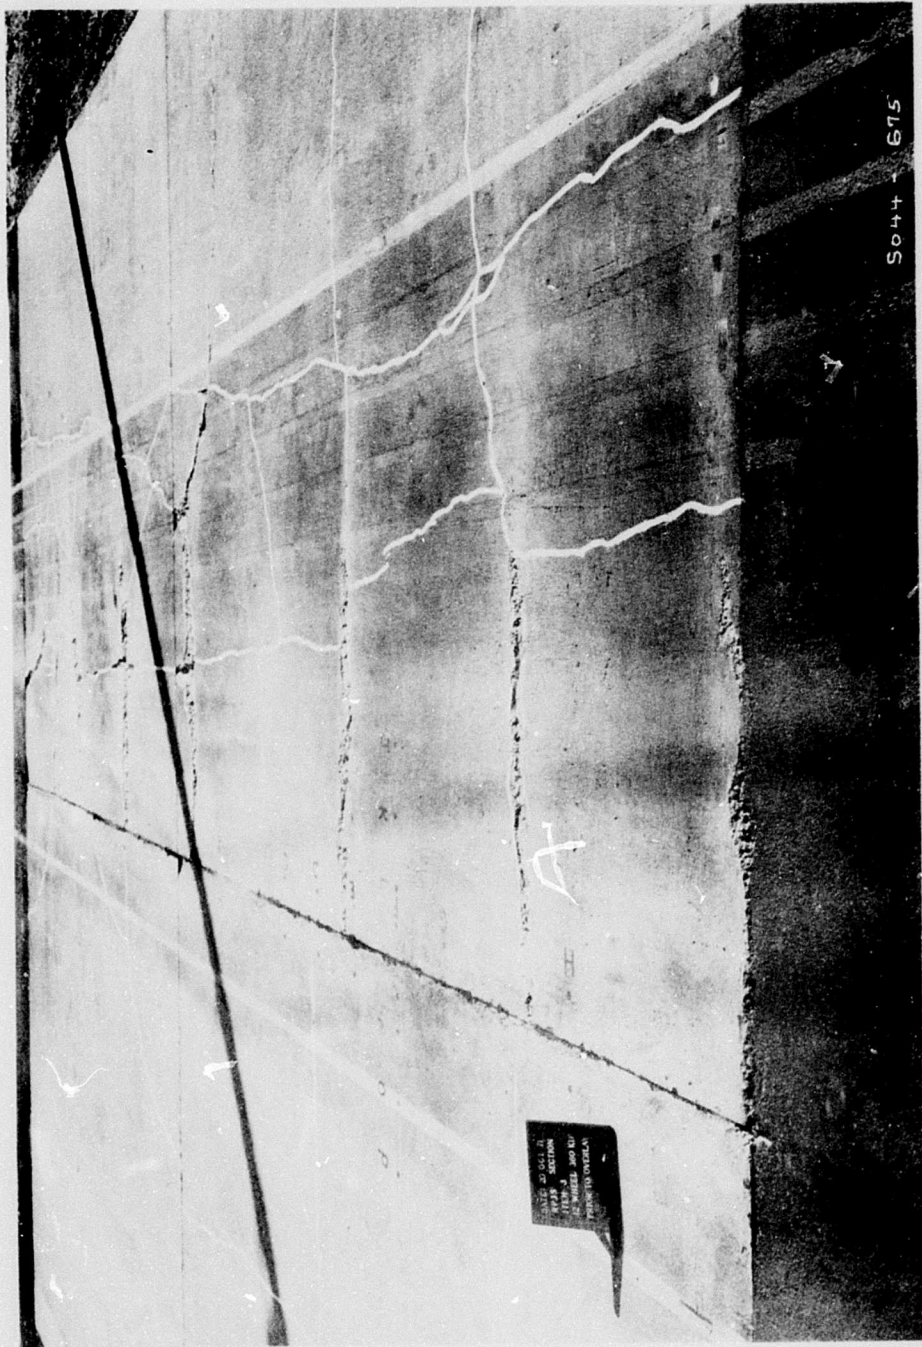
Figure 50. Item 3, 360-kip, 12-wheel-assembly lane after 688 coverages.

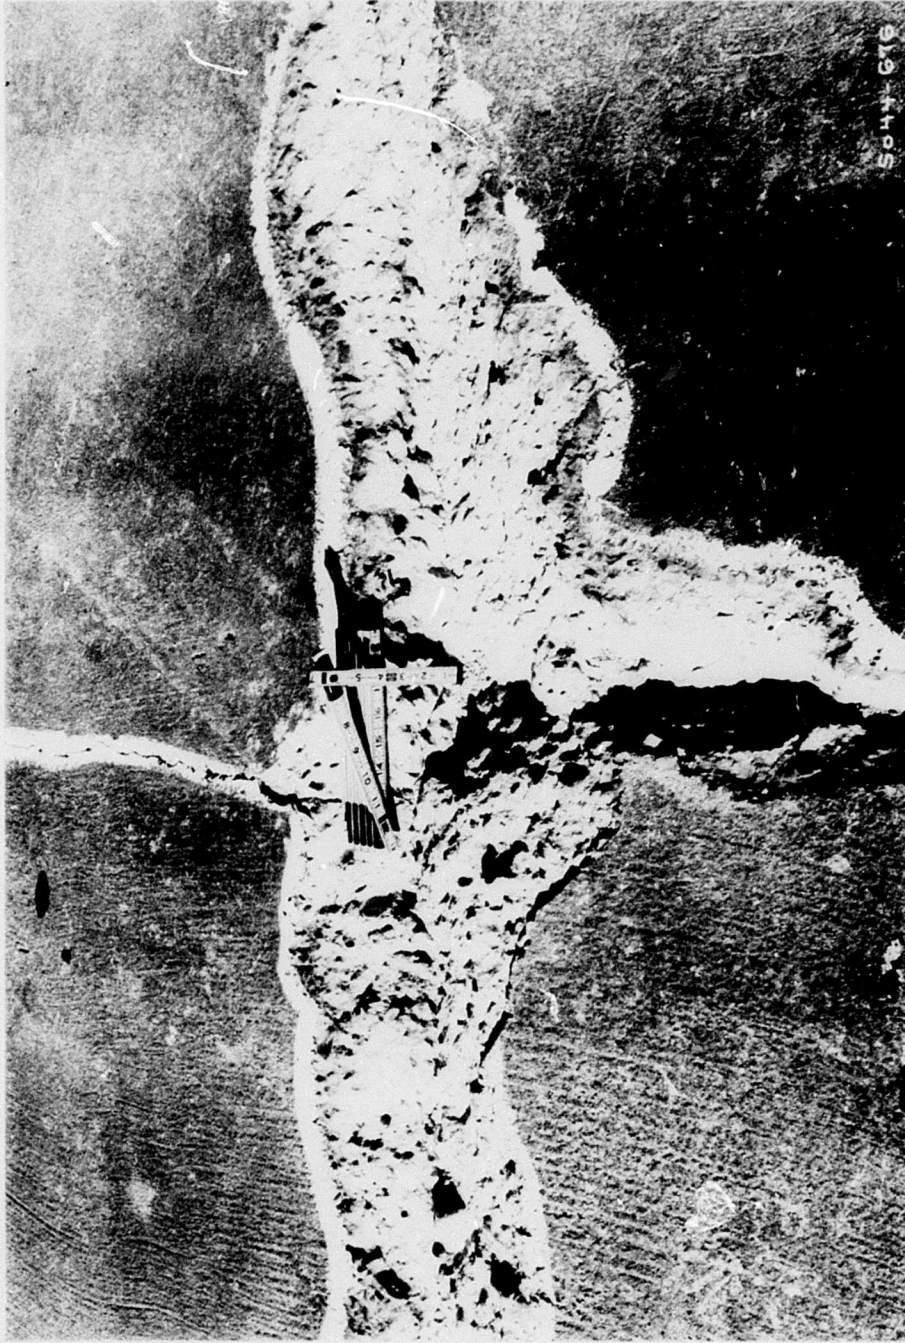
Figure 51. Typical spalled area in item 3, 360-kip, 12-wheel-assembly lane after 688 coverages.
