STRENGTHENING OF KEYED LONGITUDINAL CONSTRUCTION
JOINTS IN RIGID PAVEMENTS

ARMY ENGINEER WATERWAYS EXPERIMENT STATION

Report No. FAA-RD-72-106

AUGUST 1972
FINAL REPORT

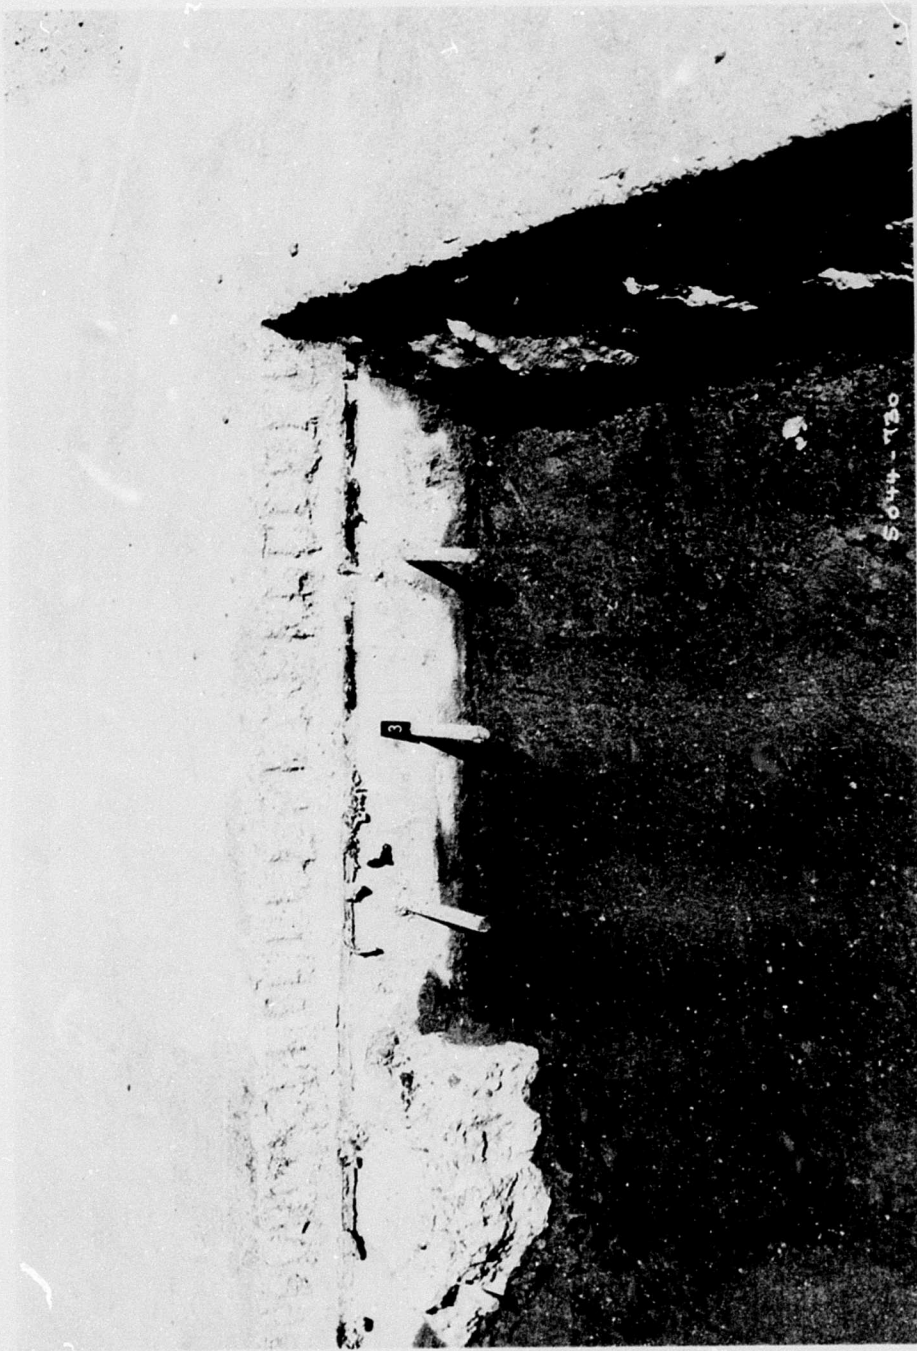
Figure 53. View of doweled longitudinal construction joint in item 3, 360-kip, 12-wheel-assembly lane after 688 coverages prior to overlaying and 5008 coverages after overlaying.

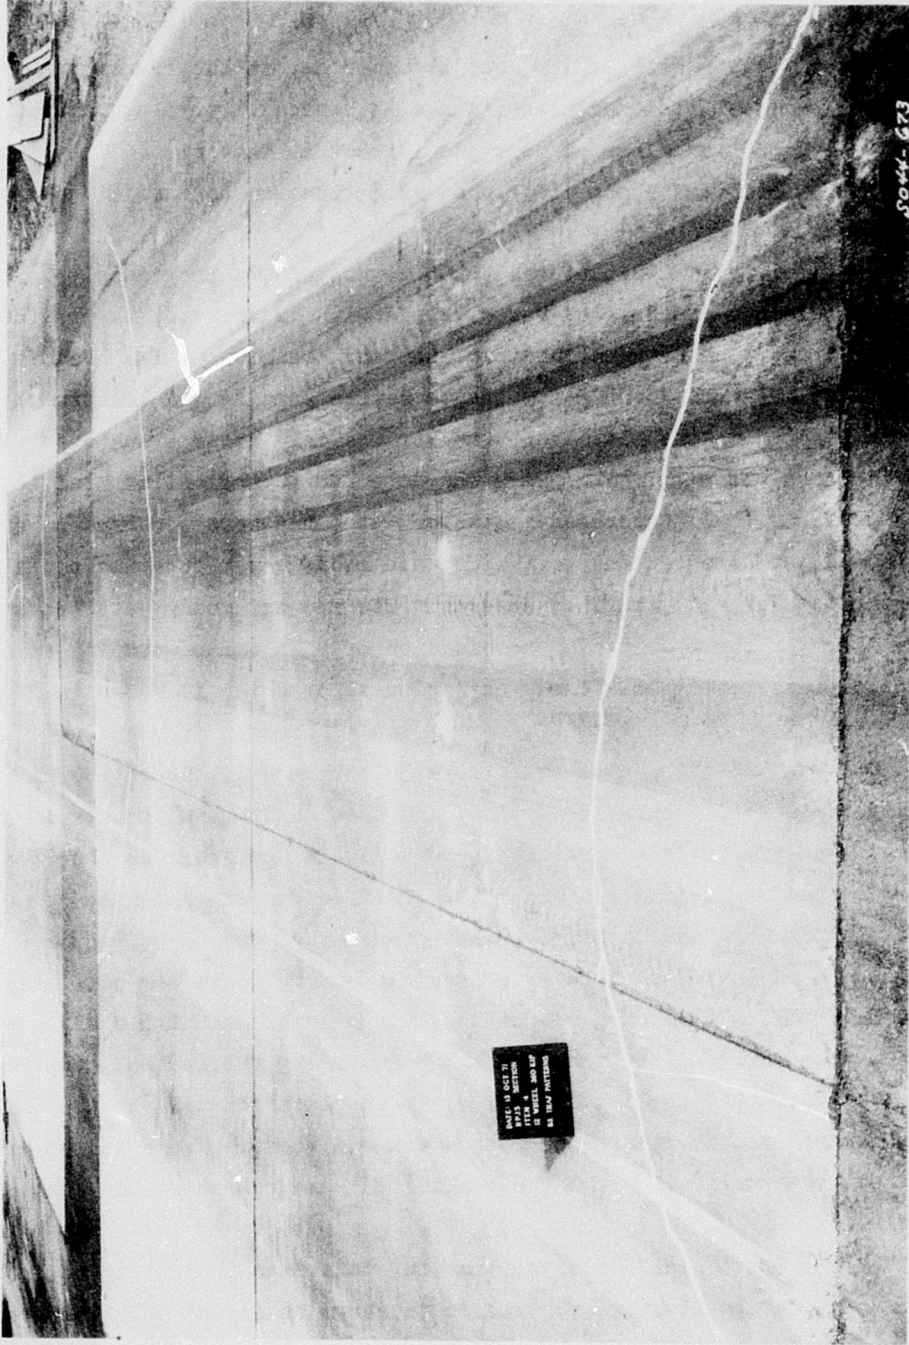
Figure 55. Item 4, 360-kip, 12-wheel-assembly lane after 1328 coverages.

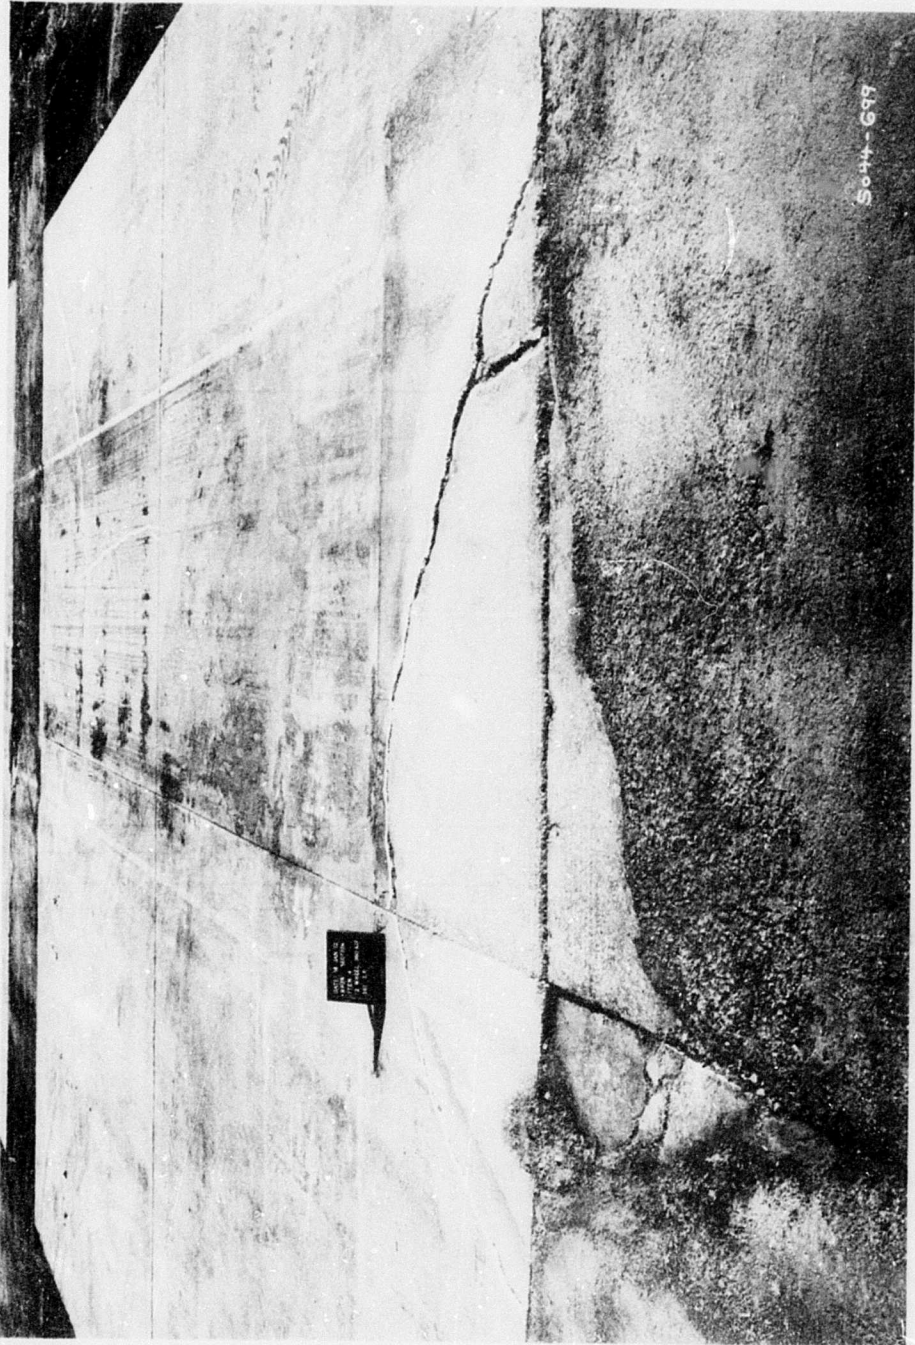
Figure 57. Item 4, 360-kip, 12-wheel-assembly lane after 6336 coverages.

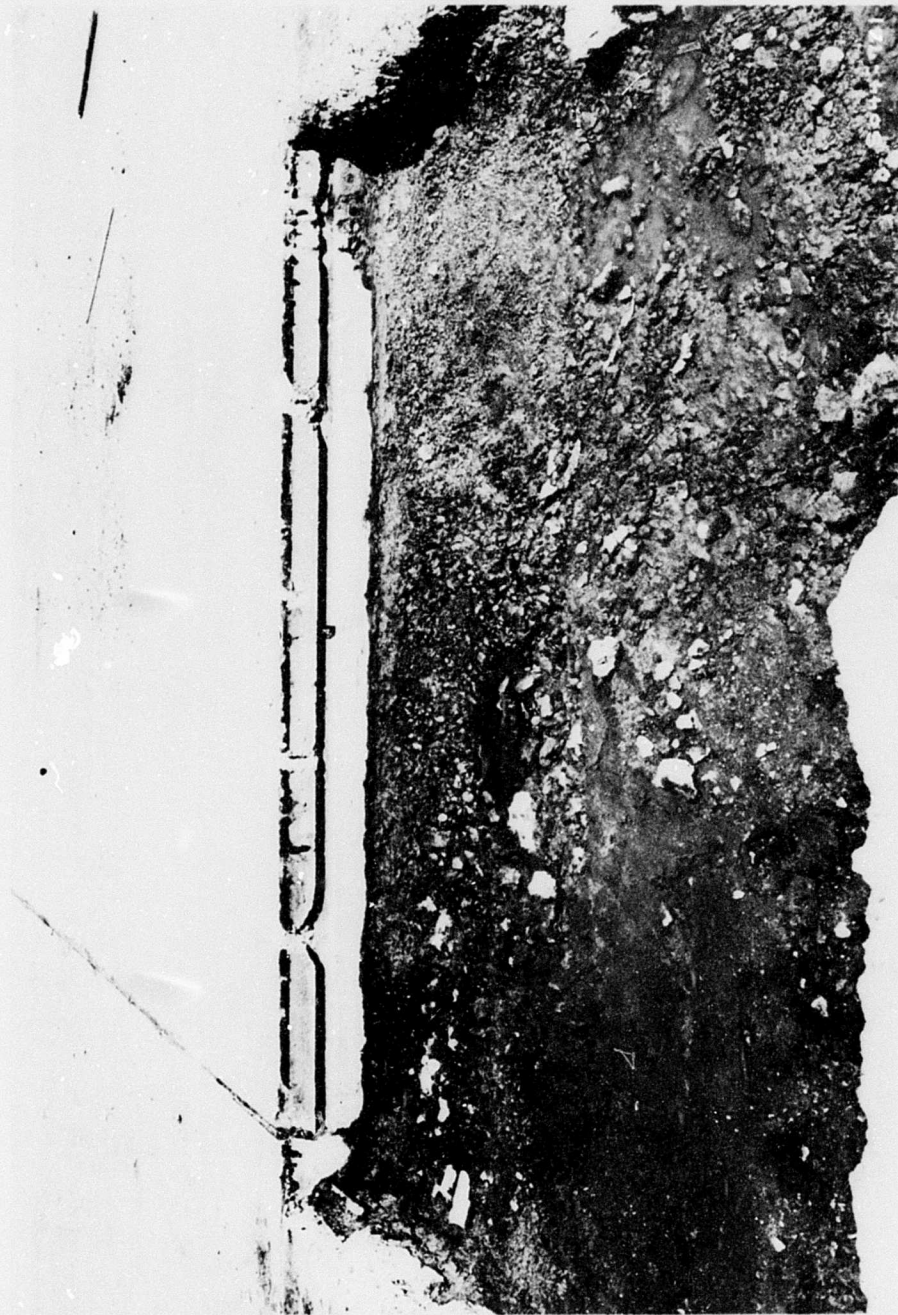
Figure 59. View of keyed longitudinal construction joint in item 4, 360-kip, 12-wheel-assembly lane after 6336 coverages.

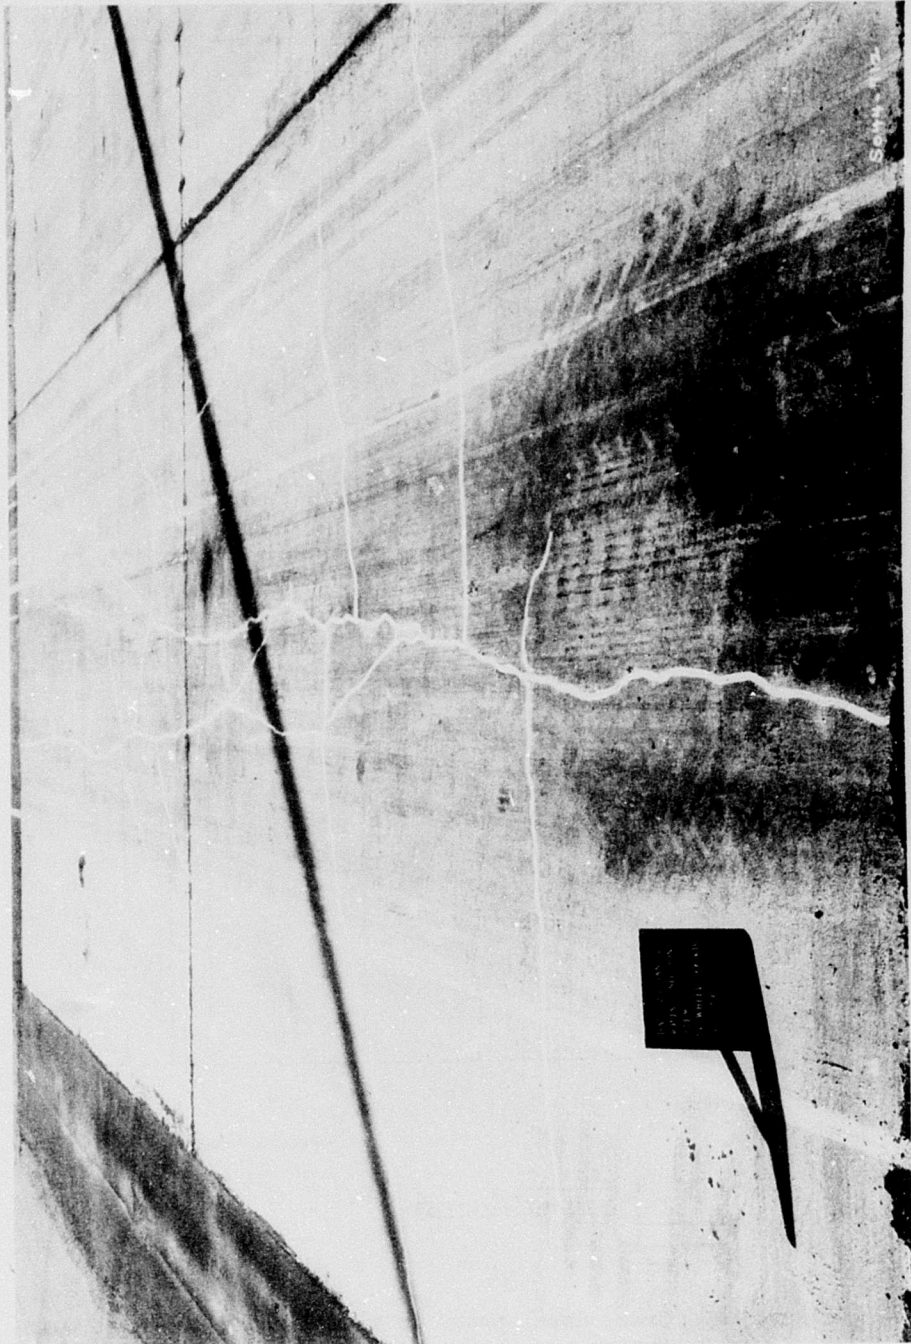
Figure 61. Item 1. 166-kip. twin-tandem-assembly lane after 35 coverages.

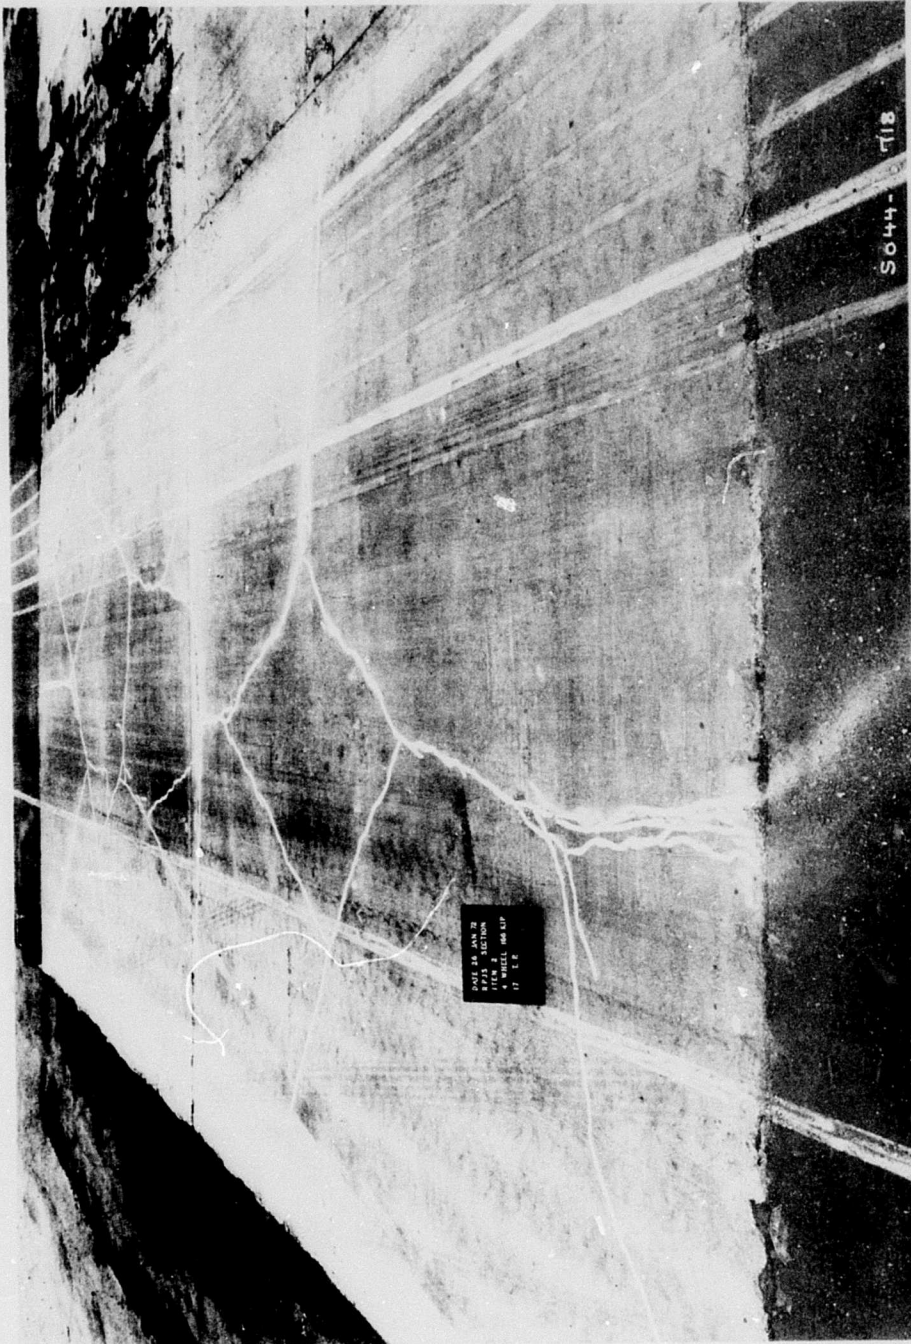
Figure 66. Item 2, 166-kip, twin-tandem-assembly lane after 170 coverages.

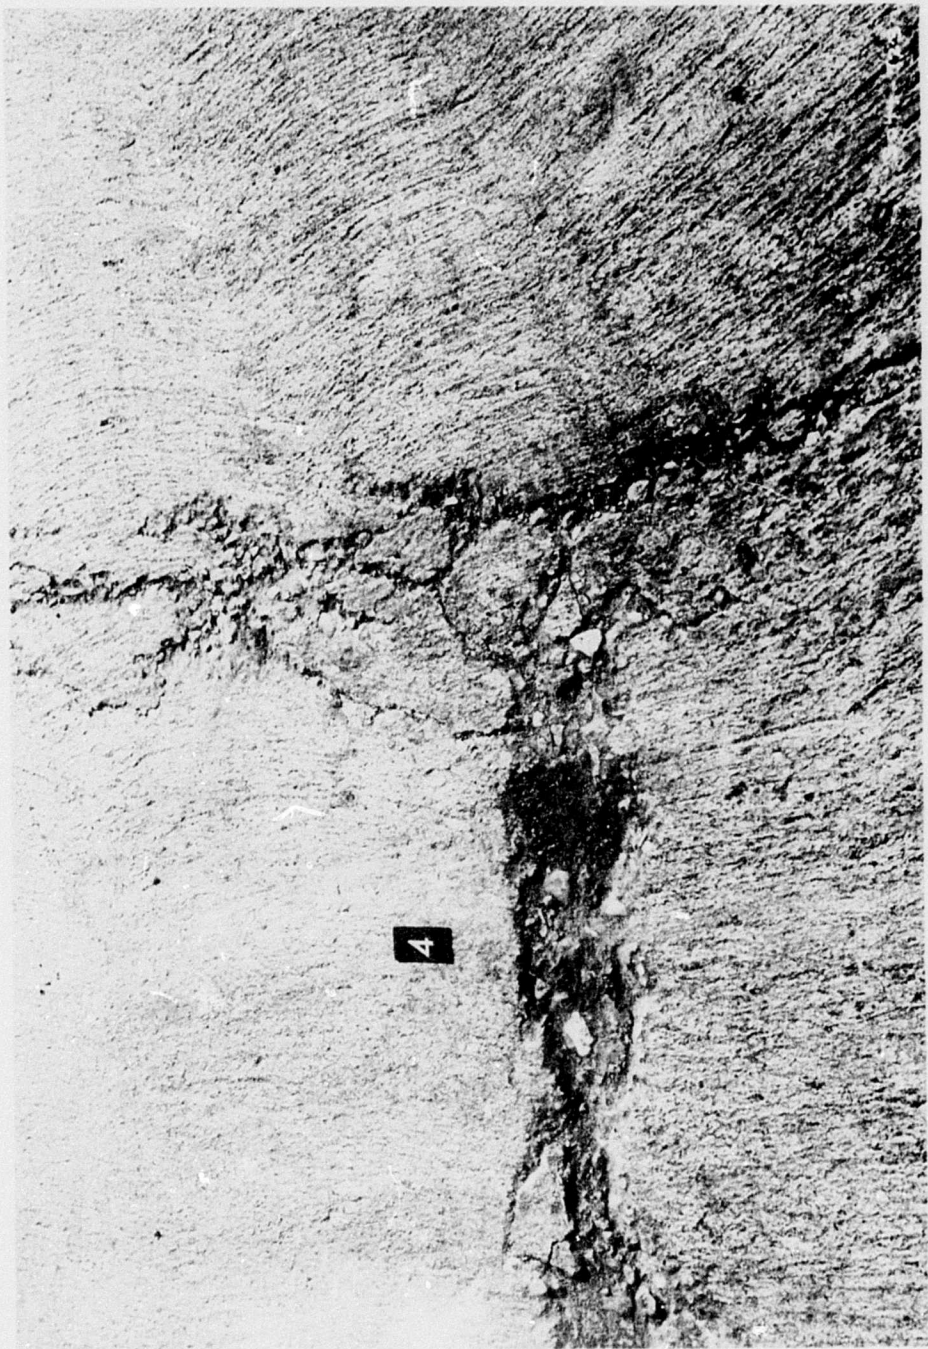
Figure 71. Spalling and flaking along the cracks in item 4, 166-kip, twin-tandem-assembly lane after 950 coverages.

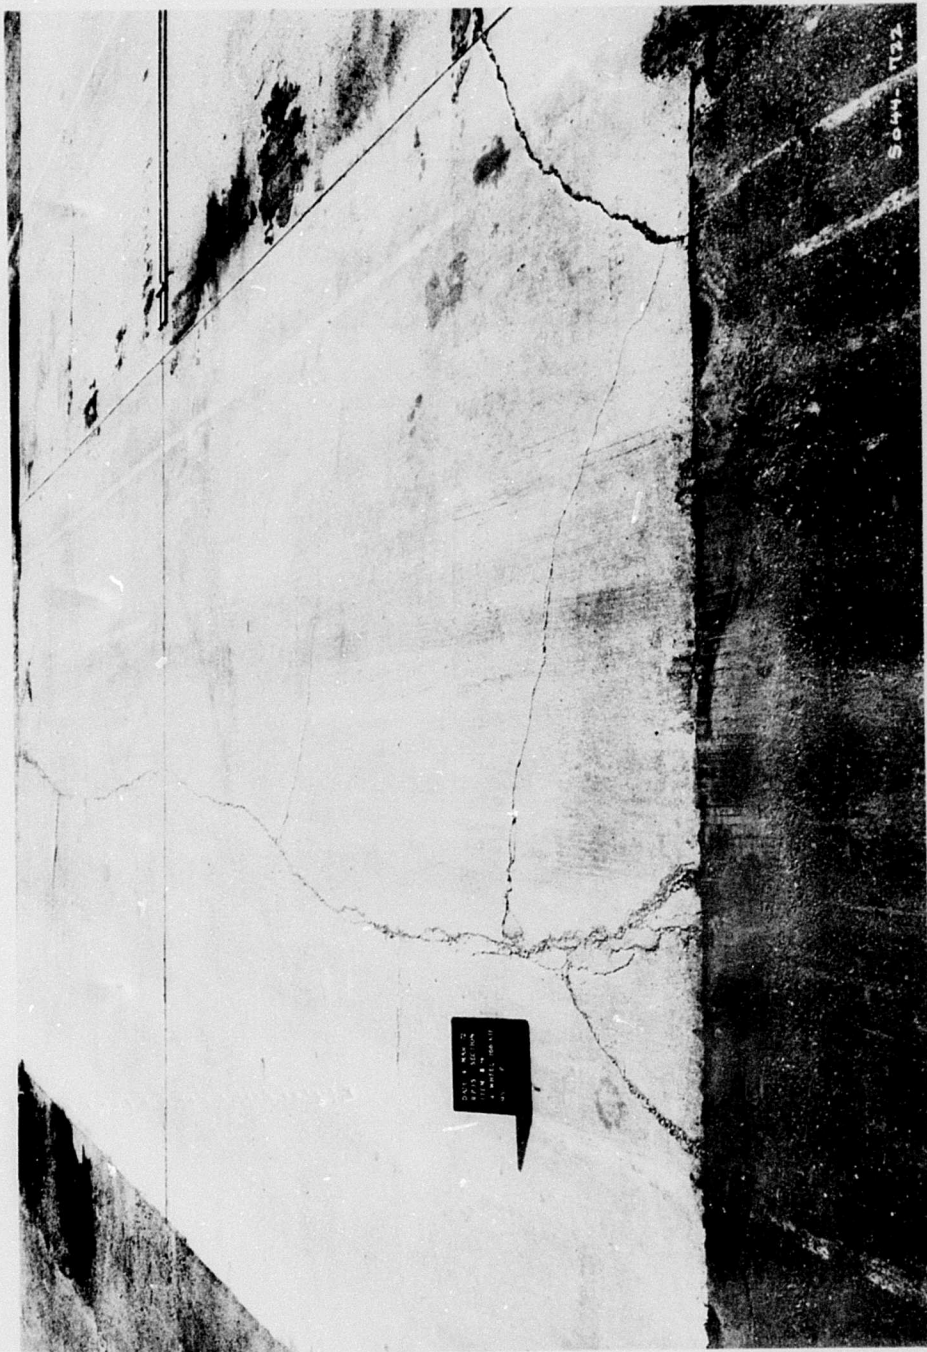
Figure 73. Item 4, 166-kip, twin-tandem-assembly lane after 950 coverages.
