**COMPARATIVE PERFORMANCE OF STRUCTURAL LAYERS IN
PAVEMENT SYSTEMS**

**VOLUME I. DESIGN, CONSTRUCTION, AND BEHAVIOR
UNDER TRAFFIC OF PAVEMENT TEST SECTIONS**

ARMY ENGINEER WATERWAYS EXPERIMENT STATION

JUNE 1974

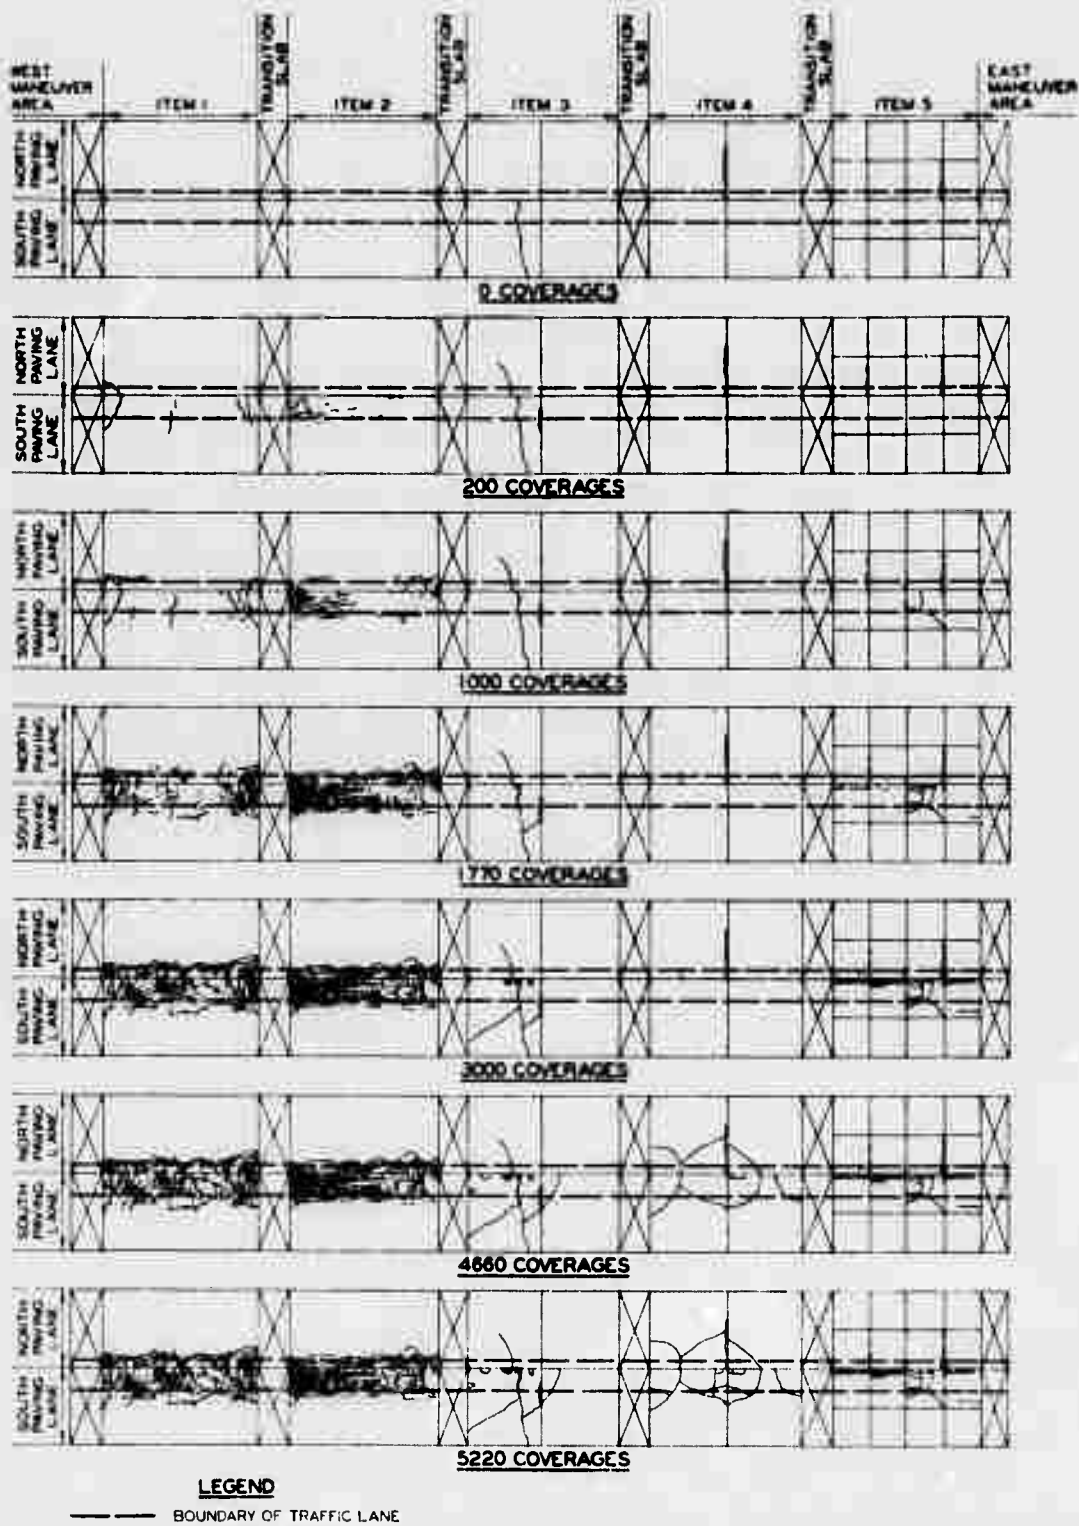
Figure A5. Crack development in lane 1, rigid pavement test section

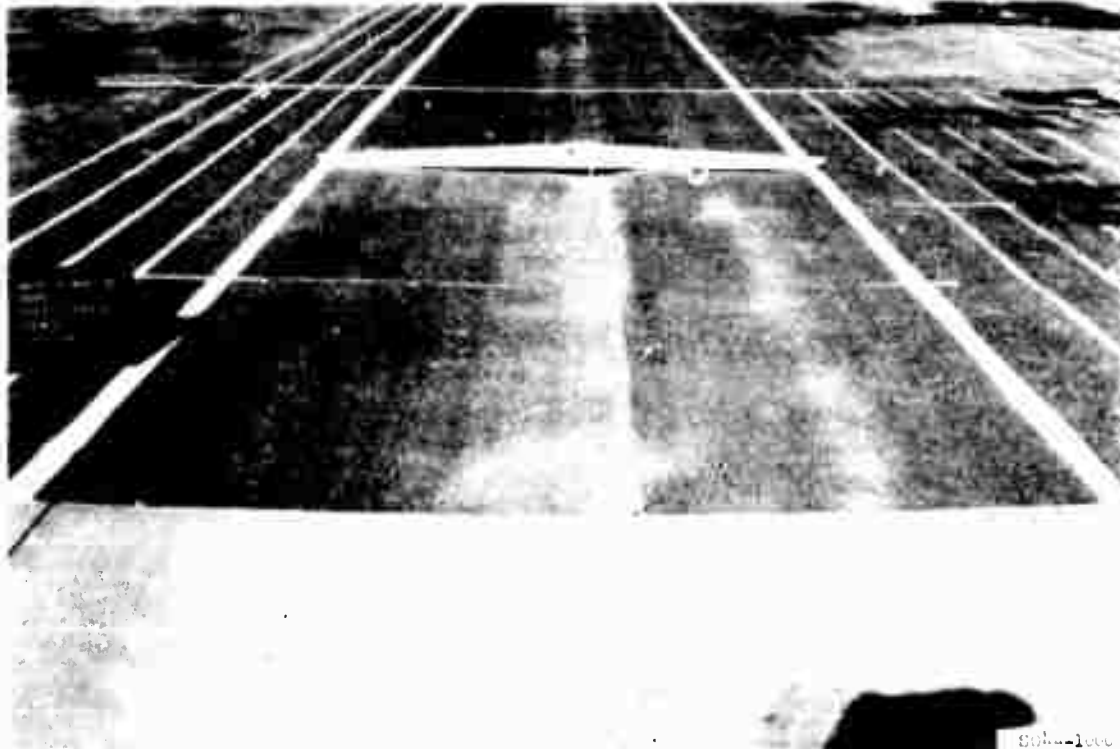
Figure B35. Cracking and deformation in item 4, lane 2, flexible pavement test section, at failure after 120 coverages of 240-kip twin-tandem assembly

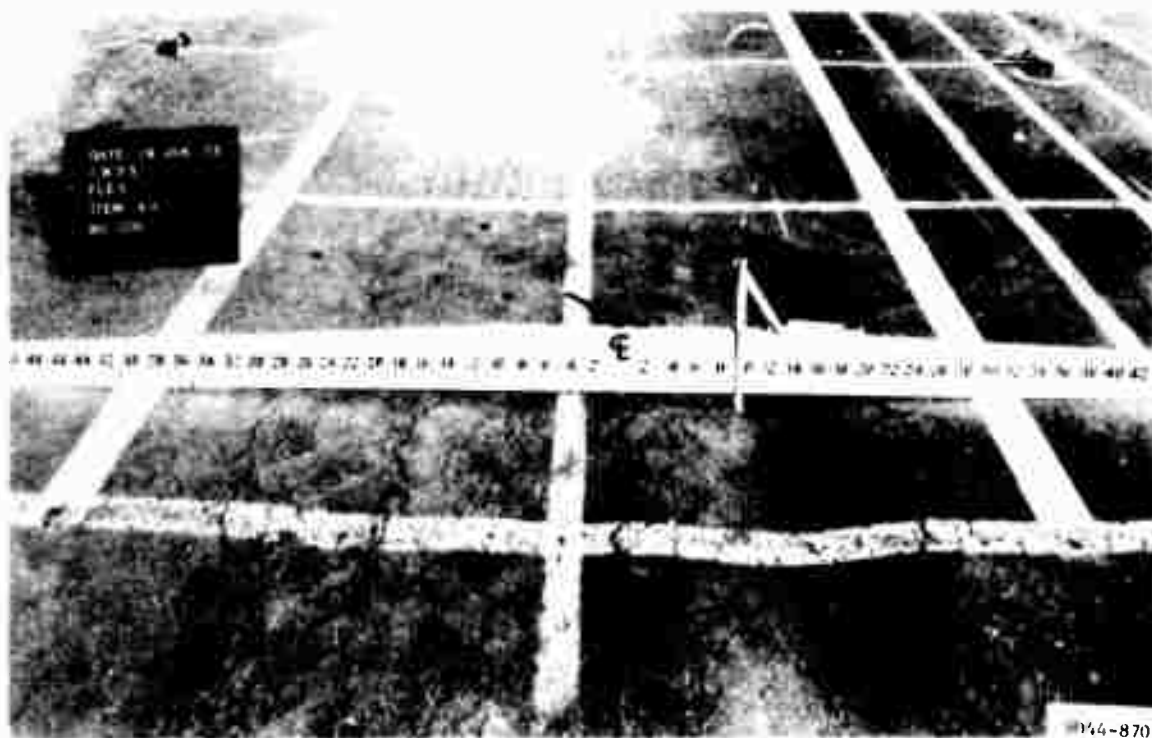
Figure B52. Cracking in subitem 4a, lane 3, flexible pavement test section, after 80 coverages of 50-kip single-wheel assembly

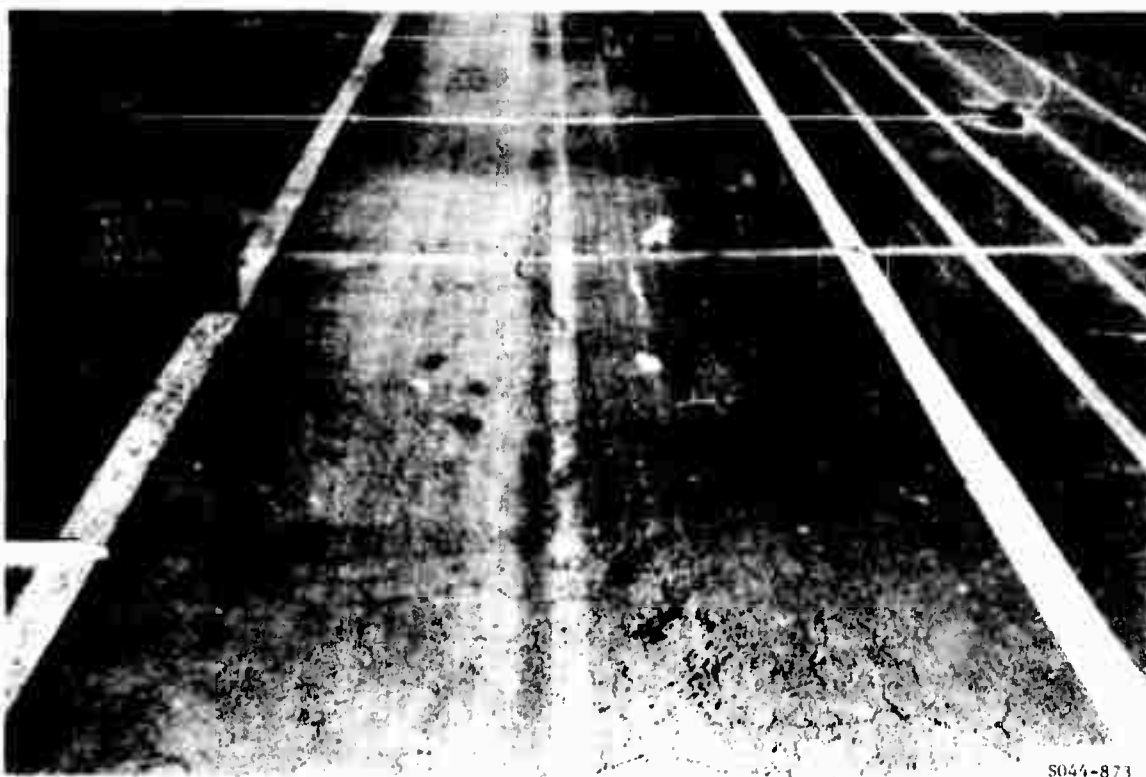
Figure B54. Cracking and deformation in subitem 4b, lane 3, flexible pavement test section, at failure after 170 coverages of 50-kip single-wheel assembly

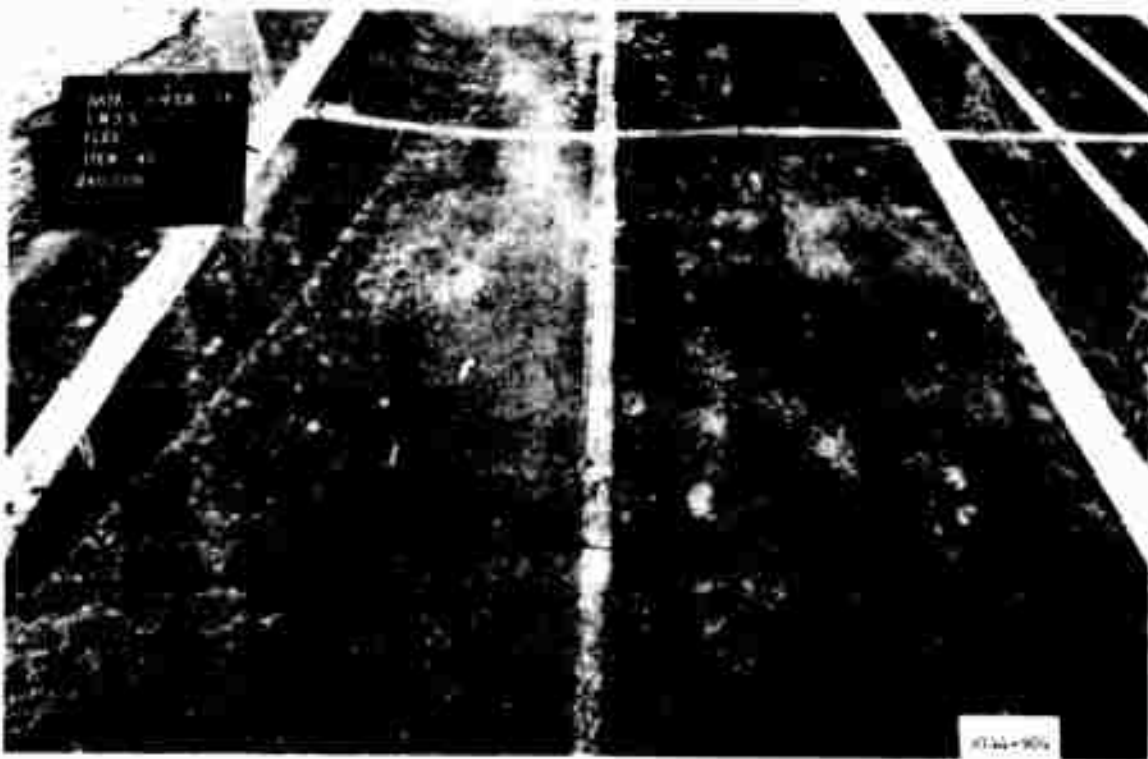
Figure B56. Cracking in subitem 4c, lane 3, flexible pavement test section, at failure after 240 coverages of 50-kip single-wheel assembly
