VITA-LIFE 400 G COATED FLEXIBLE CONDUIT
EXPOSURE TO FLOWING TAP WATER

M. A. Pelensky, et al

Frankford Arsenal
Philadelphia, Pennsylvania

August 1974

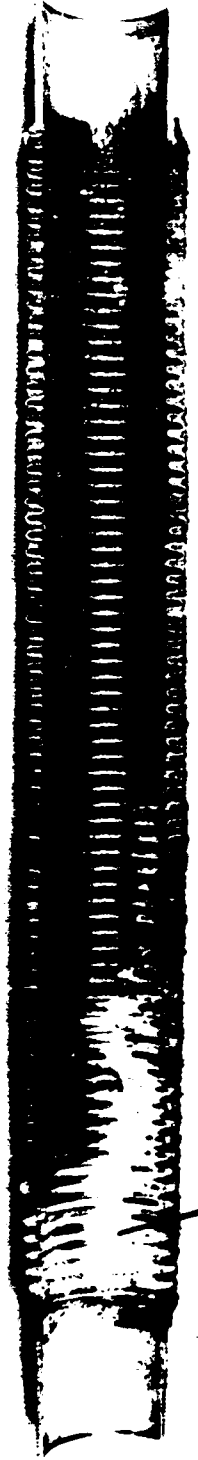
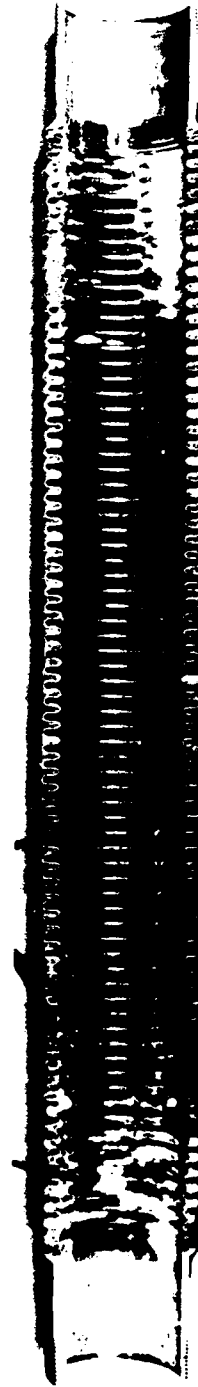
Figure 1. Four Inch Flexible Conduit - Three Months

Emulsification Rusting

During the first three days the flexible connector was subjected to flowing water (rate 2.5 gph), some whitening of the Vita-Life coating, caused by adsorption of water and emulsification, developed at the waterline, but no rusting of the conduit had occurred. But after a total period of three weeks in contact with flowing water (ca. 5 gph), partial loosening detachment of emulsified material had been noted to occur at the water-conduit interface. Rust spots, not too heavily developed, were apparent at many points along the waterline, but no rusting was observed on surfaces immediately adjacent to, above or below the waterline. Otherwise the Vita-Life coating had not altered in appearance from that when first applied⁷.

At the end of three months, it was noted that the emulsified coating had been removed partially by the flowing water, and that the rusting had progressed along the waterline the entire length of the test conduit⁸.
