BUREAU OF SHIPS GROUP
TECHNICAL INSPECTION REPORT.

(6) Operation Crossroads, U.S.S. Hughes (DD410)

(11) 1946

USS HUGHES (DD410)

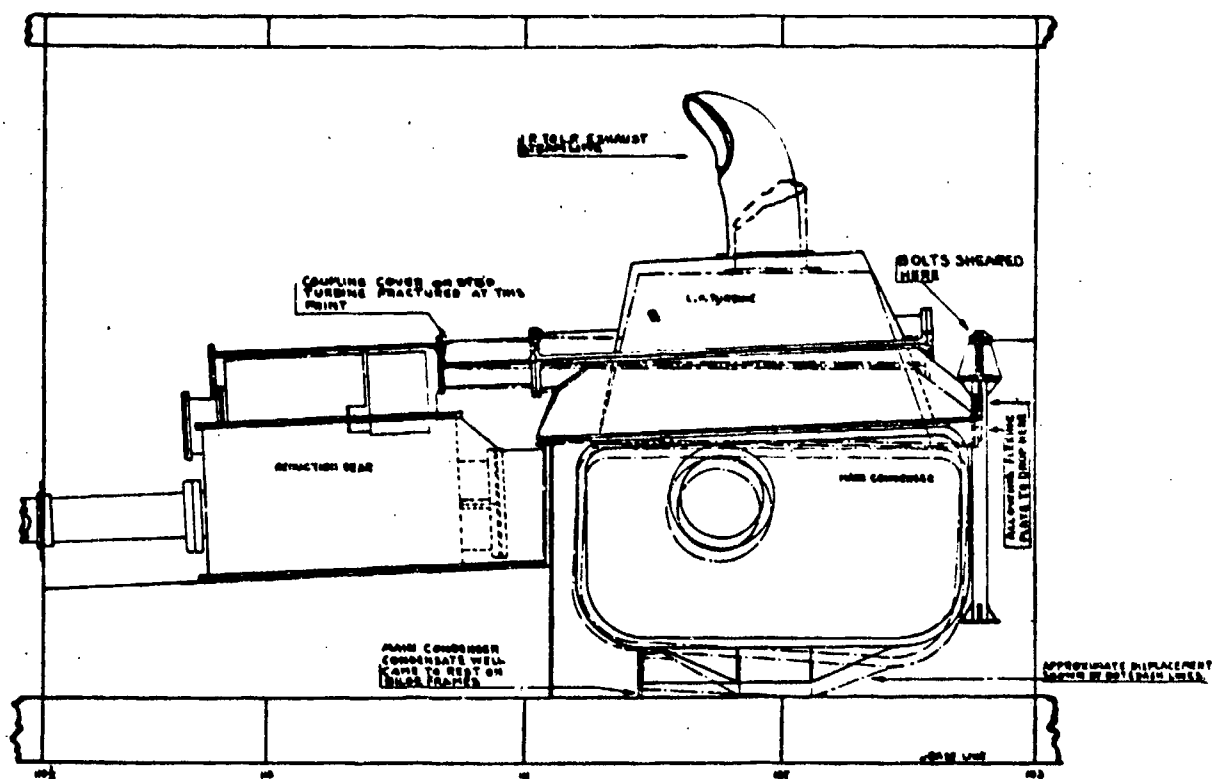
STANDARD LOW PRESSURE TURBINE, LOOKING TO PORT.
SCALE 1/2" = 1 FOOT.

U.S. HUGHES
TEST BAKER
ORIGINAL POSITION
SHOWN IN SOLID LINES.
DISPLACEMENT SHOWN
IN DASH LINES.
FACILITY GROUP
CORRESPOND
80-403-31-2.

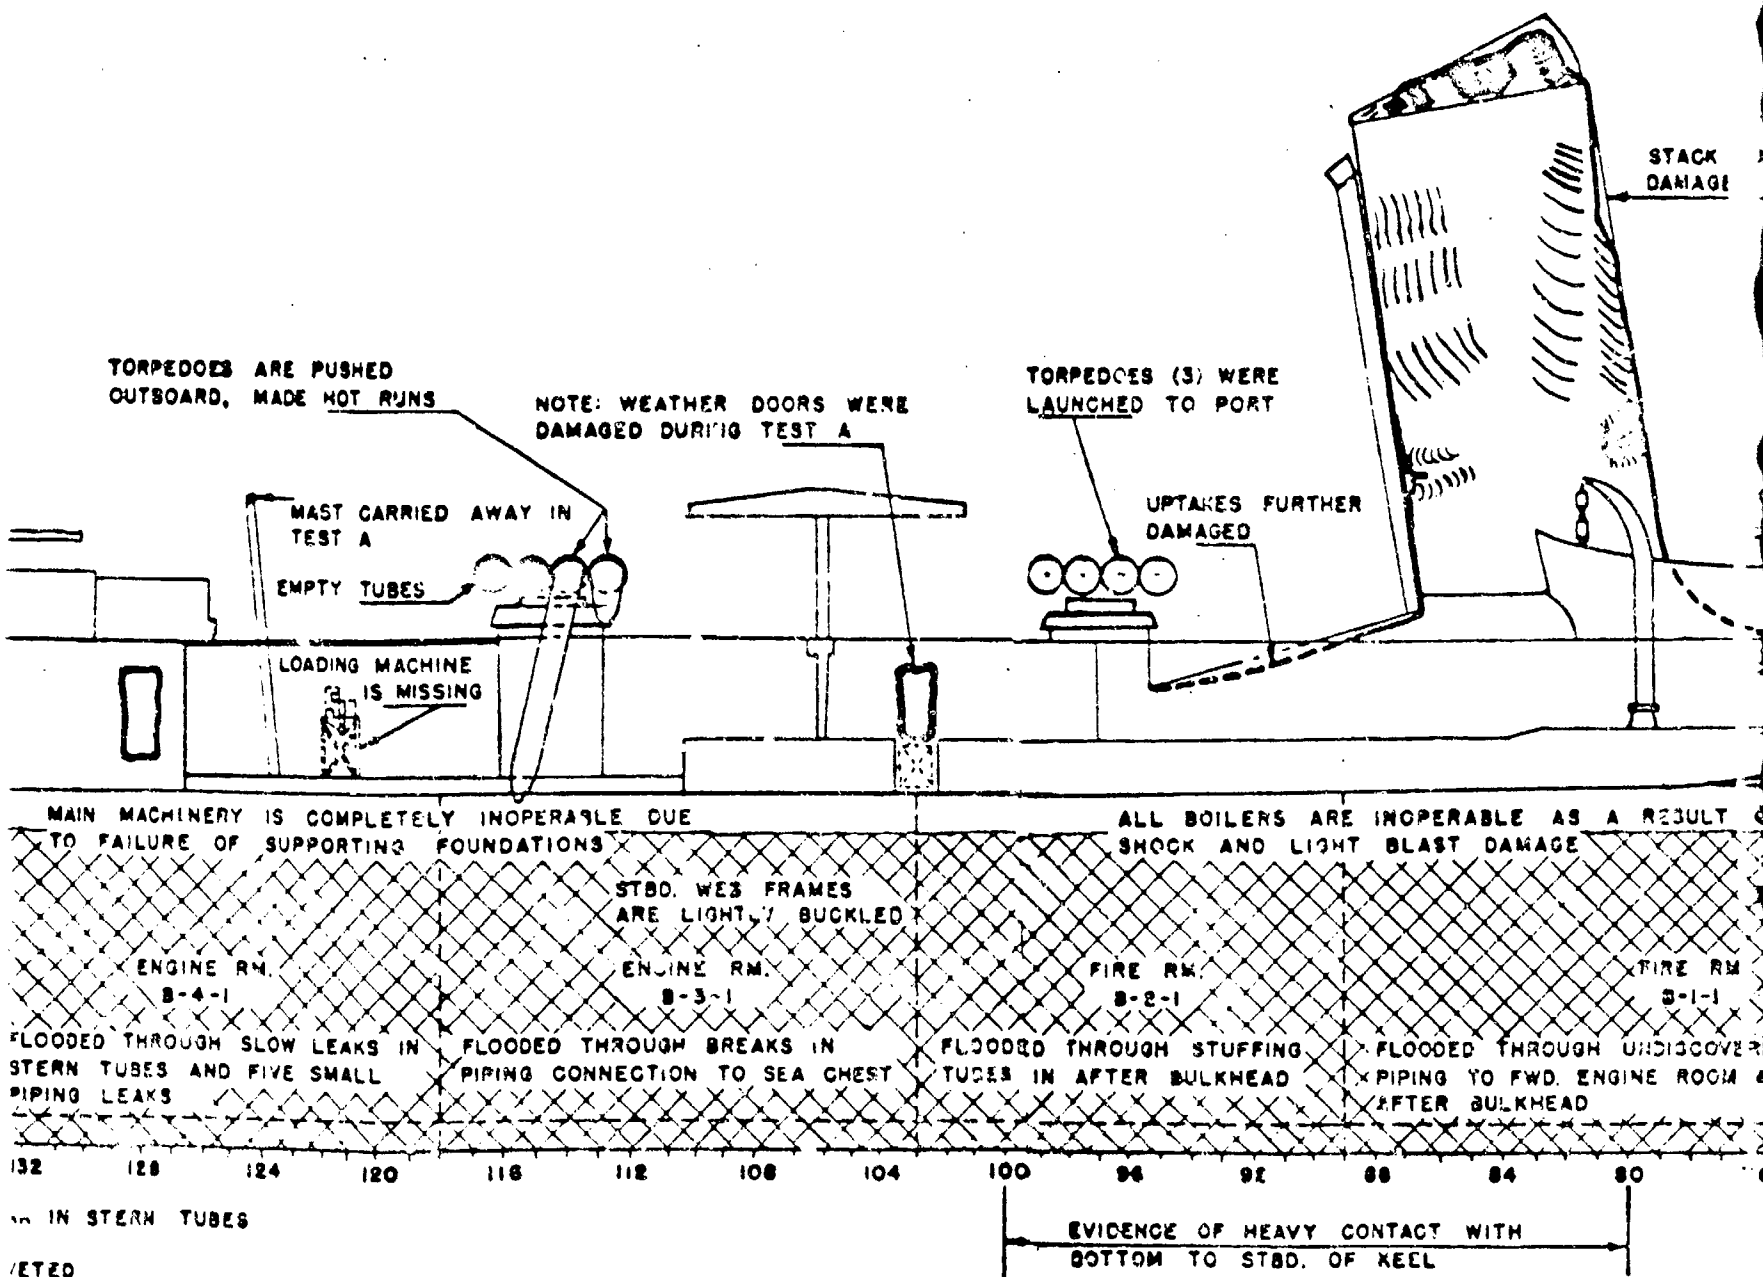
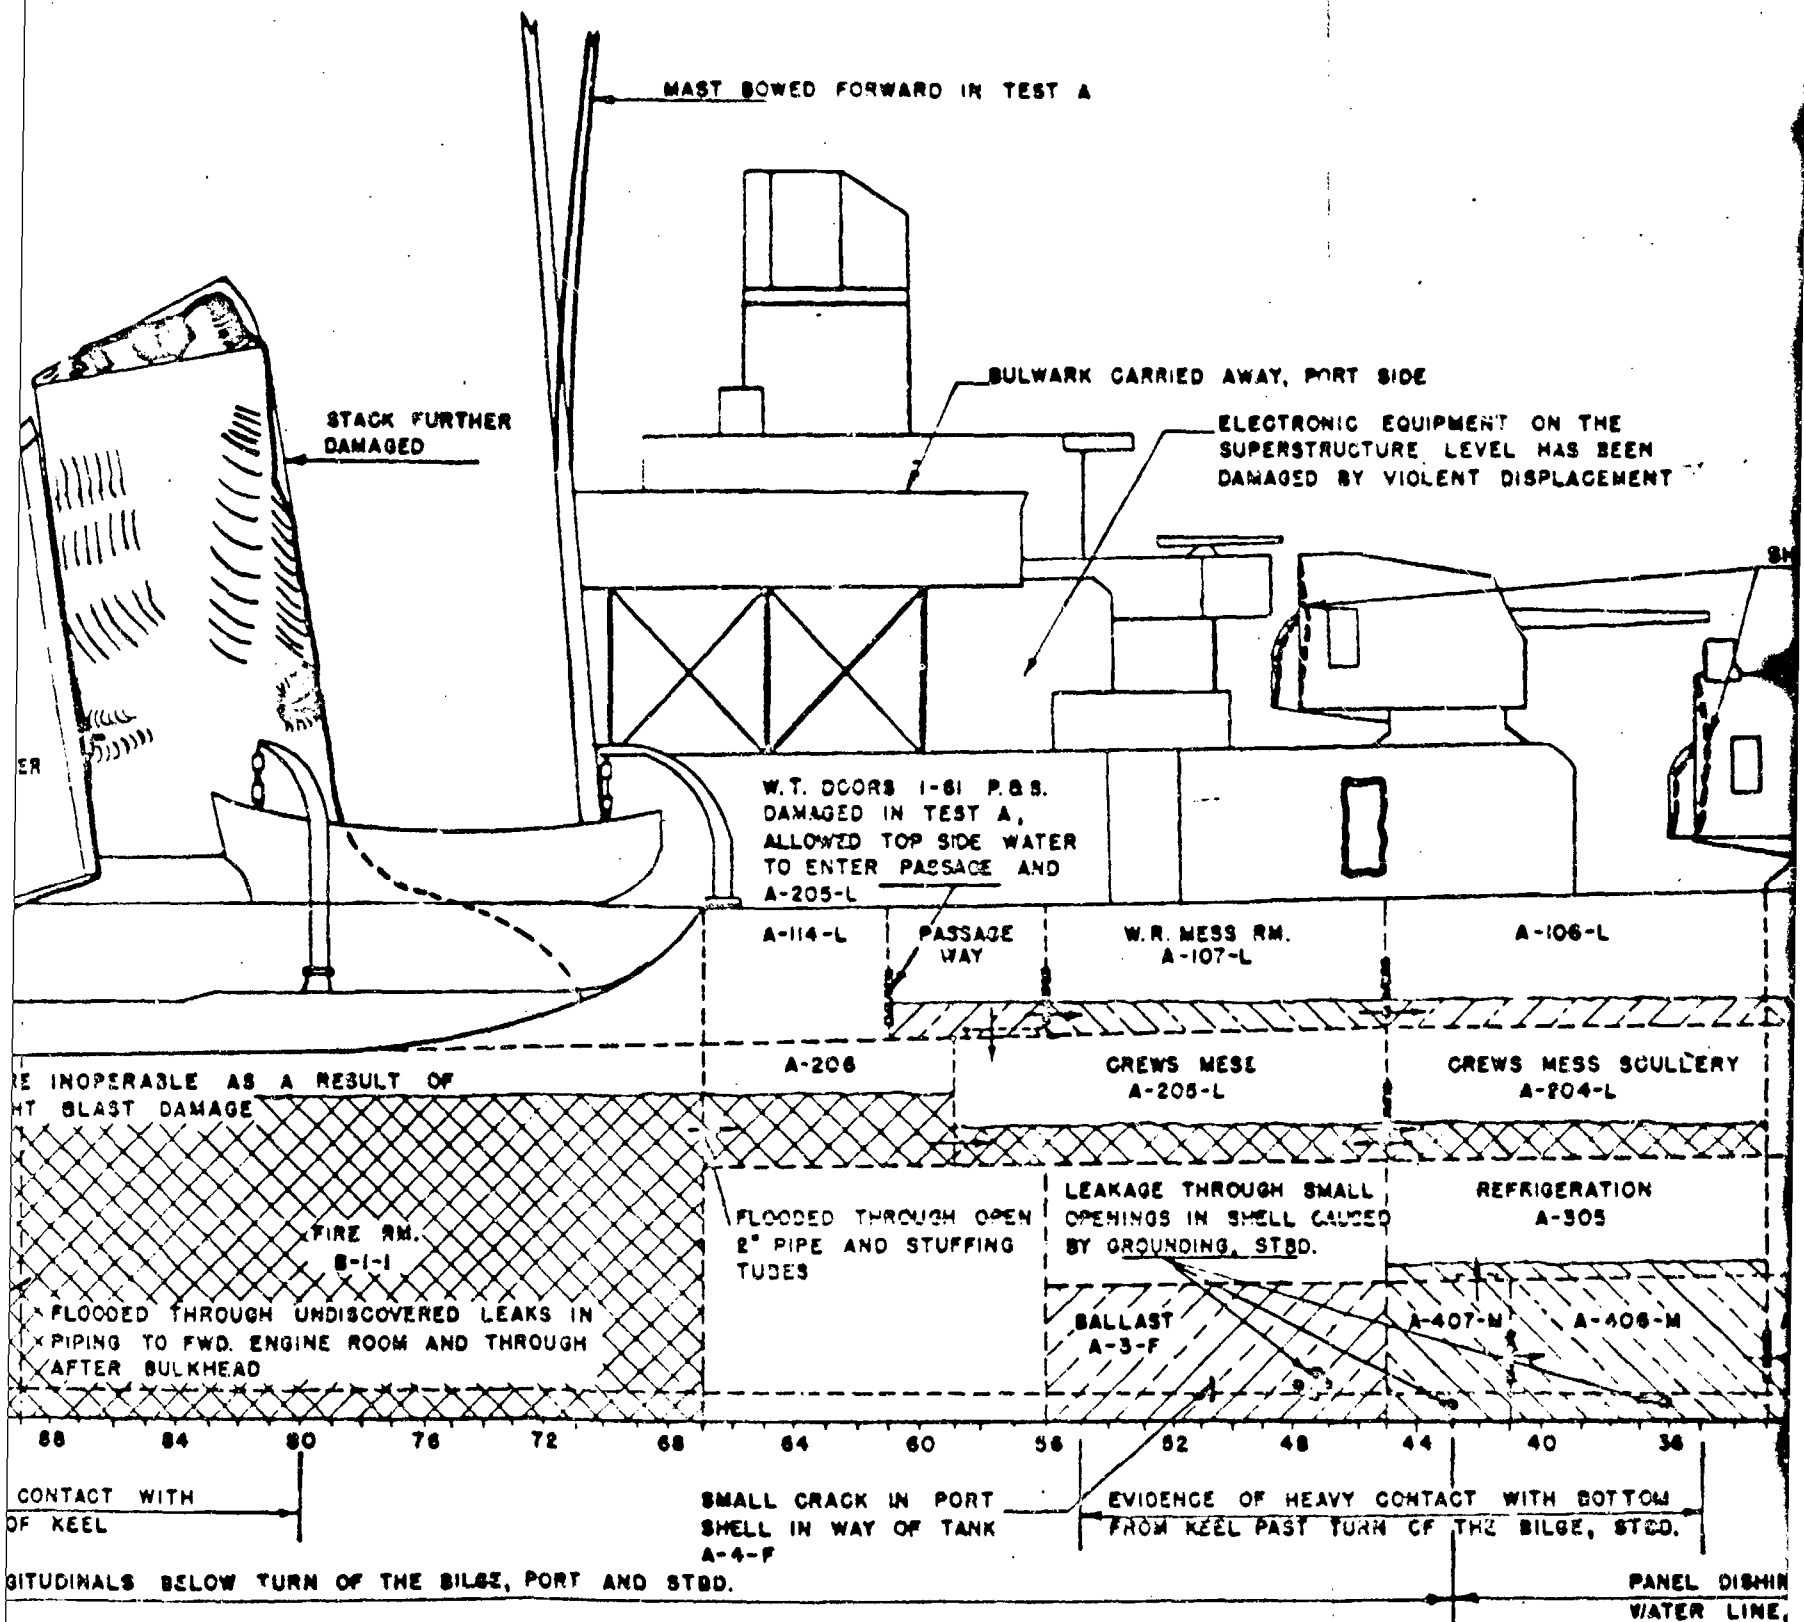
PLATING IS LIGHTLY DISHED IN LONG CONCAVE SECTIONS BETWEEN LONGITUDINALS BELOW TURN OF THE

CARRIED AWAY, PORT SIDE

ELECTRONIC EQUIPMENT ON THE
SUPERSTRUCTURE LEVEL HAS BEEN
DAMAGED BY VIOLENT DISPLACEMENT

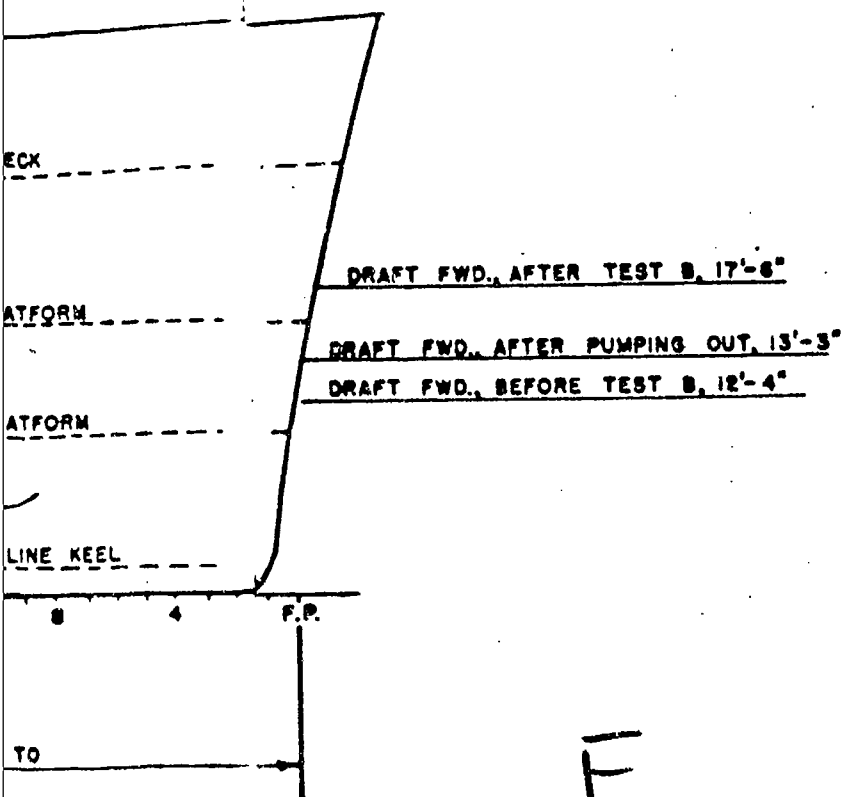
PANEL DISHING BETWEEN FRAMES AND LONGITUDINALS FROM KEEL TO
WATER LINE, PORT AND STD.
