6  
NASA/AGENA-B RANGER PROGRAM  
LAUNCH PAD DAMAGE REPORT  
for  
ATLAS 117D/AGENA-B 10205-6002  
RANGER SPACECRAFT RA-2  
COMPLEX 12, AMR.

14 IMSC-271411

This report is submitted in accordance with the requirements of Contract AF 04(647)-592. It covers the damage to the launch pad and Aerospace Ground Equipment (AGE) at Complex 12, AMR, resulting from the launch of Ranger Spacecraft RA-2/Agna-B Vehicle 6002/Atlas Booster 117D on 18 November 1961.

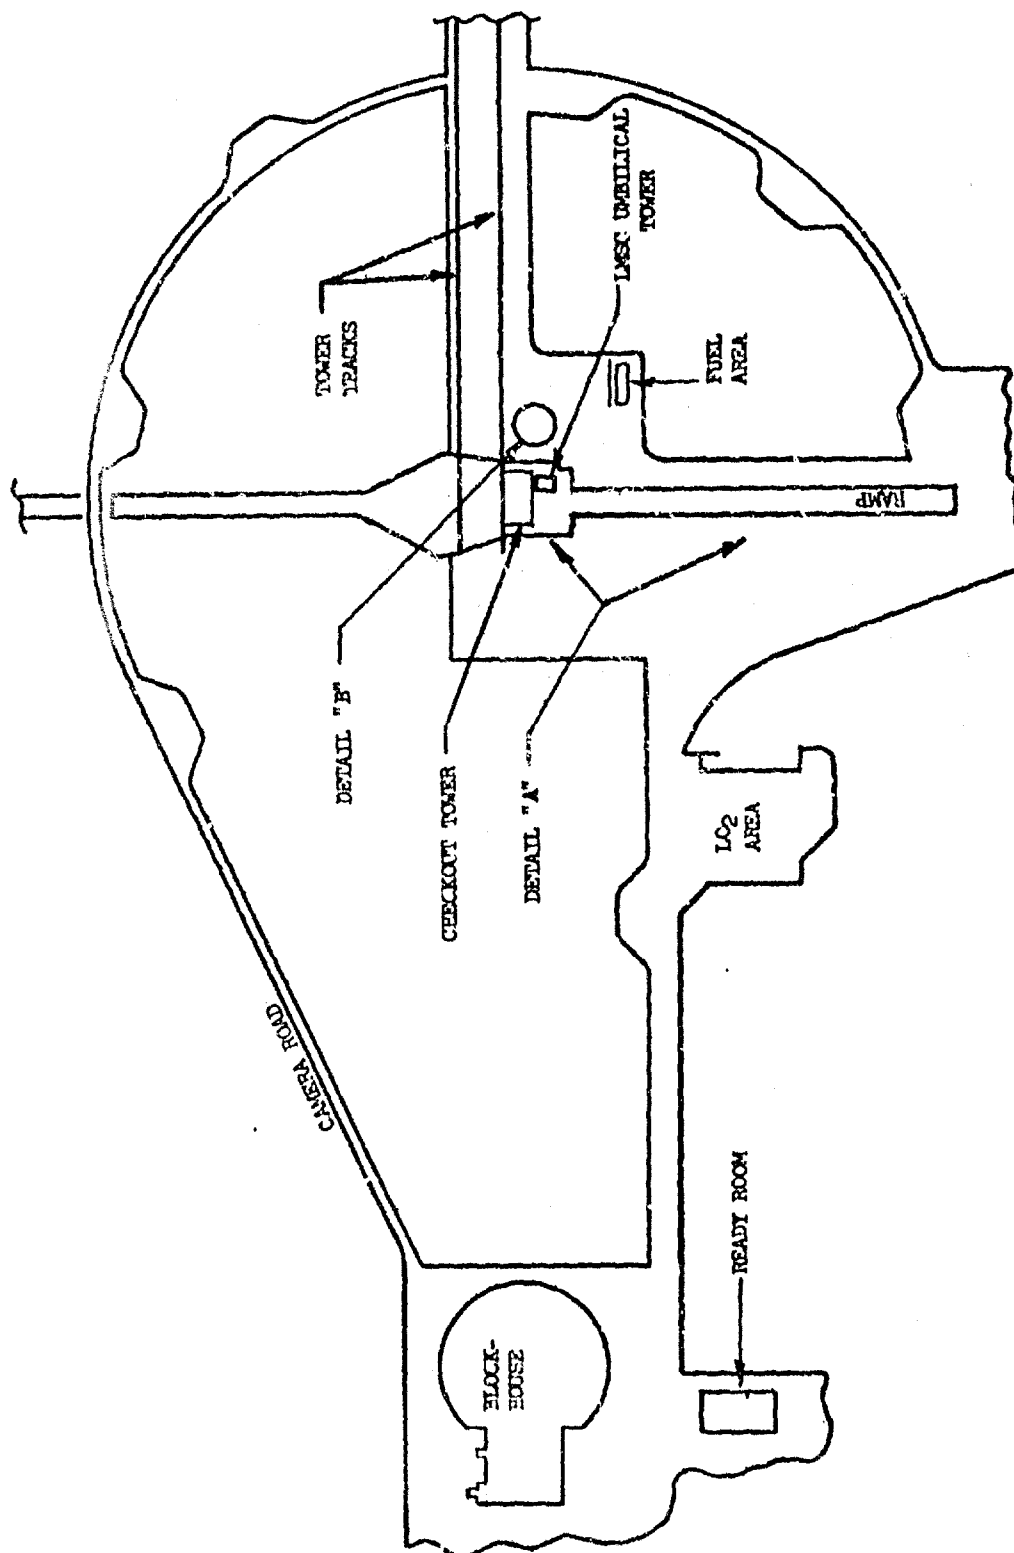
Figure 2-1. Major AGE Components, Complex 12

Figure 2-1 presents an overall view of Complex 12 and location of major AGE components. Figure 2-2, Detail "A", indicates the location of GD-A components relative to the launch area. Figure 2-2, Detail "B", shows the location of LMSC components in relation to the launch area.
