AFFDL-TR-66-43
PART VII

**AIRCRAFT GROUND-FLOTATION INVESTIGATION
PART VII DATA REPORT ON TEST SECTION 6**

W. BRABSTON and W. HILL, JR.
U. S. ARMY ENGINEER WATERWAYS EXPERIMENT STATION

AUGUST 1966

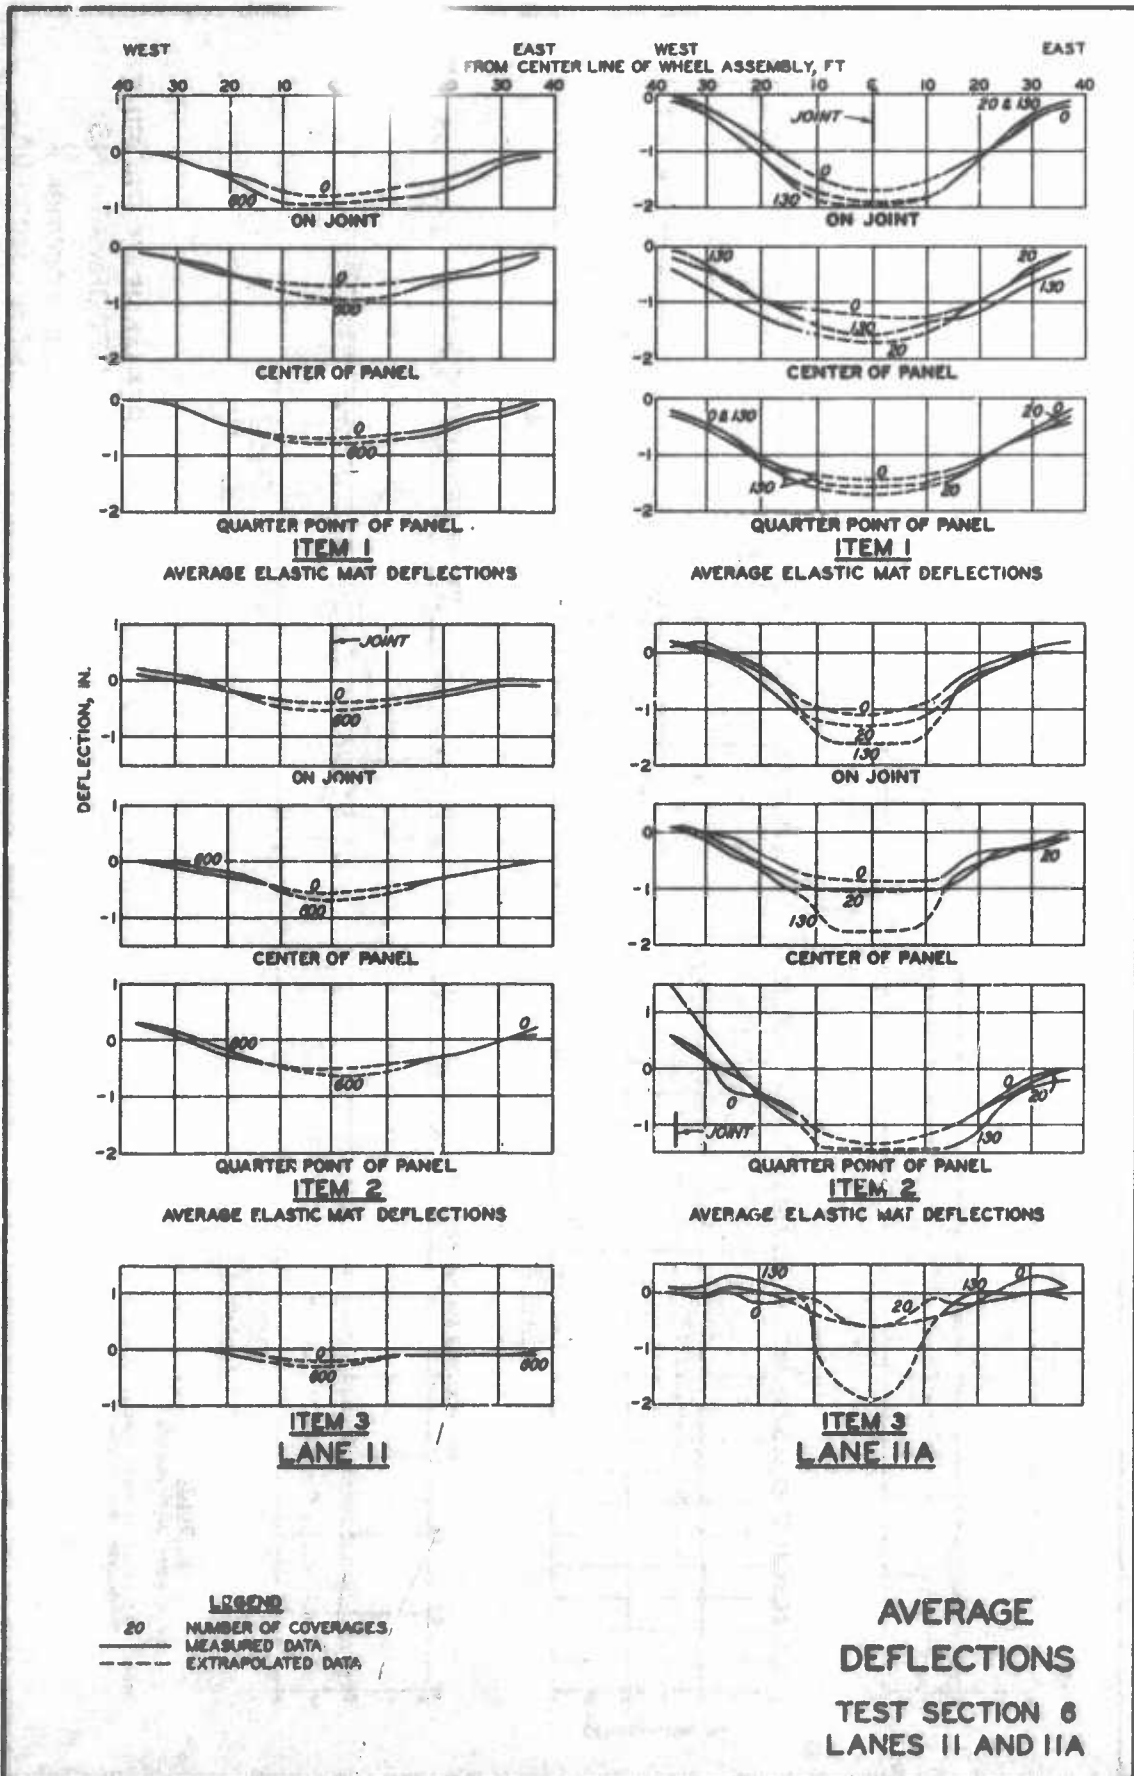
Figure 23

- c. Deflection. Average elastic mat deflections under static load of the load-wheel assembly are shown in figure 23 for three positions of the assembly relative to mat end joints. Elastic soil deflection at failure was 2.1 in.

- c. Deflection. Average elastic mat deflections under static load of the load-wheel assembly are presented in figure 23 for three positions of the assembly relative to mat end joints. Elastic soil deflections are shown in table 1 and reached 0.9 in. at failure.

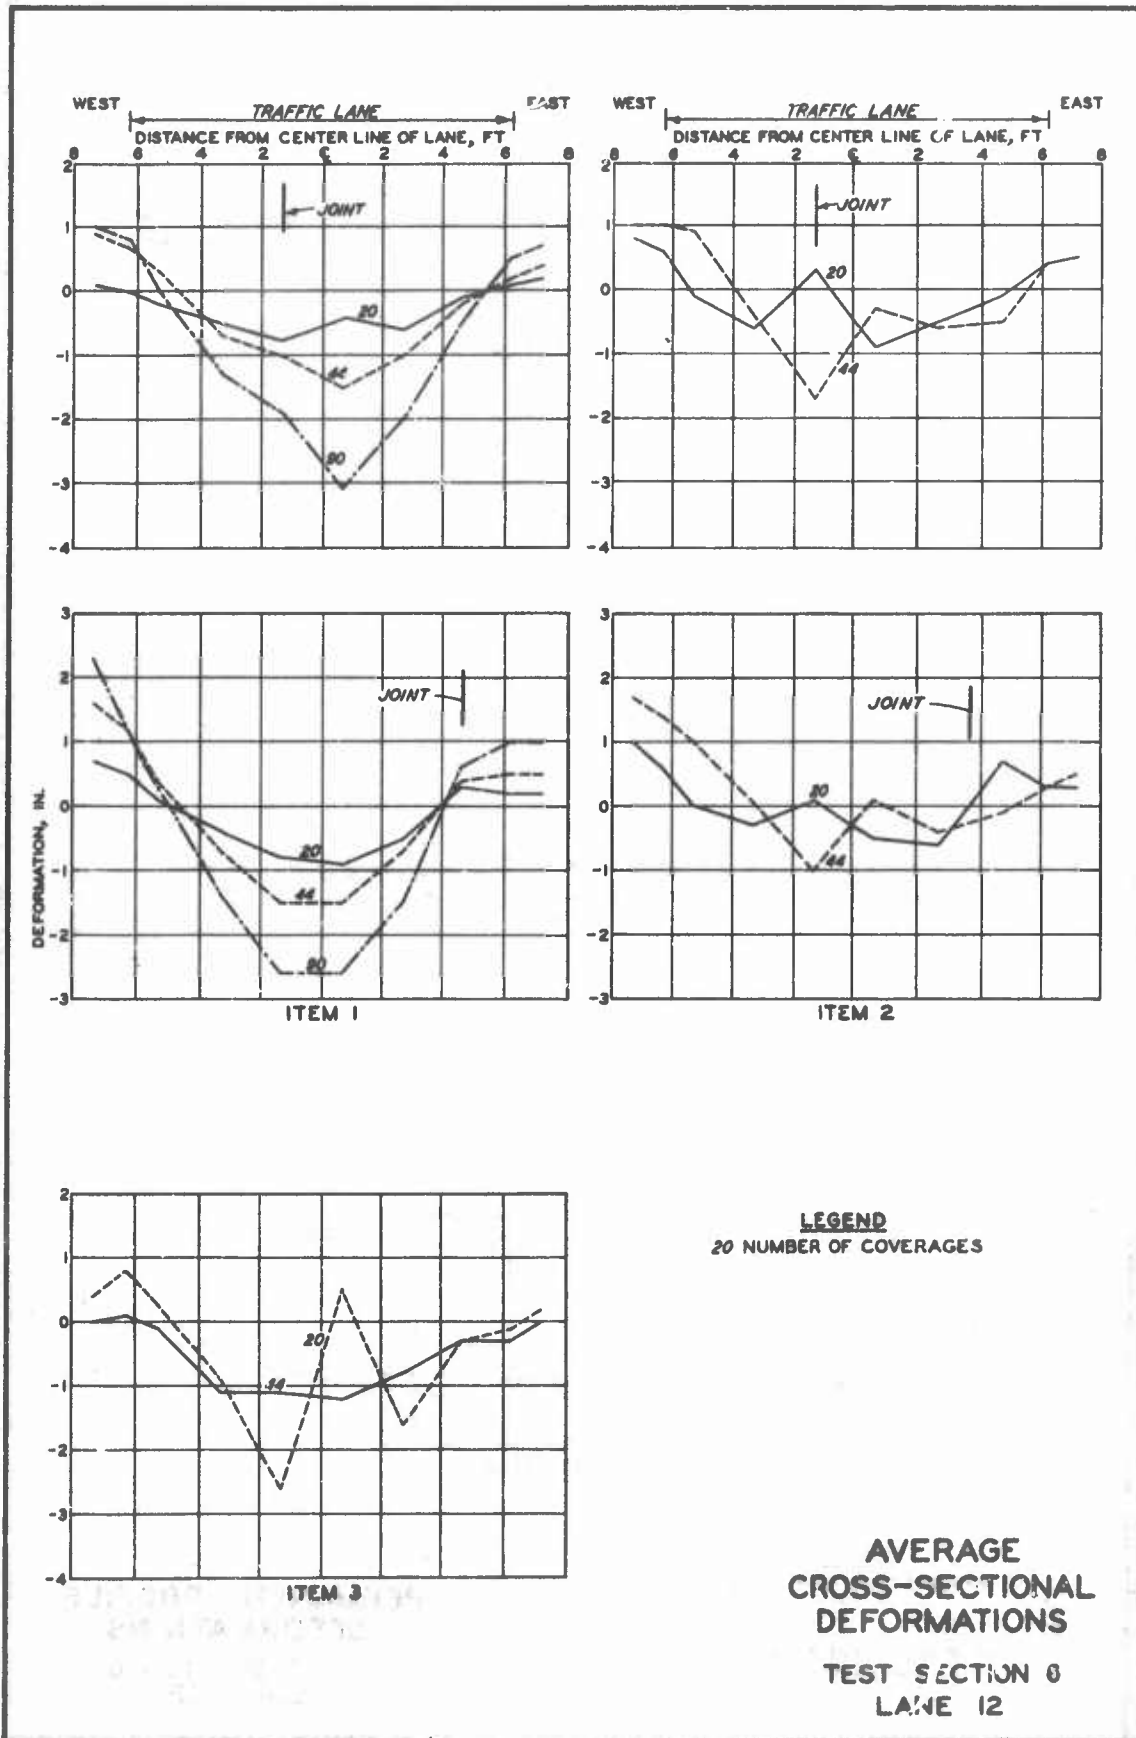
- b. Deformation. Figure 24 shows average cross-section deformations at several coverage levels for two typical mat runs. Center-line profiles are shown in figure 25. Deformations are seen to follow a consistent pattern of increasing severity with trafficking, reaching maximum values at failure of the item.

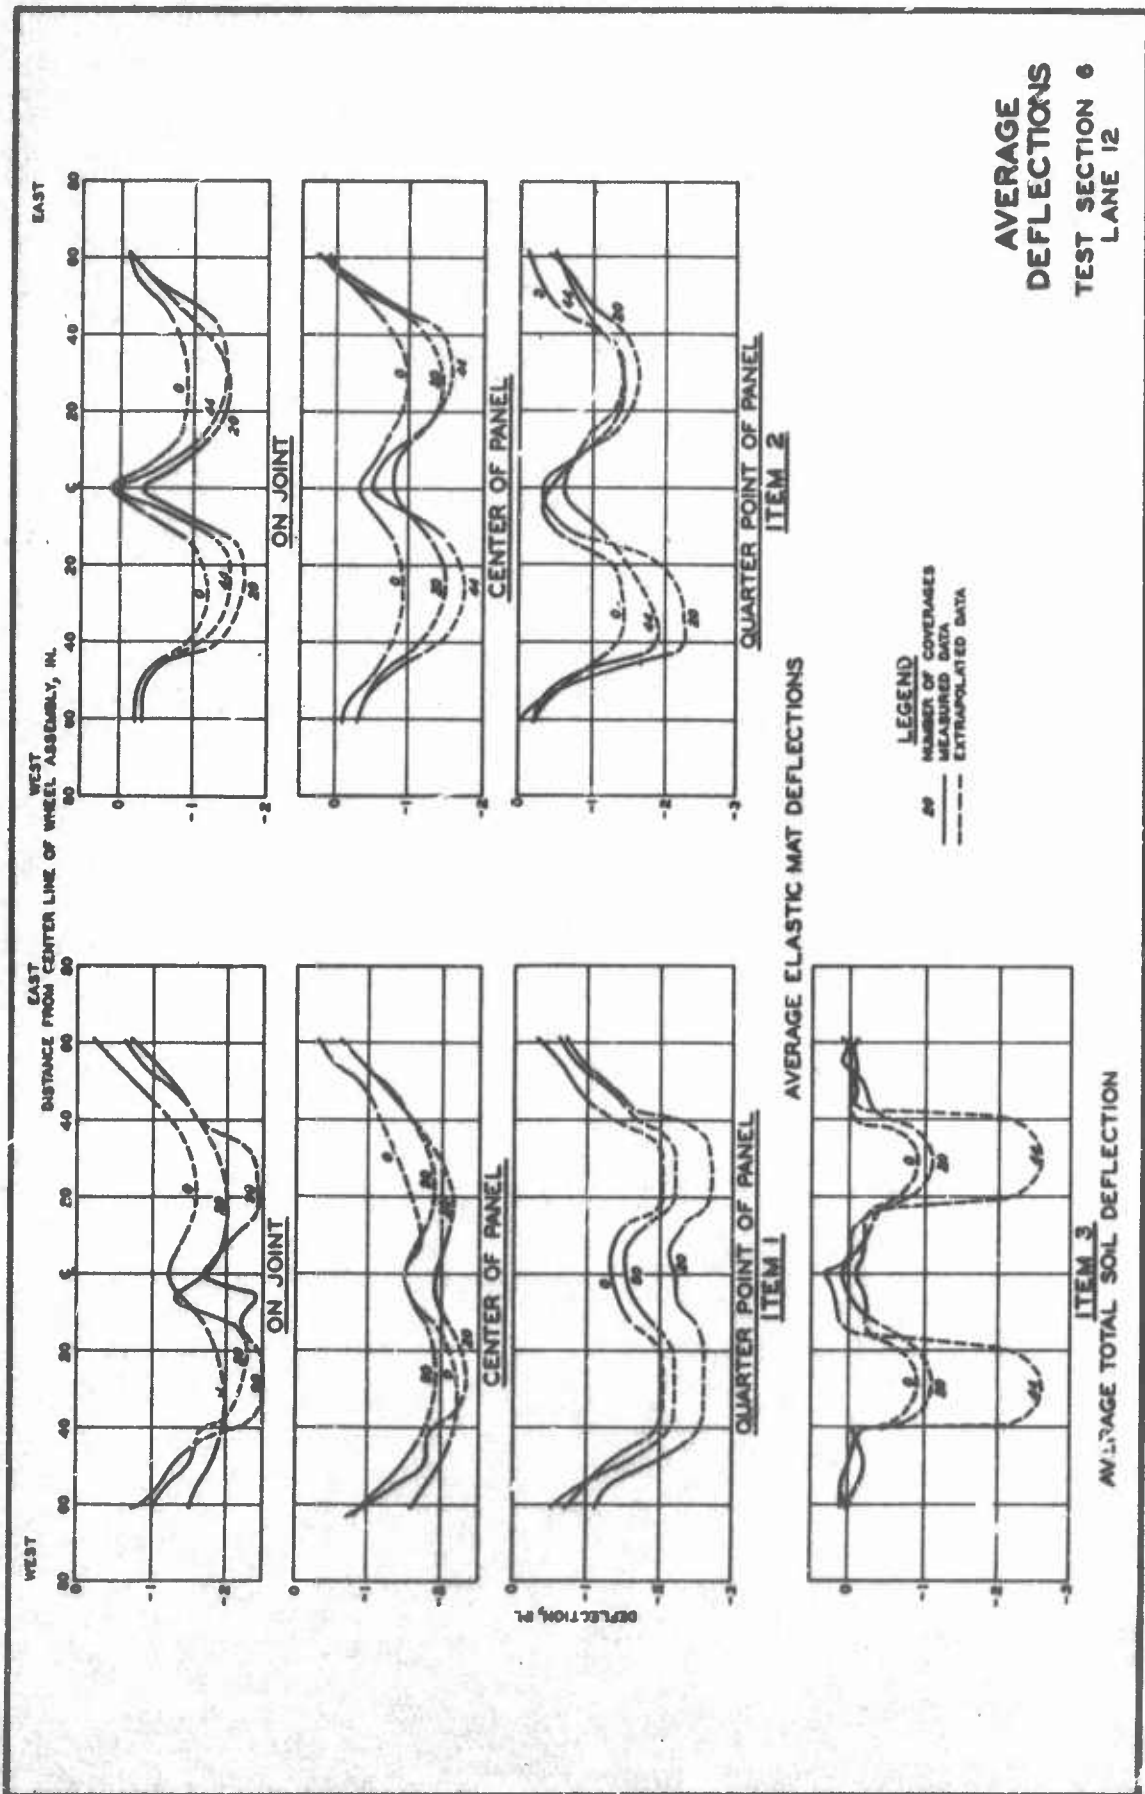
Figure 26

- c. Deflection. Average elastic mat deflections under static load of the load-wheel assembly are shown in figure 26 for three positions of the assembly relative to mat end joints. Deflection measurements were not always consistently greater with higher coverage levels, but decreased in some cases from earlier measurements. Elastic soil deflection at failure measured 2.5 in.

- c. Deflection. Average elastic mat deflections under static load of the load-wheel assembly are shown in figure 26 for three positions of the assembly relative to mat end joints. In some instances, it is seen that the greatest deflections did not always correspond with higher coverage levels. Elastic soil deflections, shown in table 1, measured 1.2 in. at failure.

- c. Deflection. Average total soil deflections are shown in figure 26 for 0, 20, and 44 coverages. A large increase in total deflection is noted at 44 coverages. Elastic soil deflections are shown in table 1. The maximum elastic deflection value recorded was 0.7 in. at failure of the item.
