REPORT ON USATECOM PROJECT NO. 8-3-0030-08-F,

PRODUCT IMPROVEMENT TEST OF

MODIFIED AR15 RIFLES

REPORT NO. DPS-1276

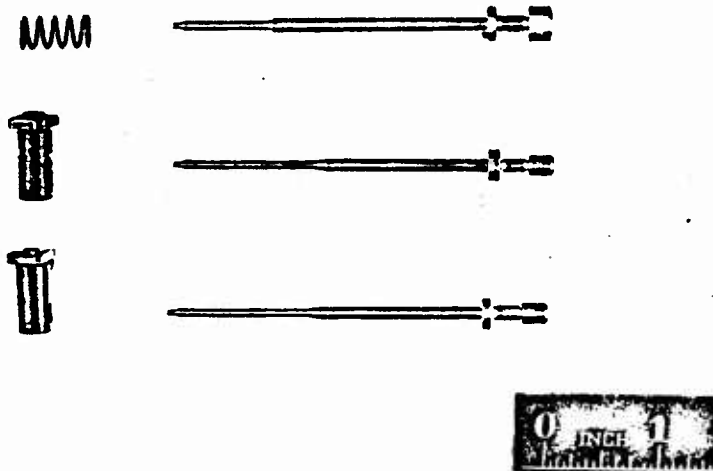
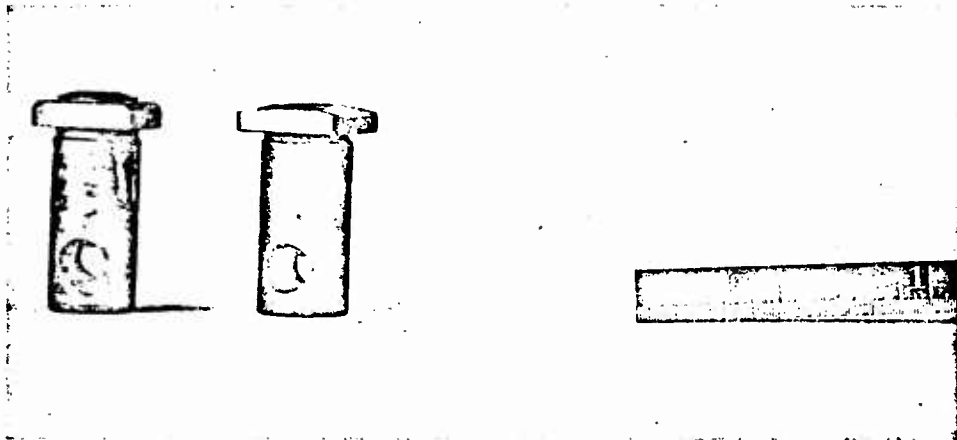
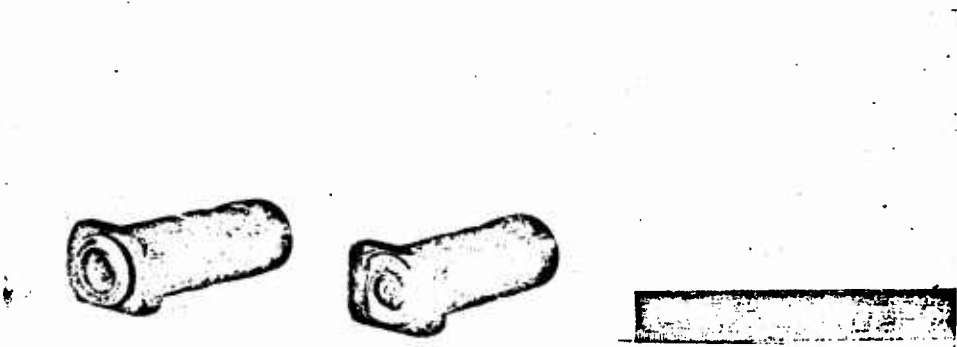
Figure 5: Three Modified Firing Pins for AR15 Rifle. TOP: Lineal Spring and Firing Pin. CENTER: First Friction Cam Pin and Firing Pin. BOTTOM: Second Friction Cam Pin and Firing Pin.

Figure 6: Two Modifications of Friction Cam Pins Showing Firing Pin Hole Differences.

Figure 7: Two Different Modifications of Friction Can Pins, Top View.

Although the firing pin with the helical compression spring performed satisfactorily, energy developed by this pin, when struck by the hammer, was reduced to a level below the present primer-sensitivity limit. The second bolt cam pin design permits greater impact energy when the firing pin is struck by the hammer and adequately controls inertial firing pin energy during chambering. Misalignment of the firing pin with the hole in the bolt face, caused by pressure of the bolt cam pin plunger on the firing pin, resulted in a damaged firing pin tip which caused pierced primers.

- c. Test data do not indicate the need for a firing pin inertia retarding device. If it is determined that such a device is desirable, the firing pin with the helical compression spring appears more promising since damage to the firing pin tip is avoided. Additional development will be required to increase the striking energy of this type of firing pin when struck by the hammer (ref Figures 5, 6, and 7, Tables III, XIV, and XV, and Appendix C).

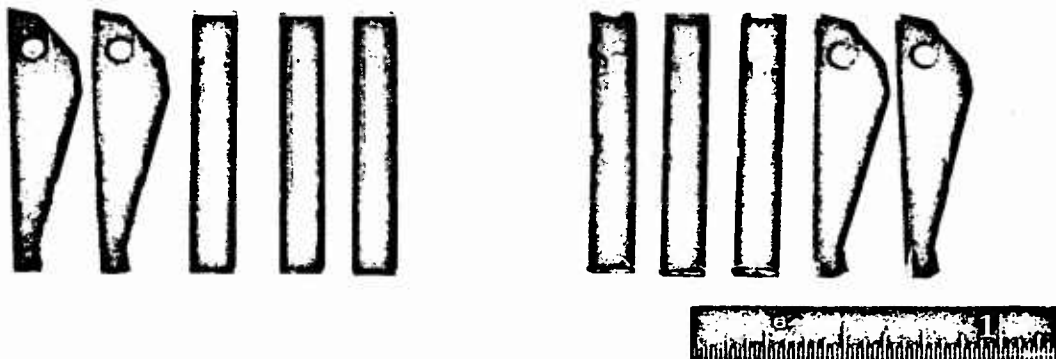
Weakness of the bolt closure plunger spring permitted the bolt closure pawl to interfere with rearward travel of the bolt carrier during firing. This resulted in damage to the pawl and pawl retaining pin in each weapon. Failure of the pawl and the retaining pin occurred after firing an average of 1993 rounds in each weapon. A second design incorporating a stronger bolt closure plunger spring and a redesigned bolt closure pawl corrected the problem of short parts life. Figure 8 compares pawl tip deformation after completion of all firing. The bolt closure device successfully assisted the chambering of all rounds which failed to completely

Figure 8: Bolt Closure Pawl Tip Deformation. Right, First Design. Left, Second Design.

- a. The frequency of feeding and chambering malfunctions indicates the necessity of a positive method of manually assisting the forward movement of the bolt and bolt carrier assemblies. The bolt closure device with 1.30-inch-long plunger spring and pawl with straight tip, hardened to Rockwell C 53, was adequate in performing its intended function (ref Figures 3 and 8 and Tables IV, V, and XV).

- a. The 1.30-inch-long bolt closure plunger spring and plunger pawl with straight tip, hardened to Rockwell C 53, be considered for adoption.
- b. The configuration of the charging handle be considered satisfactory and that fabrication of this part be improved to exclude any possibility of separation of the handle from the tang.
- c. A firing pin inertia retarding device not be considered necessary.
- d. Extractor spring life be improved.
- e. Strength of the bolt catch spring be increased.

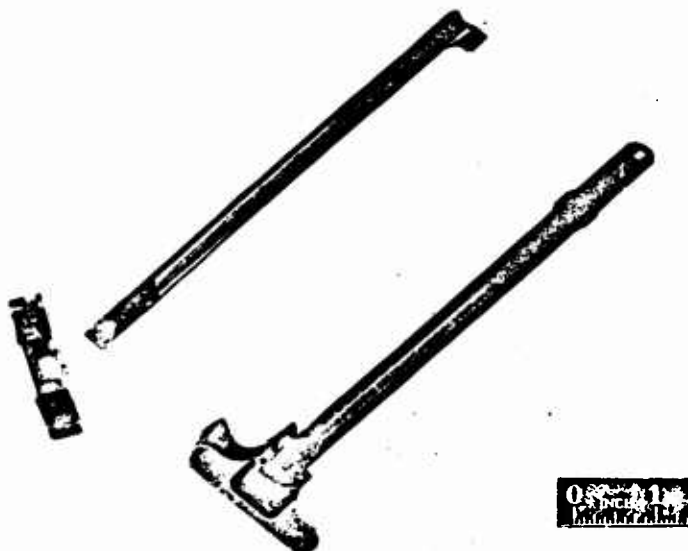
The charging handle provides adequate gripping area to facilitate retraction of the bolt and bolt carrier assemblies; however, the 2-piece fabrication of this charging handle is unsatisfactory because of separation of the tang from the handle at the weld (Figure 9).

Figure 9: Broken Charging Handles Showing Separation of Tang from Handle at Weld.

- b. The modified charging handle design provides adequate means for retracting the bolt and bolt carrier assemblies; however, fabrication should be changed to avoid separation of the tang from the handle at the weld. No other malfunctions of the charging handle were observed (ref Figure 9 and Table XVII).

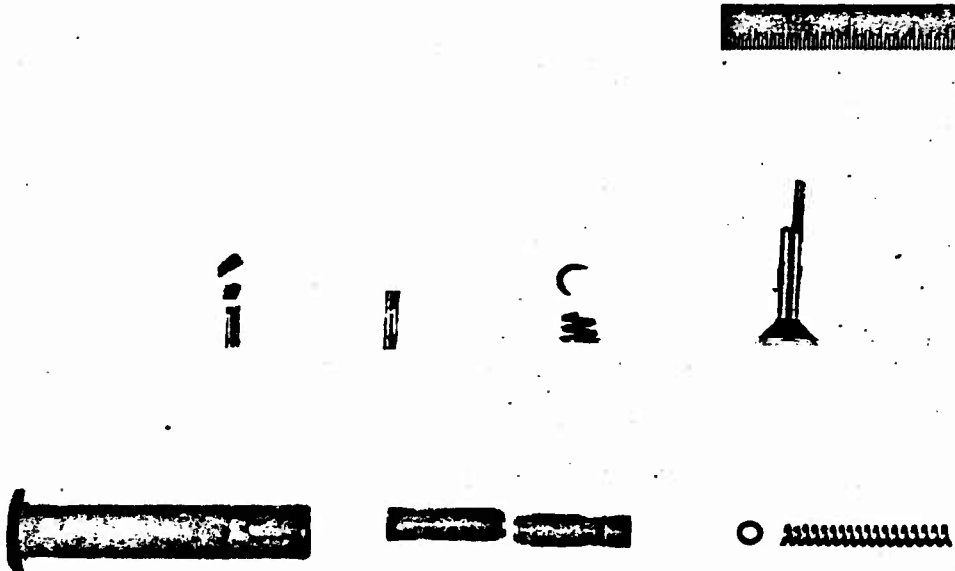
**2.1.2 Results.** All weapons were in operating order. Tables I through V contain the measurements discussed in the procedure. Figure 10 shows the various parts of the AR15 rifle which were damaged by firing. General characteristics of the modified AR15 rifle are given in Figure 11.

Figure 10: Broken Parts Encountered during Testing. TOP: Broken Bolt Closure Pawl Pin, Deformed Pawl Pin, Extractor Spring, and Firing Pin Retaining Pin. BOTTOM: Receiver Pivot Pin, Hammer Pin, and Ejector Spring.
