(6) 156-INCH DIAMETER MARAGING STEEL CASE  
HYDROBURST AND MATERIALS EVALUATION

(9) Final rept. Mar-Dec 66,  
Lockheed Propulsion Company  
Redlands, California  
*technical*

TECHNICAL REPORT NO. AFRPL-TR-66-350

Activities in the hydroburst of a previously fired 156-inch diameter, maraging steel motor case are described. The program encompassed discontinuity stress analysis of the large, welded vessel, an evaluation of ultrasonic inspection methods by post-test sectioning, and a detailed failure analysis.

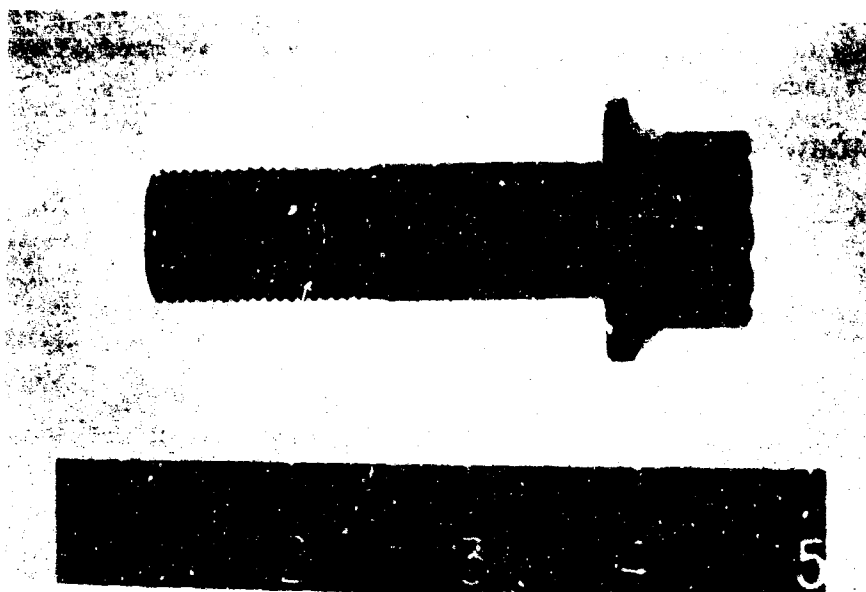
Figure 21 Thread Damage Found on Many of the Bolts

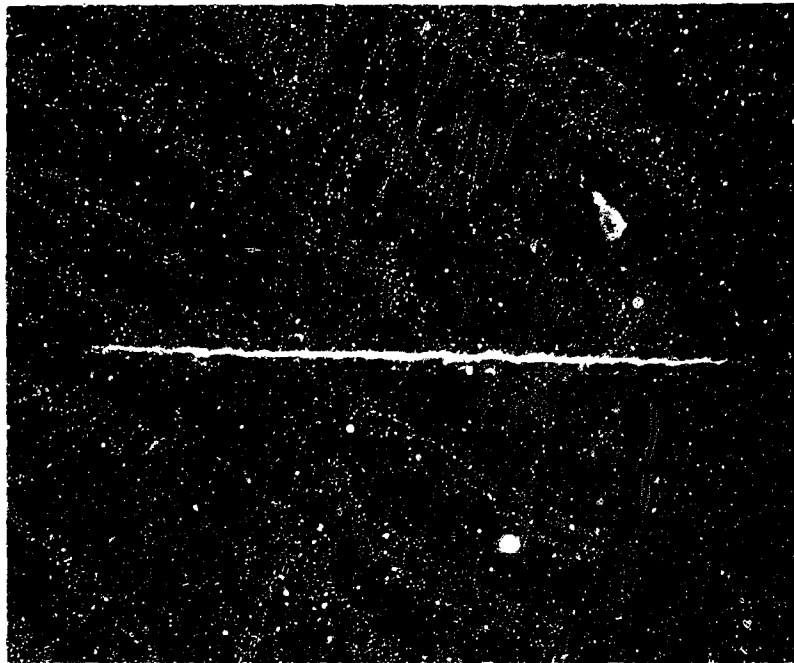
**Figure 140** Photograph of Defect No. 13 Illustrating the Delaminations Found in Plate 28A. The Thick White Line is the Delamination and the Thin White Lines are Segregated Stringers of Titanium Carbonitrides.

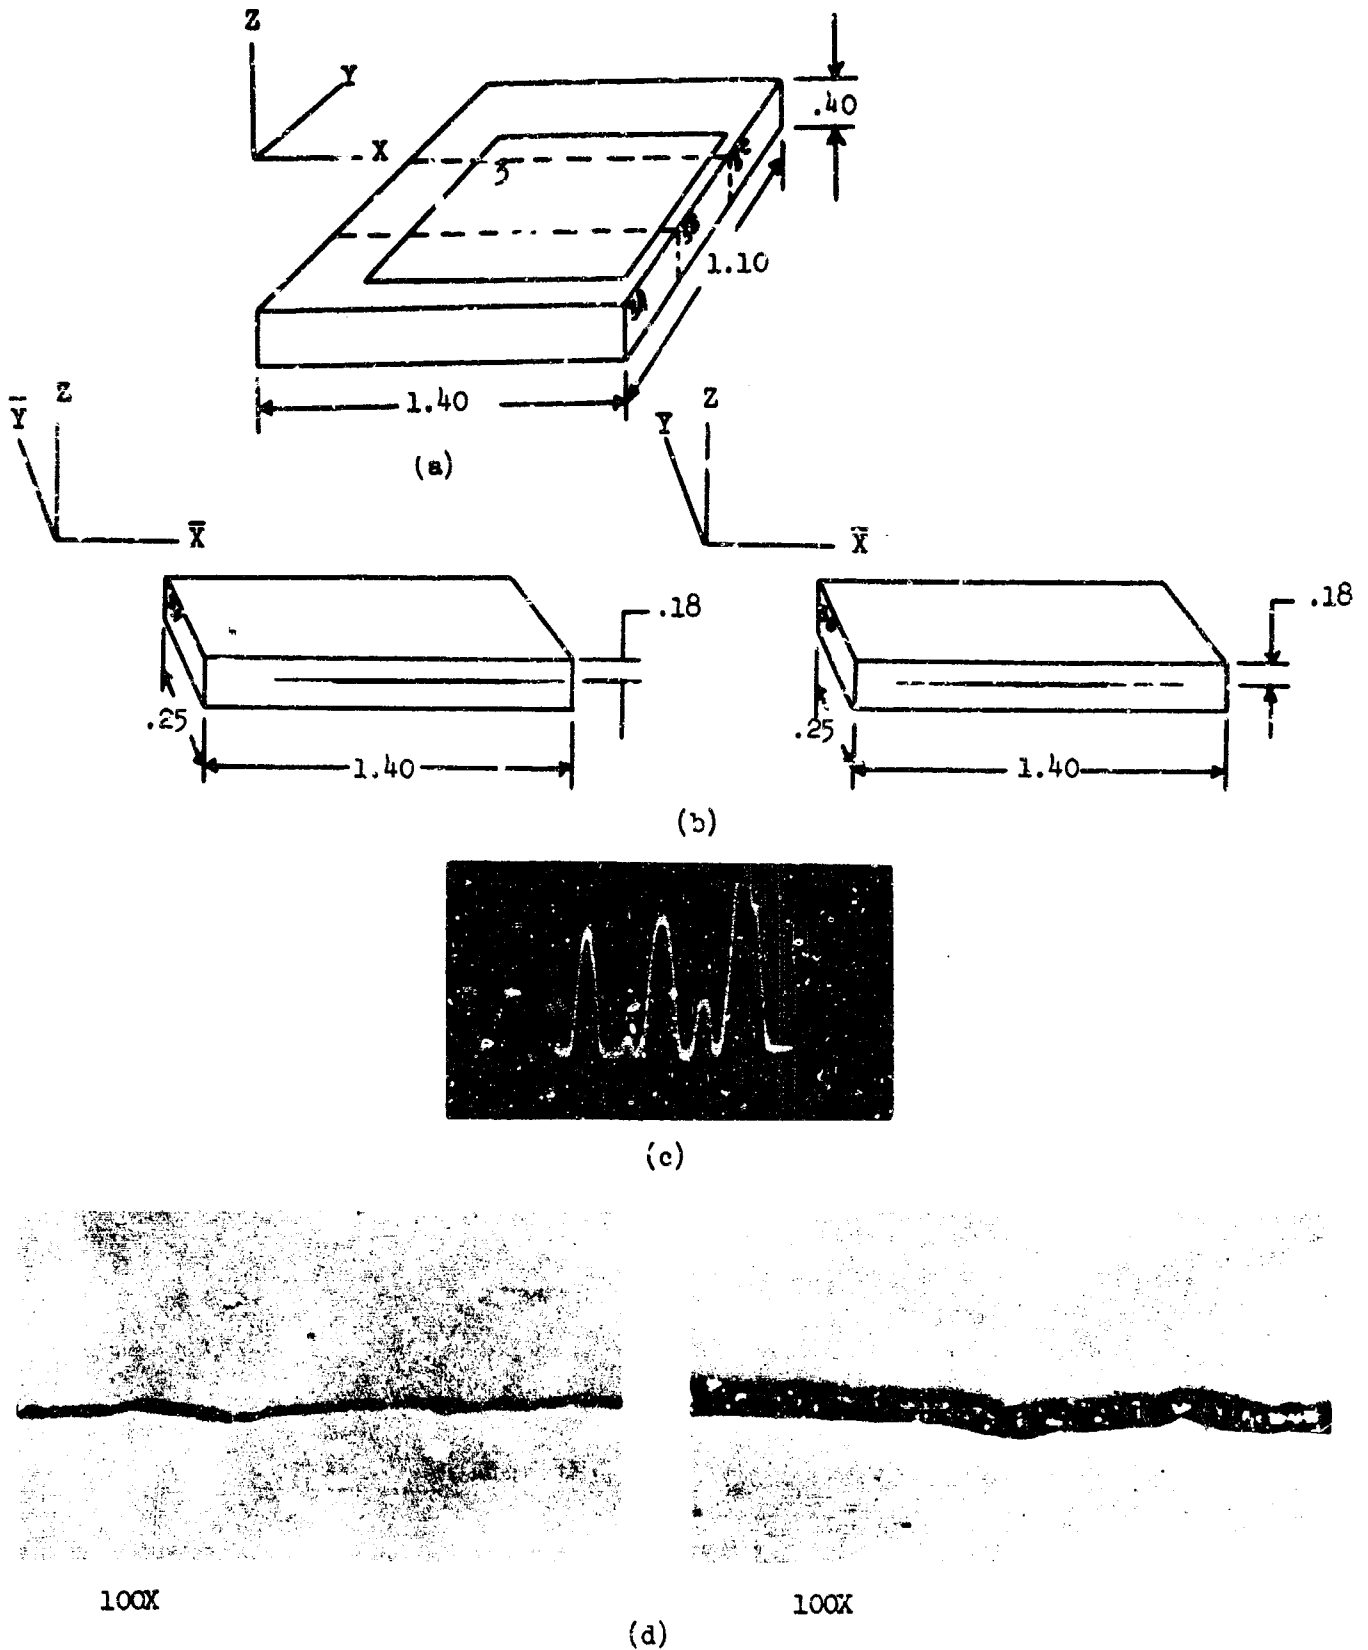
Figure 153 "Lead-Off" Page for Sample 3 Showing (a) a Sketch of the Sample, (b) Sketches of the Section Metallographic Specimens, (c) an Oscillograph Display of the Defect, and (d) Photomicrographs of the "Most Open" Portion of the Cracks in Specimens 3A and 3B, Respectively

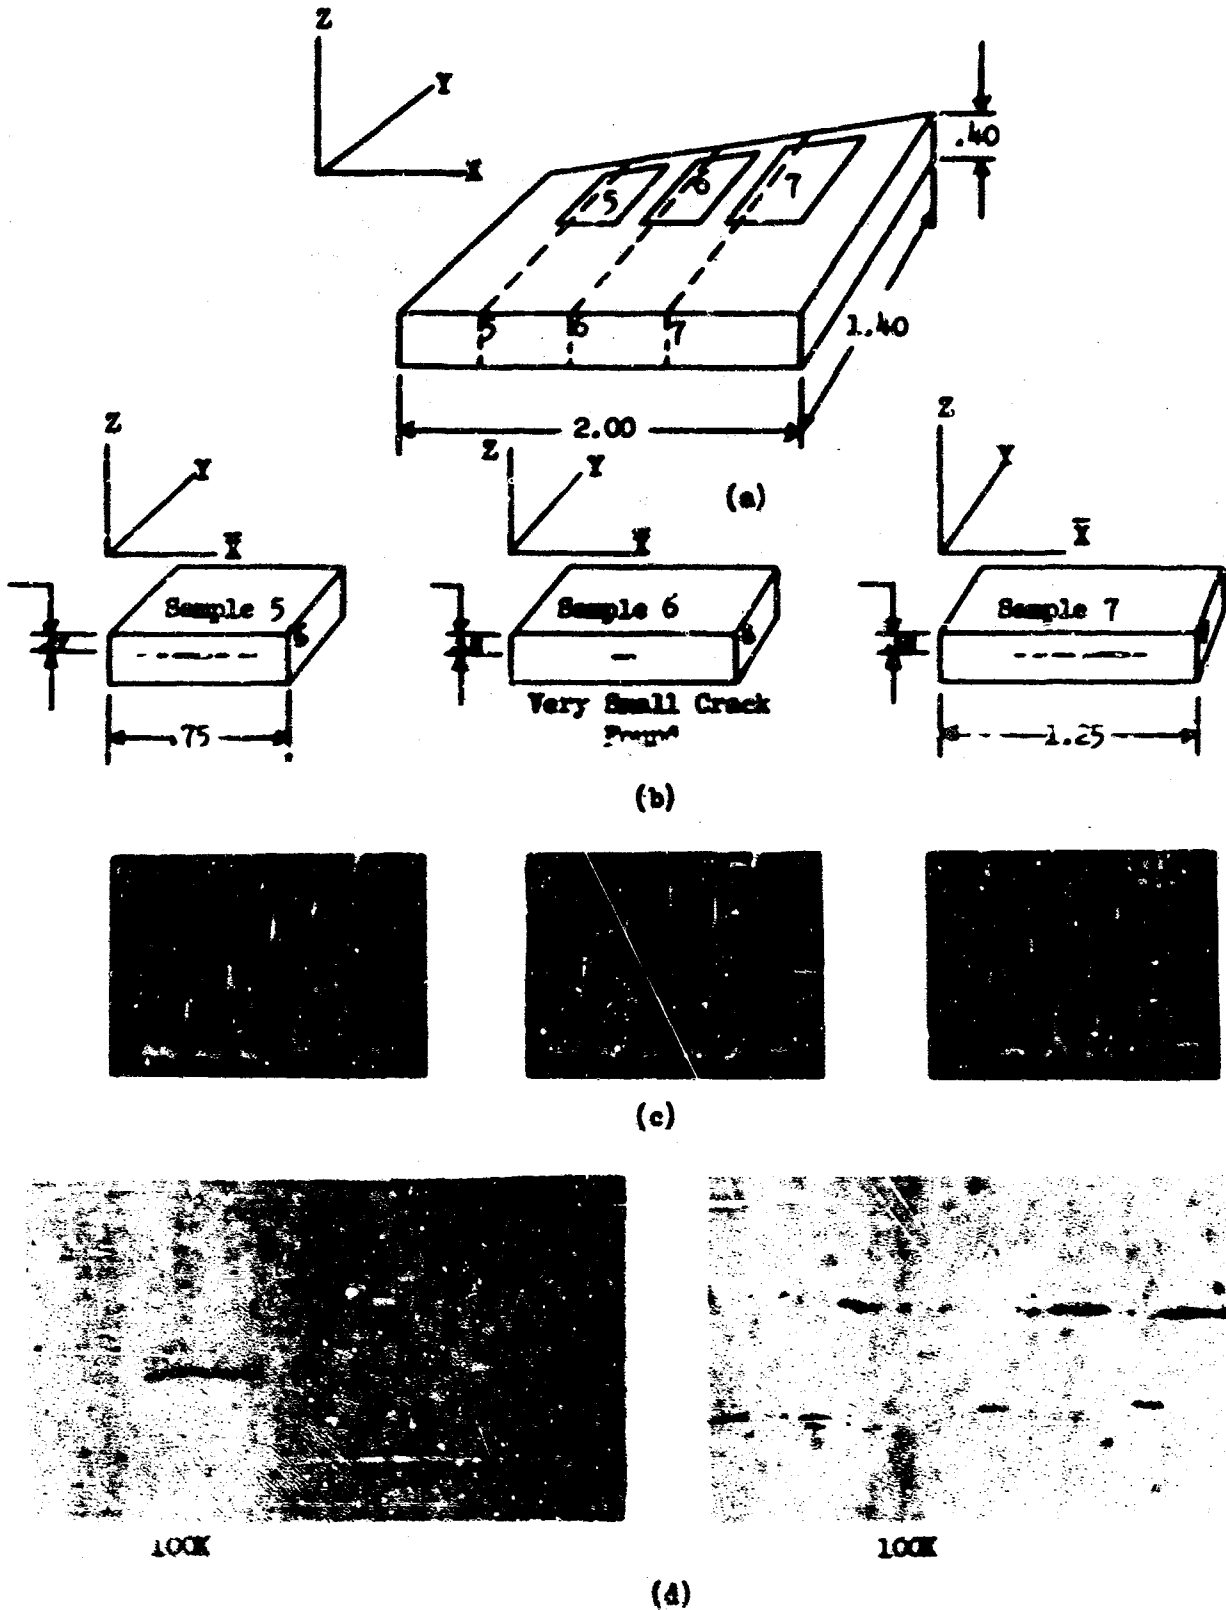
Figure 160 "Lead-Off" Page for Combination Sample 5, 6 and 7 Showing (a) a Sketch of the Sample, (b) Sketches of the Corresponding Metallographic Specimens, (c) an Oscilloscope Display of the Defects, and (d) Photomicrographs of the "Most Open" Portion of the Cracks in Specimens 5 and 7, Respectively

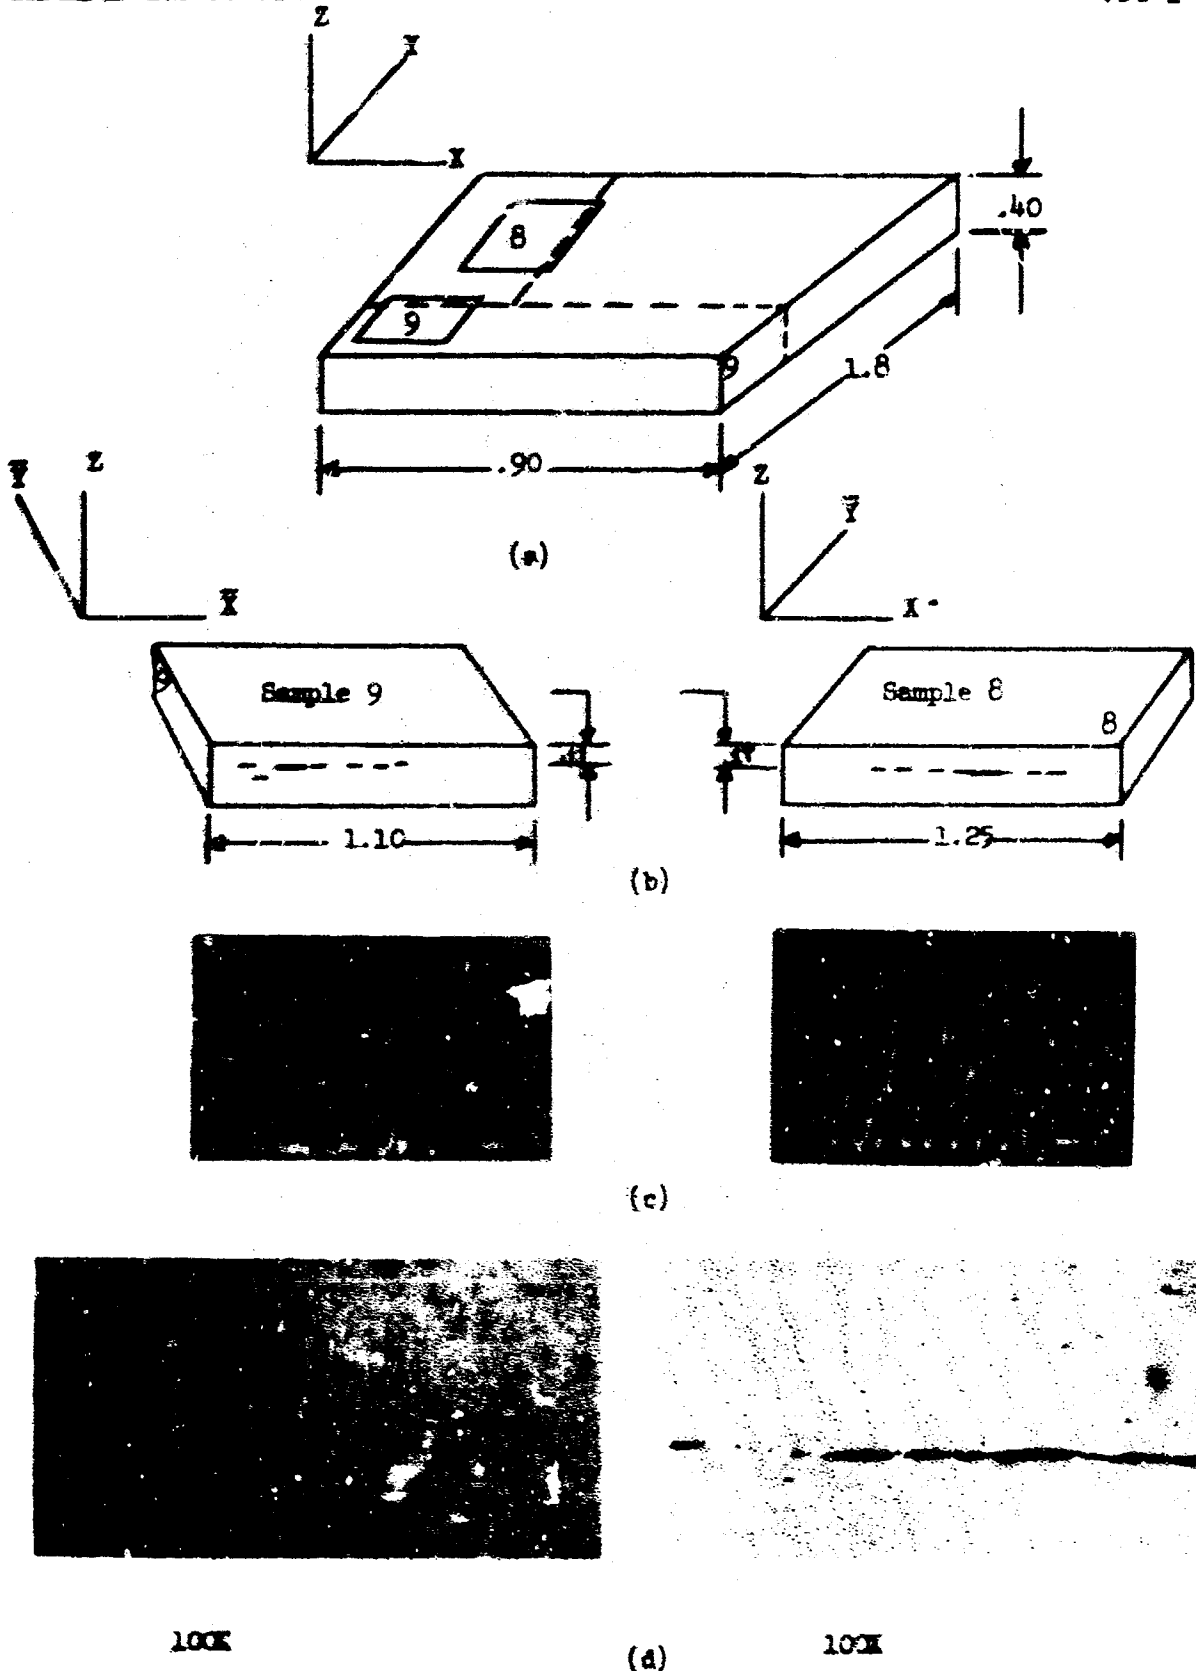
Figure 163 "Lead-Off" Page for Combination Sample 8 and 9 Showing (a) a Sketch of the Sample, (b) Sketches of the Sectioned Metallographic Samples, (c) an Oscillographic Display of the Defects, and (d) Photomicrographs of the "Most Open" Portion of the Crack in Samples 9 and 8, Respectively
