Technical Note N-891

TUNNEL COOLING FOR BYRD STATION, ANTARCTICA - PROGRESS REVIEW

C. R. Hoffman

May 1967

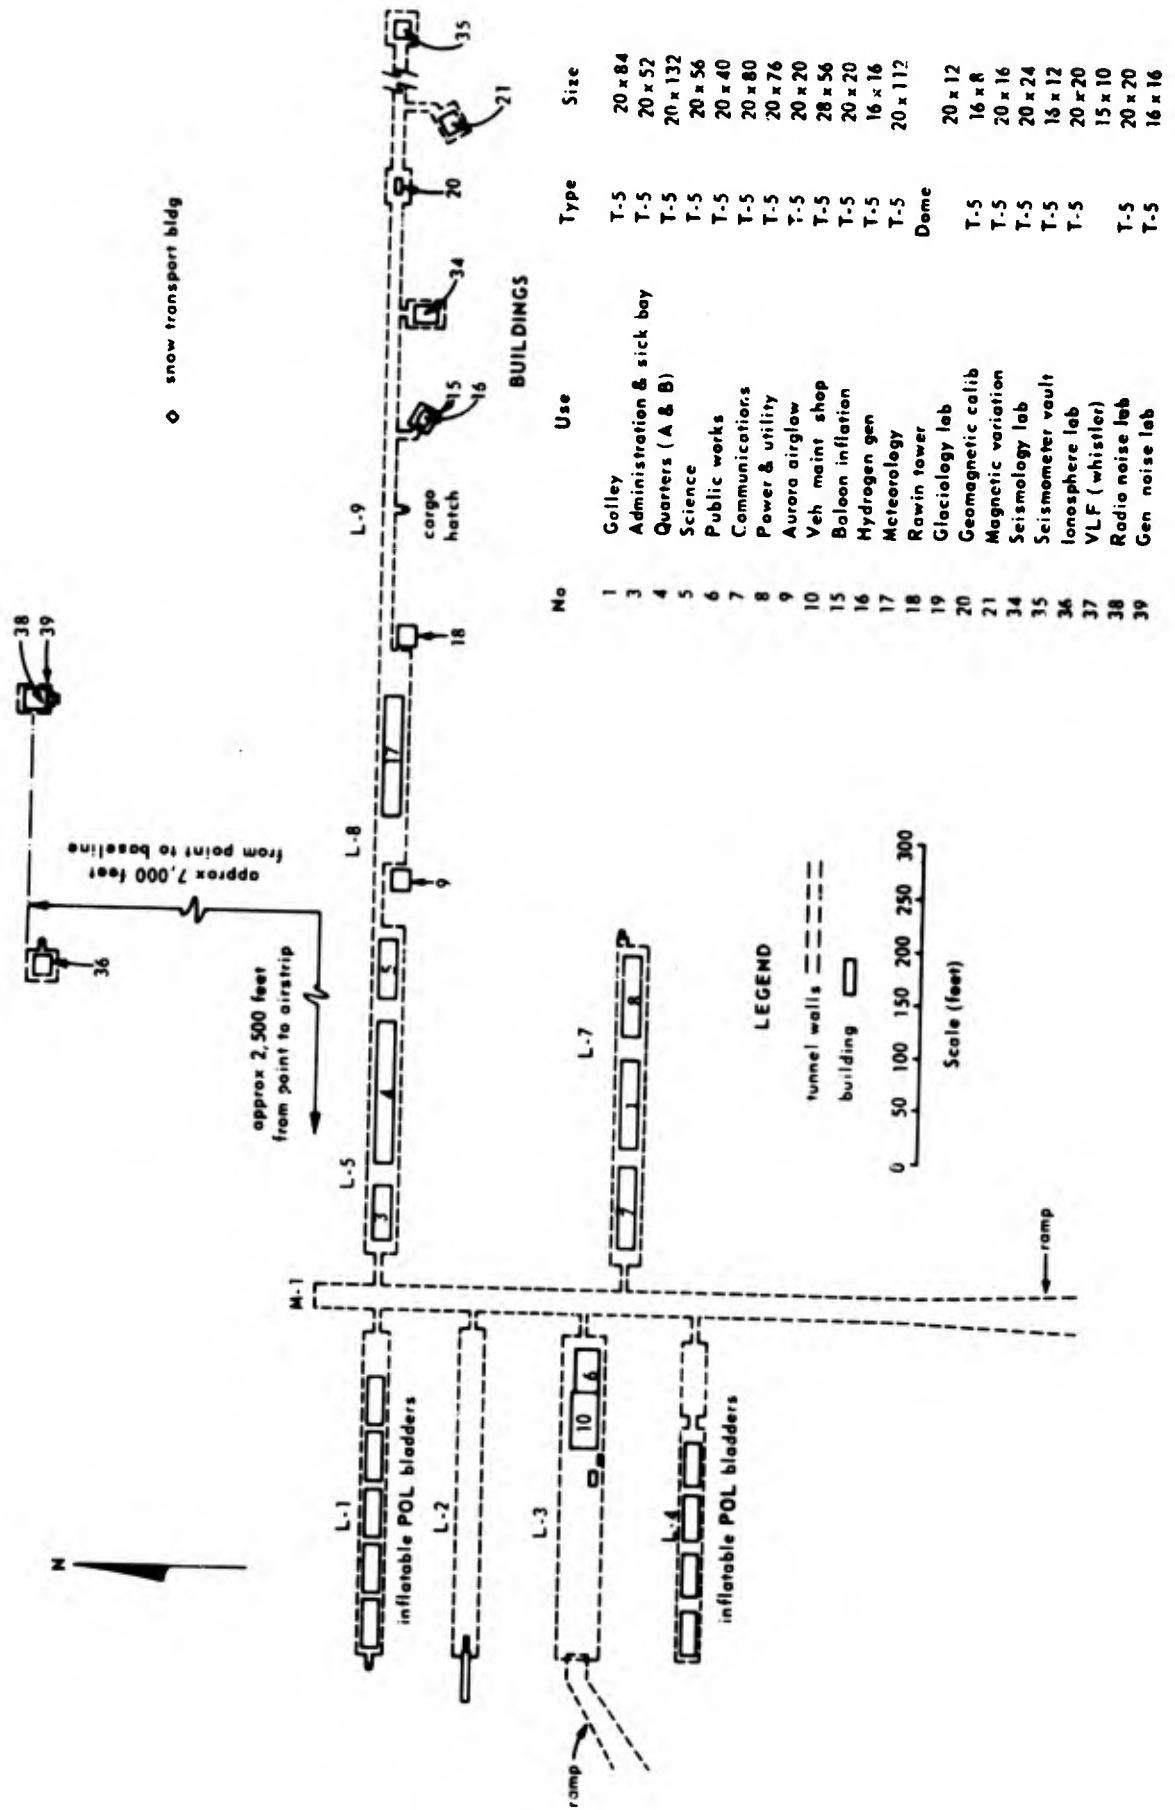
Figure 1. Plot plan of Byrd Station, Antarctica. Conditions as of DF65.

Byrd Station, Antarctica, is an undersnow camp designed by the U. S. Naval Facilities Engineering Command (NAVFAC) and constructed by Navy Seabees during the antarctic summers of 1960-61 and 1961-62. The station consists of a network of tunnels which contain prefabricated buildings and other facilities. The tunnels were constructed by excavating trenches in the snow and roofing them over with corrugated-steel arches. The general layout of the tunnel complex is shown in Figure 1.
