THIRD SUMMARY REPORT
ON
STRUCTURAL STUDIES OF BEARING STEEL
UNDERGOING CYCLIC STRESSING

May 20, 1967

RESEARCH LABORATORY
SKF INDUSTRIES, INC.
ENGINEERING AND RESEARCH CENTER
KING OF PRUSSIA, PA.

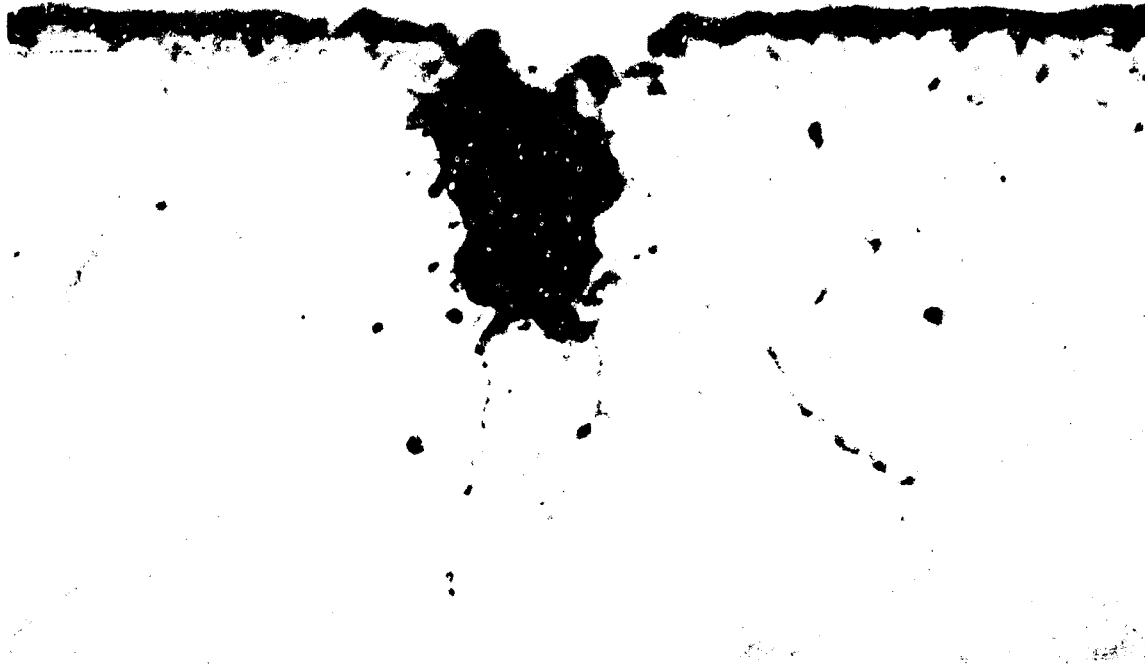
ENCLOSURE 6

The presence of lenticular carbides can therefore be taken as a measure of the time required to produce the adjacent areas of plastic deformation. Thus a distinction can be made between rapidly formed and slowly formed deformation bands. This distinction can be of value when assessing the stress raising potential of a defect or inclusion. Where rapidly formed white areas are seen around a defect it can be concluded that the defect was an effective stress concentrator. Such a defect is shown in Enclosure 6 where rapidly formed deformation bands can be seen around the inclusion.

INCIPIENT SPALL FORMING AROUND A NEAR SURFACE INCLUSION

Cracks associated with the defects and deformation bands.

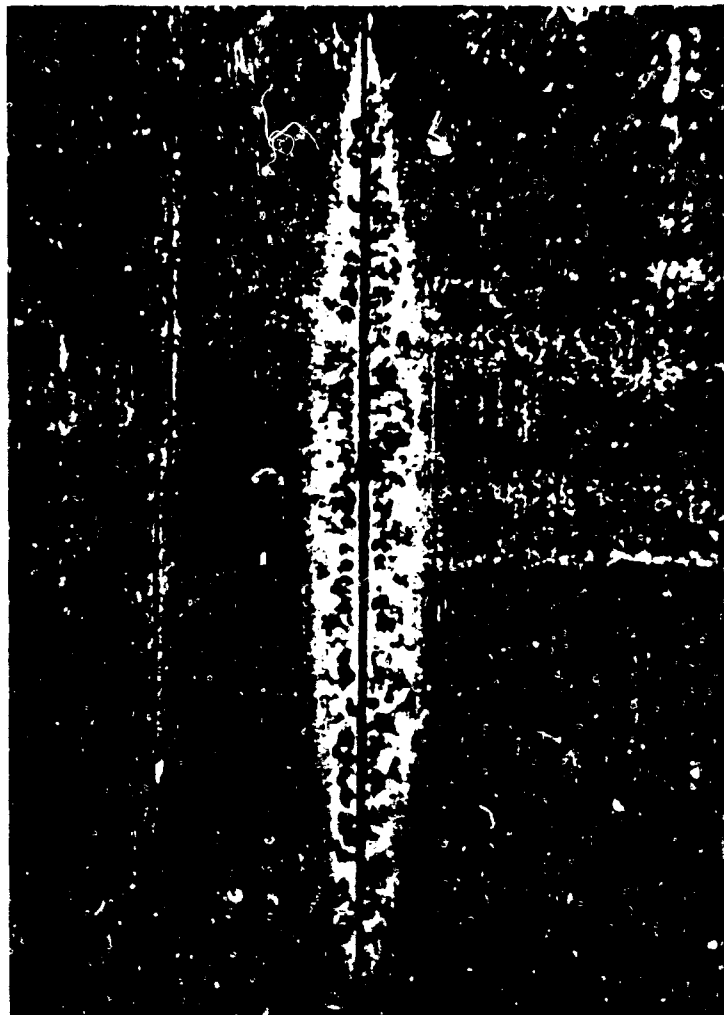
ENCLOSURE 15

SURFACE VIEW OF A GRINDING FURROW ON AN
ENDURANCE TESTED INNER RING

Surface distress is apparent in the glazed area surrounding
the furrow after 150 million revs.

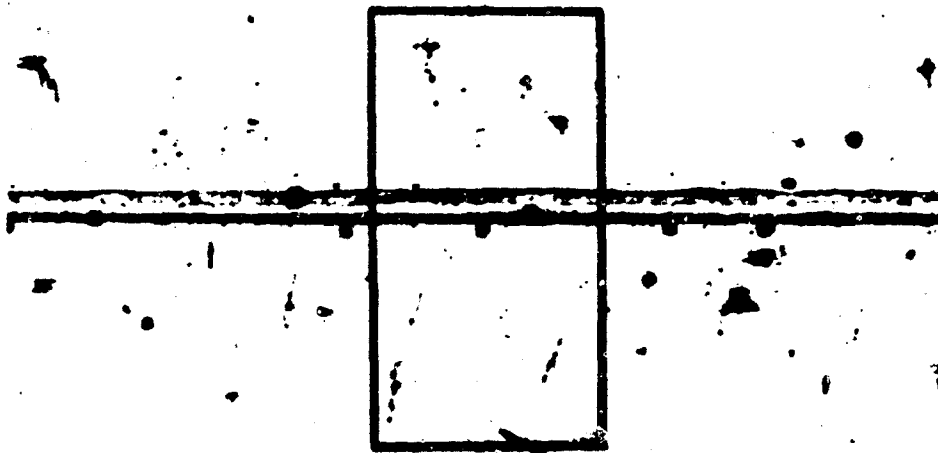
ENCLOSURE 16

SURFACE DISTRESS SIMILAR TO THAT SHOWN IN ENCLOSURE 15

Polishing to a depth of .0001" reveals cracking under the glazed and pitted area which surrounds a furrow.

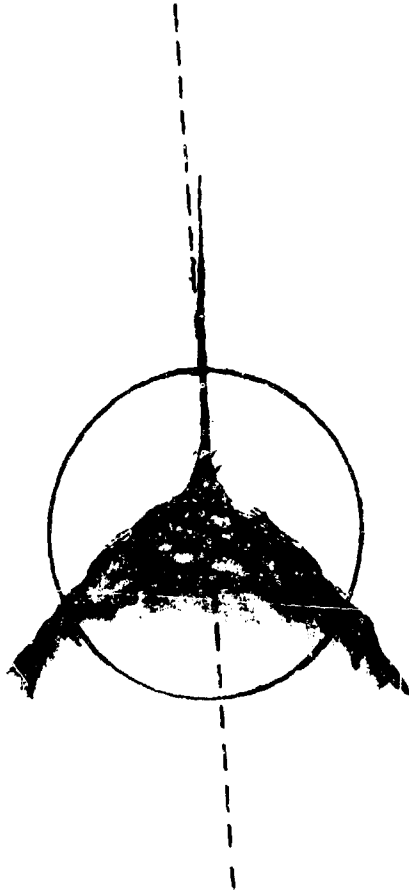
The elastohydrodynamic oil film, which under the test conditions normally keeps the bearing surfaces separated in the contact area, collapses in the vicinity of the grinding furrow due to oil leakage into the furrow. This allows metal to metal contact to occur at the borders of the furrow, leading to the glazed appearance of Enclosure 15. Heavy tractive forces which greatly intensify the local stress field are presumably generated when the metal surfaces come into contact. The increased stresses cause localized plastic disturbances which in turn leads to cracking as shown in Enclosure 16. The cracks eventually join to form an incipient spall (Enclosure 18) which then grows to become a full scale spall that ends the useful life of the bearing (Enclosure 19).

FULL SCALE SPALL INITIATED AT THE SURFACE BY A GRINDING FURROW

Furrow Initiated Spall

Circumferential plane showing the area where the grinding furrow leads into the spall. The shallow entry into the spall can be seen to follow the direction of locally produced deformation bands lying near the original contact surface.

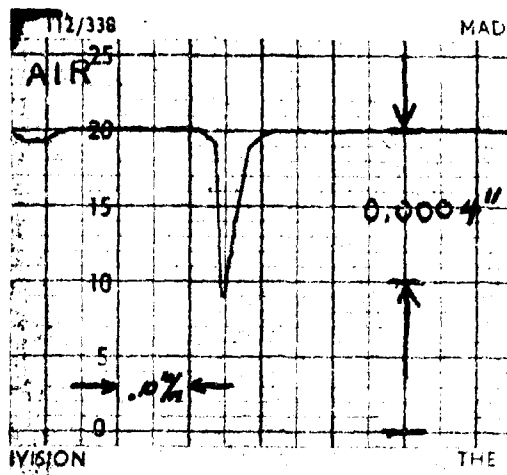
SPALLING AT AN INTENTIONALLY PRODUCED SCRATCH

Intentionally produced scratch running across the groove (perpendicular to the rolling direction) of a bearing inner ring.

Talysurf trace through the scratch shows it to be approximately 0.0004" deep.

12.8 Million Revolutions

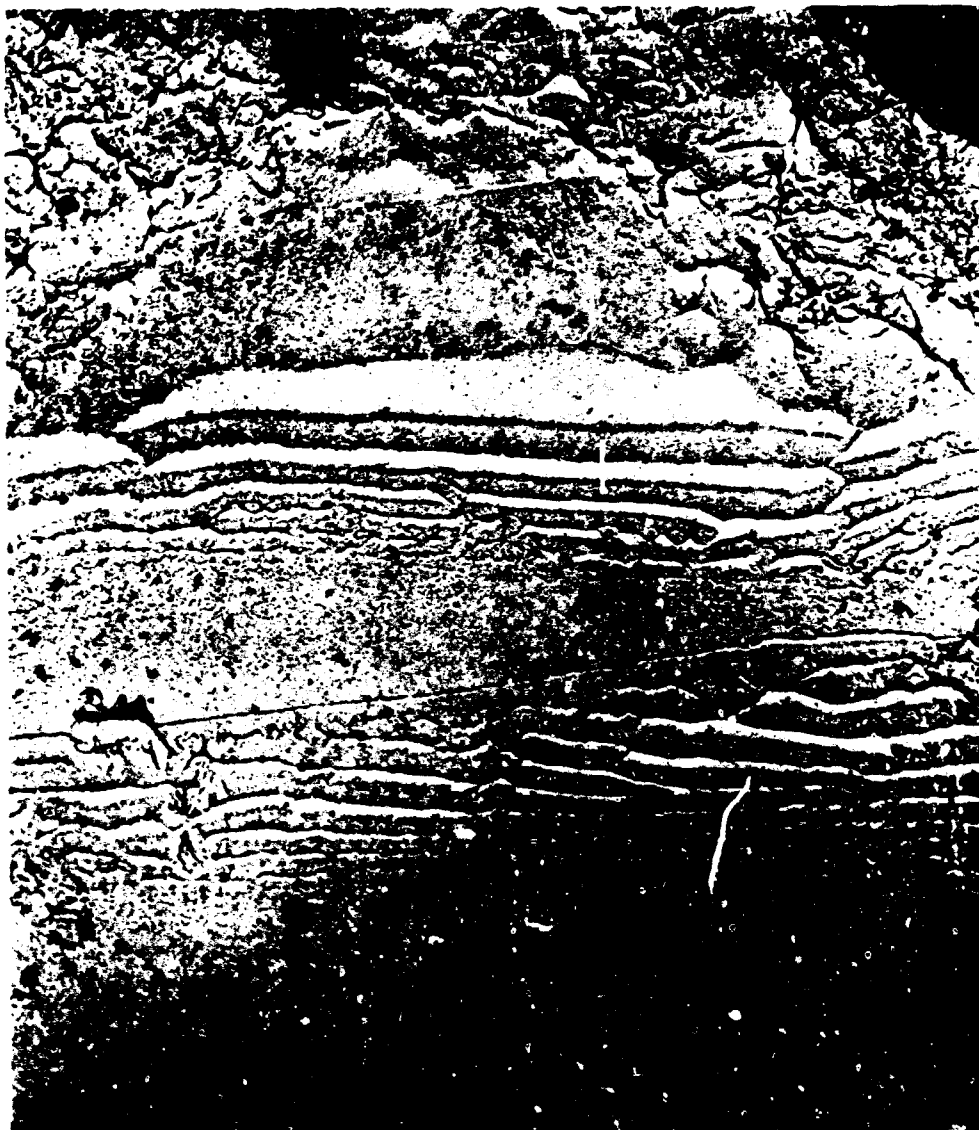
ENCLOSURE 28

Cleavage surface indicating brittle type fracture

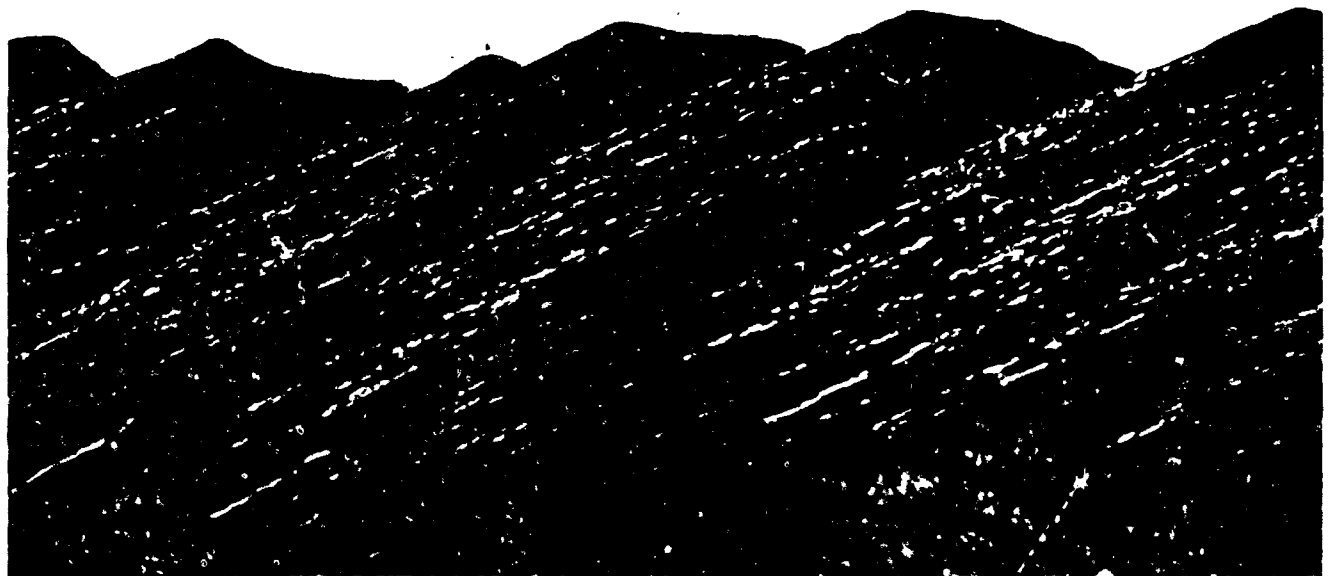
ENCLOSURE 33

SECTION THROUGH A SPALL SHOWING CRACK PROPAGATION ALONG DEFORMATION BANDS

Spalled surface showing cutting plane and furrow point of initiation.

Circumferential cut made through the spall shows that the direction 200X of crack propagation is dominated by the deformation bands.
