**Three Full-Scale Dynamic Crash Tests
of a CNU-103/E Shipping Container**

Aviation Safety Engineering and Research
a Division of
Flight Safety Foundation, Inc.

Technical Report AFATL-TR-67-55

MAY 1967

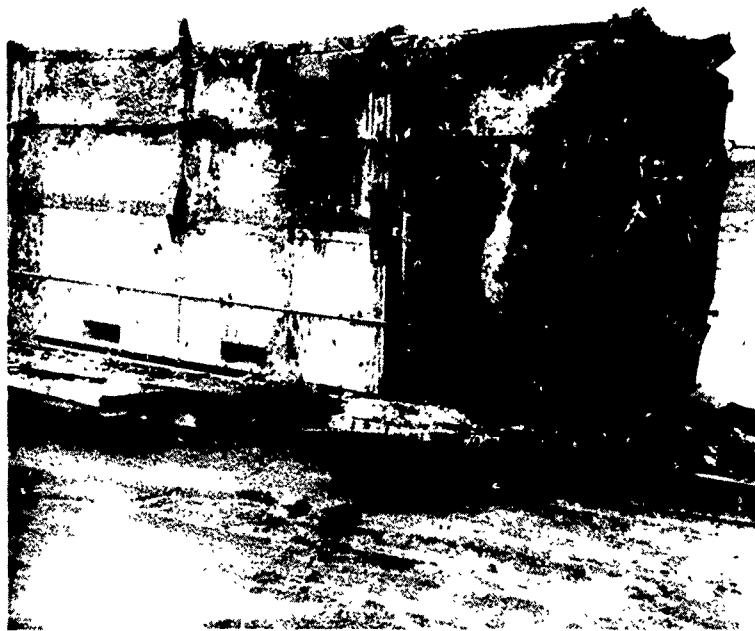
Extensive fires developed in the aircraft wreckage which required immediate removal of the Shipping Container to prevent unnecessary postcrash fire damage. The forward end of both Shipping Containers looked quite similar after being pulled from the wreckage. Figure 16 shows the container removed from the Test 1 wreckage and Figure 17 shows the container from Test 2. The postcrash fire caused more extensive damage in Test 2 which allowed a view of the crushed aluminum honeycomb shown in Figure 18.

Figure 16. Front Portion of Shipping Container - Test 1.

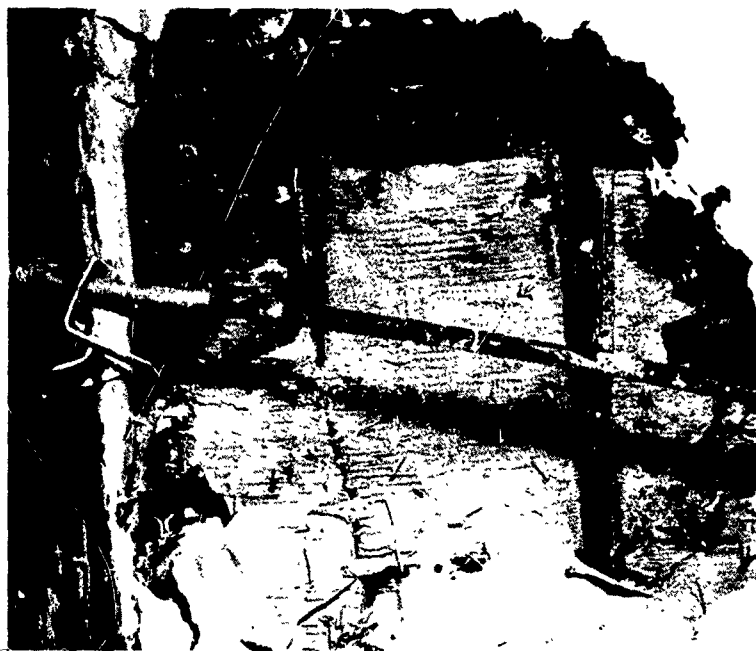
Figure 18. Aluminum Honeycomb - Shipping Container - Test 2.

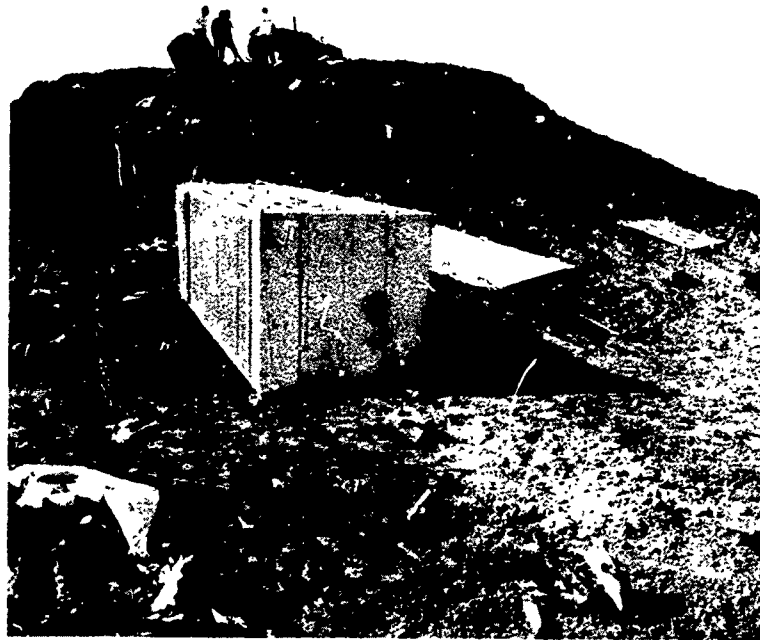
Container during the travel up the front slope of the impact hill. At a point approximately halfway up the impact slope, the aircraft horizontal stabilizer contacted the rear of the container with sufficient force to push the container over the top of the hill. As the container passed over the top of the hill, a slight roll to the right, combined with a slight nose down attitude, developed. This continued until the front edge of the container contacted the earth on the rear slope. The container turned over and came to rest on its right side with the rear of the container forward. Figure 22 shows the final position of the container on the rear slope.

Figure 22. Final Position of Shipping Container - Test 3.

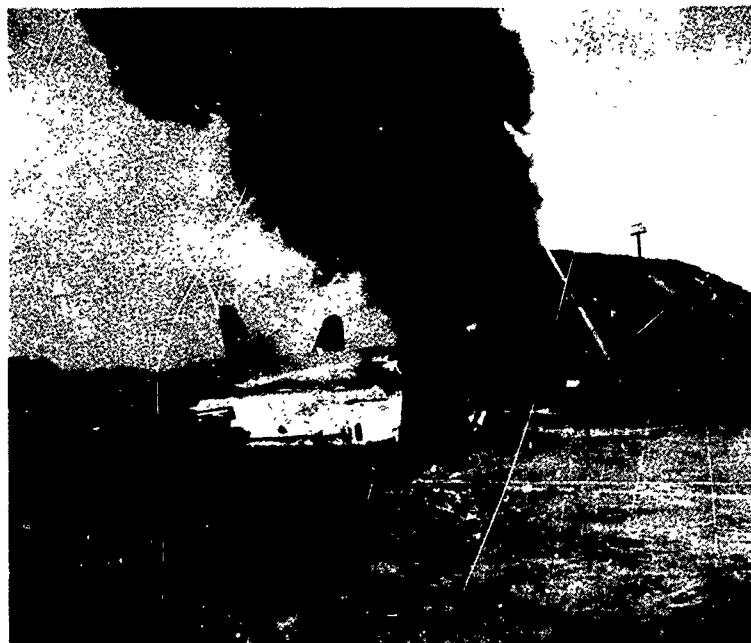
Both aircraft were completely destroyed in the impact. Figure 25 shows the first test aircraft immediately after impact while Figure 26 shows a later postcrash scene after the tail booms and Shipping Container had been moved. The wreckage is the entire aircraft except for the above mentioned items and the wing tips. The fire, shown in Figure 25, resulted from a maximum of 50 gallons of oil, 3 to 4 gallons of fuel and a normal load of hydraulic fluid. Figure 27 shows the forward fuselage of the first test aircraft. Note the almost perfect accordion effect from the wall impact.

Figure 25. C-119 - Postcrash - Test 1.
