AGAM-P (M) (23 Jul 68) FOR OT RD 682187 8 August 1968  
SUBJECT: Operational Report - Lessons Learned, Headquarters, 93d  
Engineer Battalion (Const), Period Ending 30 April 1968

DEPARTMENT OF THE ARMY  
Headquarters, 93d Engineer Battalion (Const)  
APO San Francisco 96530

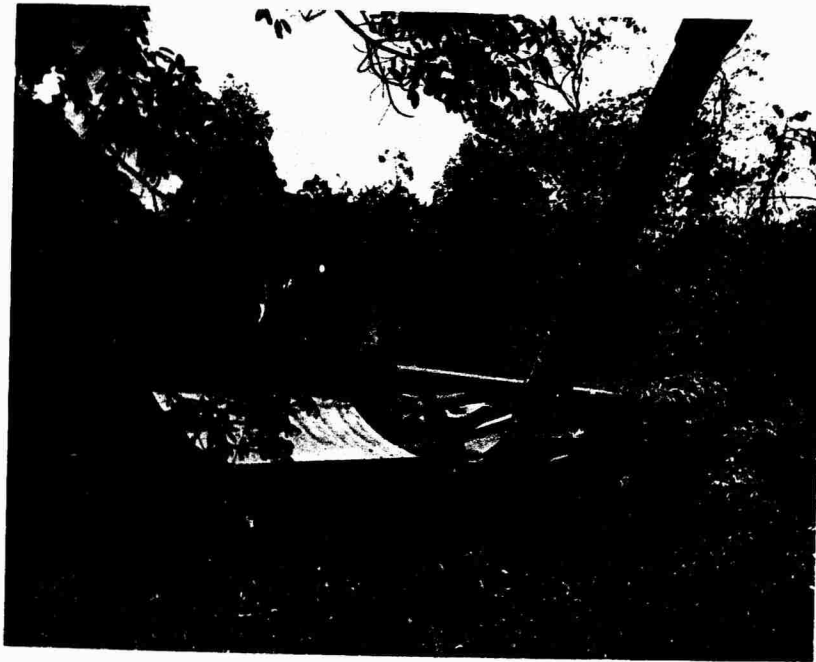
Photograph No 7 (Binh Son) Tree grouping typical of those encountered in the Binh Son operational area.

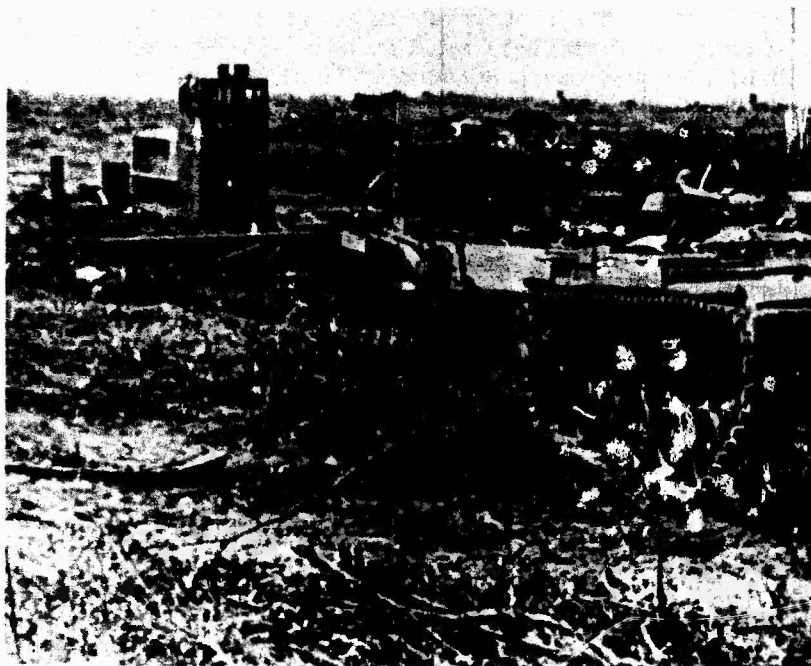
The lower ball of the rear tug assembly contributed greatly to the resistance offered by the machine to extraction. Modification and redesign as suggested in the initial evaluation to both the rear tug assembly and the drums would have a definite advantage over the present configuration under these conditions. The 12 point split drum would decrease the suction effect on the soil and the higher tug assembly would not be buried to a depth sufficient to cause resistance to extraction.

Photograph No 10 (Long Binh) Tactical Tree Crusher partially buried due to unstable soil conditions. Attempted extraction by scheme shown here was unsuccessful. A single M88 VTR was later used to extract machine.
