**FLIGHT TEST-WHIRLING ARM CORRELATION
OF RAIN EROSION RESISTANCE
OF MATERIALS**

GEORGE F. SCHMITT, JR.

TECHNICAL REPORT AFML-TR-67-420

SEPTEMBER 1968

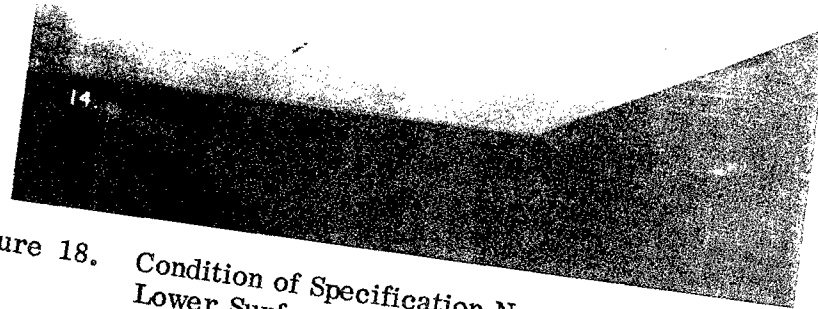
Figure 18. Condition of Specification Neoprene Sample on Lower Surface of Right Stabilizer After Flight 13

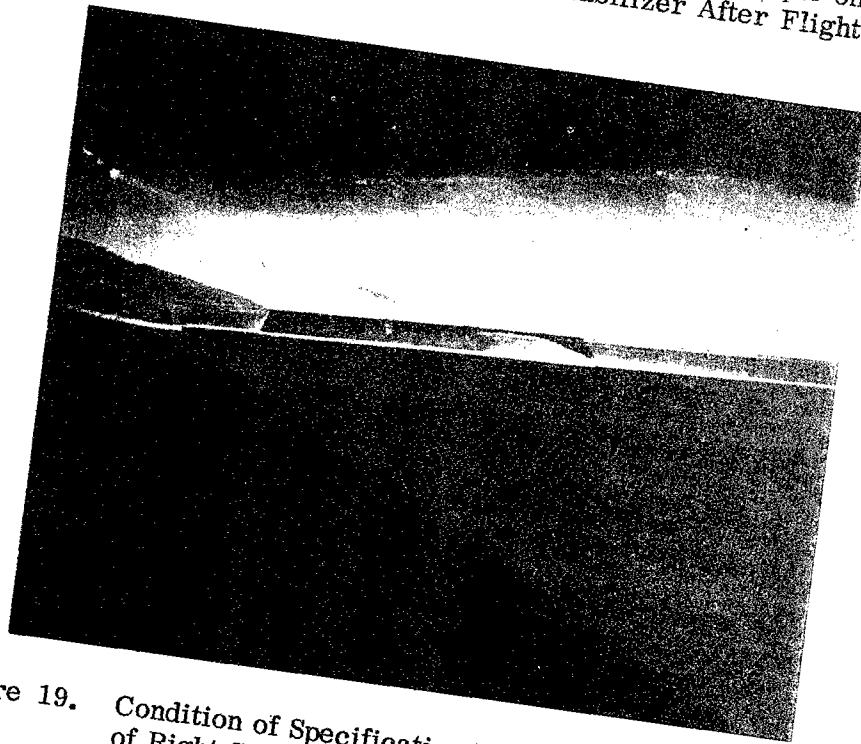
The first visible damage received by this coating was noted after Flight 7. Hail approximately the size of marbles was encountered on at least two penetrations. Figures 13 and 14 show that one-third of the leading edge of the sample was removed from the top and bottom of the right stabilizer. The neoprene on the left stabilizer received similar damage on this flight as can be seen in Figures 15 and 16. Only bare metal remained at the exposed sections. Both coatings had been torn from the stabilizer in small segments based on the jaggedness of the edge of the remaining samples. The sample on the left stabilizer was considered to have failed on Flight 7; however, the test continued with the sample on the right stabilizer. The postflight inspection for Flight 13 showed that three-fourths of the leading edge of the right stabilizer initially covered by neoprene was now exposed (Figures 17 and 18). The neoprene adhered to the bottom of the stabilizer but gradually peeled from the top of the stabilizer during Flights 12 through 16. Testing was terminated on this sample after Flight 16 because the entire leading edge and most of the top surface had eroded away (Figures 19 and 20).

Figure 19. Condition of Specification Neoprene on Upper Surface of Right Stabilizer After Flight 16

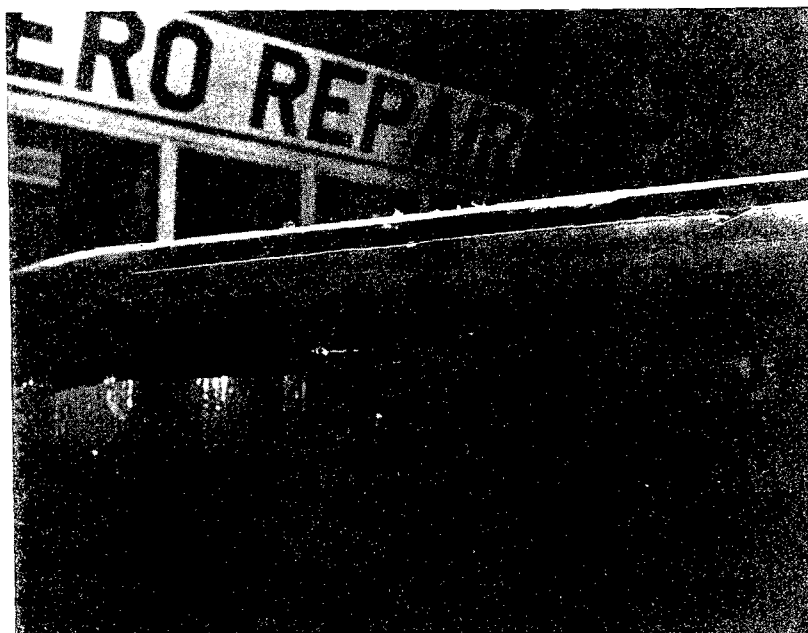
Figure 20. Condition of Specification Neoprene on Lower Surface of Right Stabilizer After Flight 16

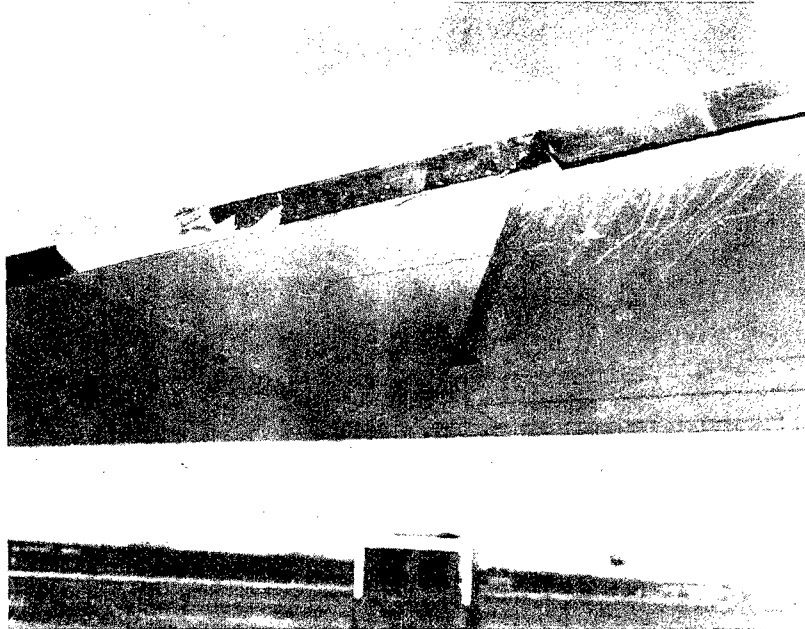
The pigmented urethane on the right stabilizer withstood the adverse conditions until its bond to the metal was broken when the inboard, adjacent urethane sample was blown from the aircraft during Flight 20. The sample peeled 4 inches during the next two flights. Figures 23 and 24 show the condition of this sample

Figure 24. Final Condition of Pigmented Urethane Sample on Lower Surface of Right Stabilizer

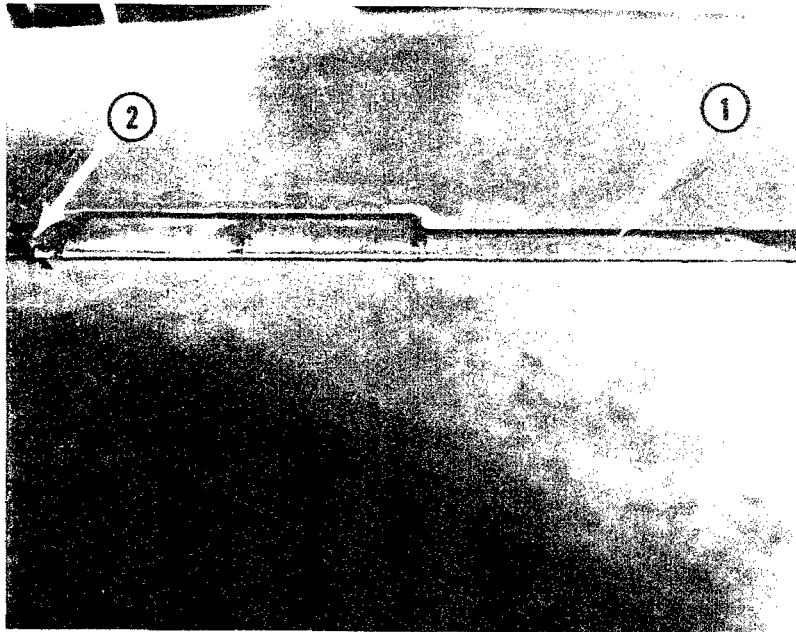
Figure 26. Sections of Clear Urethane Tape (1) Were Torn From Sample on Right Stabilizer During Hail Encounter on Flight 7 and Clear Urethane (2) Was Peeled an Additional Amount on the Inboard Edge

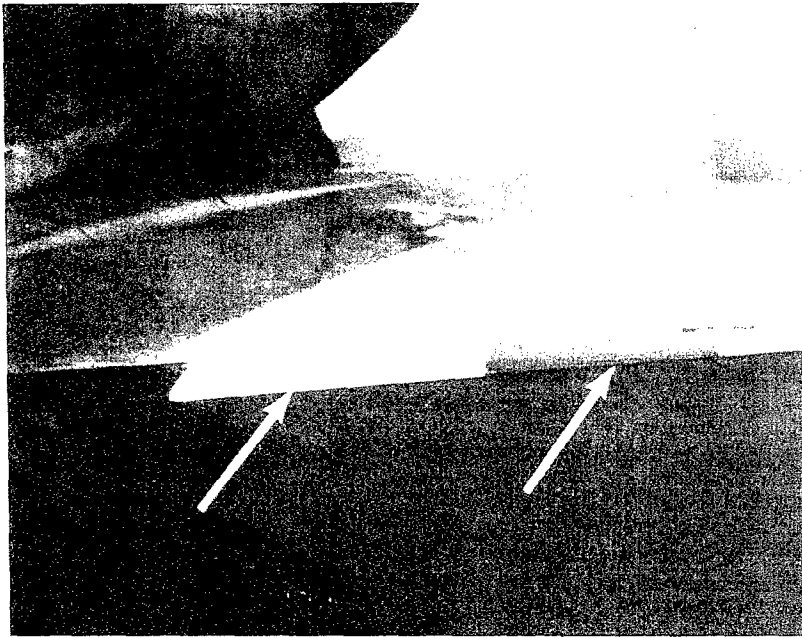
Figure 30. Pigmented Urethane and Clear Urethane on Left Stabilizer Completed the Tests With No Adverse Effects

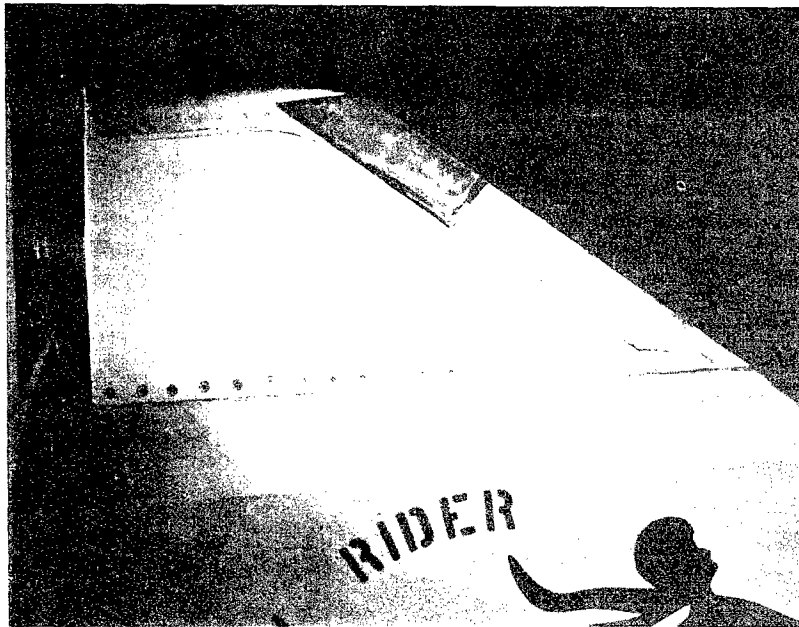
Figure 31. First Sign of Breakdown of Nickel Sample on Leading Edge of Vertical Stabilizer After Flight 7

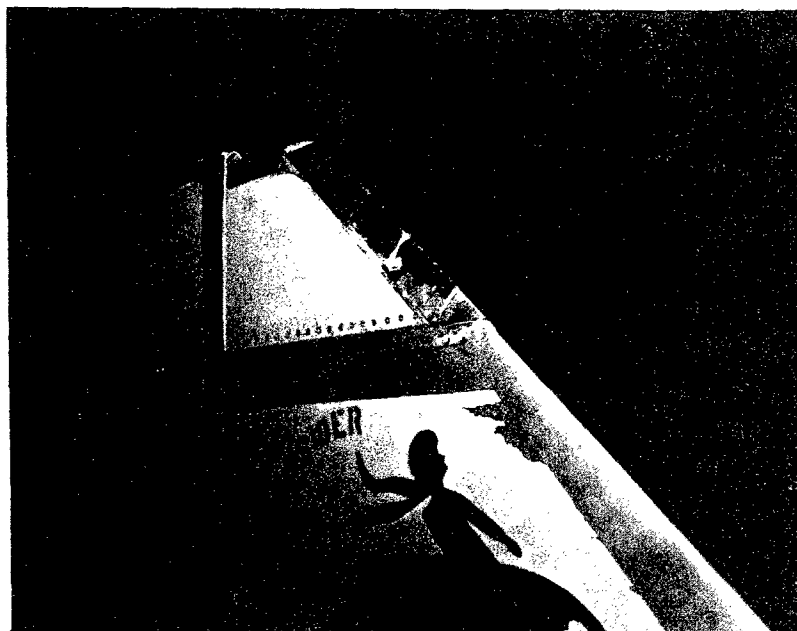
Figure 32. Increased Damage to Nickel Sample on Vertical Stabilizer as of Flight 16

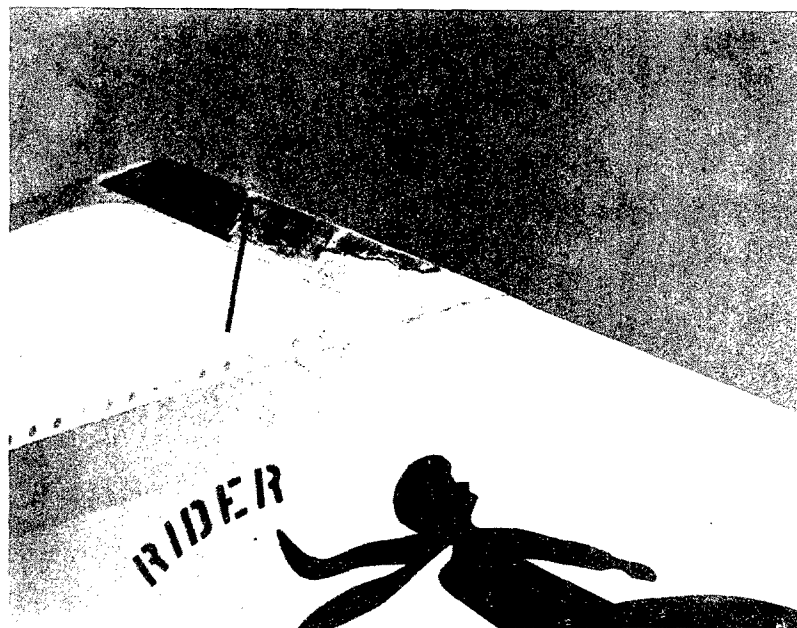
Figure 33. Approximately Two-thirds of the Nickel Sample on the Right Side of the Vertical Stabilizer Was Lost by the End of Program; the Urethane Sample Above the Nickel Had Little Damage

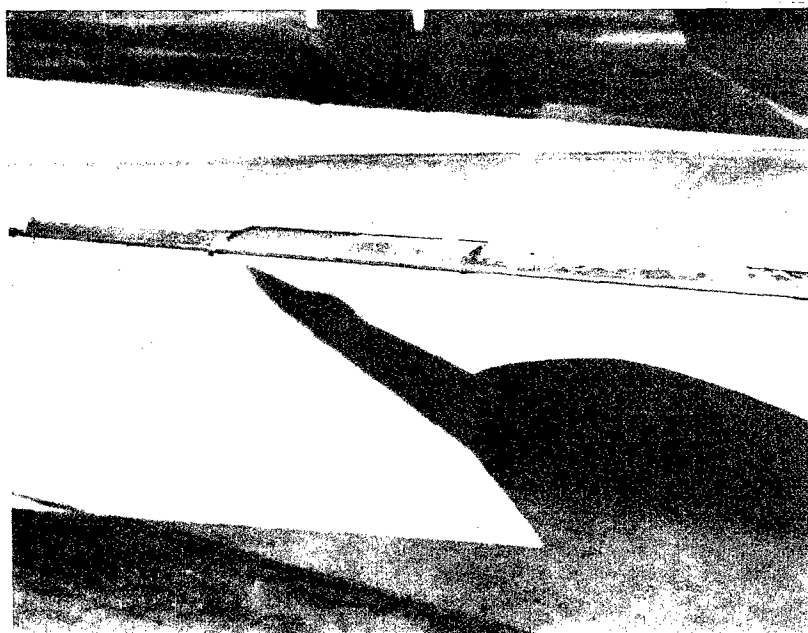
Figure 34. Damage to Nickel Sample on Right Stabilizer Upon Completing Tests

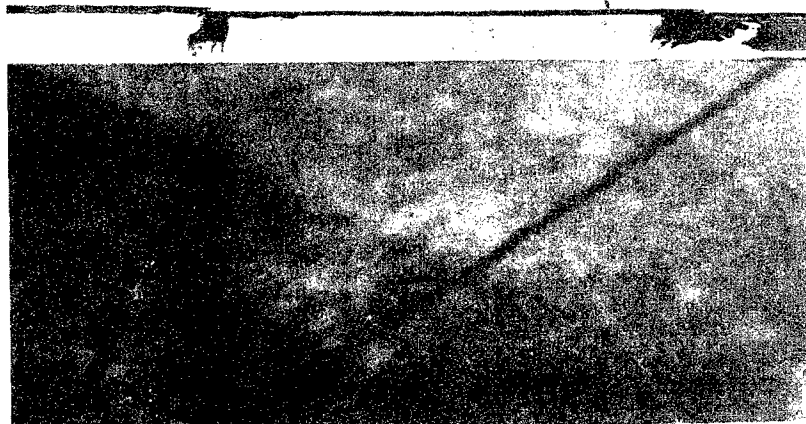
Figure 35. All Urethane Tape on Upper Surface of Left Stabilizer Was Lost During Flight 7

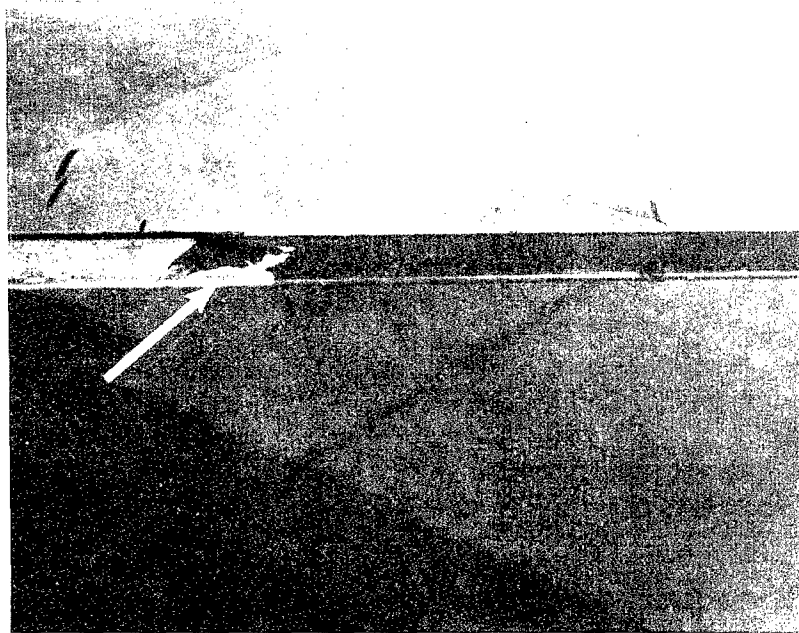
The first visible sign of damage was peeling of the inboard edge of the sample on the left stabilizer which occurred during Flight 7 (Figures 38 and 39). This partial breakdown continued through Flight 13 at which time approximately one-third of the shoe had been sheared away (Figures 40 and 41). This loose segment was not brittle nor did it have any surface roughness. (The shoe retained these characteristics until complete removal occurred.) The failure of this sample appears due to the inability of the adhesive to hold the shoe to the metal. This was particularly noticeable during the Flight 16 postflight (Figures 42 and 43). The adhesive along the leading edge was adhering to the loosened section of Estane, but no adhesive remained on the exposed metal surface. This shoe was lost during flight 17. The Estane boot on the right stabilizer showed slight peeling of the inboard edge as a result of Flight 16; however, the peel was too insignificant to photograph. This sample remained glossy with no surface roughness or breaks throughout the test phase except for the peeling of the inboard edge which had increased about an inch on the top and bottom stabilizer surfaces (Figures 44 and 45).

Figure 38. Estane on Inboard Edge of Upper Surface on Left Stabilizer Peeled as a Result of Hail Encounter on Flight 7

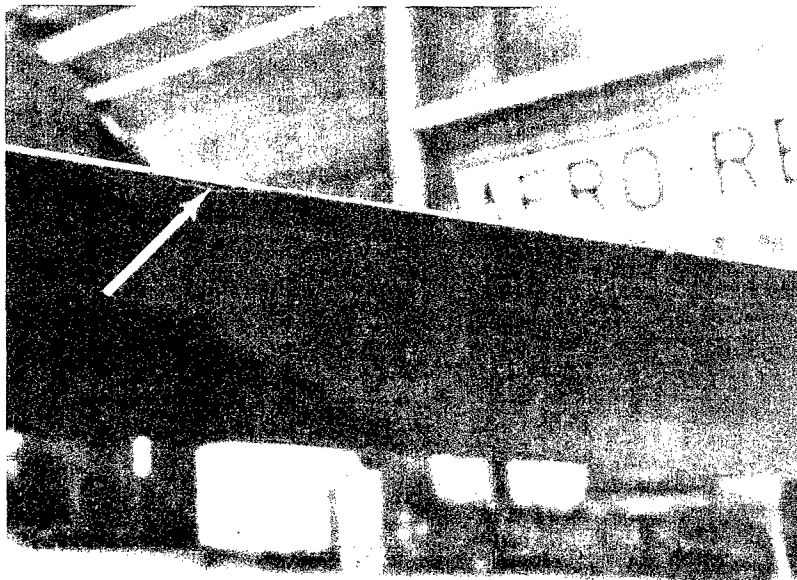
Figure 39. Estane on Lower Surface of Left Stabilizer Received Slight Damage During Flight 7

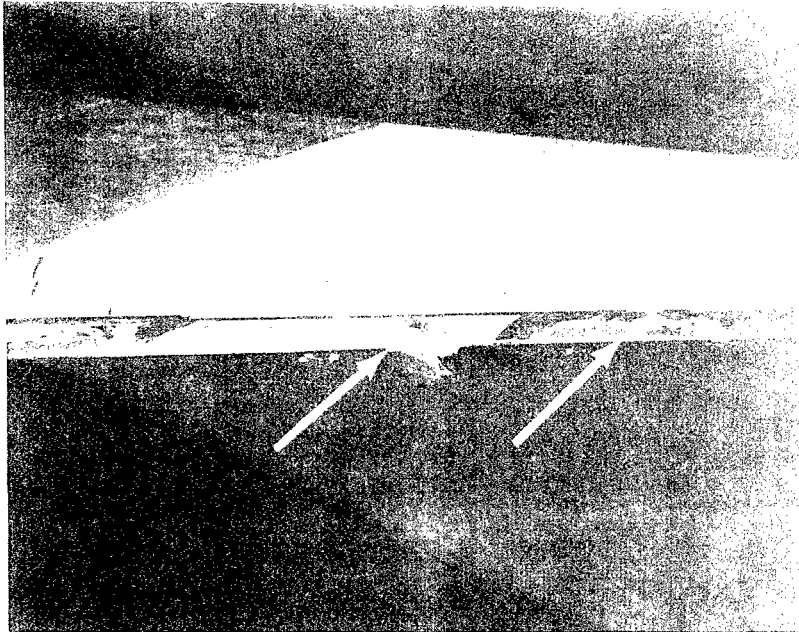
small cuts received were enlarged during the following flights as can be seen in the Flight 13 postflight photograph of the sample (Figures 50 and 51). The final damage was received and photographed after Flight 16 (Figures 42 and 43). The test was considered to be over for this sample since the entire leading edge had been destroyed.

Figure 42. Estane Boot Almost Completely Peeled From Left Stabilizer and Adjacent Neoprene With Insignificant Amount Remaining on Leading Edge on Flight 16

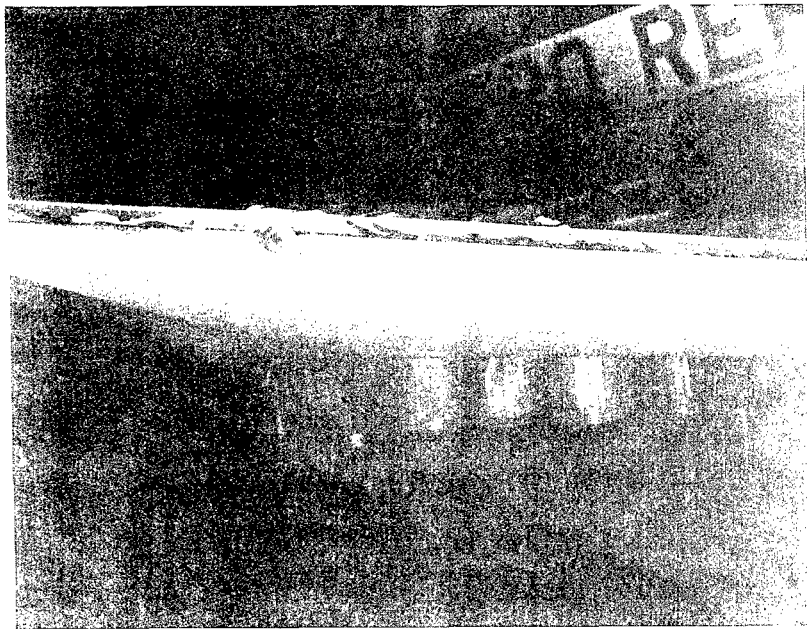
Figure 43. Damage to Estane and Neoprene on Lower Surface of Left Stabilizer on Flight 16

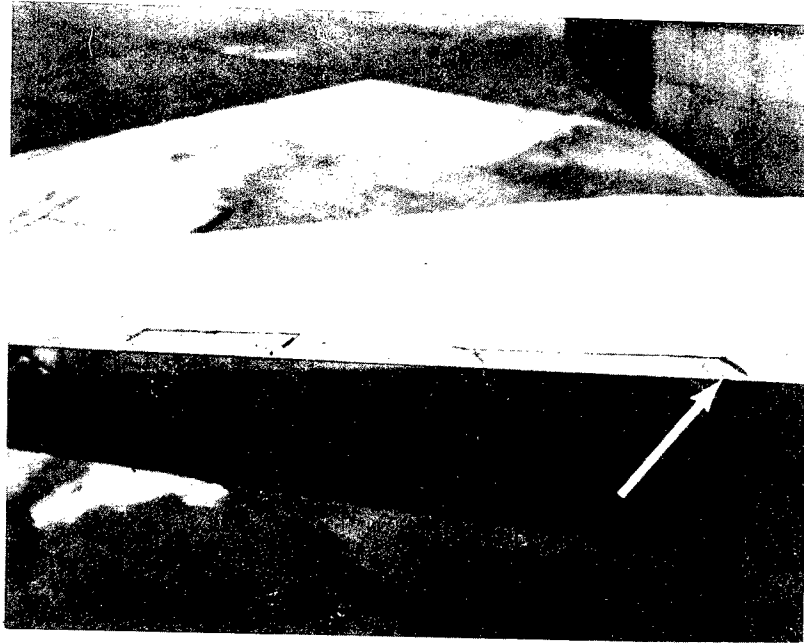
Figure 44. Slightly Peeled Section of Estane on Upper Surface of Right Stabilizer

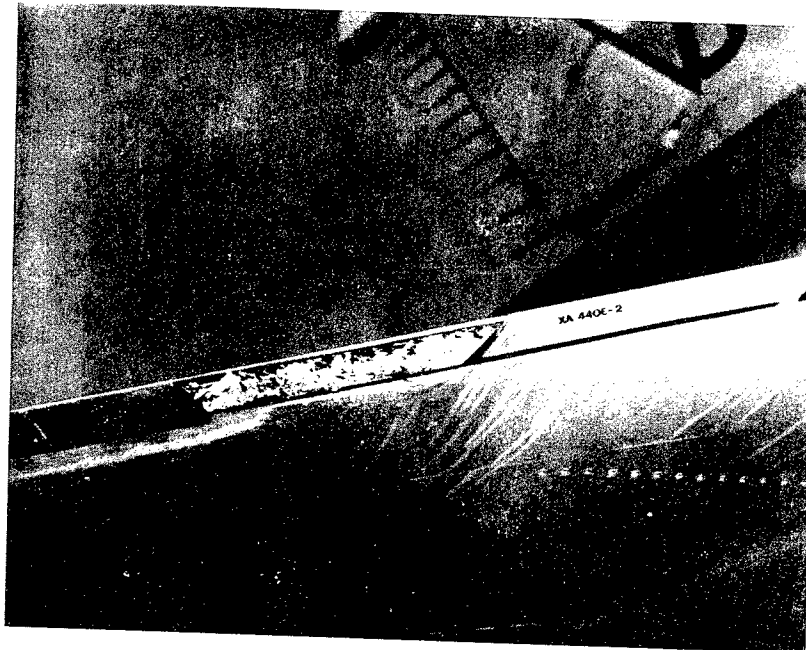
Figure 45. Corner of Estane Pulled Slightly From Lower Surface of Right Stabilizer

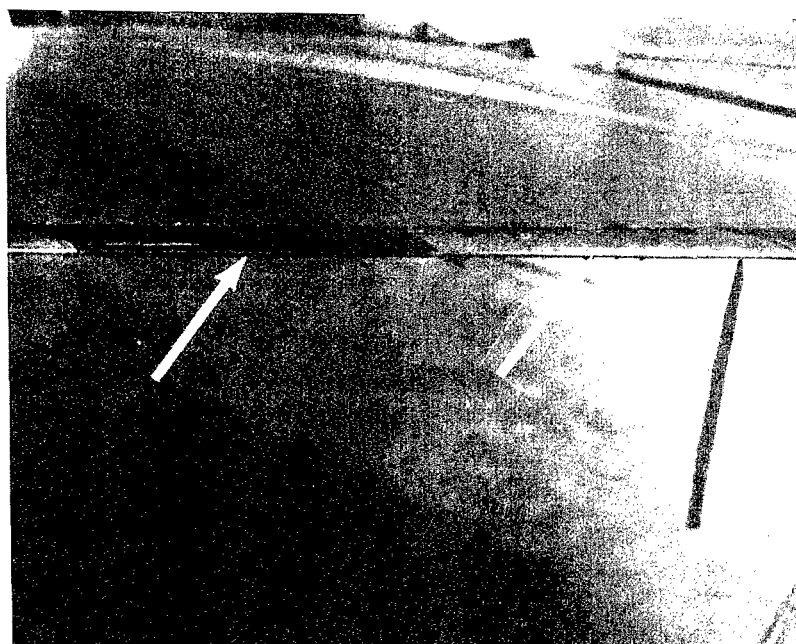
The neoprene boot on the right stabilizer showed no visible adverse effects until Flight 7 when almost all the sample was lost during the flight (Figures 46 and 47). The boot on the left stabilizer remained intact although it had cuts along the length of the boot (Figures 48 and 49). It can be speculated that the hail which was encountered shredded the missing segment on the right stabilizer. The

Figure 46. Neoprene on Upper Surface of Right Stabilizer Eroded Away During Flight 7 While Adjacent Estane Received No Damage

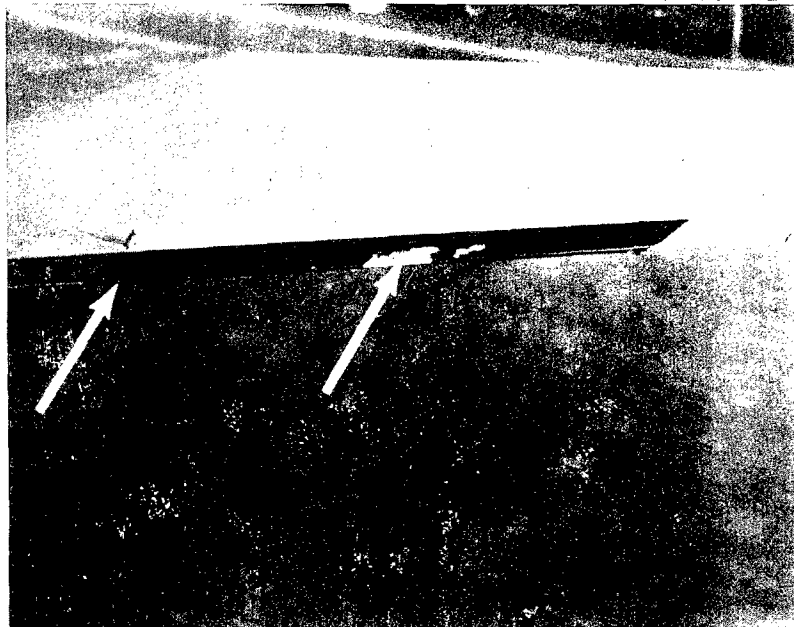
Figure 48. One Arrow Points to One of the Cuts in the Leading Edge of Neoprene on Left Stabilizer and the Second Arrow Indicates the Damage to the Hycar Boot During Flight 7

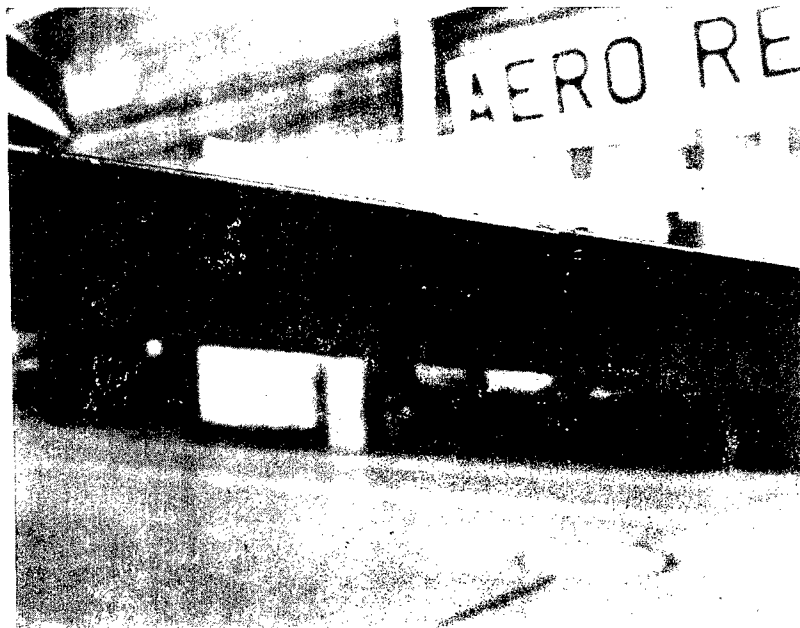
Figure 49. Damage to Neoprene and Hycar Boots on Lower Side of Left Stabilizer After Flight 7

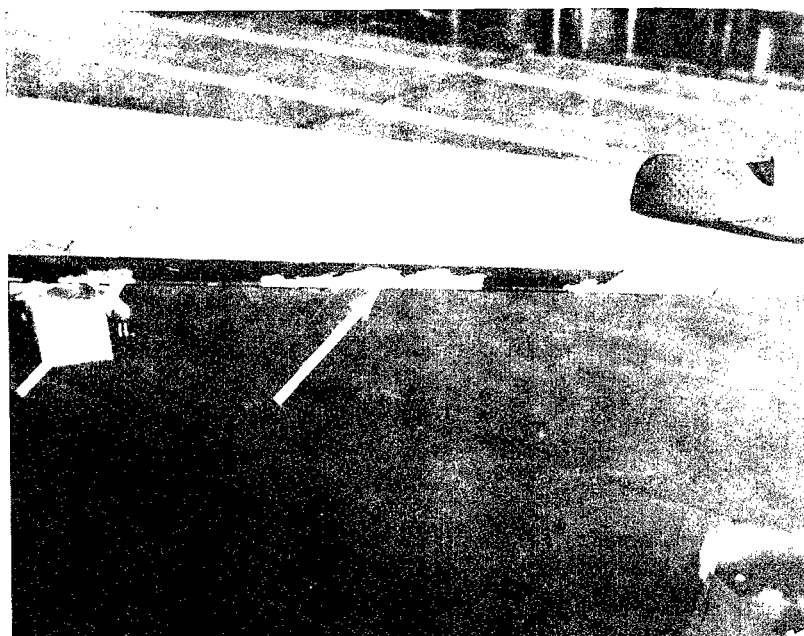
Figure 50. Increased Deterioration of Neoprene and Hycar Boots on Left Stabilizer Observed By Flight 13

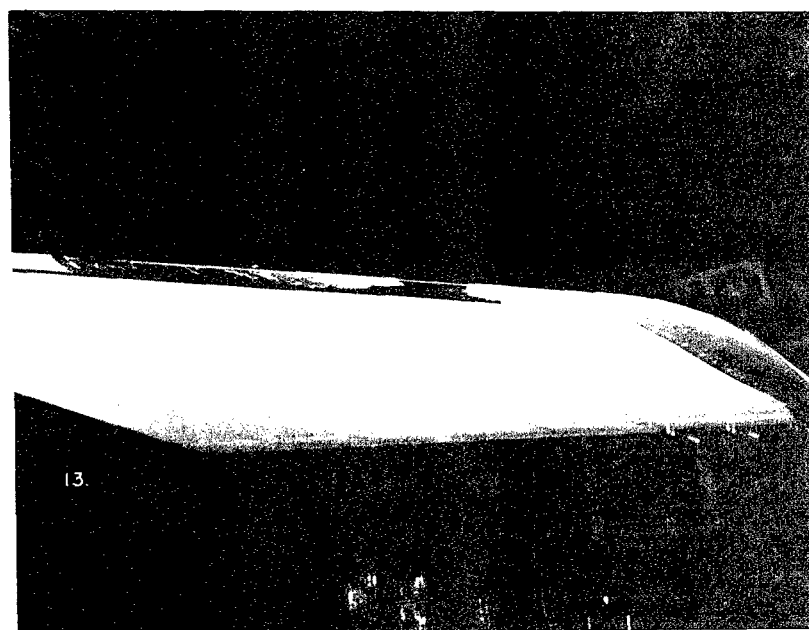
Figure 51. Damage to Neoprene and Hycar Boots on Lower Surface of Left Stabilizer After Flight 13

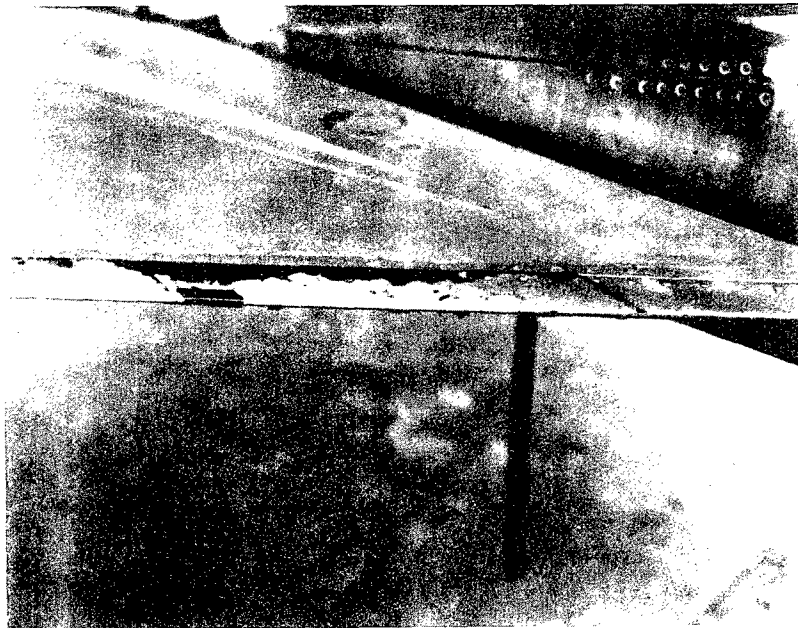
Figure 53. Hail Encounter on Flight 7 Removed Almost All the Hycar Boot From Upper Surface of Right Stabilizer

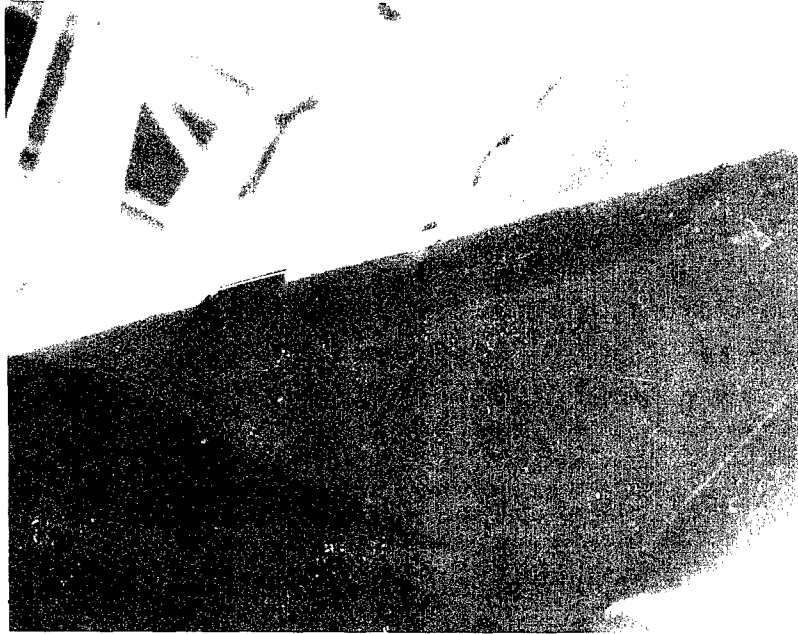
Figure 54. Severely Damaged Hycar Boot on Lower Surface of Right Stabilizer After Seventh Thunderstorm Penetration Mission

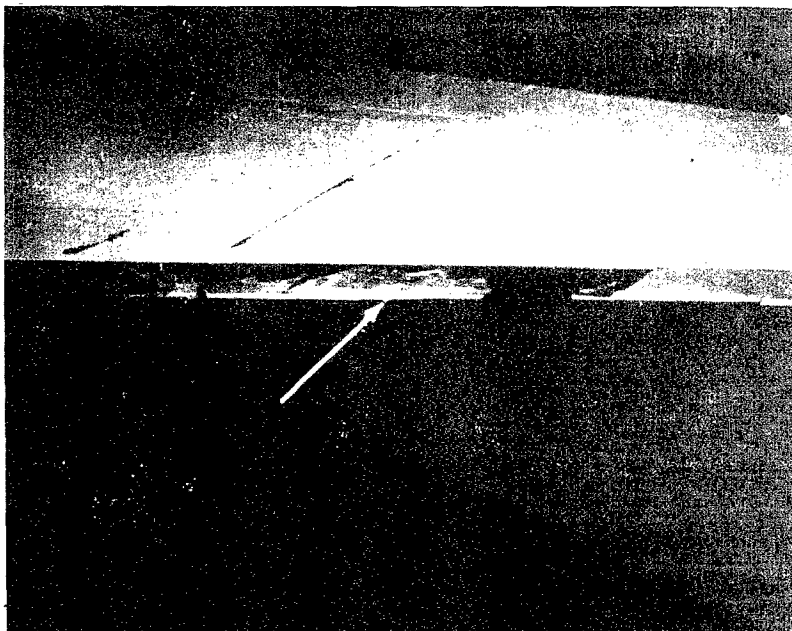
Figure 55. Three-fourths of Hycar Boot Removed From Upper Surface of Left Stabilizer During Flight 16

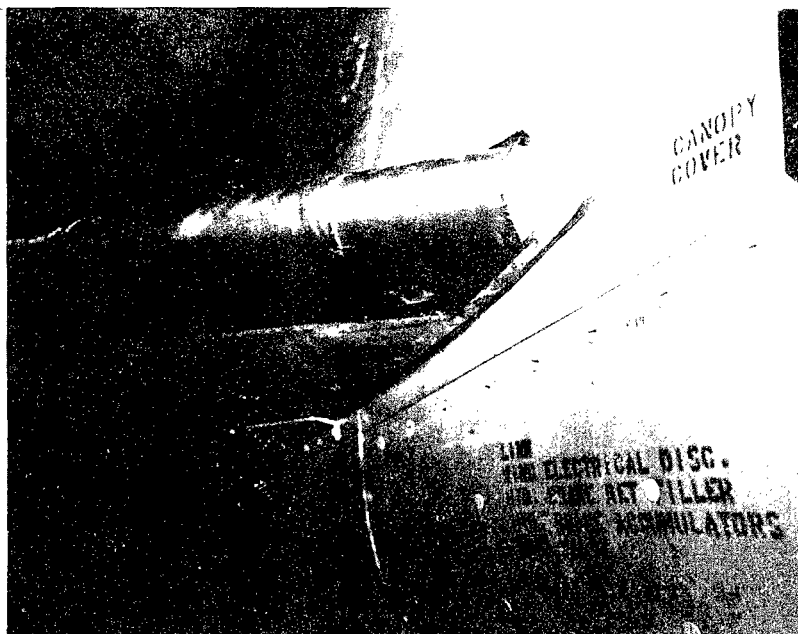
Figure 56. Edge of Slit in Deicing Boot Frayed After Flight 2

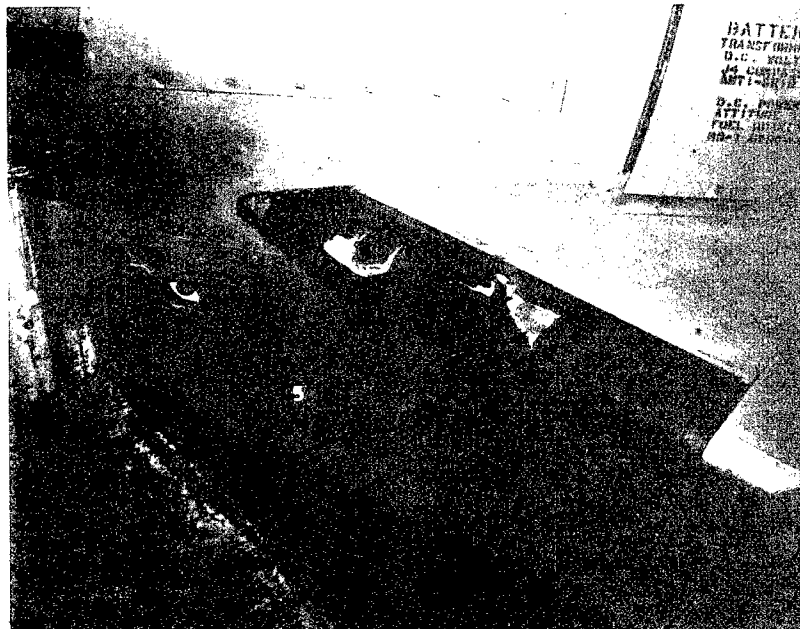
Figure 59. Increased Failure of Deicing Boot on Left Wing After Flight 3

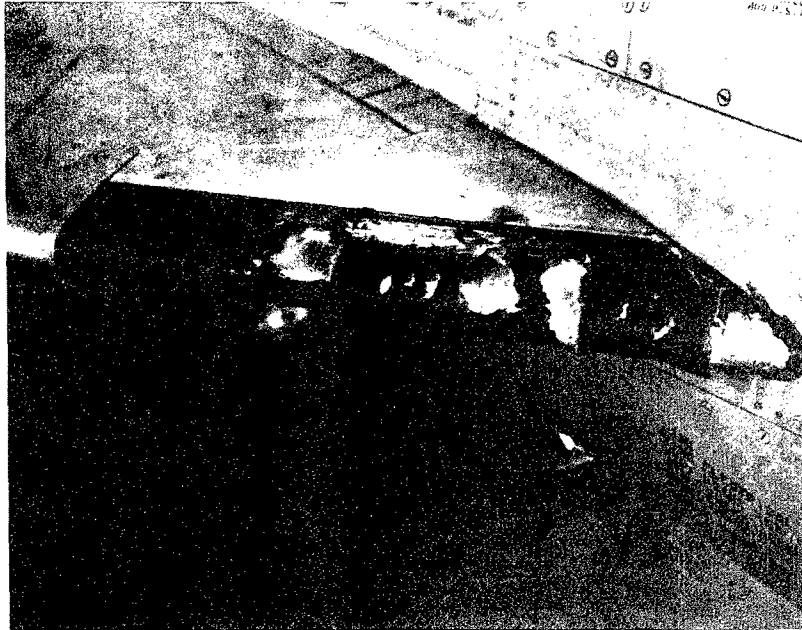
Figure 60. Severe Damage to Deicing Boot Caused by Hail and Ice Crystal Impingement During Flight 7

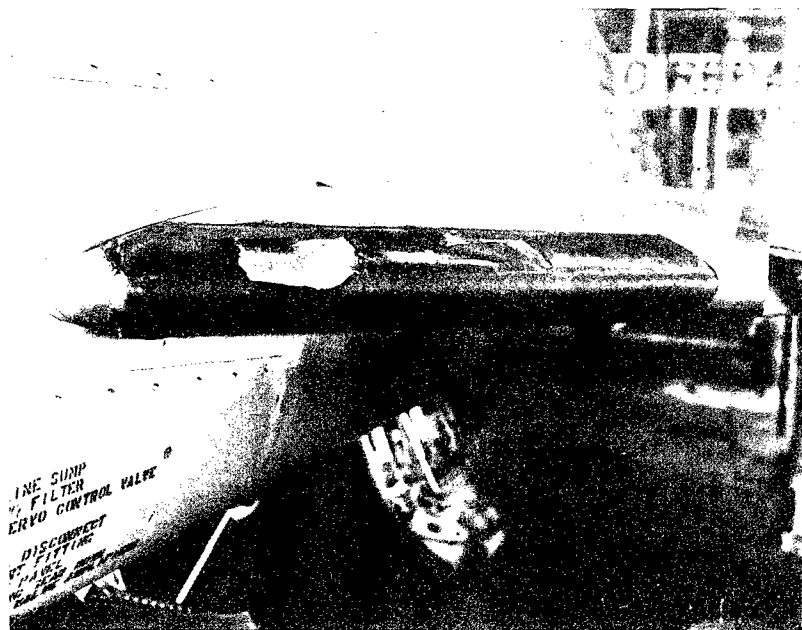
Figure 61. Significant Damage to Deicing Boot on Left Wing Caused by Hail and Ice Crystal Encounter on Flight 7

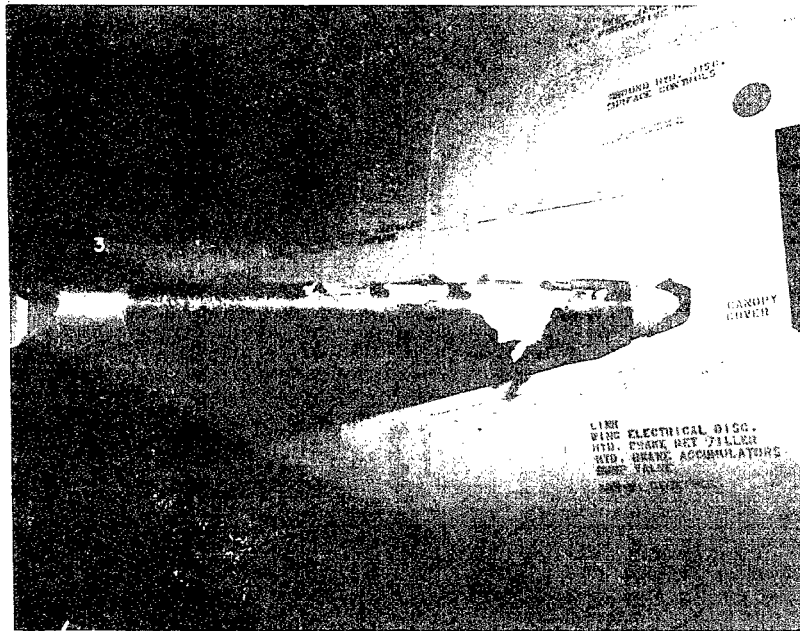
Figure 62. Severe Breakdown on Deicing Boot on Right Wing Observed After Flight 13

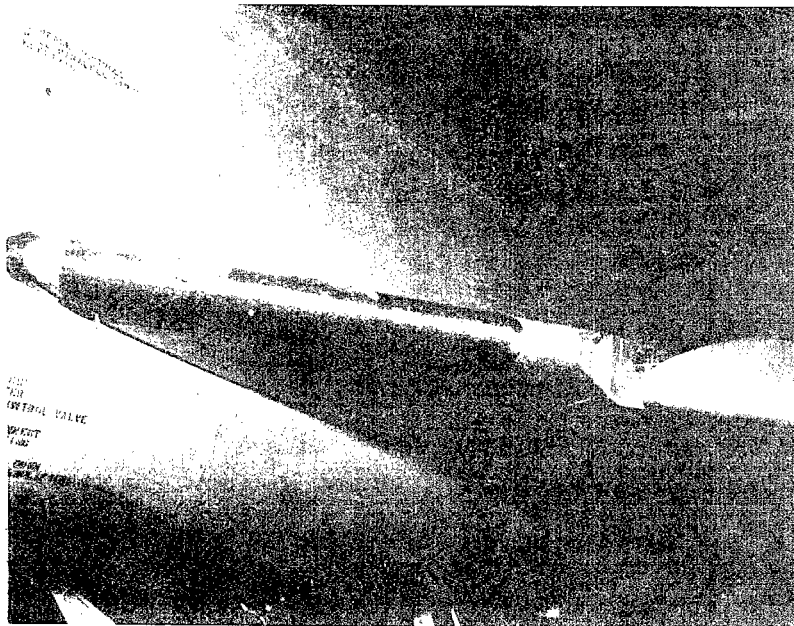
Figure 63. Increased Visible Erosion of Left Wing Deicing Boot After Flight 13

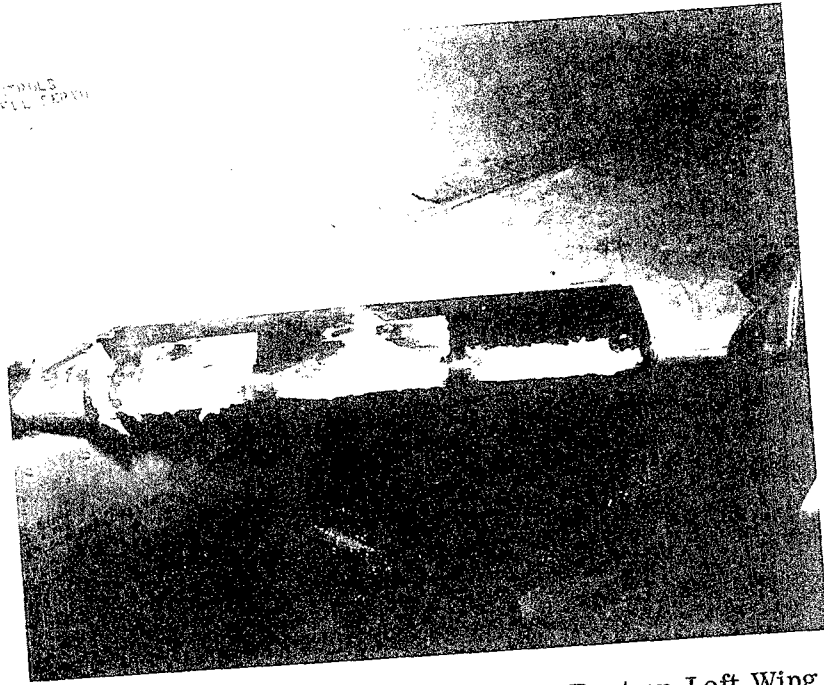
Figure 64. Complete Breakdown of Deicing Boot on Left Wing After Flight 16

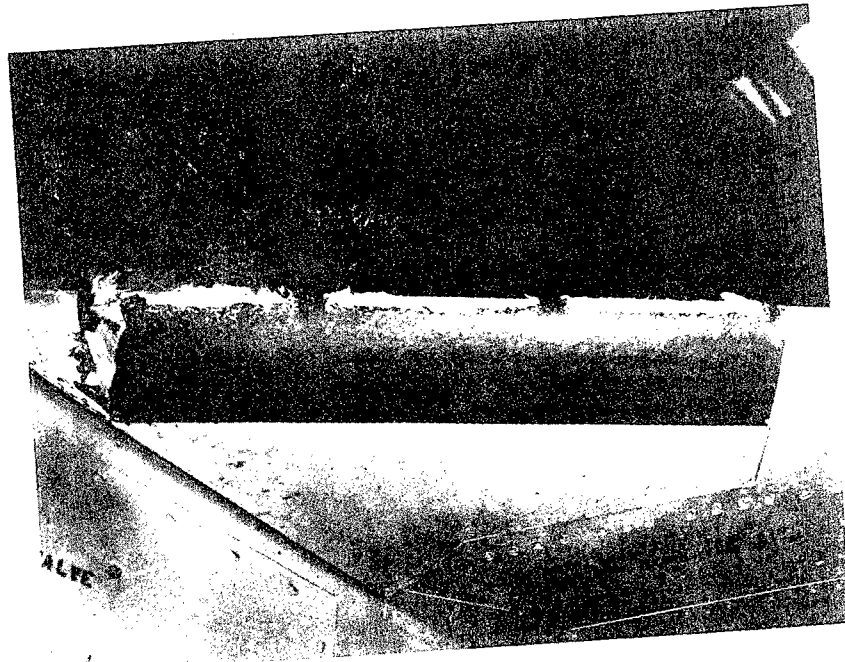
Figure 65. Section of Deicing Boot on Lower Surface of Left Wing Received Little Damage on Flight 16

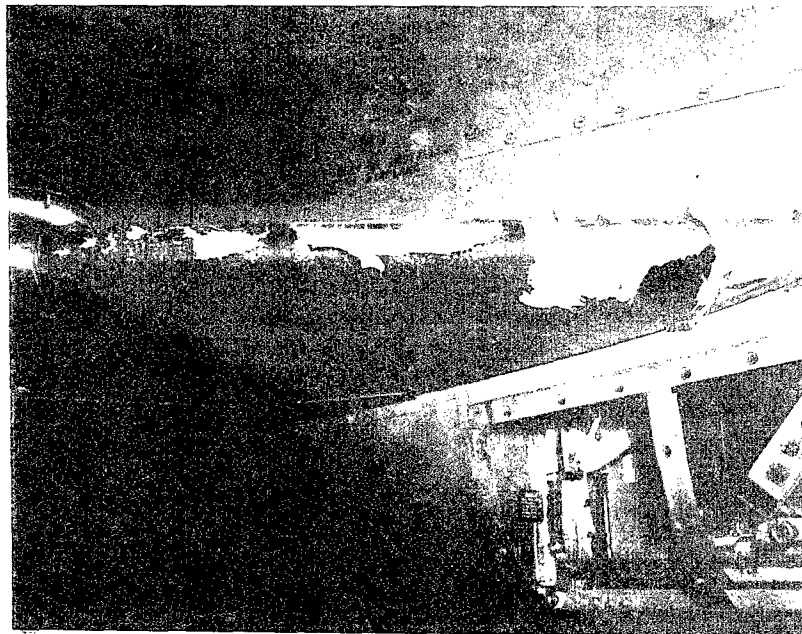
Figure 67. Surface of Deicing Boot on Lower Surface of Right Wing Leading Edge Not Damaged as Much as the Section on Top of Wing

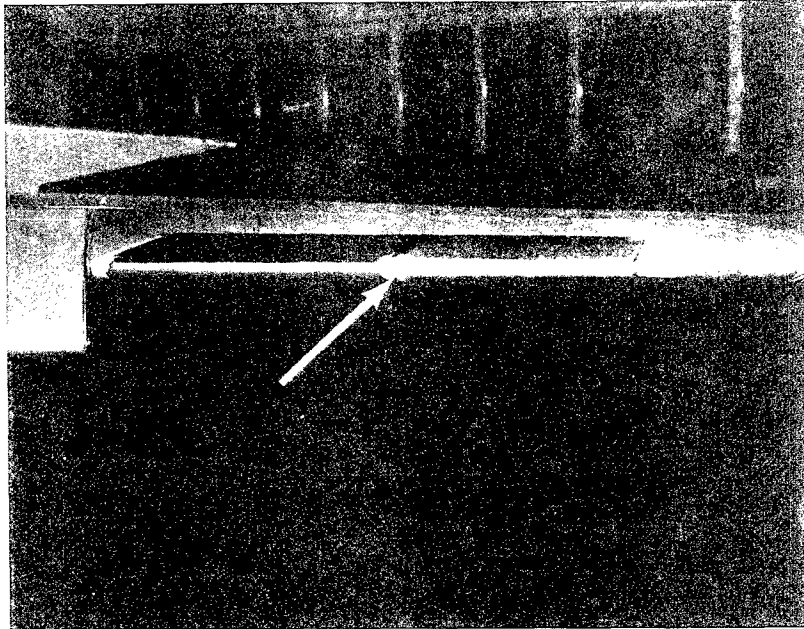
Figure 68. Goodrich Samples 1 and 2 on Left Wing Tip Show Little Adverse Effect After Flight 16; the Arrow Indicates Slight Damage to Inboard Edge of Sample 1

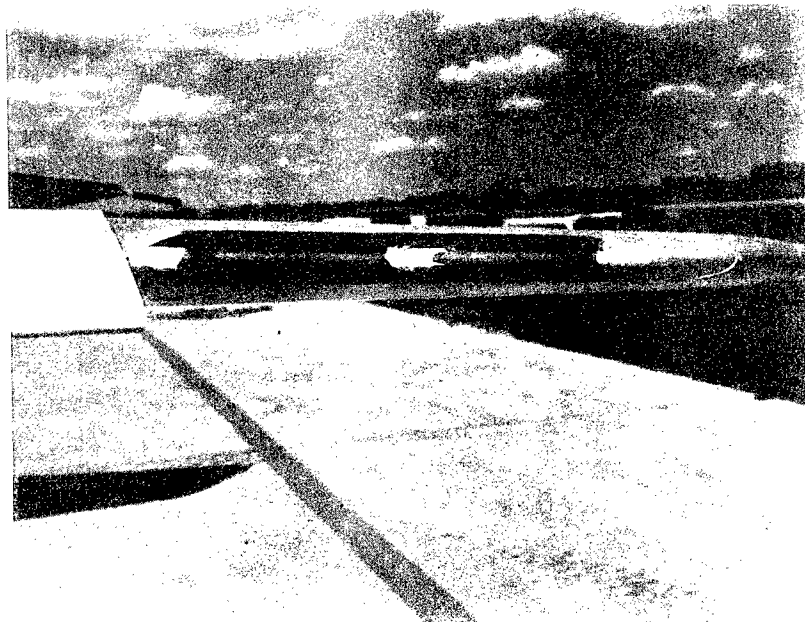
Figure 69. Final Damage Received by Goodrich Samples on Left Wing Tip

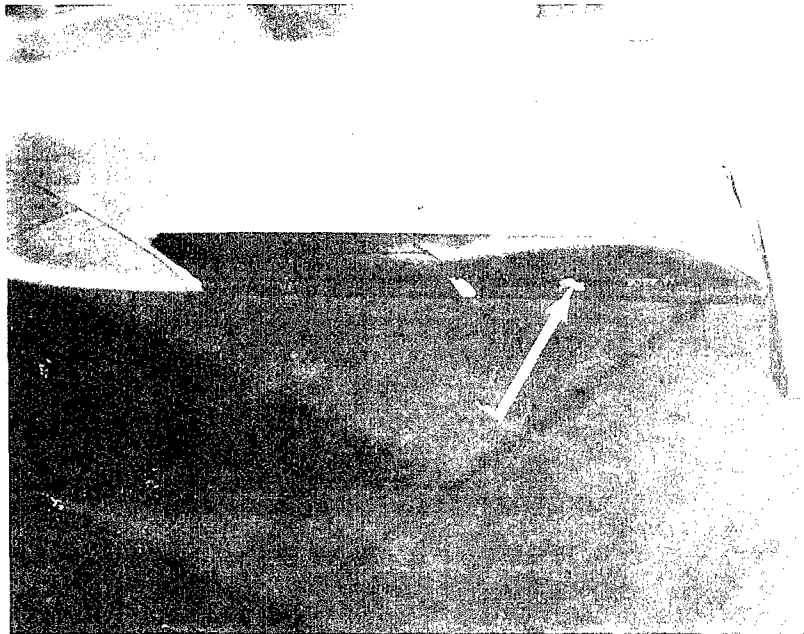
Figure 70. Goodrich Samples 3 and 4 on Leading Edge of Right Wing Received Damage During Flight 7; the Arrow Points to a Cut on Leading Edge in Sample 3

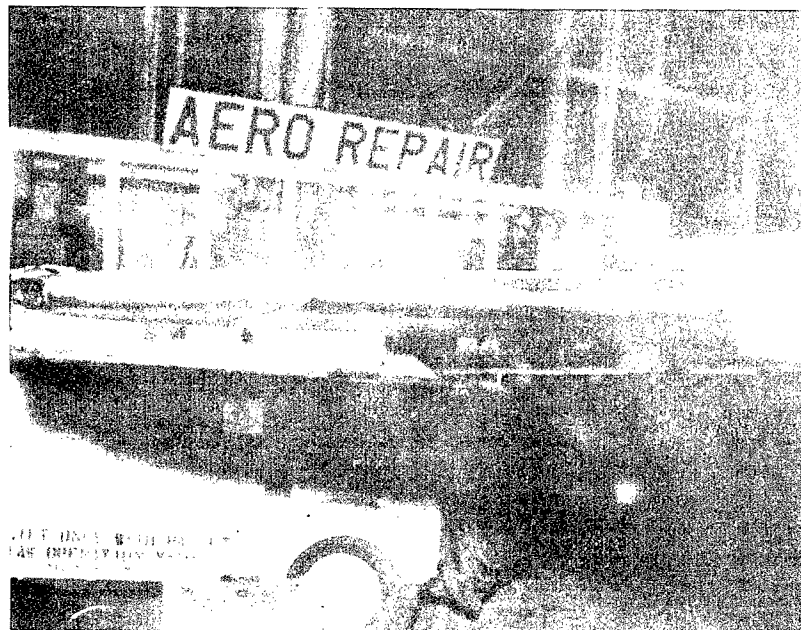
Figure 71. Inboard Sample on Right Wing Tip With Torn Leading Edge After Flight 13

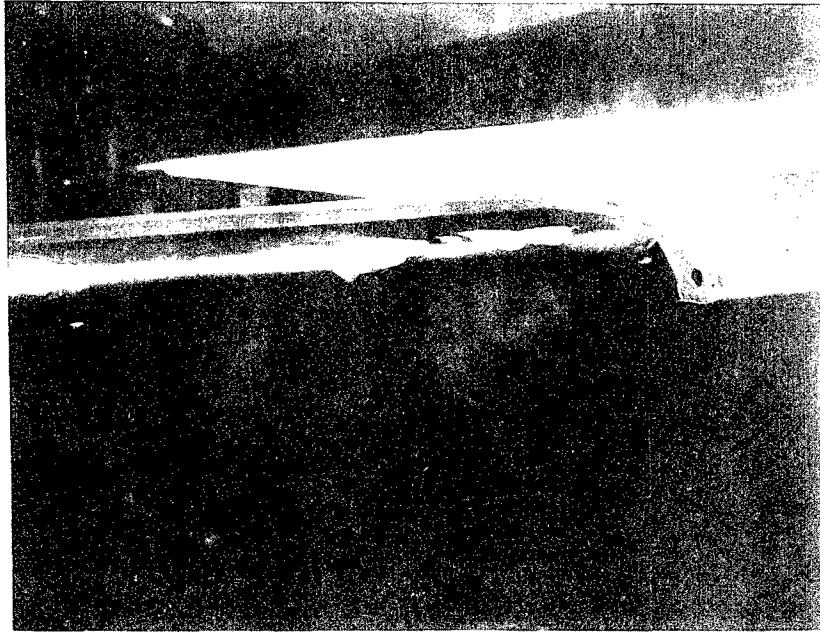
Figure 72. Samples 3 and 4 on Right Wing Tip After Flight 16

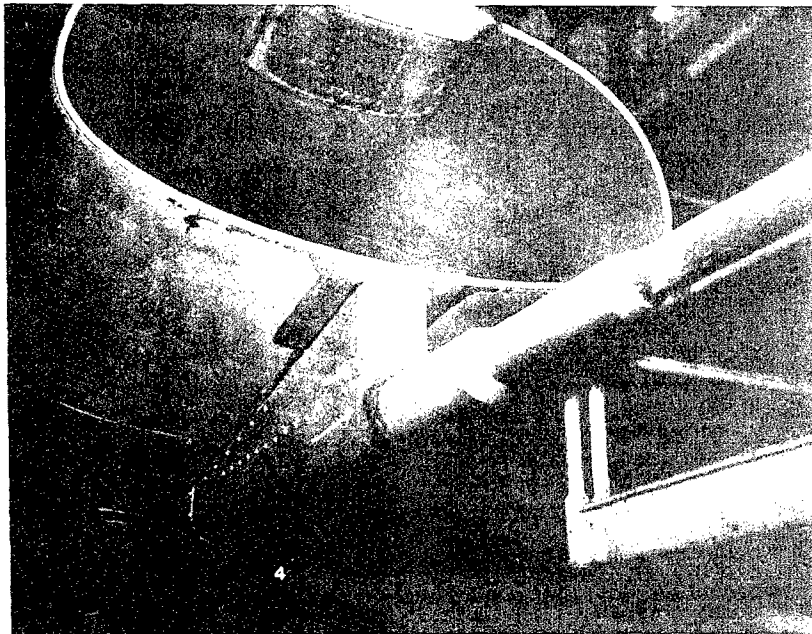
Figure 74. Damage to Goodrich Sample on Noseboom Mount During Three Flights
