Technical Note N-855

MAINTENANCE PAINTING OF BUILDINGS--FIRST PROGRESS REPORT

Joseph B. Crilly and James H. Mitchell

8 November 1966

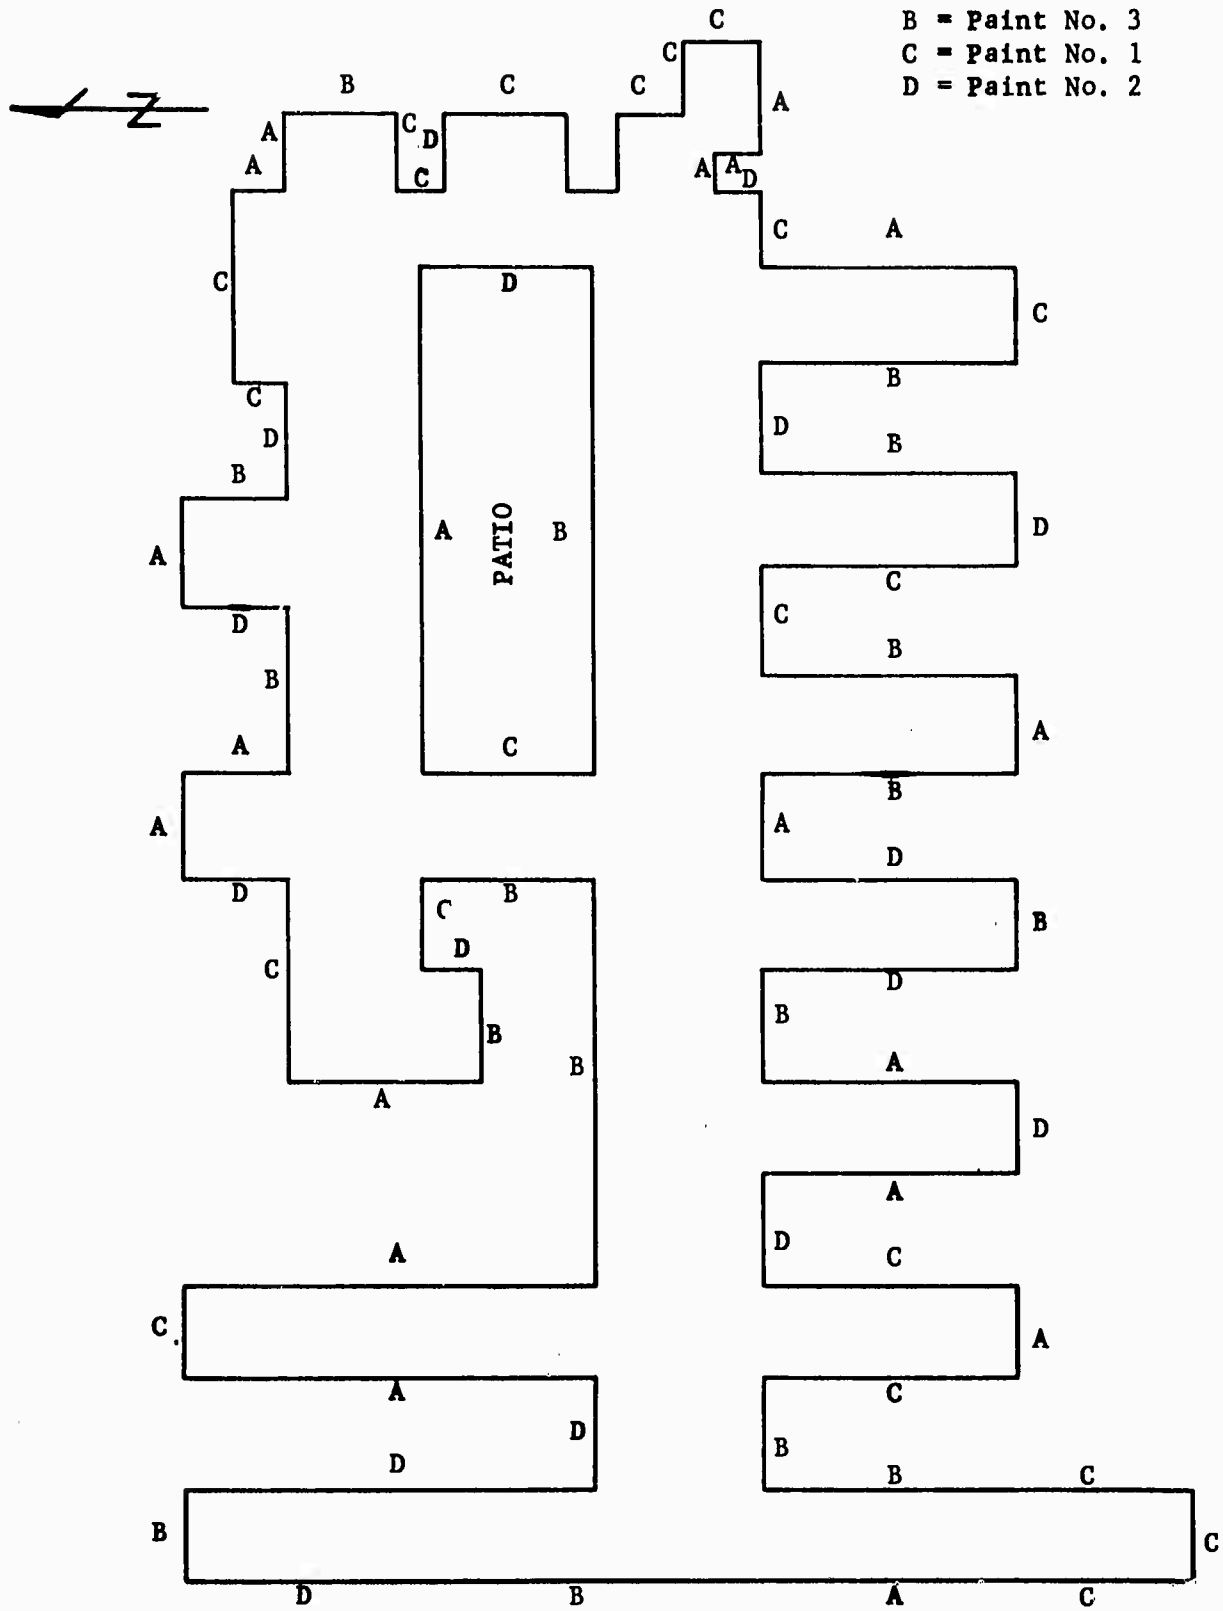
Figure 1. Drawing of CBC Base Hospital.

The CBCenter Hospital is well suited for a painting experiment because it has many different exposures. There are seven wings on the southern part of the building each of which have south, east and west exposures. The building surface was divided into seventy-six sections, based primarily on the irregular structural design of the building. One of four different paints, designated as A, B, C, or D, was randomly chosen to be applied to each section, as shown in Figure 1.

- A = TT-P-102a
- B = Paint No. 3
- C = Paint No. 1
- D = Paint No. 2

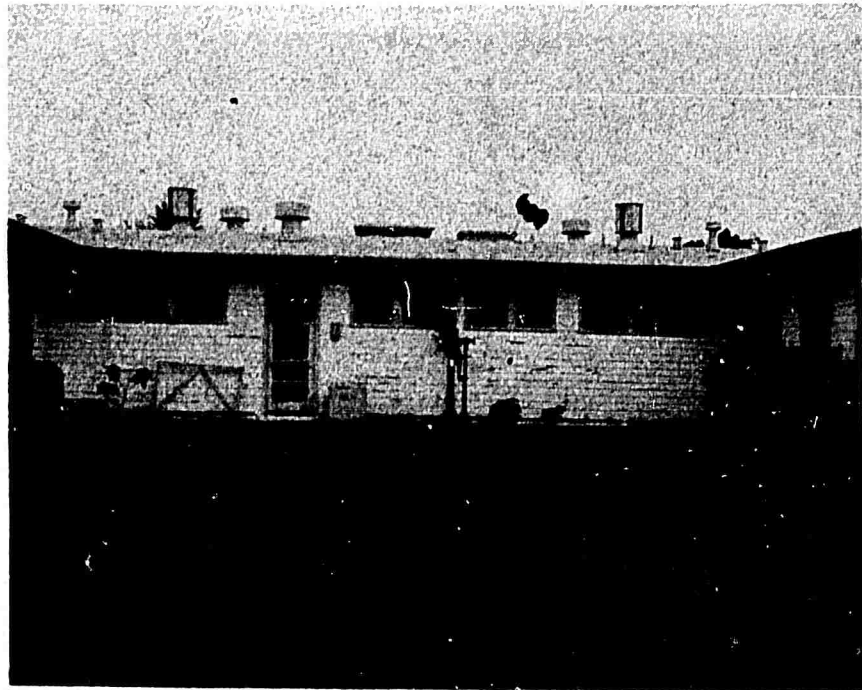
A high degree of surface preparation was prescribed for the hospital to obtain a better than normal paint job. The condition of the old paint was bad (i.e., cracks and flakes) on the southern wings and in the patio, see Figure 2, but the northern wings of the building were generally in good condition. All loose paint was removed with a putty knife or a disk or vibrator sander and the rough edges were feathered to prevent lifting or curling of the base paint. Chalk and dirt were removed with steel wool or, if the old paint had no cracks and flakes, by water and a stiff brush. The bare wood was primed with TT-P-25a the same day it was sanded to prevent absorption of moisture overnight.

Figure 2. Condition of the old paint on a southern exposure of the Construction Battalion Center Base Hospital.

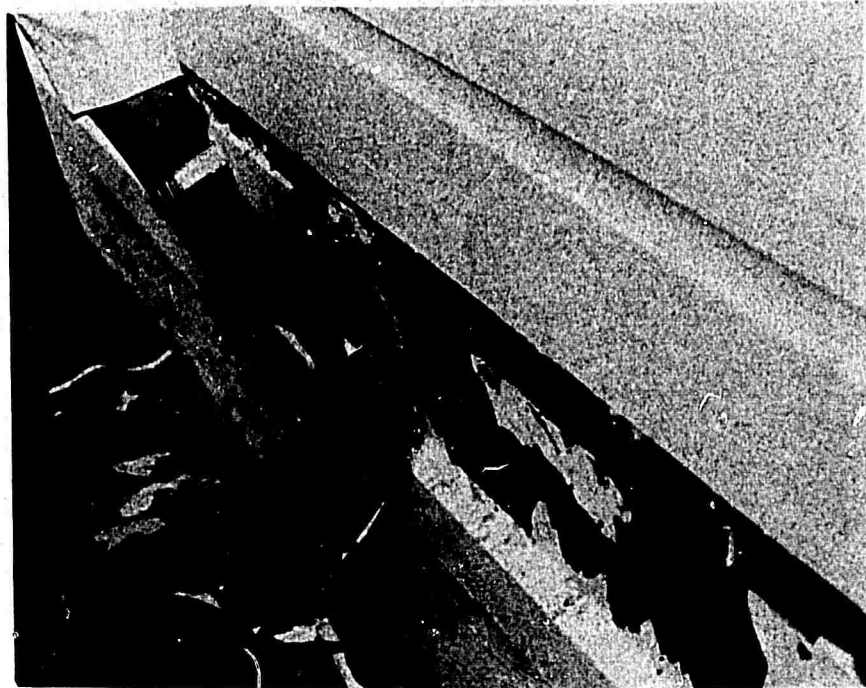
The old paint on the north side of the hospital seemed to be in good condition (no cracks and flakes) and some areas were washed with water to remove the chalk and dirt. On two isolated areas, blisters were noticed after the wall had been washed with water, allowed to dry for a week and then coated with TT-P-102a, a slow drying linseed oil paint. The blisters may have existed before washing with water or before painting with TT-P-102a, but they were not noticed until 24 hours after the paint was applied. Figure 3 shows adhesion failures and the flexibility of the old paint after the wall had been washed, allowed to dry for a week, and coated with TT-P-102a. The inside wall directly behind the blisters was dry but the blisters were full of water when they were noticed. Laboratory tests showed that water as well as linseed oil paint can soften the old paint which is on the hospital.

Figure 3. Adhesion failures and softening of the old paint 24 hours after washing with water and applying TT-P-102a.

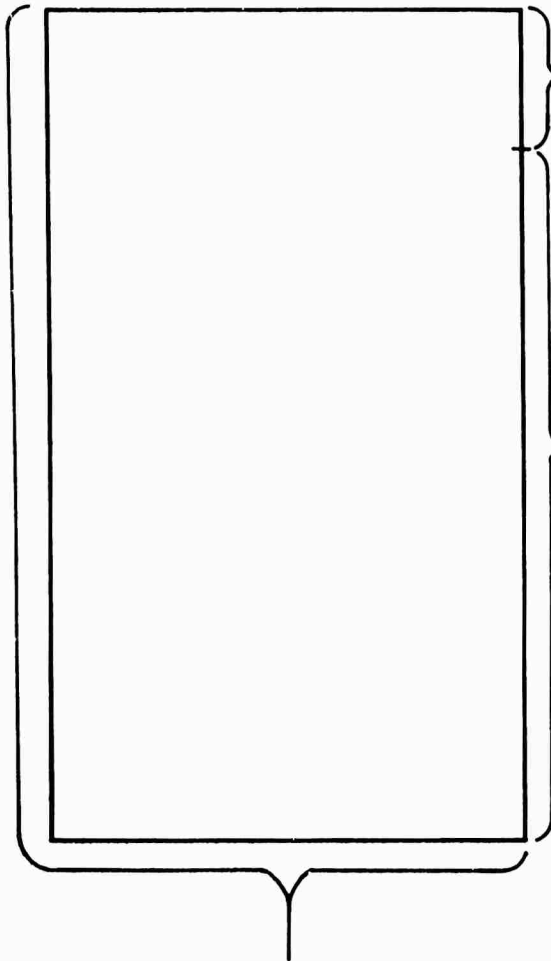
Figure 4. Repainting system for Building 563.

Loosely adherent paint on the east side of Building 563, the protective coatings laboratory, was scraped off and rusted areas were sand-blasted lightly and the metal was then washed with mineral spirits. The galvanized iron was then treated with a coat of wash primer, MIL-P-15328b, followed by a coat of red lead primer, TT-P-86C, except for a ten foot strip which was primed and top coated with Paint No. 4. Tightly adherent paint on the west side of Building 563 was cleaned by brushing the surface with a detergent solution after priming when necessary with TT-P-645. The topcoat on all of the building except the ten foot strip was spray painted with two coats of TT-P-102a, class B, color. The ten foot strip was topcoated with two coats of Paint No. 4. Figure 4 illustrates the treatments for Building 563.

Remove all old paint by sandblasting. Wash with mineral spirits. Prime with Paint No. 4. Topcoat with Paint No. 4

Remove all old paint. Wash with mineral spirits. Condition with MIL-P-15328B. Prime with TT-P-86c. Topcoat with TT-P-102a, Class B

Remove loose paint. Spot prime with TT-P-645. Wash with detergent and water. Topcoat with TT-P-102a, Class B

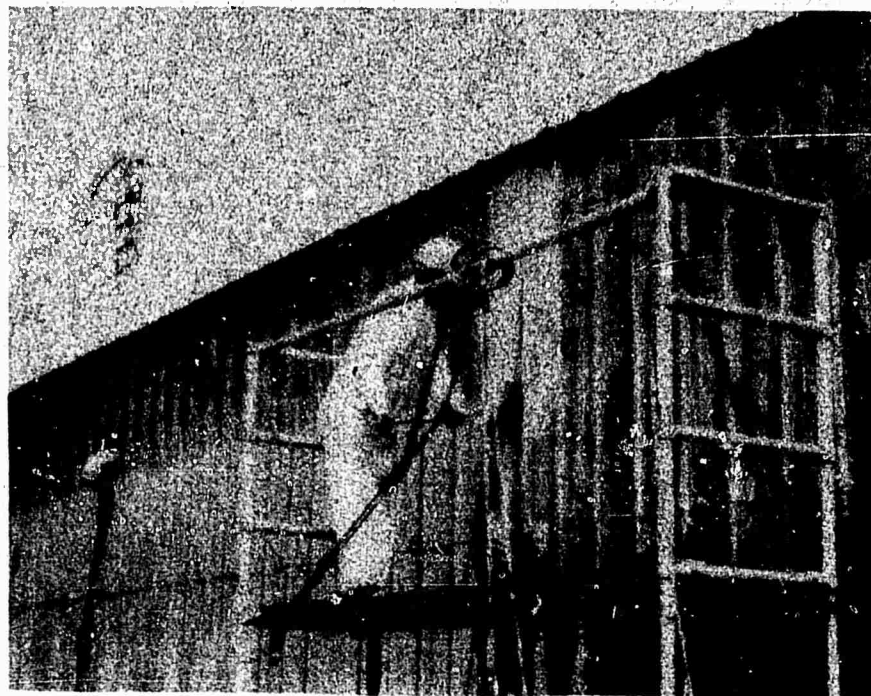
Figure 6. Brushing detergent solution on the surface.
