AFFTC-TD-69-4

FLIGHT PLANNING AND CONDUCT OF THE X-15A-2 ENVELOPE EXPANSION PROGRAM

Technology Document No. 69-4

JULY 1969

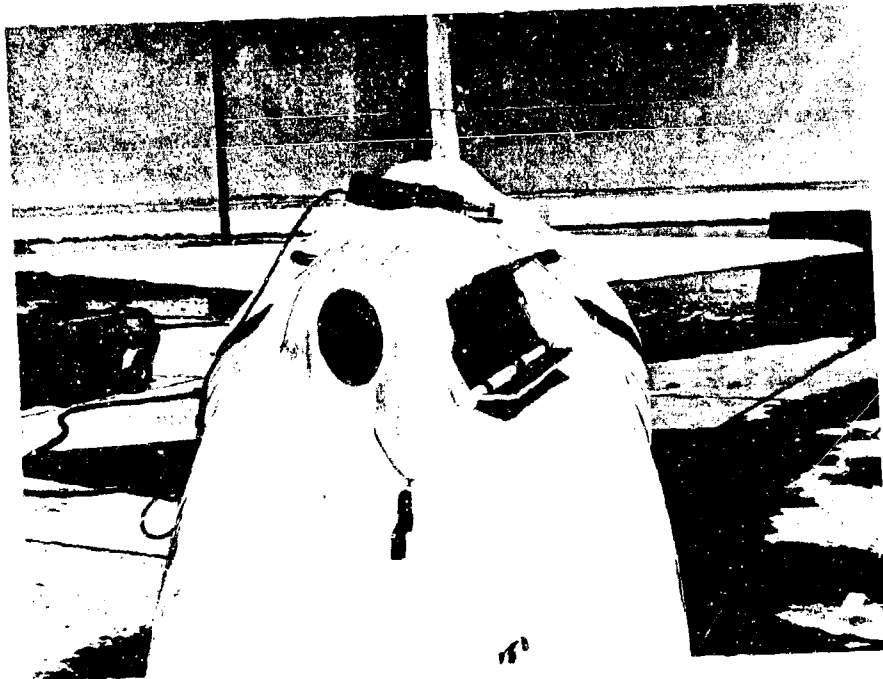
Figure 37 VERTICAL
TAIL AFTER FLIGHT
No. 2-52-96

two separate spray coatings (figure 37). The failure was attributed to the spray mixture being too dry at the start of the second coat. A tensile test of the ablative coat in this area prior to the flight had indicated that the adherence was slightly sub-marginal, but was not considered critical for this flight. The second problem was erosion of the ablative material on the leading edge of the ramjet pylon (figure 38). It was believed that this increased erosion was the result of shock wave impingement from the ramjet, however the seriousness of the problem was not fully appreciated until the next flight.

Aircraft preparation for this flight consisted mainly of refurbishing the ablative material wear resulting from the last flight. This task required approximately 700 man-hours over a two week period.

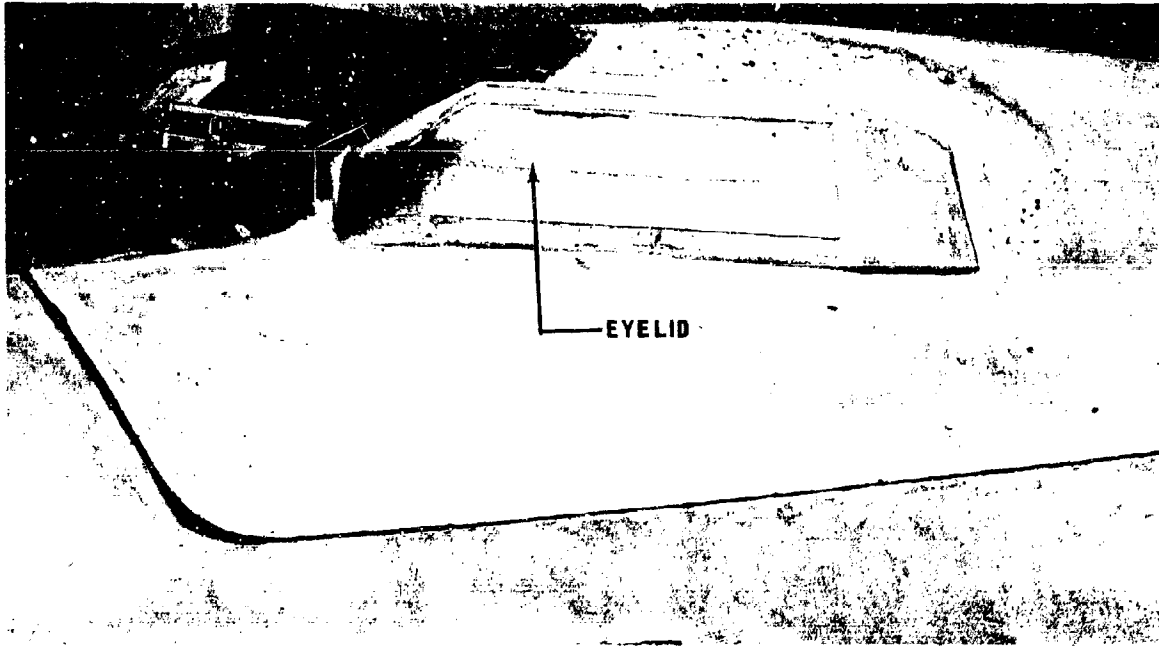
Figure 48 LEFT CANOPY

The condition of the canopy after the flight is shown in figures 48 and 49. The extent of the "fogging" on the unprotected left windshield due to redeposit of the ablation products may also be observed.

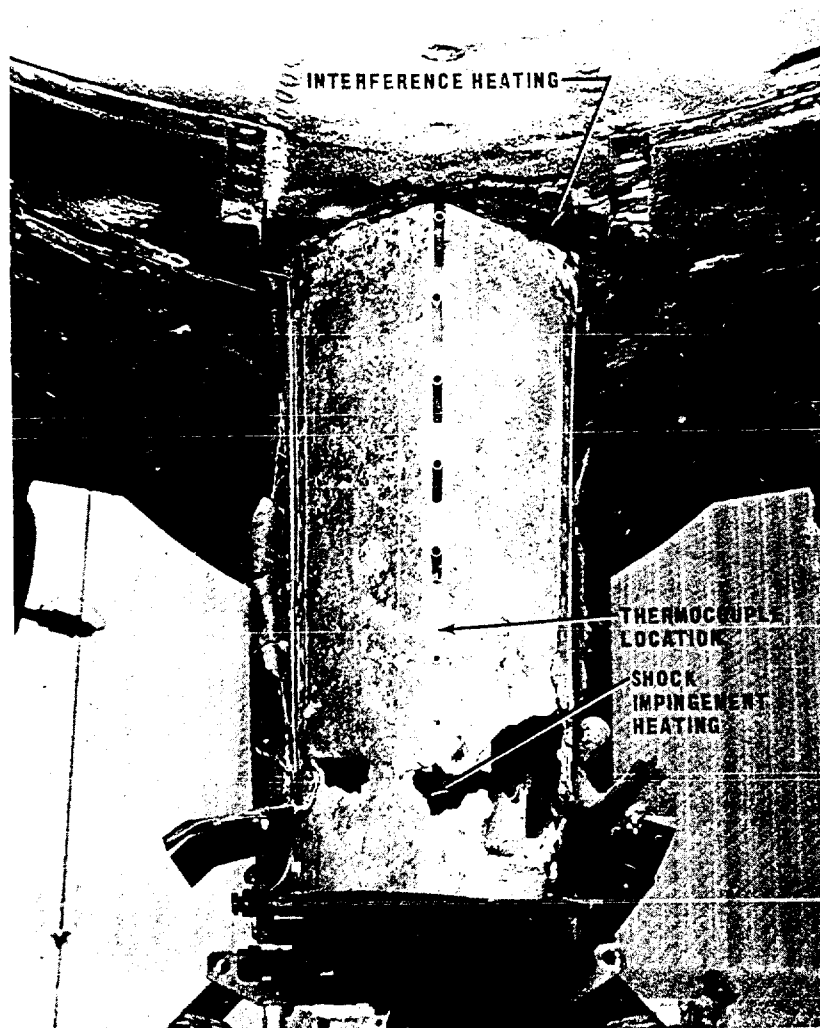
Figure 51 PYLON HEAT DAMAGE-FRONT

The most severe melting damage occurred near the bottom of the ramjet pylon where shock waves generated by the ramjet spike tip, spike flare, cowl lip and bottom pressure probe were assumed to have intersected (figures 51, 52, and 53). A postflight thermal analysis of the heating in this area was made using the recorded temperature from the thermocouple located at the leading edge of the pylon and the observed heat damage as a guide. The measured temperature indicated a low value (less than 0°F) until approximately 145 seconds after launch when a rapid rise in temperature occurred, indicating that the ablative material had burned

Two areas of high heating due to flow interference were the pylon/fuselage junction and the ramjet cowl lip. A reasonable temperature profile for the indicated damage was also obtained by increasing the undisturbed heat-transfer coefficient by a significant factor. The calculated temperature due to interference heating of the ramjet cowl lip exceeded the melting point of the 4130 steel (2800 degrees F) for a short time causing the melting damage shown in figure 54. A complete analysis of this subject may be found in reference 7.
