Technical Note N-1037

CORROSION OF DSRV MATERIALS IN SEA WATER -
SIX MONTHS EXPOSURE

Fred M. Reinhart

NAVAL CIVIL ENGINEERING LABORATORY
Port Hueneme, California 93041

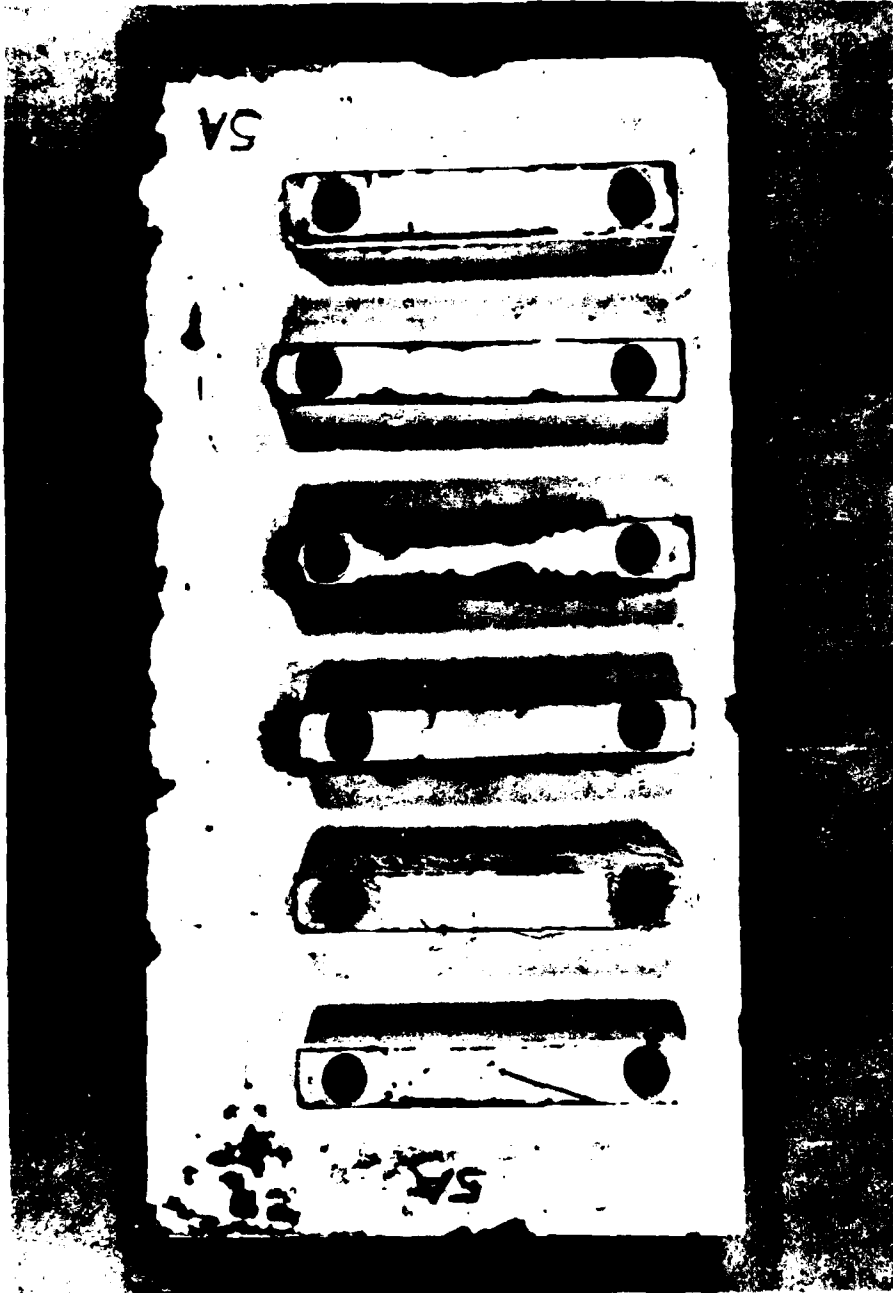
Specimens simulating four conditions noted in the above paragraph were exposed at mean tide level at the Point Mugu site for evaluation. Typical specimens are shown in Figures 1 and 2. The specimen in Figure 1 is an anodized and painted 6061-T6 aluminum alloy panel to which is fastened six painted 6Al-4V titanium alloy strips with A-286 stainless steel fasteners.

The top coat of paint had peeled on nearly 50 percent of the front and back surfaces of the panel. The 6061-T6 anodized and painted panel had been attacked by pitting corrosion where it had been in contact with the insulators and the paint and anodized coating had been worn off. The paint had failed along the edges and at the corners of the 6Al-4V titanium alloy strips.

The pitting corrosion of the anodized and painted 6061-T6 aluminum alloy panel was attributed to galvanic corrosion because of its electrical contact with the 6Al-4V titanium alloy strips and fasteners.

Figure 1. Painted titanium alloy strips bolted to an aluminum alloy panel with stainless steel bolts.
