Air Force Report No.
SAMSO-TR-69-353

**THE DETERIORATION OF STAINLESS STEEL REGENERATIVELY
COOLED THRUST CHAMBERS**

J. K. STANLEY
Materials Sciences Laboratory

Laboratory Operations
THE AEROSPACE CORPORATION

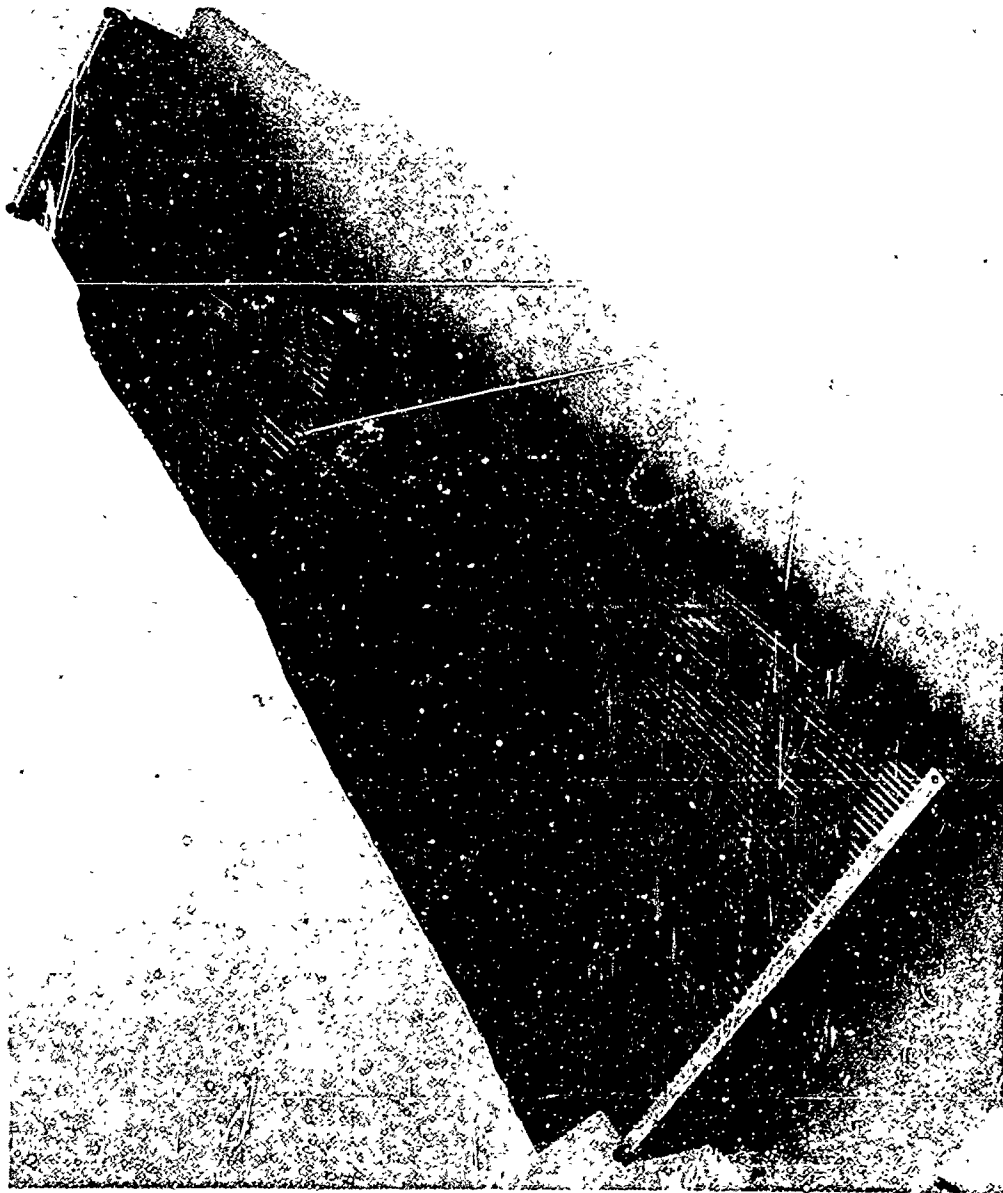
Figure 1. Rocket Engine Section Showing Brazed Tube Construction
(Terminal blocks installed for flow measurements; overall length
about 5 ft. Note heat markings below the bifurcated joint.)

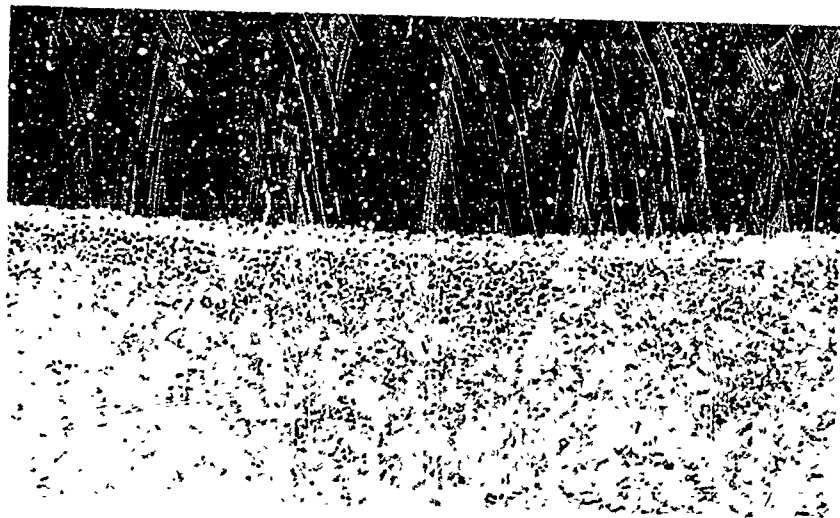
Photomicrograph Fig. 4(a) shows the coke formation and some carburization beneath the coking inside the tube in the vicinity of the failure (burnout); Fig. 4(b) shows the edge of the fracture and the voids show that the metal was separating at the increased temperature.

(a) Carbon deposits formed on inside of tube as a result of Aerozine-50 decomposition. 200 X

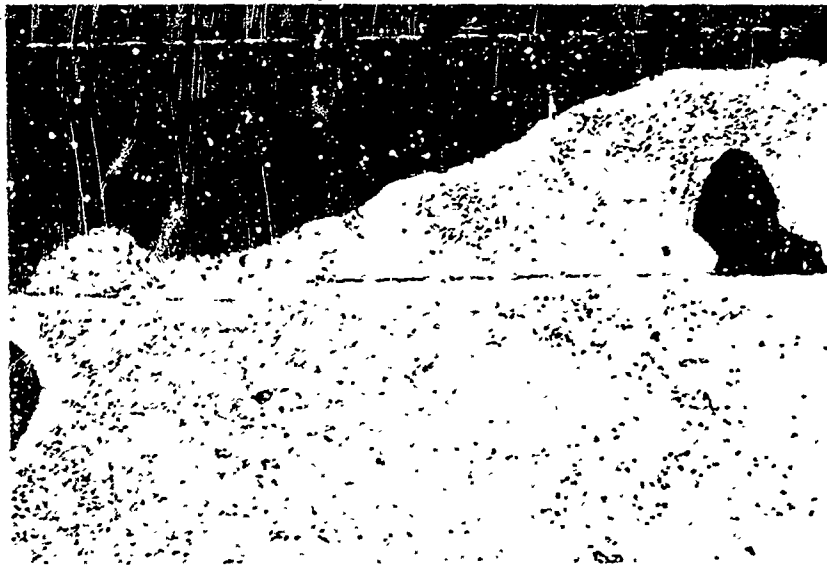
(b) Areas of dendritic structures are resolidified
metal adhering to wall 200X

Figure 5. Other Features at Edge of Failure on
Burnout Sample
(Etched in Aqua Regia)

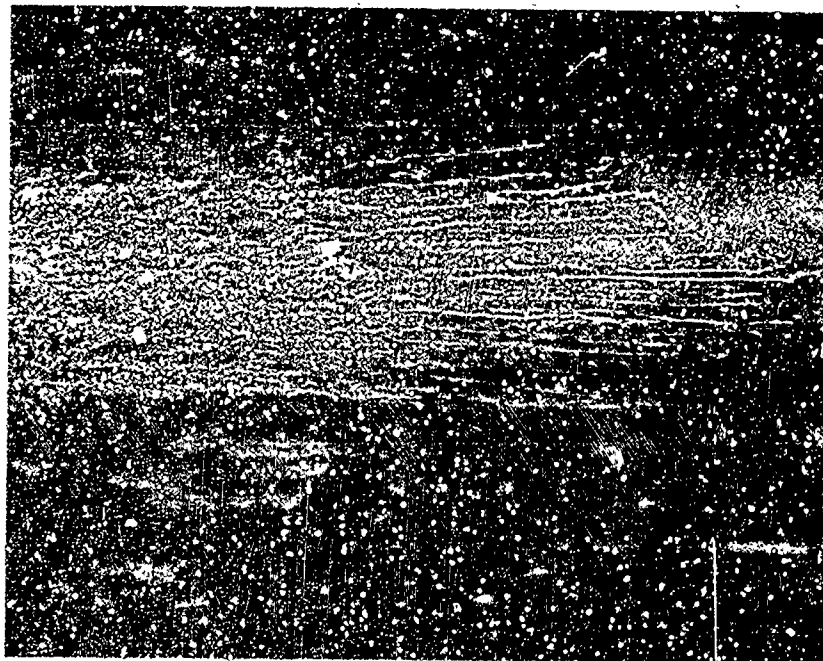
Occasionally, solidified beads or crystallized metal, apparently melted from the tubes, appeared on the combustion side of the chamber. Figure 9(a) shows a beaded spray and Fig. 9(b) shows the crystallized metal. This material had been assumed to be molten metal, but x-ray analysis identified it as a Cr_7C_3 carbide.

(a) Beaded spray 4X

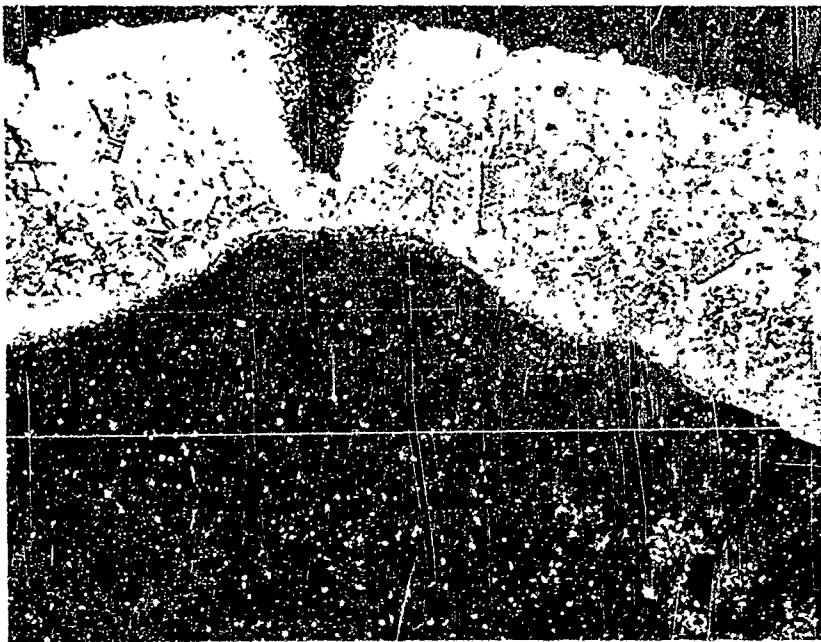
internal surface is shown in Fig. 13(a). Occasional melting can occur as shown in Fig. 13(b).

(a) Etched in Aqua Regia 100X

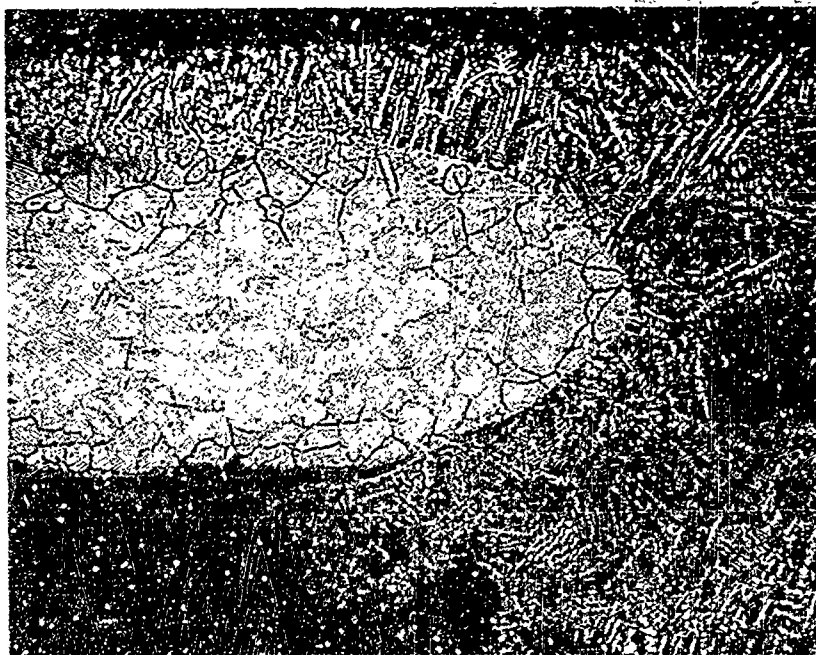
(b) Etched in Oxalic Acid (Electrolytic) 100X

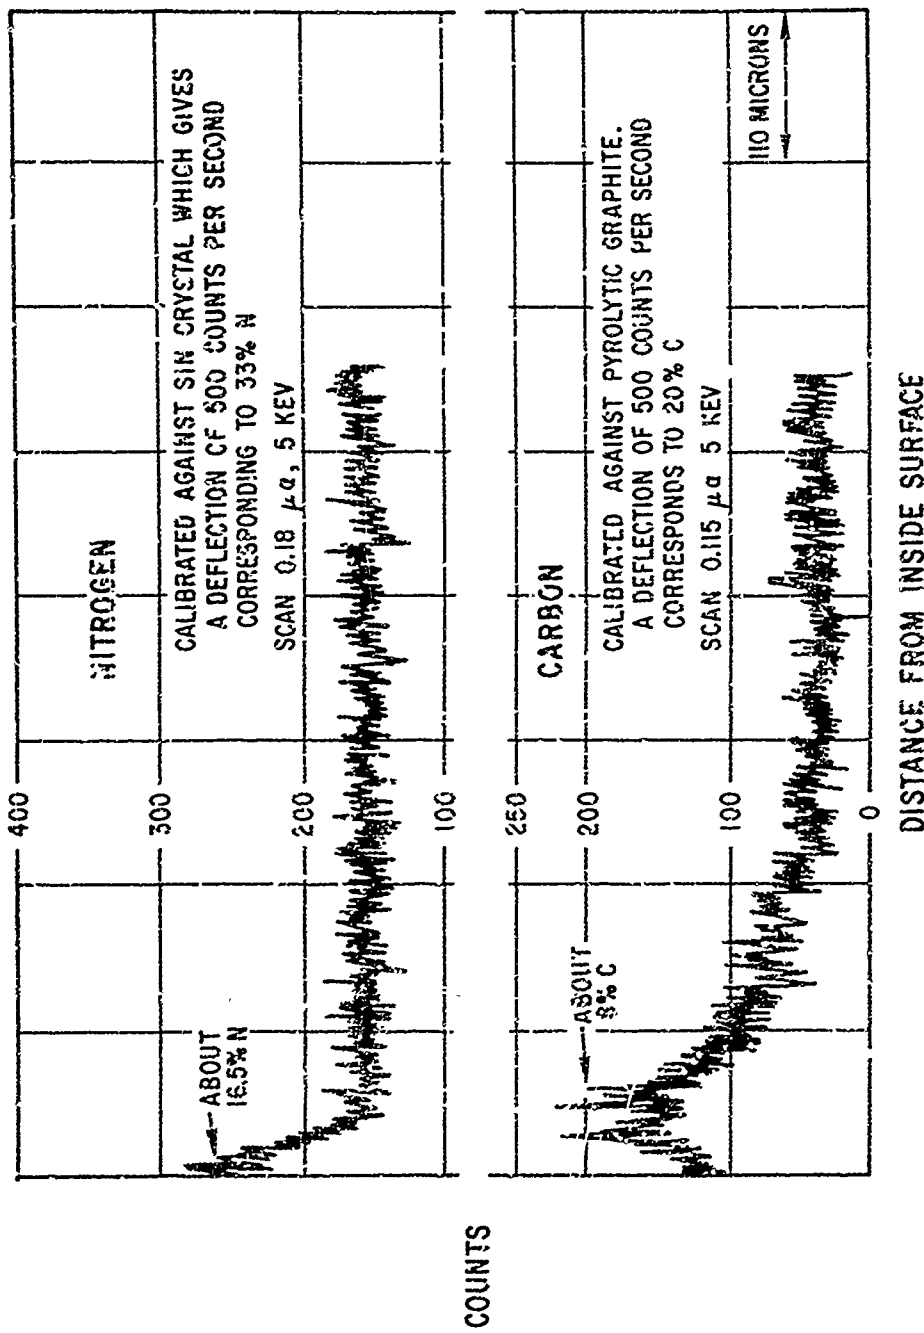
A microprobe traverse was made on the distressed tubes to identify the carburized and nitrided zones (Fig. 14).

Figure 14. Microprobe Traverse on Inside of Distressed Type 304 Stainless Steel Tube

Microprobe and metallographic analyses indicated two zones on the inside surface of the stainless steel tubes - a dark etching carburized structure consisting of carbide ($\text{Fe} \cdot \text{Cr}_7\text{C}_3$) and austenite, and a light etching constituent, superimposed on the carburized layer, consisting of nitride ($\text{Fe} \cdot \text{Cr} \cdot \text{N}$).
