Technical Note N- 1081

DEEP-OCEAN BIODETERIORATION OF MATERIALS -  
SIX MONTHS AT 6,000 FEET

NAVAL CIVIL ENGINEERING LABORATORY  
Port Hueneme, California 93041

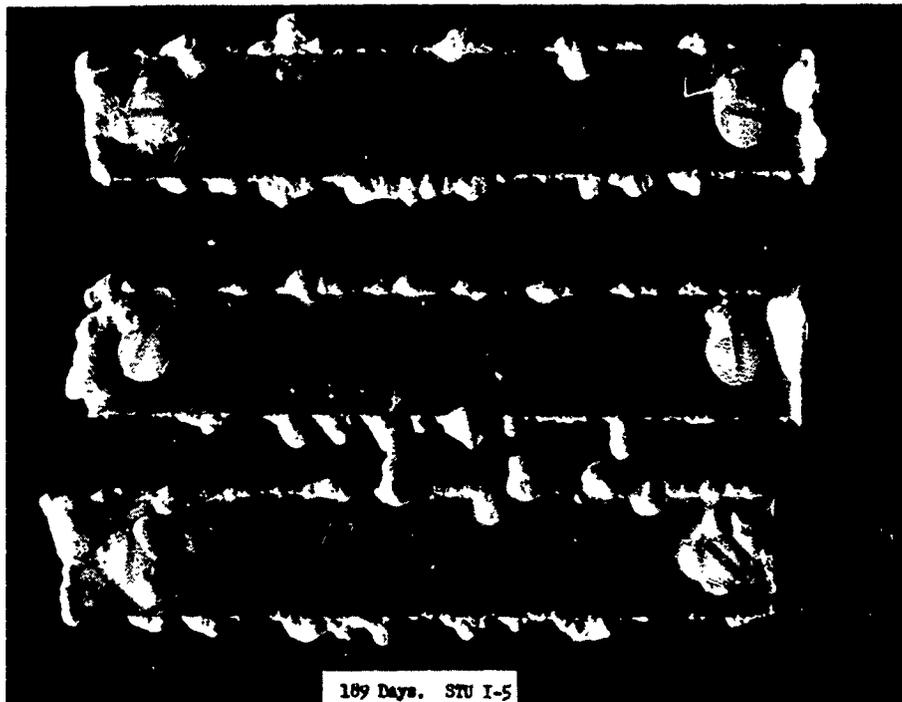
Figure 20. "Exposed" aluminum alloy test panels with corrosion products formed along the ends and edges.
