THIRD QUARTERLY TECHNICAL REPORT
MONTANA LARGE APERTURE SEISMIC ARRAY

April 1970

(Prepared under Contract No. F19628-70-C-0010 by Philco-Ford Corporation, Communication and Technical Services Division, 214 North 30th, Billings, Montana 59101.)

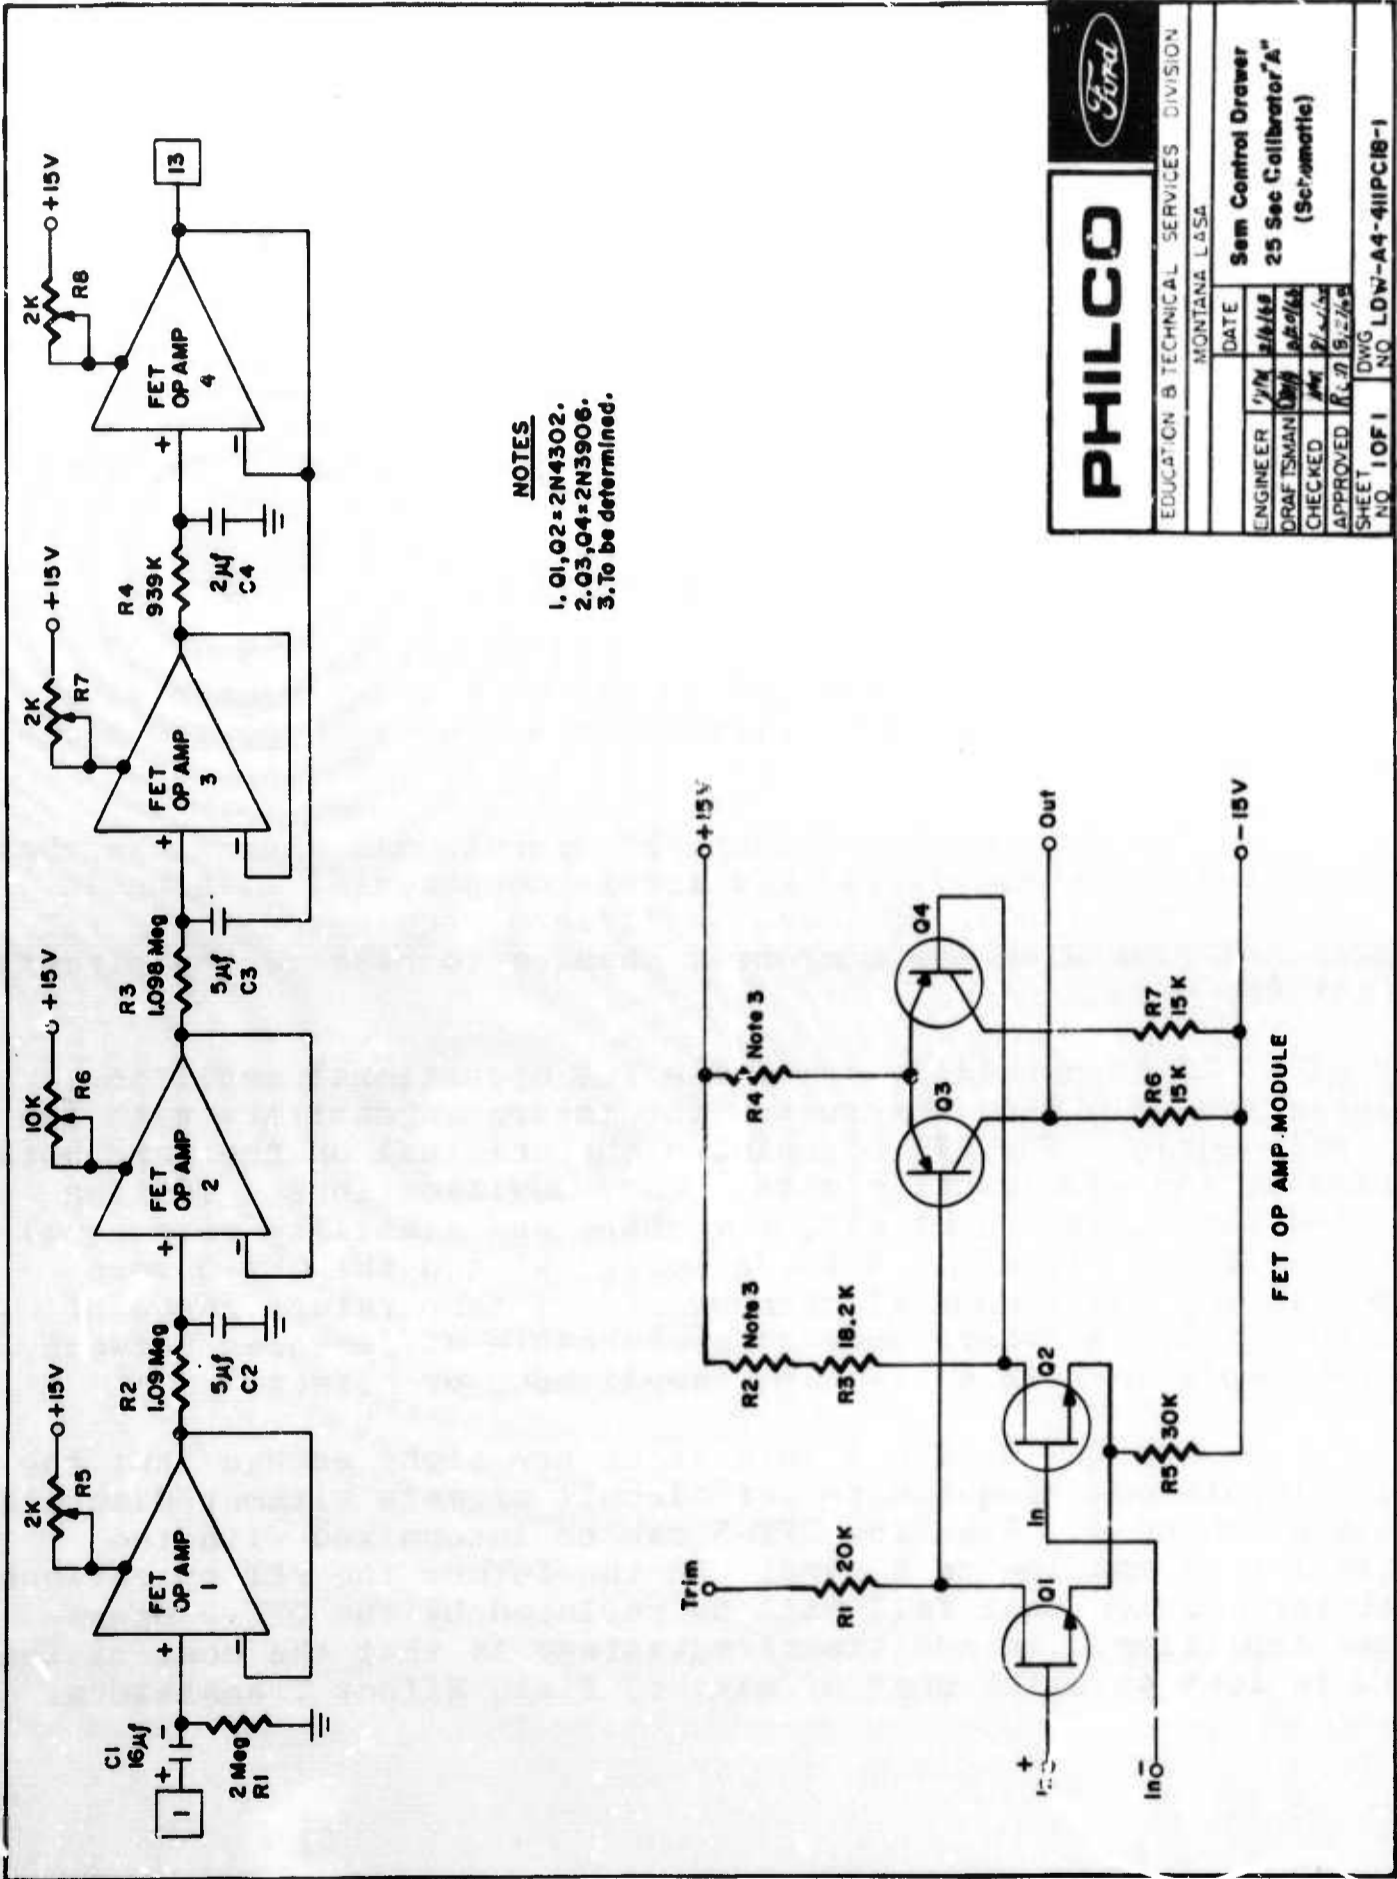
The card contains four FET operational amplifiers that were originally produced, using discrete components, at Lincoln Laboratory. The repair of these amplifiers requires matched FET transistors plus discrete component changes to balance the circuit and set the gain.

Figure 3.3 25-Second Calibrator A Schematic Diagram

A commercially available FET operational amplifier, Philbrick/Nexus QFT-5, was tested for interchangeability with the original module. The QFT-5 replaced the original on the card both physically and electrically without any modifications. Testing revealed that gain, dc offset, waveshape and stability were equal to the original circuit. Both the original and the QFT-5 were tested in the environmental chamber over a temperature range of +6°C to +56°C, and there were no measureable differences between the two amplifiers in wave-shape, amplitude, or offset.

The QFT-5 offset tolerances are tight enough that the card trim pots are adequate to set circuit offsets without discrete component changes. Also the QFT-5 can be intermixed with the original type modules on a card. In the future the FET operational amplifier modules that fail will be replaced by the QFT-5 operational amplifier. An additional advantage is that the cost of the QFT-5 is less than the cost of matched Field Effect Transistors.

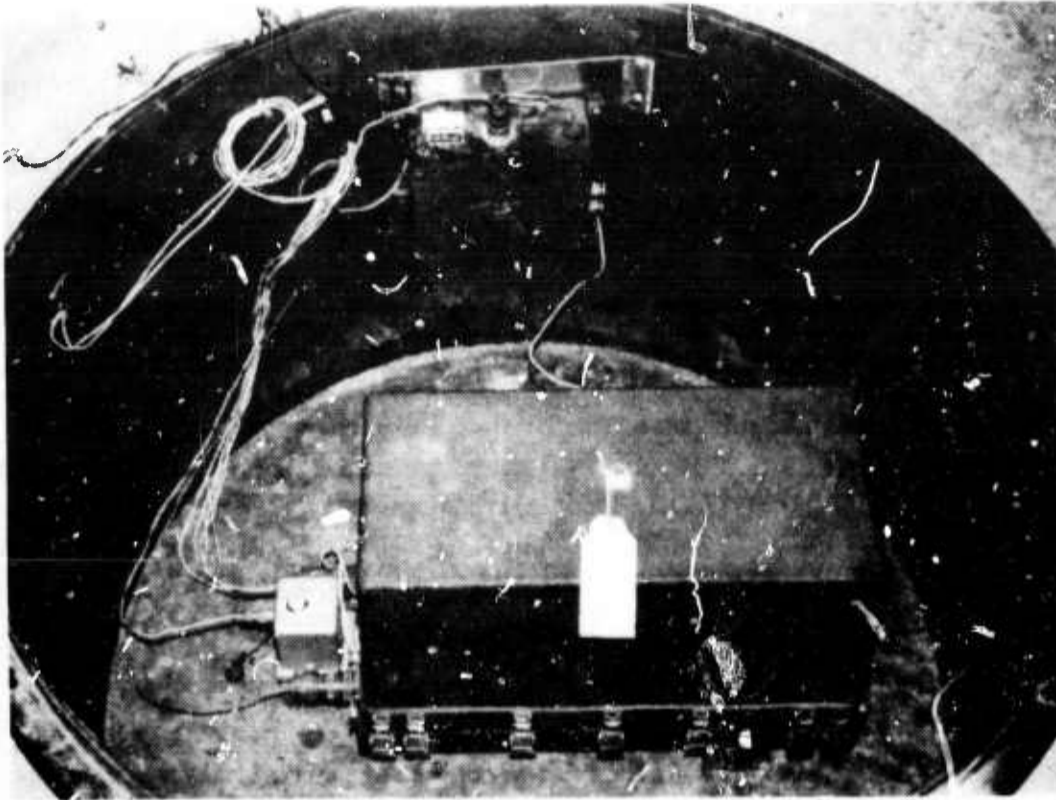
The LP vault has inherently a high relative humidity of approximately 98%. The original installation of the vault included an unsealed junction box from which distribution of connecting cables was made to the three individual tanks and associated damping junction assemblies. As temperature changed within the vault, condensation took place and numerous troubles resulted from leakage between wires and ground, and crosstalk between wires. Approximately a year ago an attempt was made to seal the junction box to alleviate the problem, but proved unsuccessful. Leakage still occurred in the cabling and in the junction box. Since July 1969, 36 failures in the LP systems occurred due to this moisture problem.

Figure 3.4 Vertical LP Seismometer Installation
After Modification

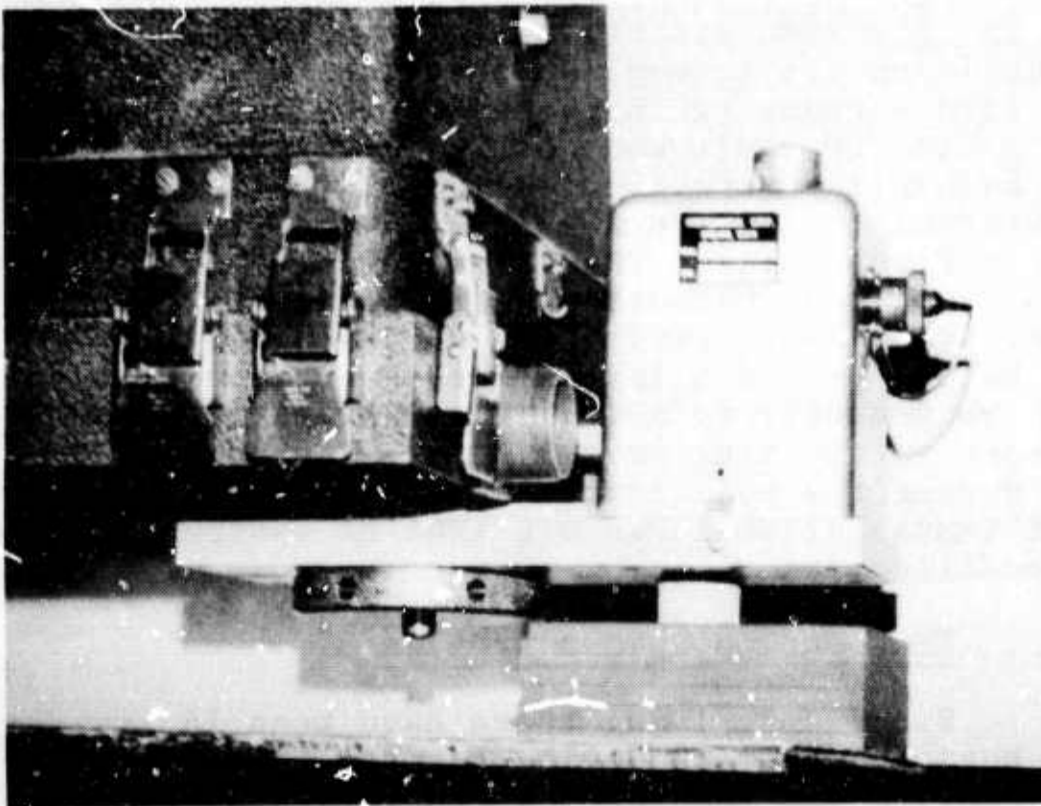
Since July 1969, there have been 15 incidents where the free-period adjusting device reached the end of its travel while correcting the free period remotely from the LDC. The only solution to this problem in the past has been to open the tank and manually reset the free period. This is quite undesirable

Figure 3.5 Modified Free-Period Remote Adjusting
Device Mounting

as it means disturbing the instrument which may require several days to reach stable noise level again.

A one-month evaluation period was allocated for the first site during which noise levels were recorded prior to and after the modification in reference to other sites. The reinforcing of the mounting plate was a result of this evaluation. An increase in noise level of the vertical instrument in the range of 40 to 60-second periods was noted prior to the reinforcing of the mounting plate. While no evidence of noise was seen on the horizontal instrument, the same mounting technique was employed on them as a preventive measure. Observations of this site have shown no increase in noise level since the final configuration was installed.

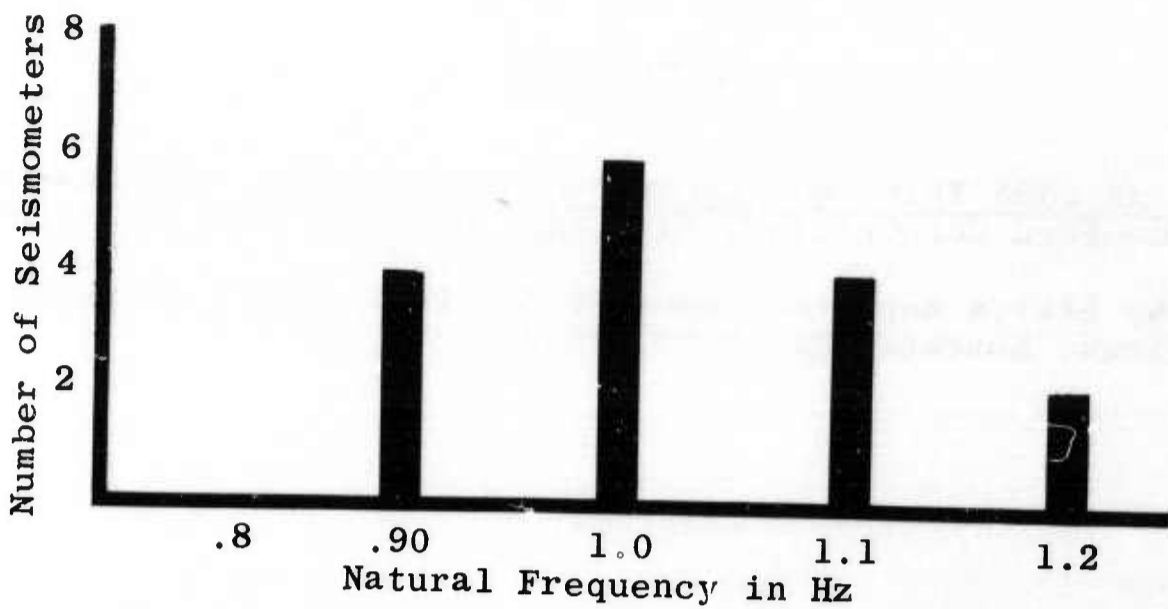
Seismometer natural frequency was measured using the Lissajous method. The distribution of natural frequencies at subarray C2 is plotted in Figure 3.6. A comparison of the results with original installation records indicates that seismometer natural frequencies have decreased an average of .07 Hz. This was substantiated by the fact that damping resistances had to be lowered in all cases where the damping was out of tolerance (overshoot ratio of 15:1 - 22:1). The exact cause of the decrease is unknown but it is suspected to be spring fatigue.

Figure 3.6 Distribution of SP Seismometer Natural Frequencies at Subarray C2

During the exchange of RA-5's at subarray C2, additional checks were made of system parameters. These checks included seismometer natural frequency, seismometer damping ratio, and system frequency response. To obtain a sampling of this data across the entire array, these checks will be continued at all well-head vaults visited for RA-5 replacement. The damping ratio will also be corrected when necessary.
