AFRPL-TR-70-43

**LONG-TERM STORABILITY
OF
PROPELLANT TANKAGE AND COMPONENTS
INTERIM REPORT #1**

R. B. MEARS, 1st LIEUTENANT, USAF

MAY 1970

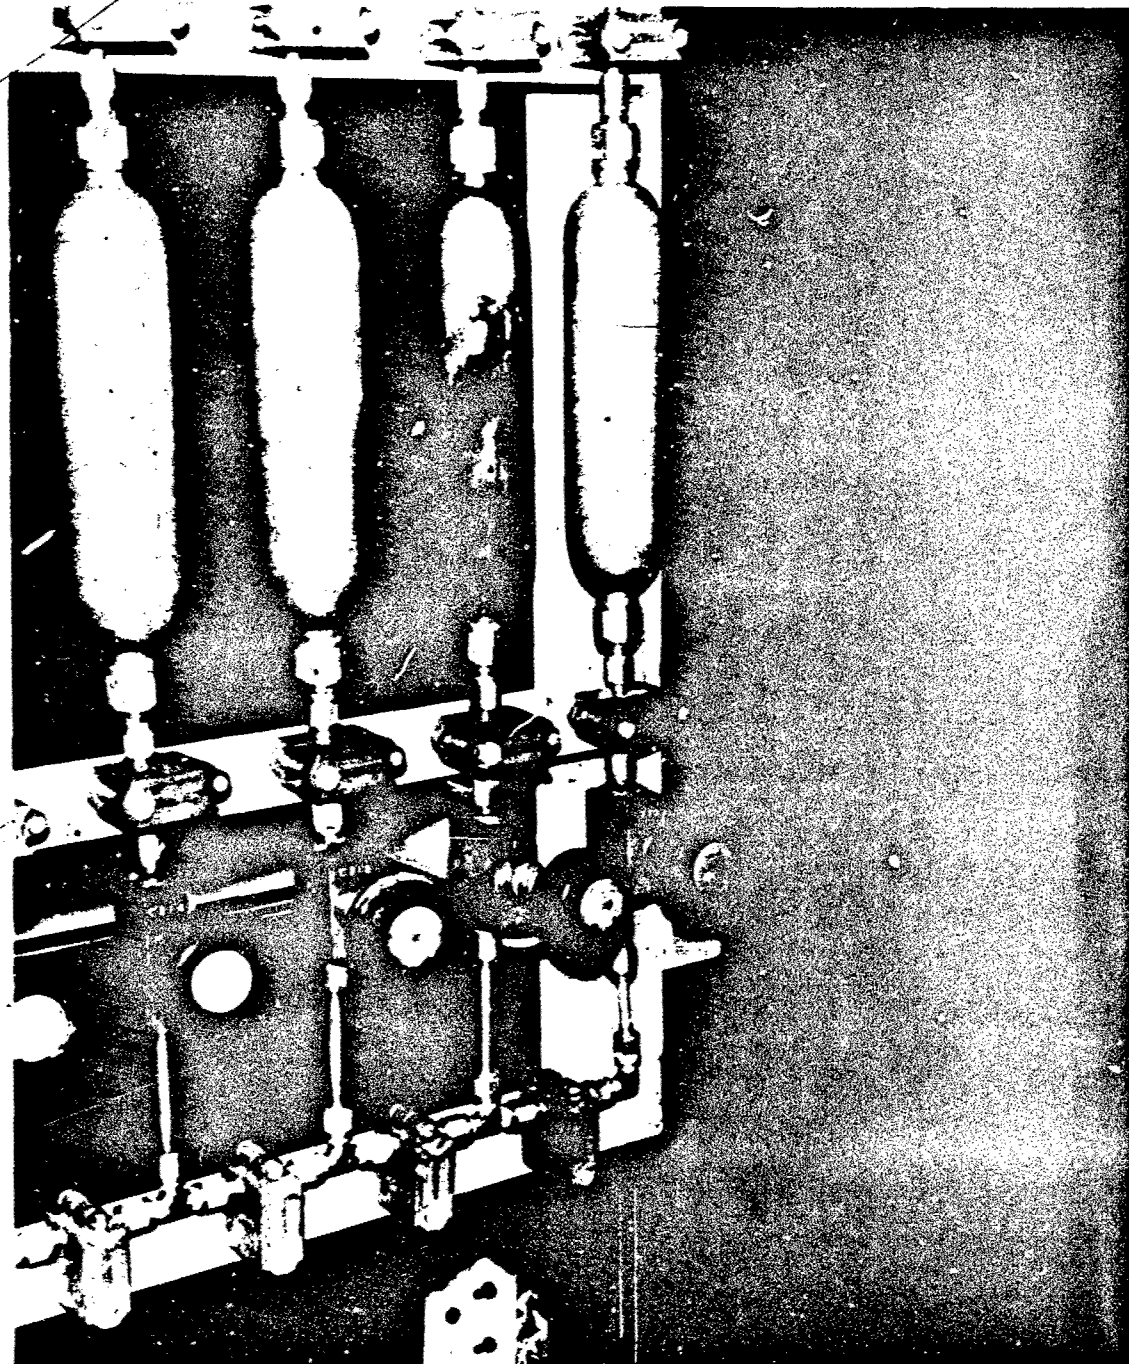
On 14 August 1969 twelve Phase II integrated systems were loaded with ClF_5 . Approximately two weeks later the environment in the oxidizer storage facility was maintained at 85°F and 85 percent relative humidity. During the afternoon of Friday, 12 September, the storage facility was inspected and no systems were found to be leaking. On the morning of Sunday, 14 September, the facility was again inspected and a very large concentration of ClF_5 vapors was found in the facility. After a thorough inspection it was determined that at least two tanks were leaking ClF_5 , (one Group I 301 cryogenically stretch-formed AISI 301 stainless steel container, and one Group III integrated system with an AM350 steel tank). (Figures 8 & 9) (Appendix II). Numerous other tanks and systems were detanked because of corrosion damage to their external surfaces. The surfaces were cleaned and the tanks helium leak checked, and all tanks were or will be returned to test, since no leaks were found. The original leak was located in an aluminum tubing weld of a system containing ClF_5 . The large concentration of HF (the product of ClF_5 hydrolysis) vapors resulting from the leaks also damaged the building's conditioning system which has been rebuilt.

Figure 8. ARDE 301 Cylinder With ClF_5 Leak

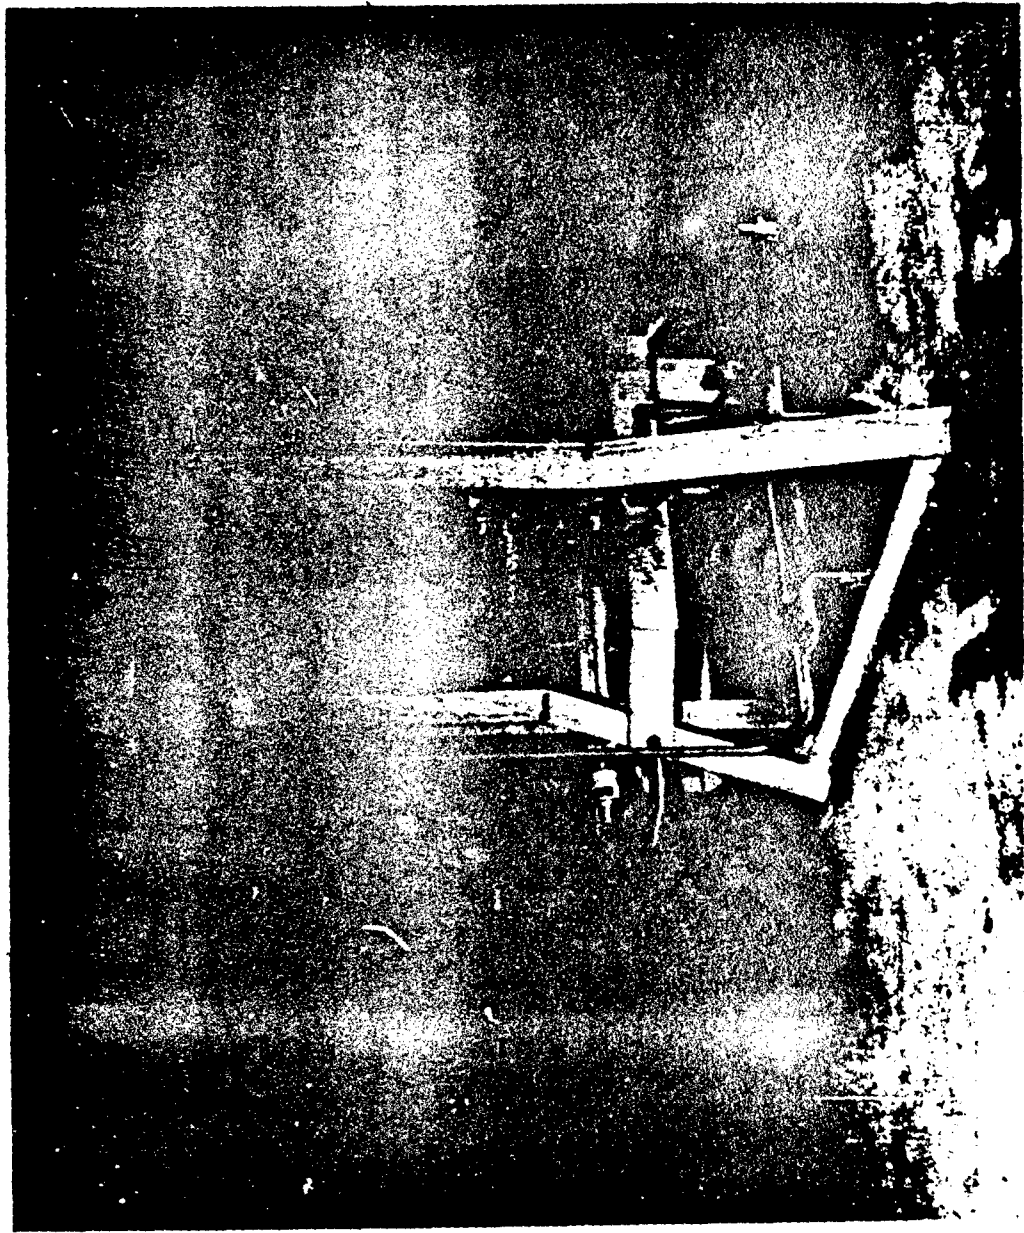
Figure 9. Integrated System With ClF_5 Leak

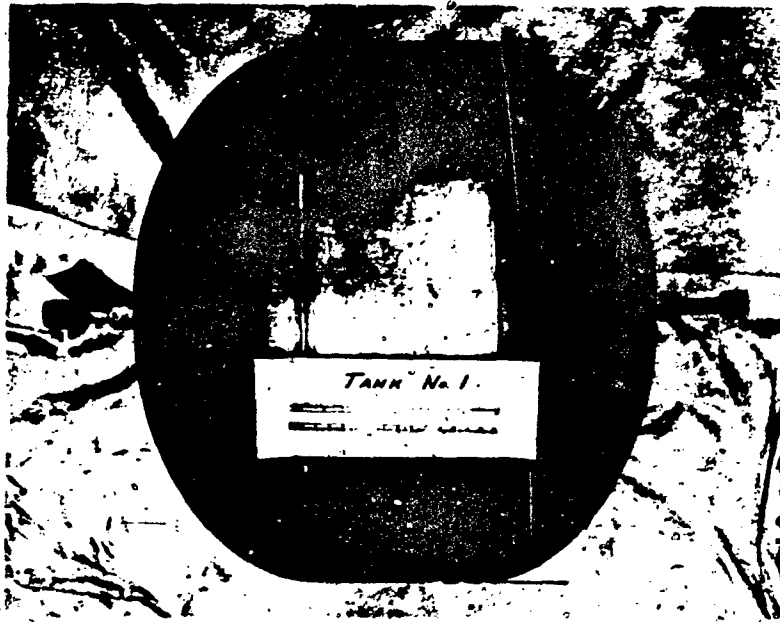
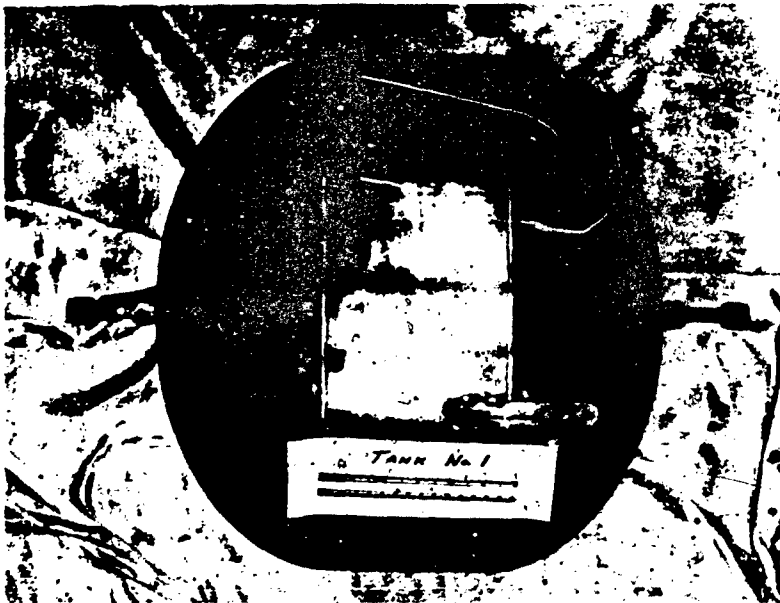
1. Macroexamination - Two small cracks were visible on the external surface of the tank. The cracks were in the heat affected zone (HAZ) of a dome segment-to-fitting weld. Except for these cracks the overall appearance of the tank was good, Figure 1.

Figure 1. Side Views of Tank No. 1. 0.2X

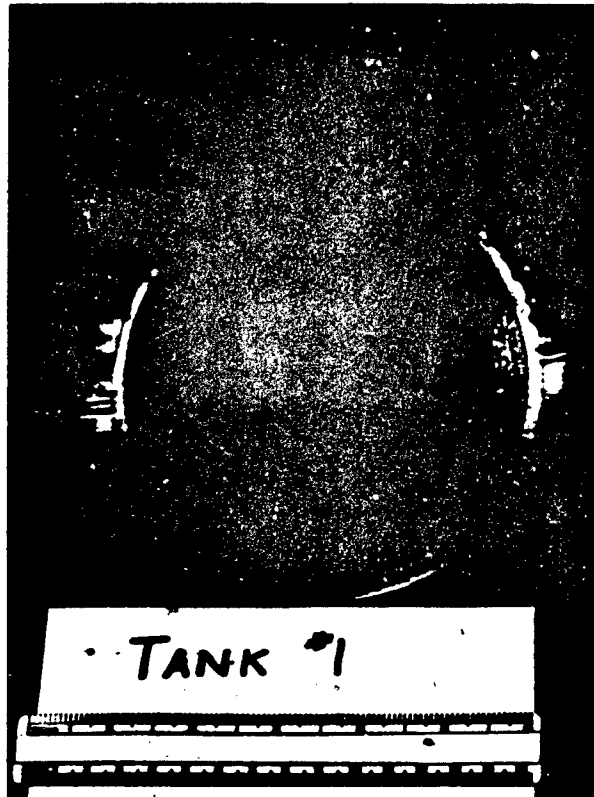
4. **Metallographic Examination** - The areas showing cracks in the X-rays were visibly inspected and numerous small cracks were found in the internal surface of the tank, Figures 4, 5, and 6. Microsections were taken through several of the cracks. As shown in Figures 7, 8, and 9, the cracks were typical of N_2O_4 induced stress corrosion.
5. **Electron Microscopy** - Electron fractography of the fracture surfaces was not possible since the fractures were too small to replicate.
6. **Chemical Analysis** - Although the chemical analysis of the Ti-5Al-2.5 Sn was required to be the extra low interstitial grade (ELI), the analysis of the failed tank showed the material was more closely the normal interstitial grade. This analysis, however, would not result in more stress corrosion occurring than in the ELI grade.

Figure 3. Circled Areas in Bottom of Tank
Where Cracks Were Found (Inside View)

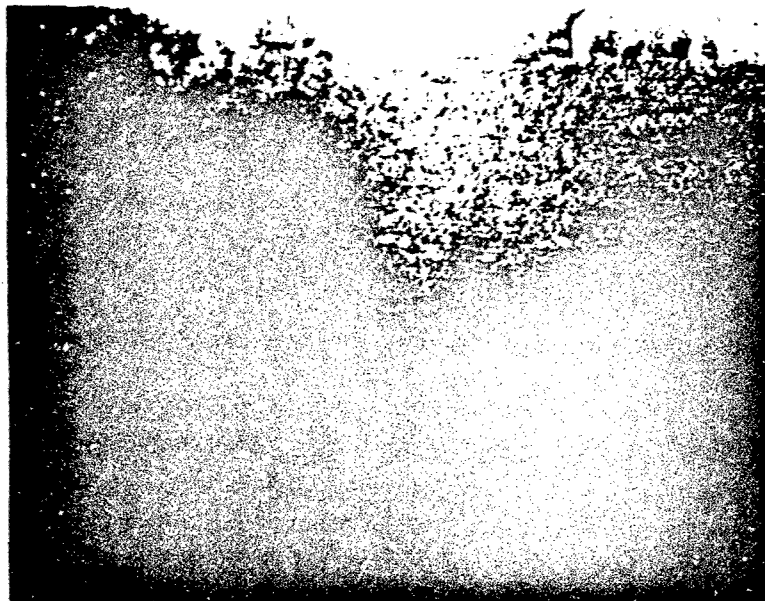
1. The failure was caused by stress-corrosion cracking occurring in the heat affected zone of the beanie-to-dome segment welds in each end of the tank.
2. The stress-corrosion cracking was caused by internal attack by the uninhibited N_2O_4 .

**Figure 6. Internal Stress Corrosion Crack
in Bottom of Tank No. 1 ($\approx 20X$)**

For exposure of titanium to nitrogen tetroxide, only nitrogen tetroxide containing 0.4 to 0.8 percent NO should be used to prevent stress corrosion.

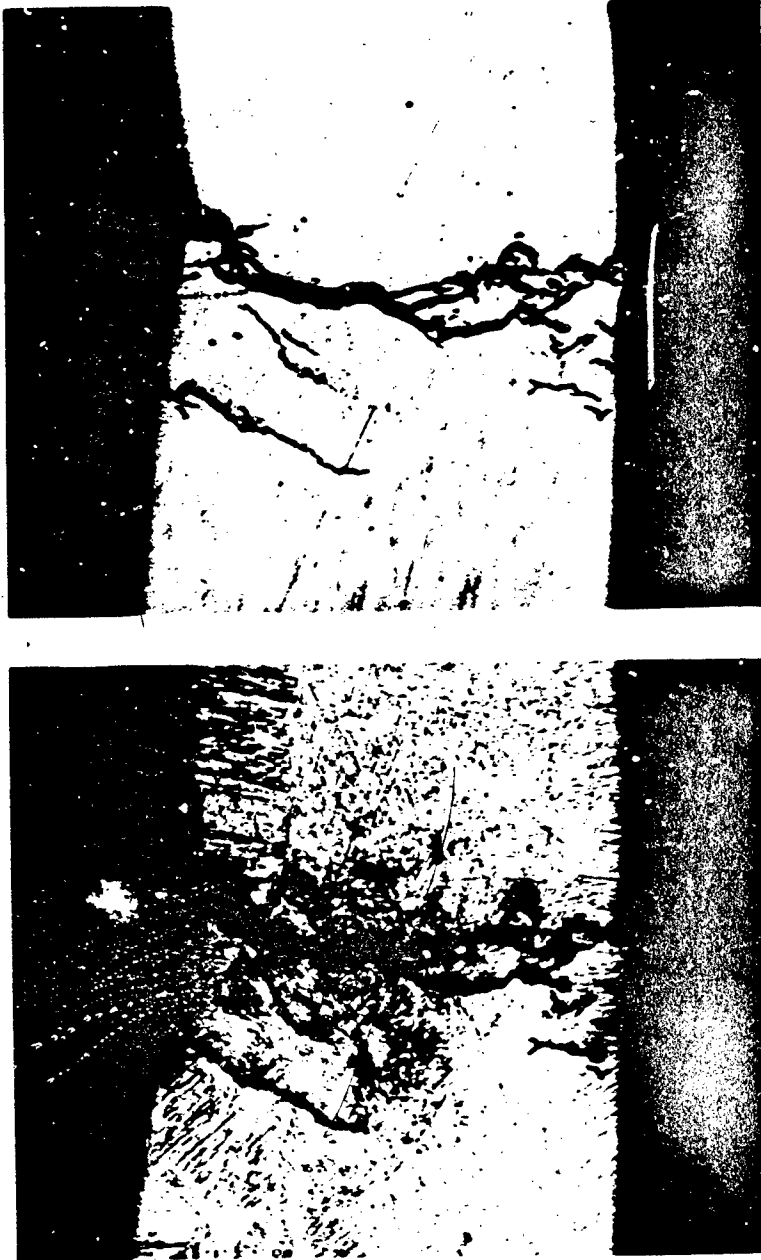
Figure 7. Microsection of Stress-Corrosion Crack in Bottom of Tank (150X)

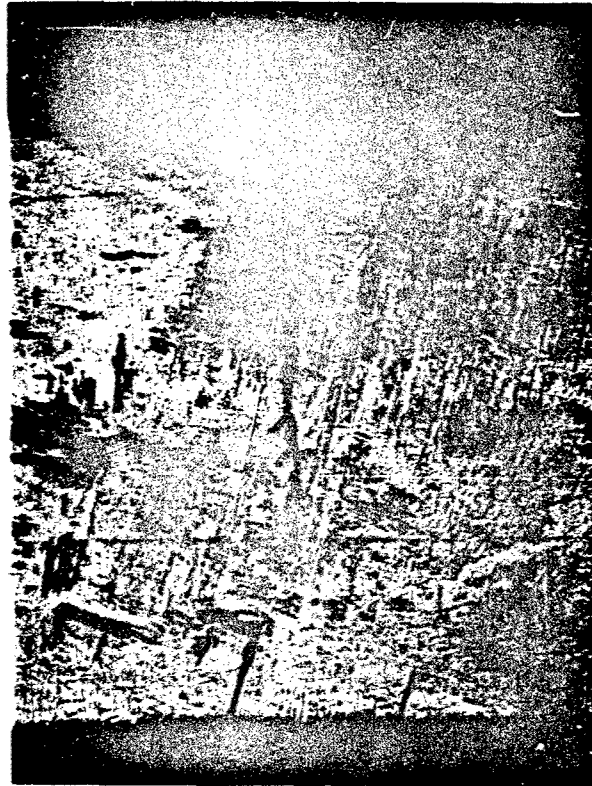
Figure 8. Microsection of Stress-Corrosion Crack
in Bottom of Tank No. 1 (150X)

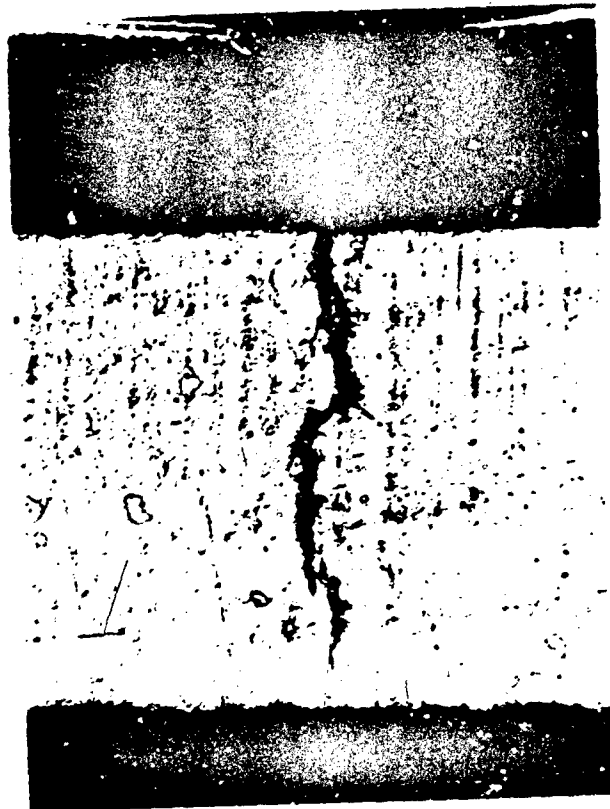
Figure 9. Microsection of Stress-Corrosion Crack
in Top of Tank No. 1 (150X)

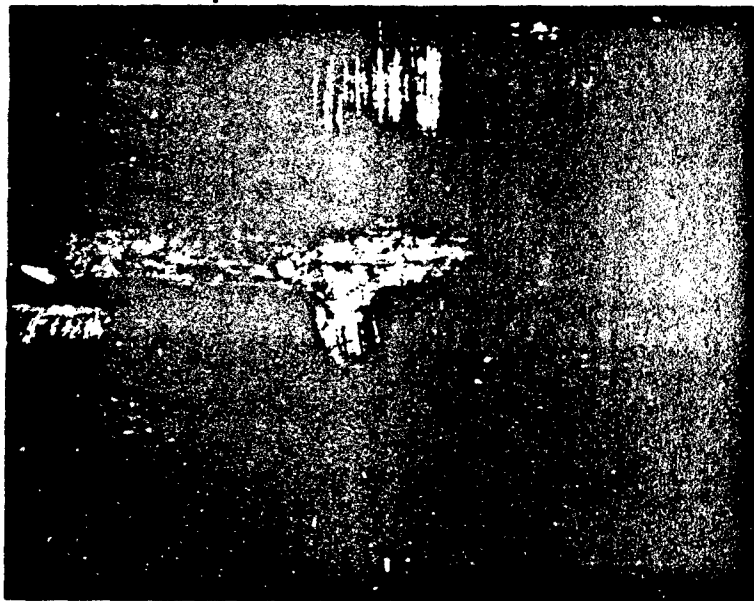
Figure 3. Photomicrograph of Crack (5X)

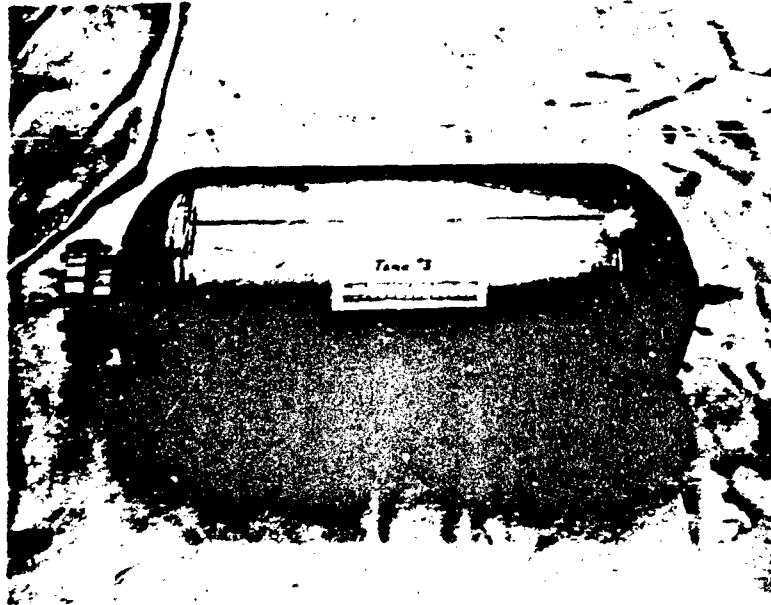
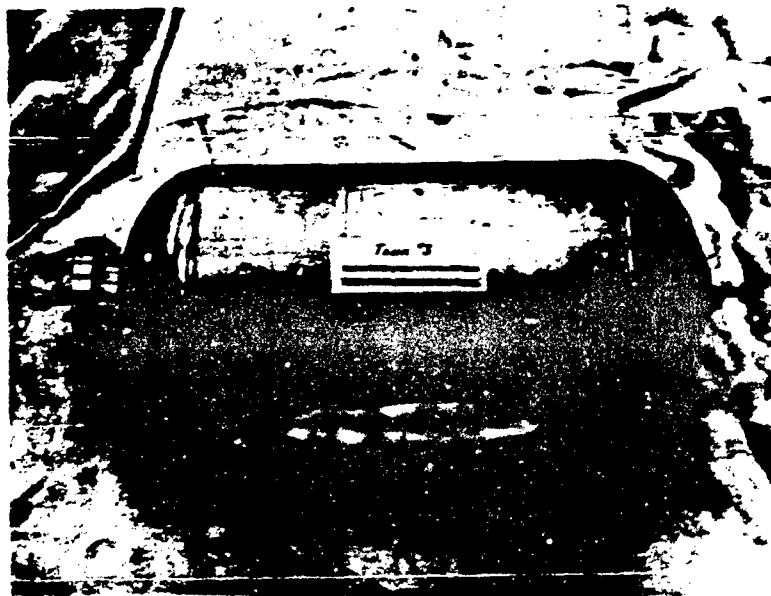
Figure 2. Side Views of Tank No. 3

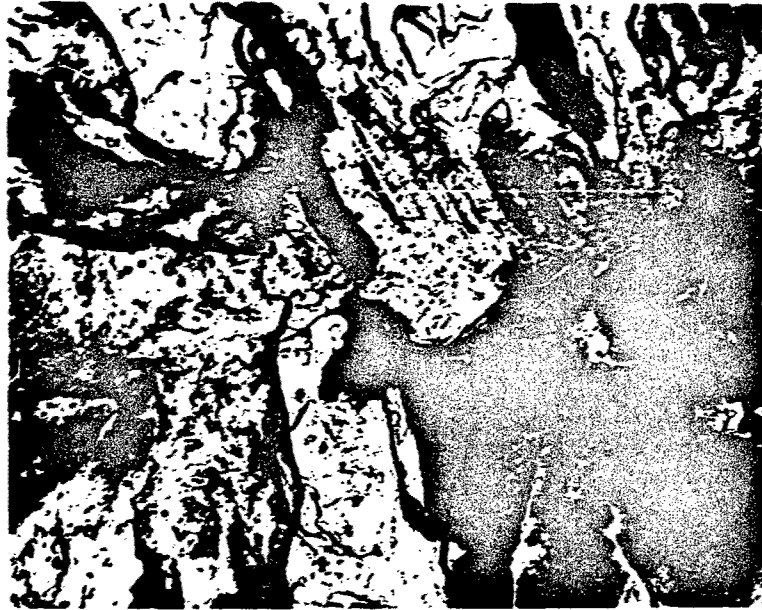
Figure 9. Electronphotomicrograph Showing Evidence of Stress Corrosion (6500X)

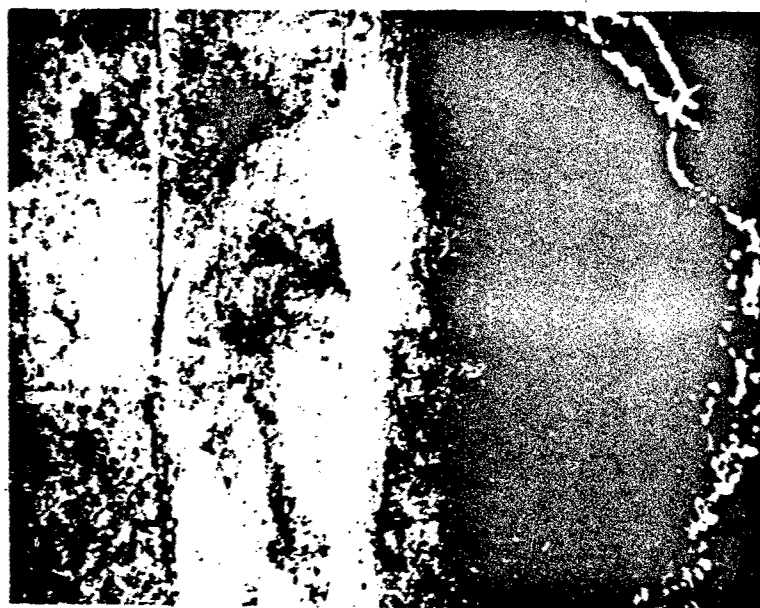
Figure 6. Photomicrograph Showing a Leak in the Bottom of the Failed Tank. 10X

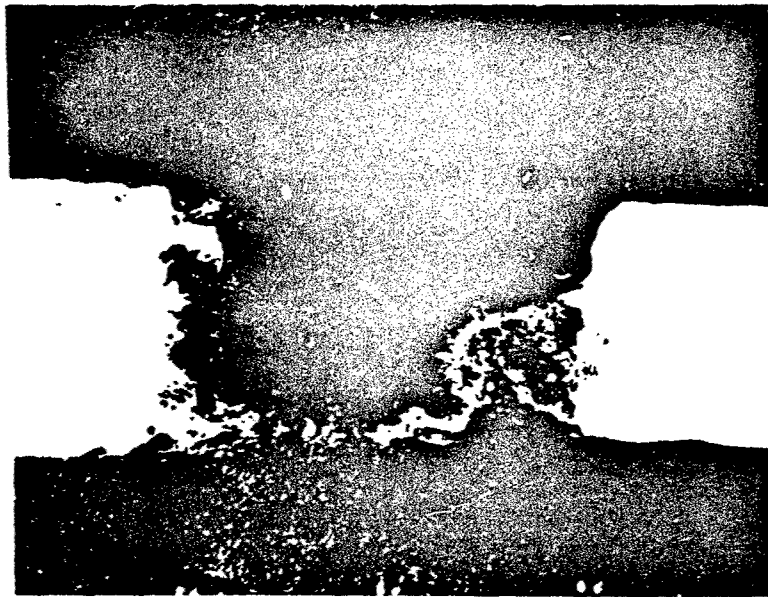
Figure 9B. Photomicrograph Showing Another Cross Section of a Pit in the Bottom of the Failed Tank. Unetched 60X

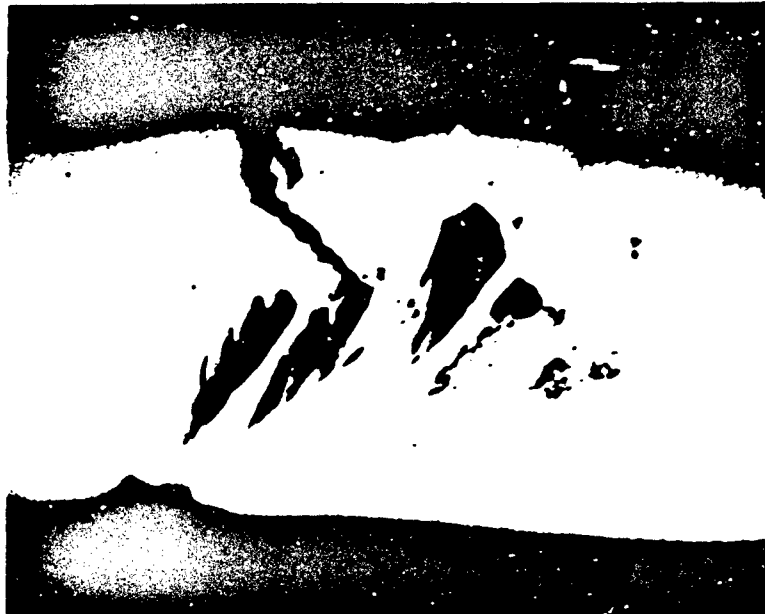
Figure 10. Photomicrograph Showing a Cross Section Through the Hot Short Crack in the Origin of the Failure of Tank Serial Number AF-4 Unetched 60X

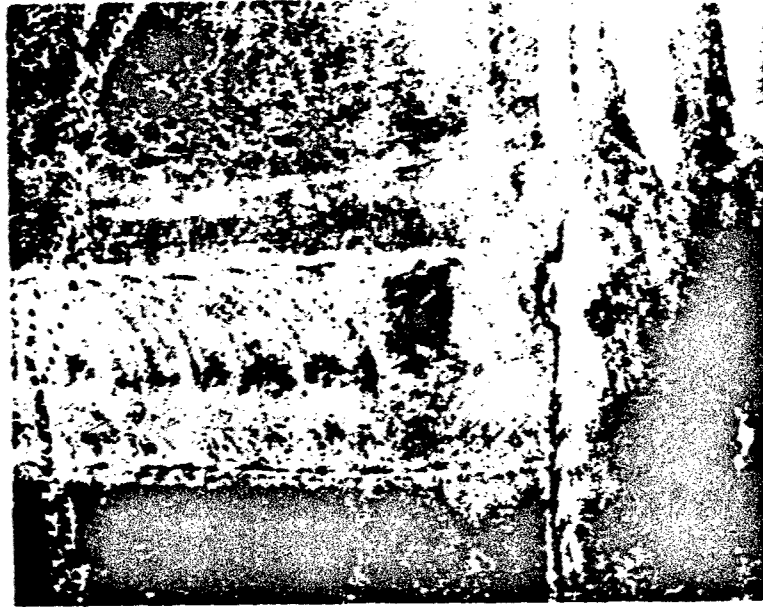
Figure 12. Photomicrograph Showing Pitting Corrosion Near a Weld Cross-Over on the Outside Bottom of the Failed Tank 10X

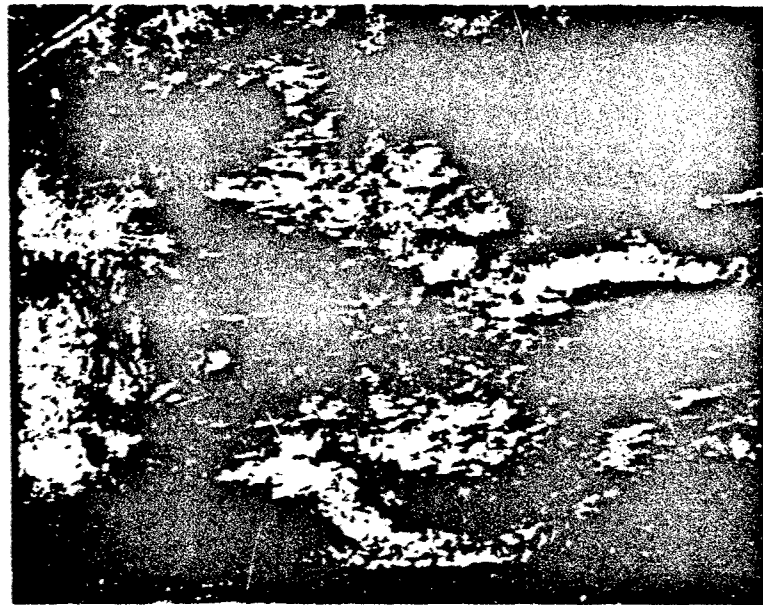
Figure 13. Photomicrograph Showing Pitting Corrosion in a Ground Area of a Weldment on the Outside Bottom of the Failed Tank 10X

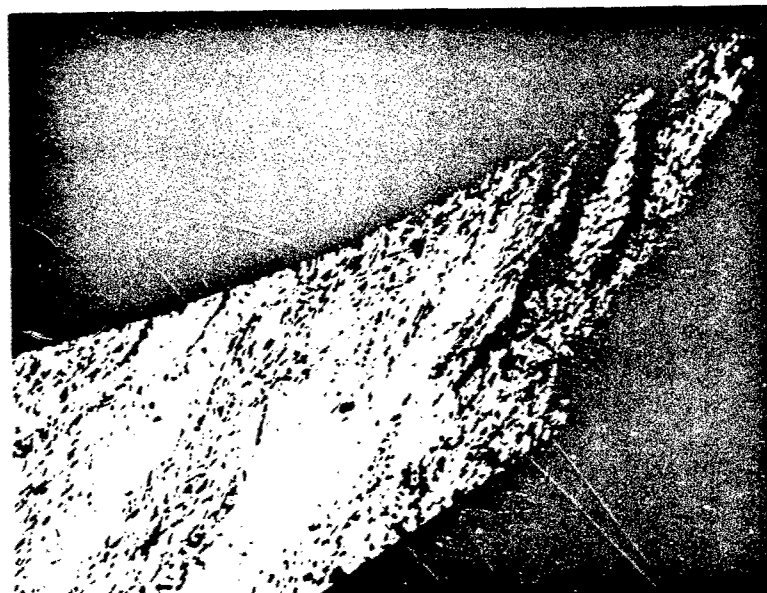
Figure 6. Microsection Through Area Shown in Figure 5. (25X)

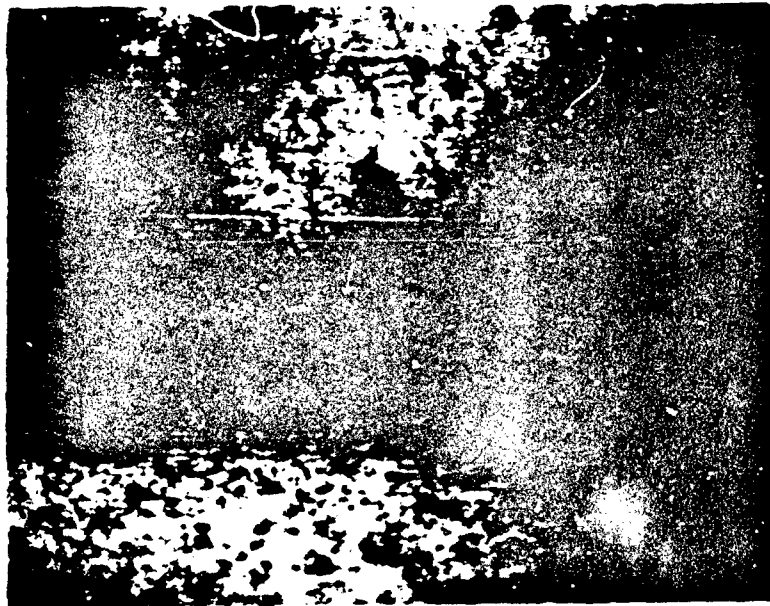
Figure 7. Photomicrograph of Cracks Near Fillet
Weld of Tube Assembly (20X)

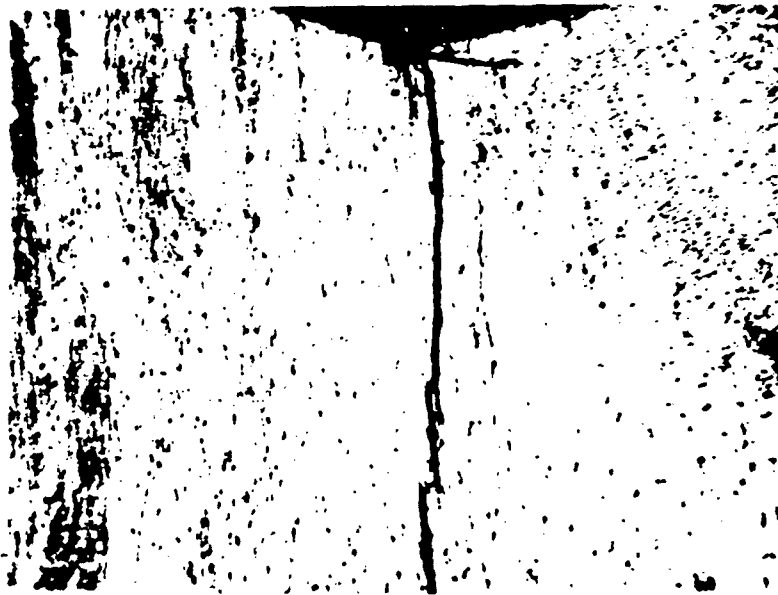
Figure 8. Microsection Through Crack Shown in
Figure 7. (50X)

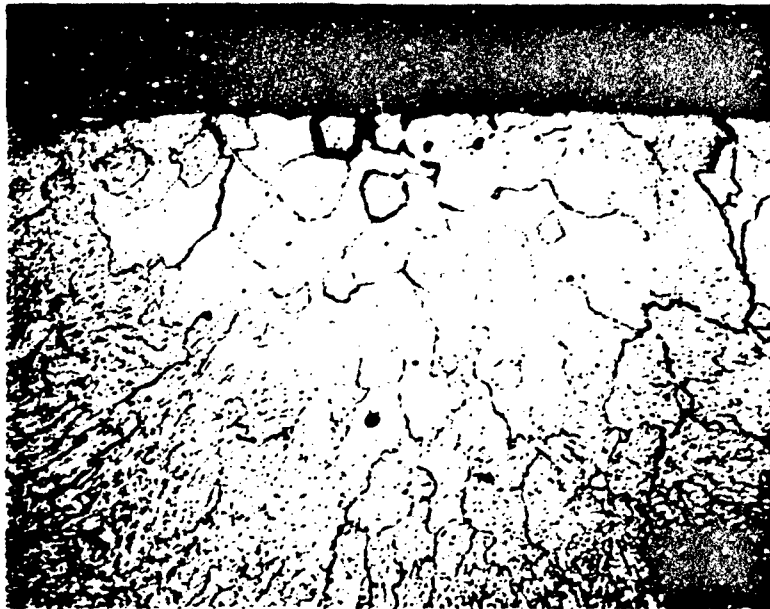
Figure 11. Photomicrograph of Intergranular Corrosion and Stress-Corrosion Cracks on External Surface of Area Shown in Figure 10. (50X)

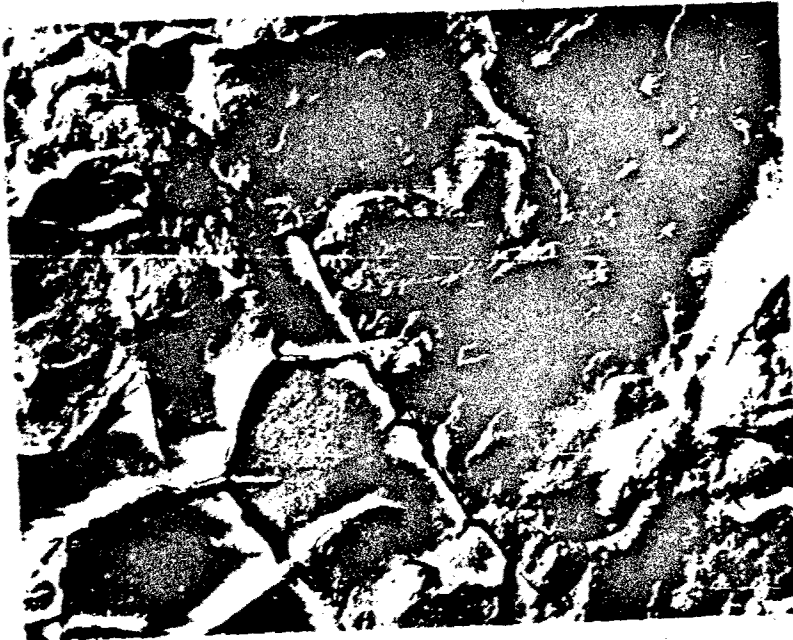
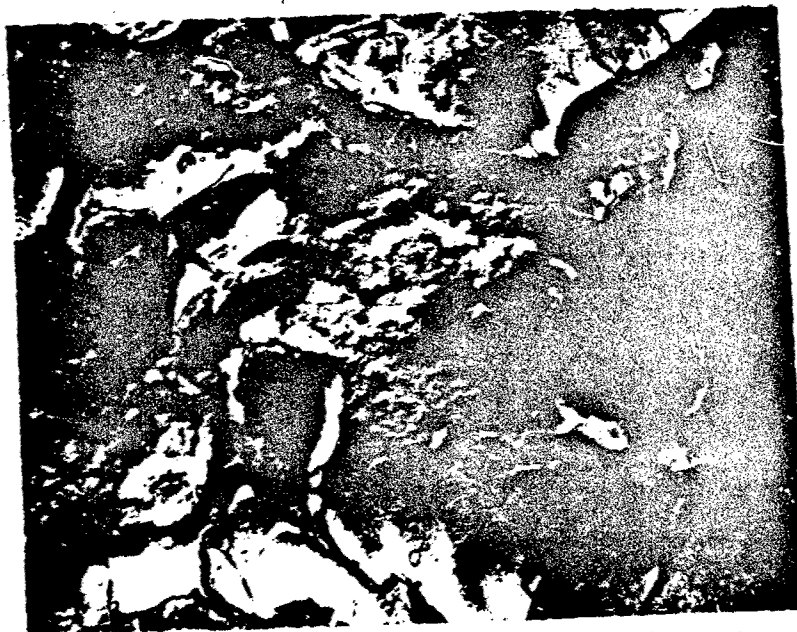
Figure 12. Electron Photomicrographs of Fracture Surface of Outlet Crack. (6500X)

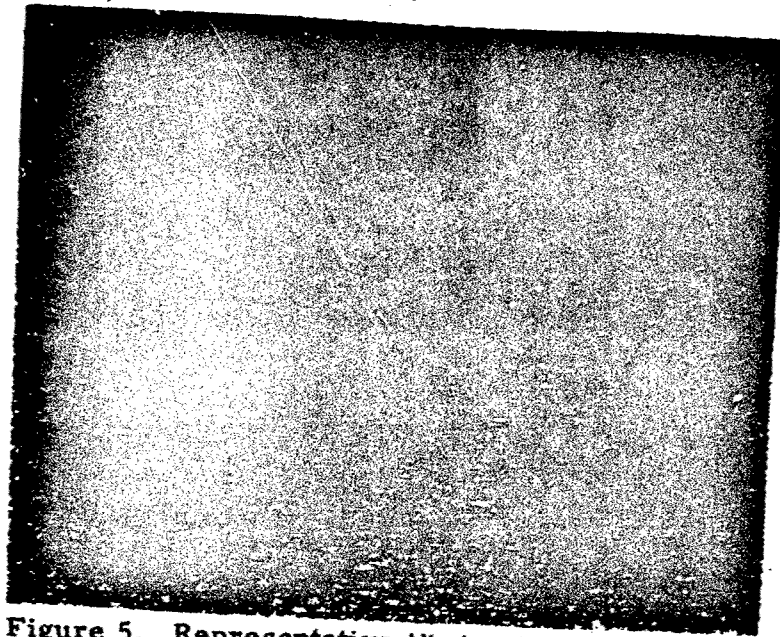
Figure 5. Representative Photomicrograph of Corrosion Pits in Tank No. 6. 100X

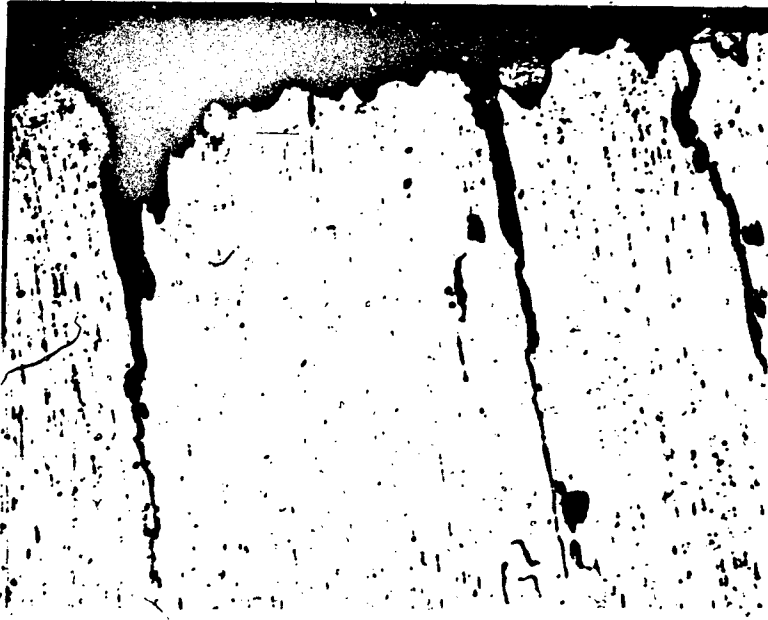
Figure 5. Photomicrograph of Stress-Corrosion Cracks
in HAX (100X)

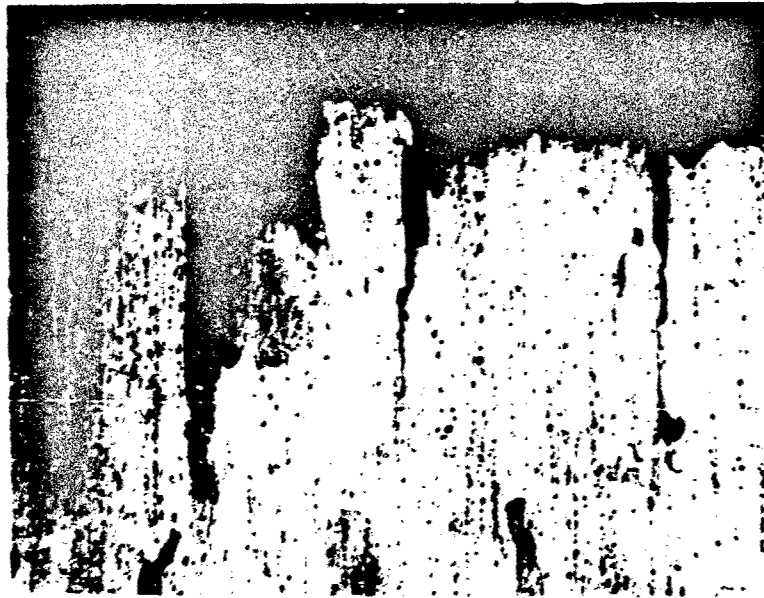
Figure 6. Photomicrograph of Area in Figure 5 in Etched Condition showing End Grain Exposure (75X)

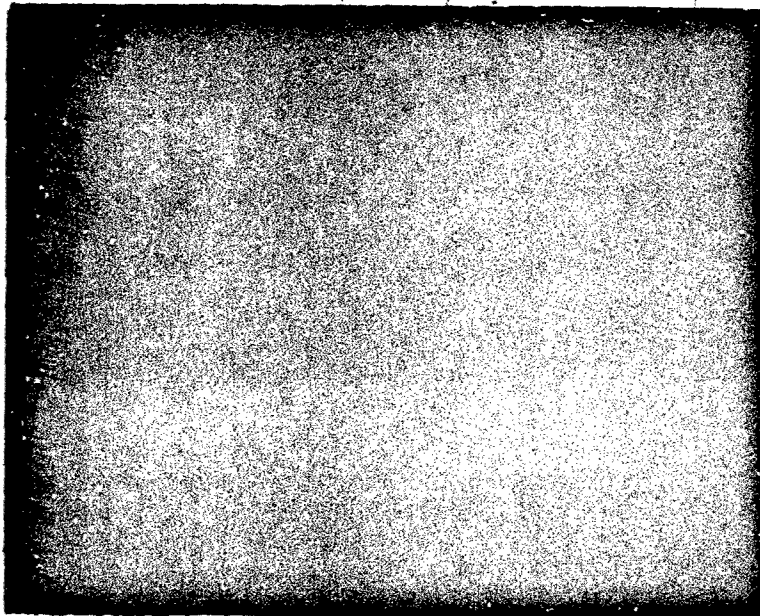
Figure 4. A Photomicrograph Showing the Pitting Corrosion In the Area of the "Off-Scale" Leak Area. 10X Magnification

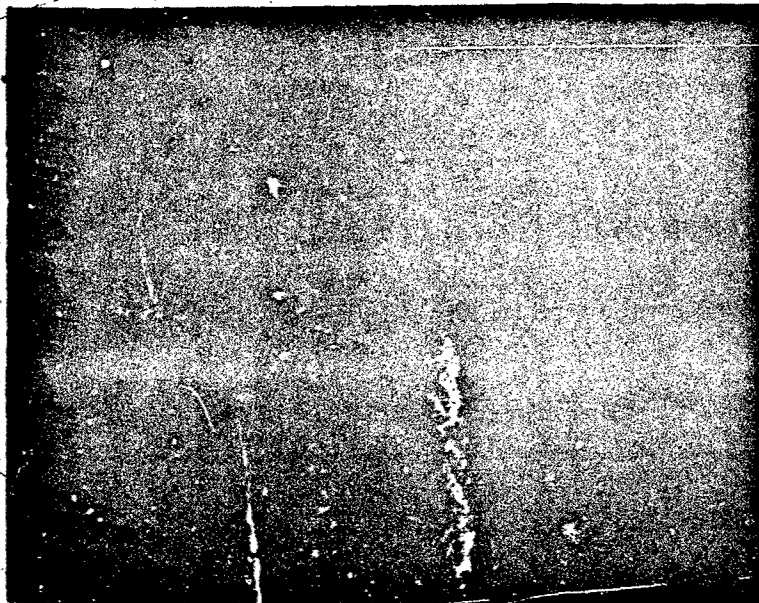
Figure 5. A Photomicrograph Showing the Pitting Corrosion In The Area of The 2.16×10^{-7} atm cc/sec Leak. 10X Magnification

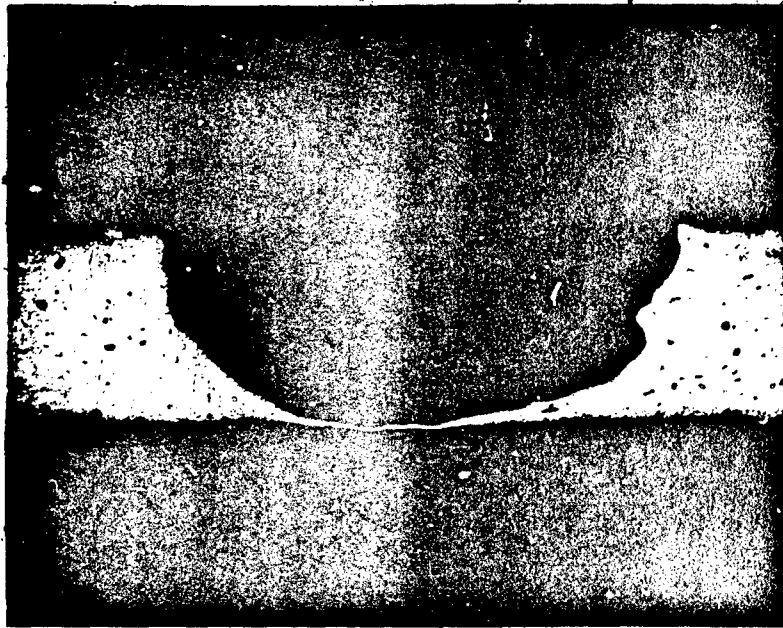
**Figure 6. Photomicrograph Showing The Corrosion Pit
In The "OFF-Scale" Leak. 50X Magnification**

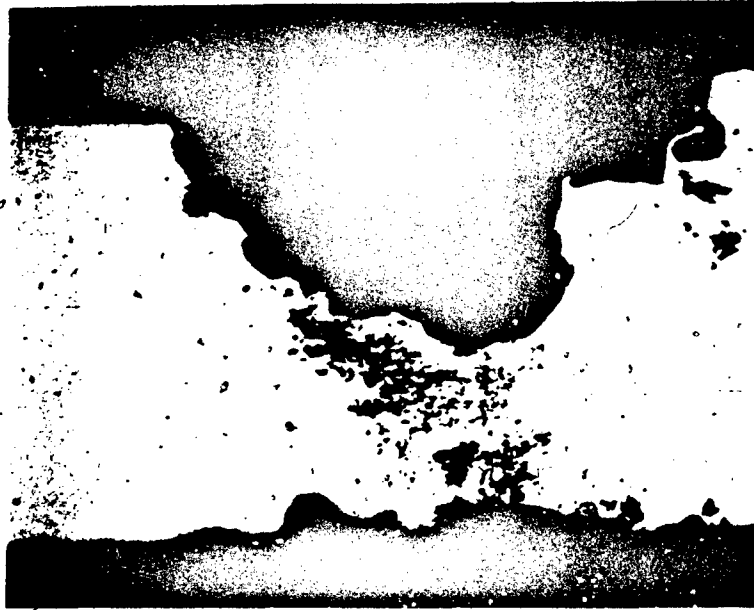
Figure 4. Photomicrograph Showing The micro-structure in a leak area of the AM350 precipitation-hardening stainless steel tank No. 9. 100X

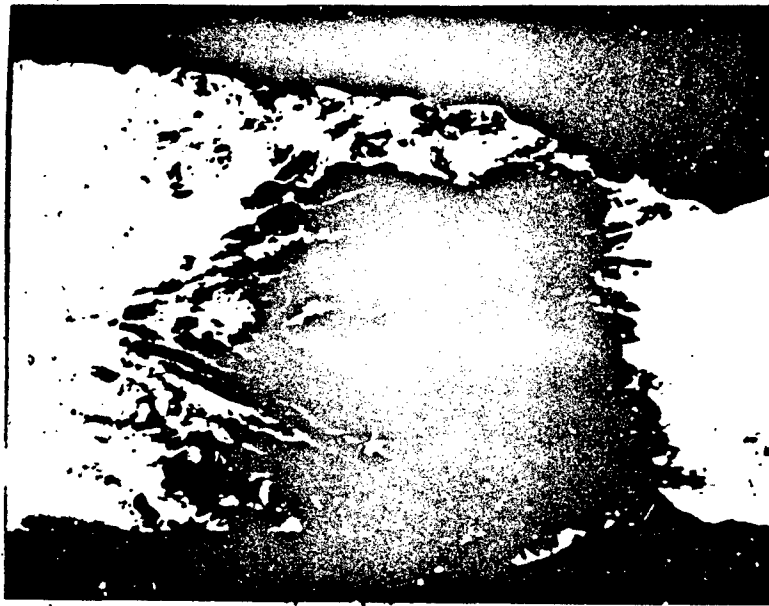
Figure 5. Photomicrograph Similar to That shown in Figure 4. 100X

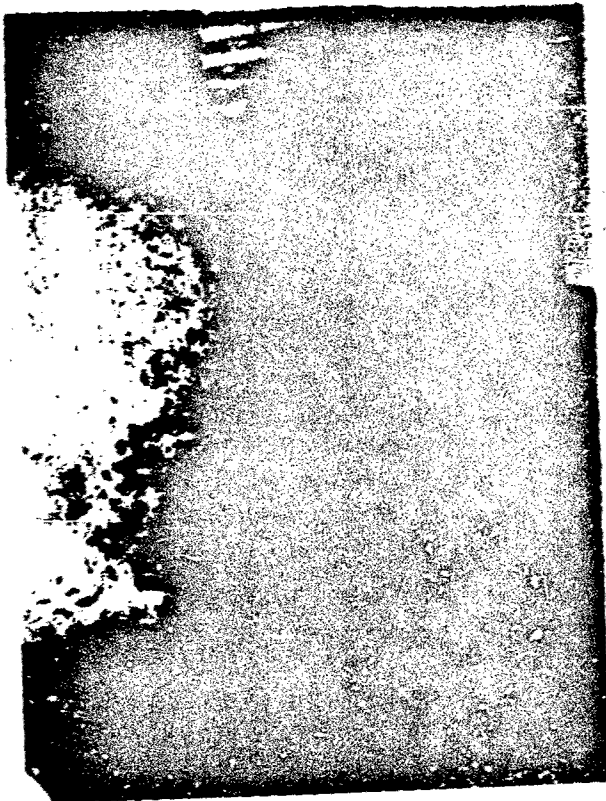
Figure 4. Large corrosion pit in HAX of fitting
of end "B" of Tank No. 10. 3X

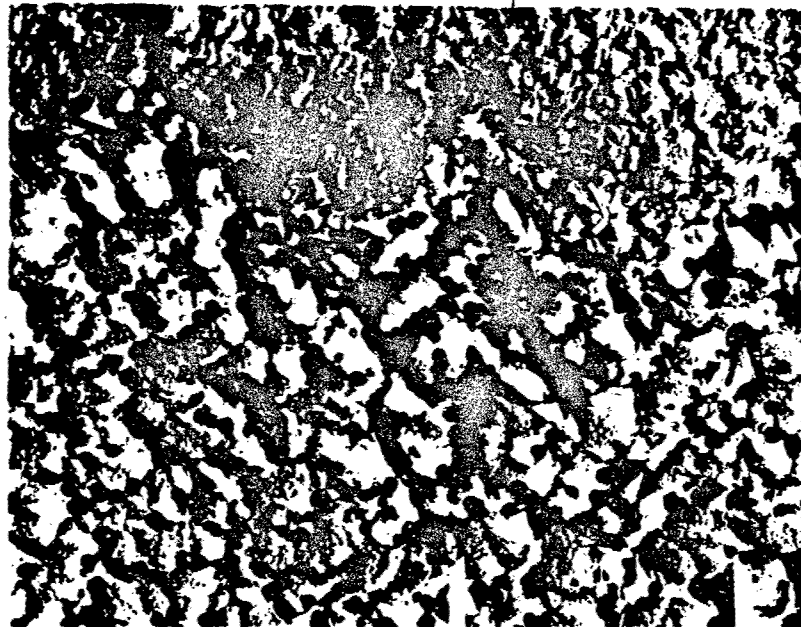
Figure 6. Electron Photomicrograph of Corrosion Failure in Tank No. 10. 7000x

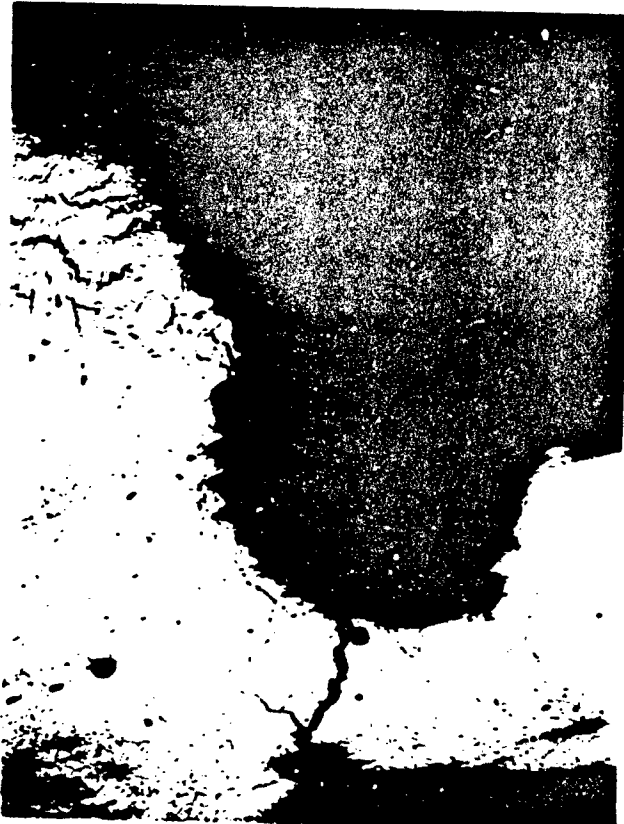
Figure 7. Leak Area in Fitting of Tank No. 10.
75X

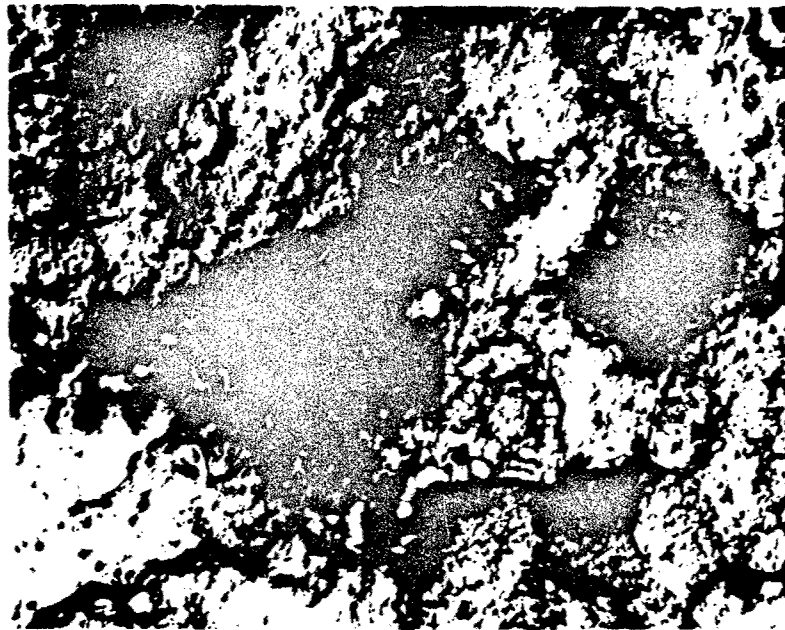
Figure 15. Electron photomicrograph showing representative evidence of intergranular corrosion observed on the surface of the fractures of leak areas 62 x 1 and 32 x 10. 15,000X

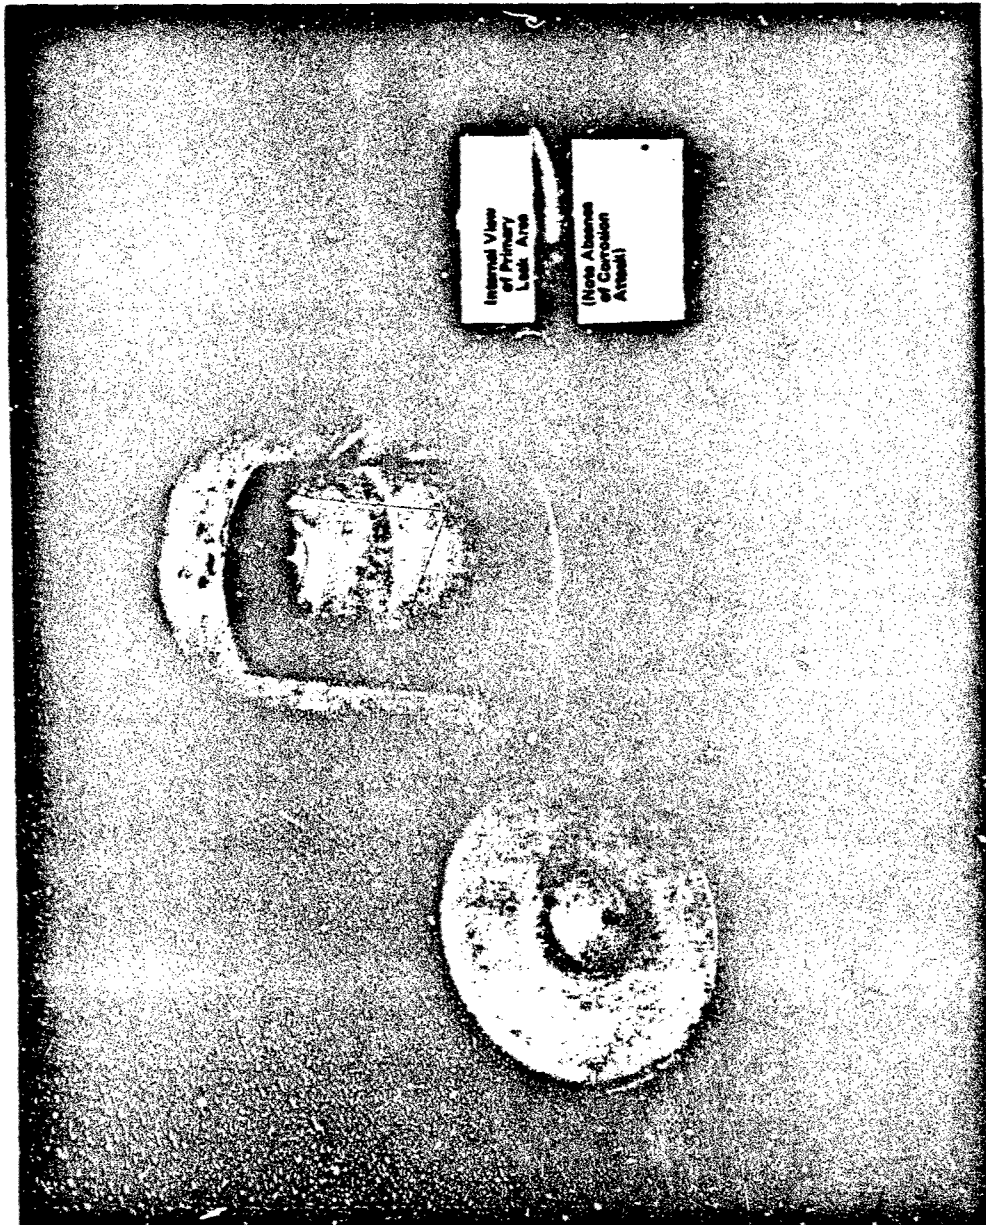
Figure 3. Internal View of Primary Leak Area
(Note Absence of Corrosion Attack)

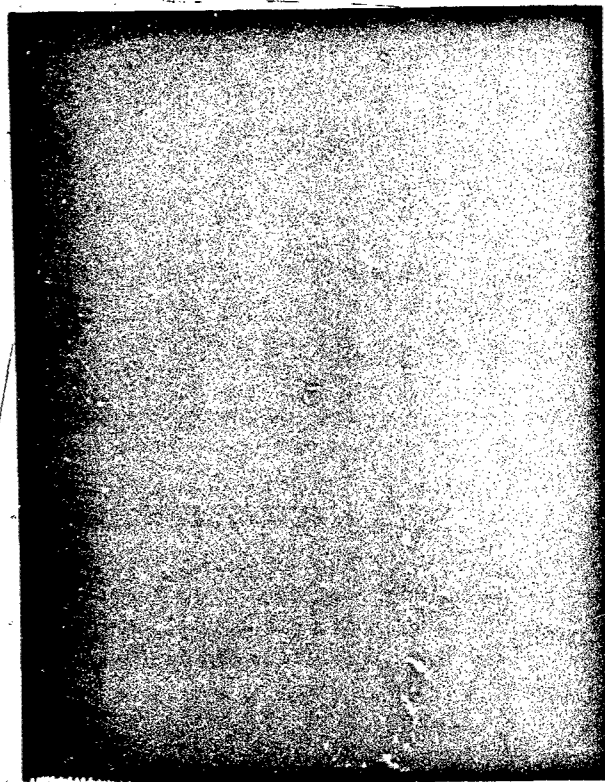
Figure 5. Internal View of Holes in HAZ
of Vertical Weld Bead
