AFRPL-TR-70-43

**LONG-TERM STORABILITY
OF
PROPELLANT TANKAGE AND COMPONENTS
INTERIM REPORT #1**

R. B. MEARS, 1st LIEUTENANT, USAF

MAY 1970

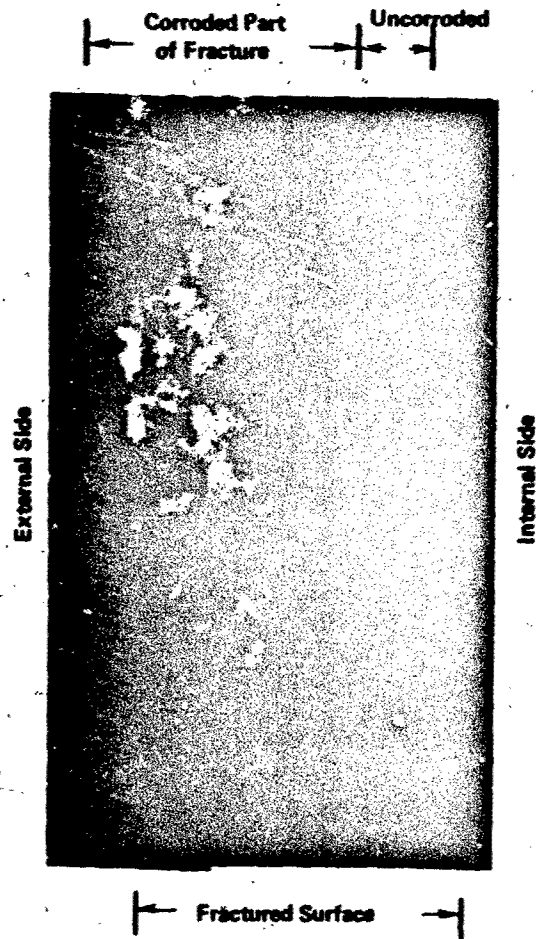
It is speculated that the corrosive environment which etched the surface of the tank was enough to have caused the stress corrosion cracking. The massive build-up of corrosion products seen in Fig. 1 and the exfoliation attack is attributed to the action of the acids formed by the hydrolysis mentioned above.

Figure 7. Edge View of Crack Through Thickness of Material Showing Corrosion Progressing from External (Left Side) to Internal (Right Side) Surface.

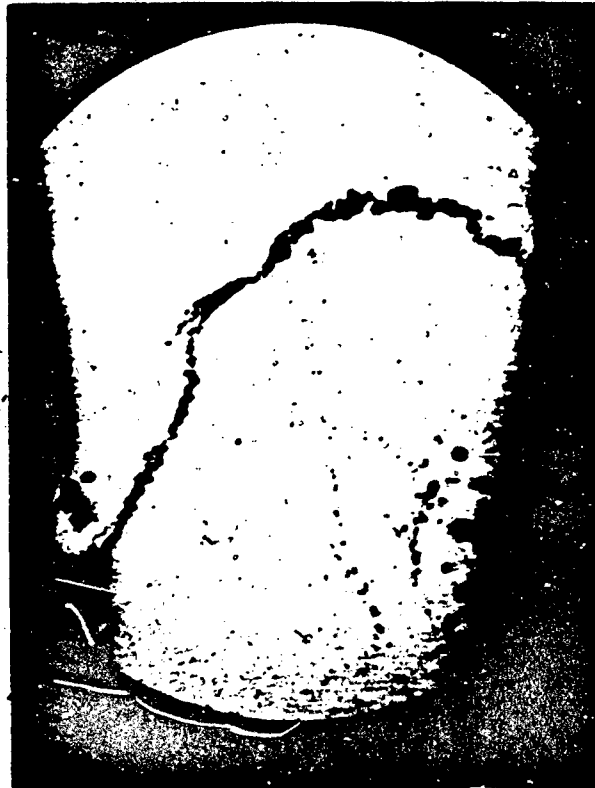
Figure 8. Stress Corrosion Crack of Primary Leak Area (ref Fig. 1).

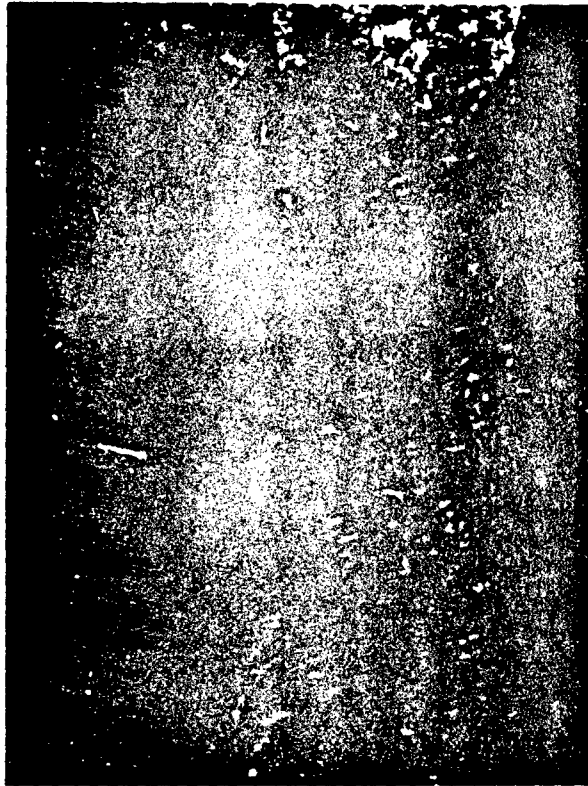
Figure 10. Exfoliation Corrosion
