SUBJECT: Operational Report - Lessons Learned, Headquarters, 84th Engineer Battalion, for Period Ending 30 April 1970

DEPARTMENT OF THE ARMY
HEADQUARTERS, 84TH ENGINEER BATTALION (CONSTRUCTION)
APO SAN FRANCISCO 96238

SUBJECT: Operational Report - Lessons Learned, 84th Engineer
Battalion (Construction), for the period ending 30 April 1970
RCS CSFOR-65 (R2)

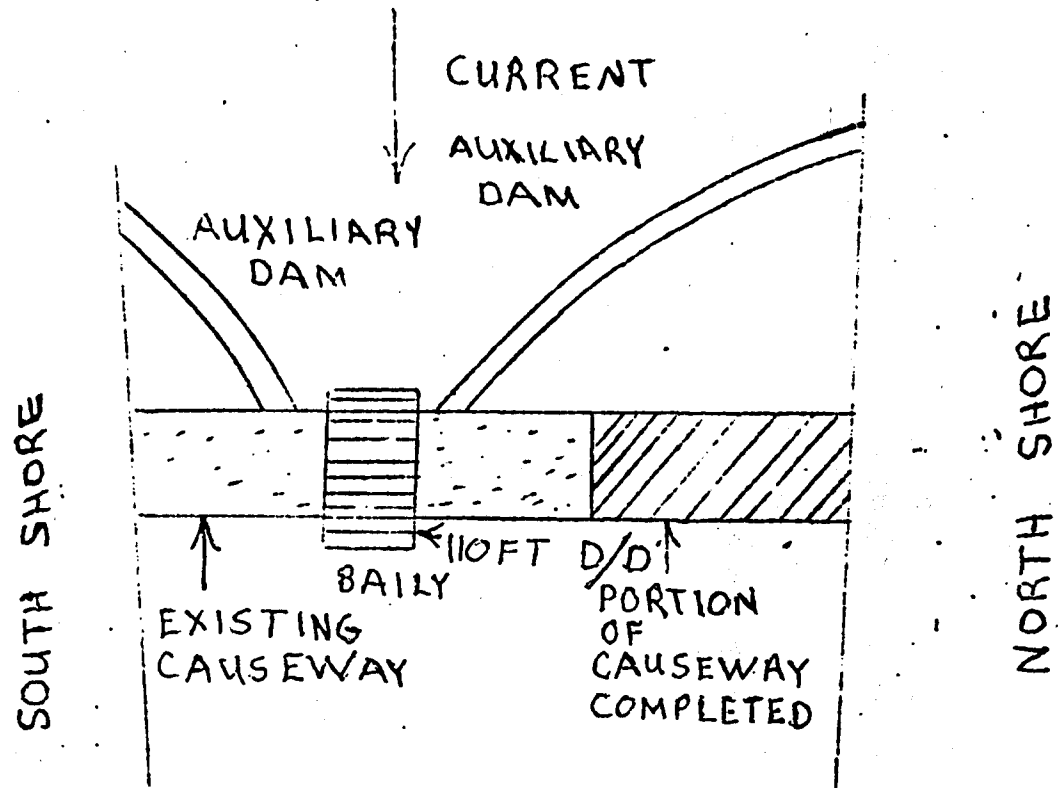
OBSERVATION: A causeway had been constructed 2/3 of the way across the Song Lai Giang River in Bong Son. This causeway was built to provide a working surface for construction tasks on the Bong Son Bridge. When the pile driving was nearly complete on the existing causeway, it was necessary to construct the remaining 1/3 of the causeway.

EVALUATION: Before constructing the final 1/3 of the causeway, a section in the middle of the existing causeway was removed and a 110 ft double bally was placed over the gap. This gap would take the full flow of the river when the causeway was completed. Earthmoving was begun for the final 1/3 of the causeway and it was observed that much of the fill put in the gap was washed away by the current. This increased as the causeway lengthened because the narrowing channel increased the speed of the flowing water.

CAUSEWAY
BONG SON BRIDGE

RECOMMENDATION: Before this became a major problem auxiliary dams were constructed by dozing sand from the river bed. One dam extended from a point upstream from the causeway on the north river bank to a point on the causeway near to and north of the bally bridge. The other dam extended from a point upstream from the causeway on the south river bank to a point on the causeway south of and near to the bally bridge. This is shown in the following diagram. These dams channeled the water into the gap which had been cut in the construction causeway. The final portion of the causeway was then easily completed.

b. Reference: Para 2(b)10. Causeway. A simpler method would be to add blast rock as a rip-rap at ends of the causeway adjacent to stream.
