Category II Propulsion
System Evaluation

TECHNICAL REPORT 100-1000

AUGUST 1971

This report presents the results of the UH-1N Category II propulsion system evaluation conducted at the Air Force Flight Test Center, Edwards AFB, California. A total of 6.4 hours of propulsion system evaluation time was spent on UH-1N S/N 69-6610, and 16.0 hours were spent on aircraft S/N 68-10776. This evaluation was a part of the Category II systems evaluation program which was initiated on 18 October 1970. The AFFTC was responsible for the conduct of the program under the jurisdiction of the UH-1N System Program Office (SPO), Wright-Patterson AFB, Ohio.

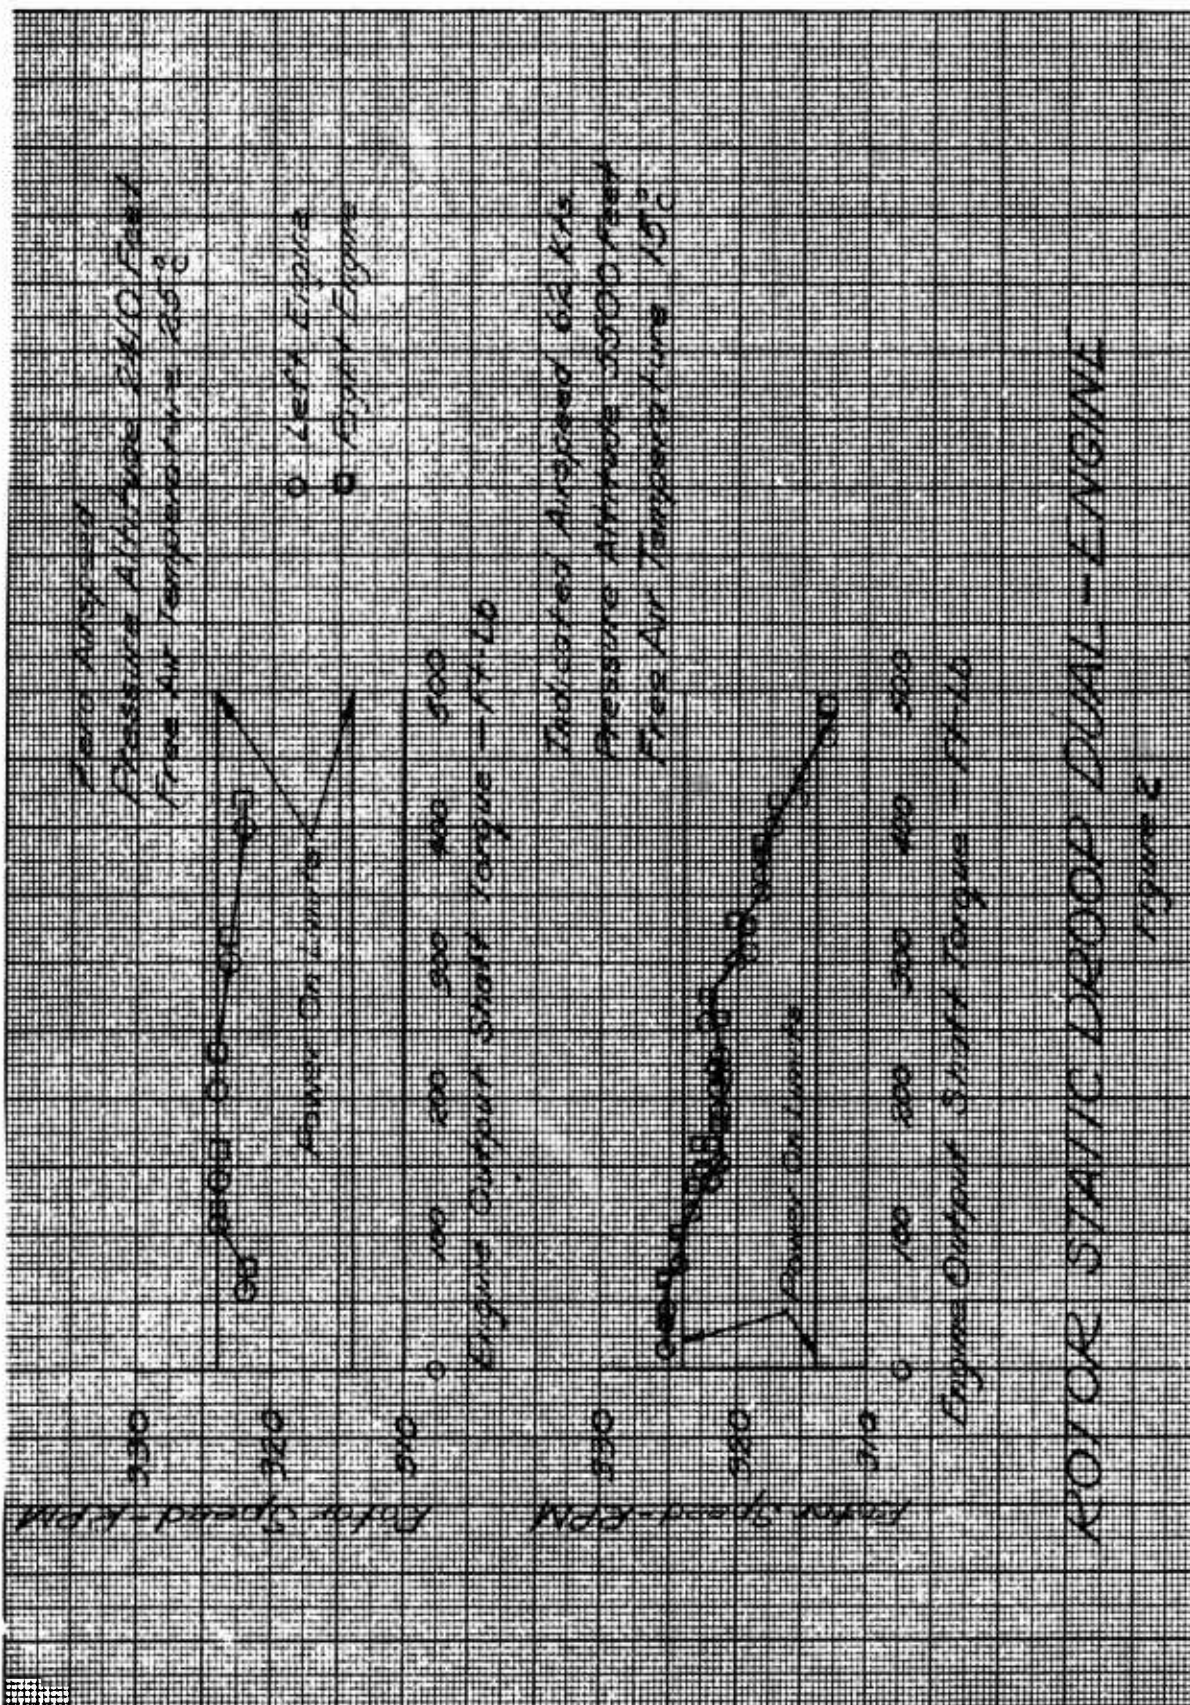
Figure 2

ROTOR STATIC DROOP DUAL-ENGINE

Dual engine static droop characteristics are shown in figure 2. During the ground run-up and takeoff, rotor speed stayed within two rpm without beep adjustment. Slight overcompensation occurred in the mid power range. This was a desirable feature because it helped to maintain a high rotor speed as a safety margin. At 5,000 feet PA, 62 KIAS, droop compensation was less ideal. Rotor speed gradually decayed with application of more power. Minimum rotor speed of 313 rpm was 1 rpm below minimum allowable power on limit of 314 rpm, but this was not considered significant. No hysteresis was apparent. Dual-engine static droop characteristics were considered acceptable.

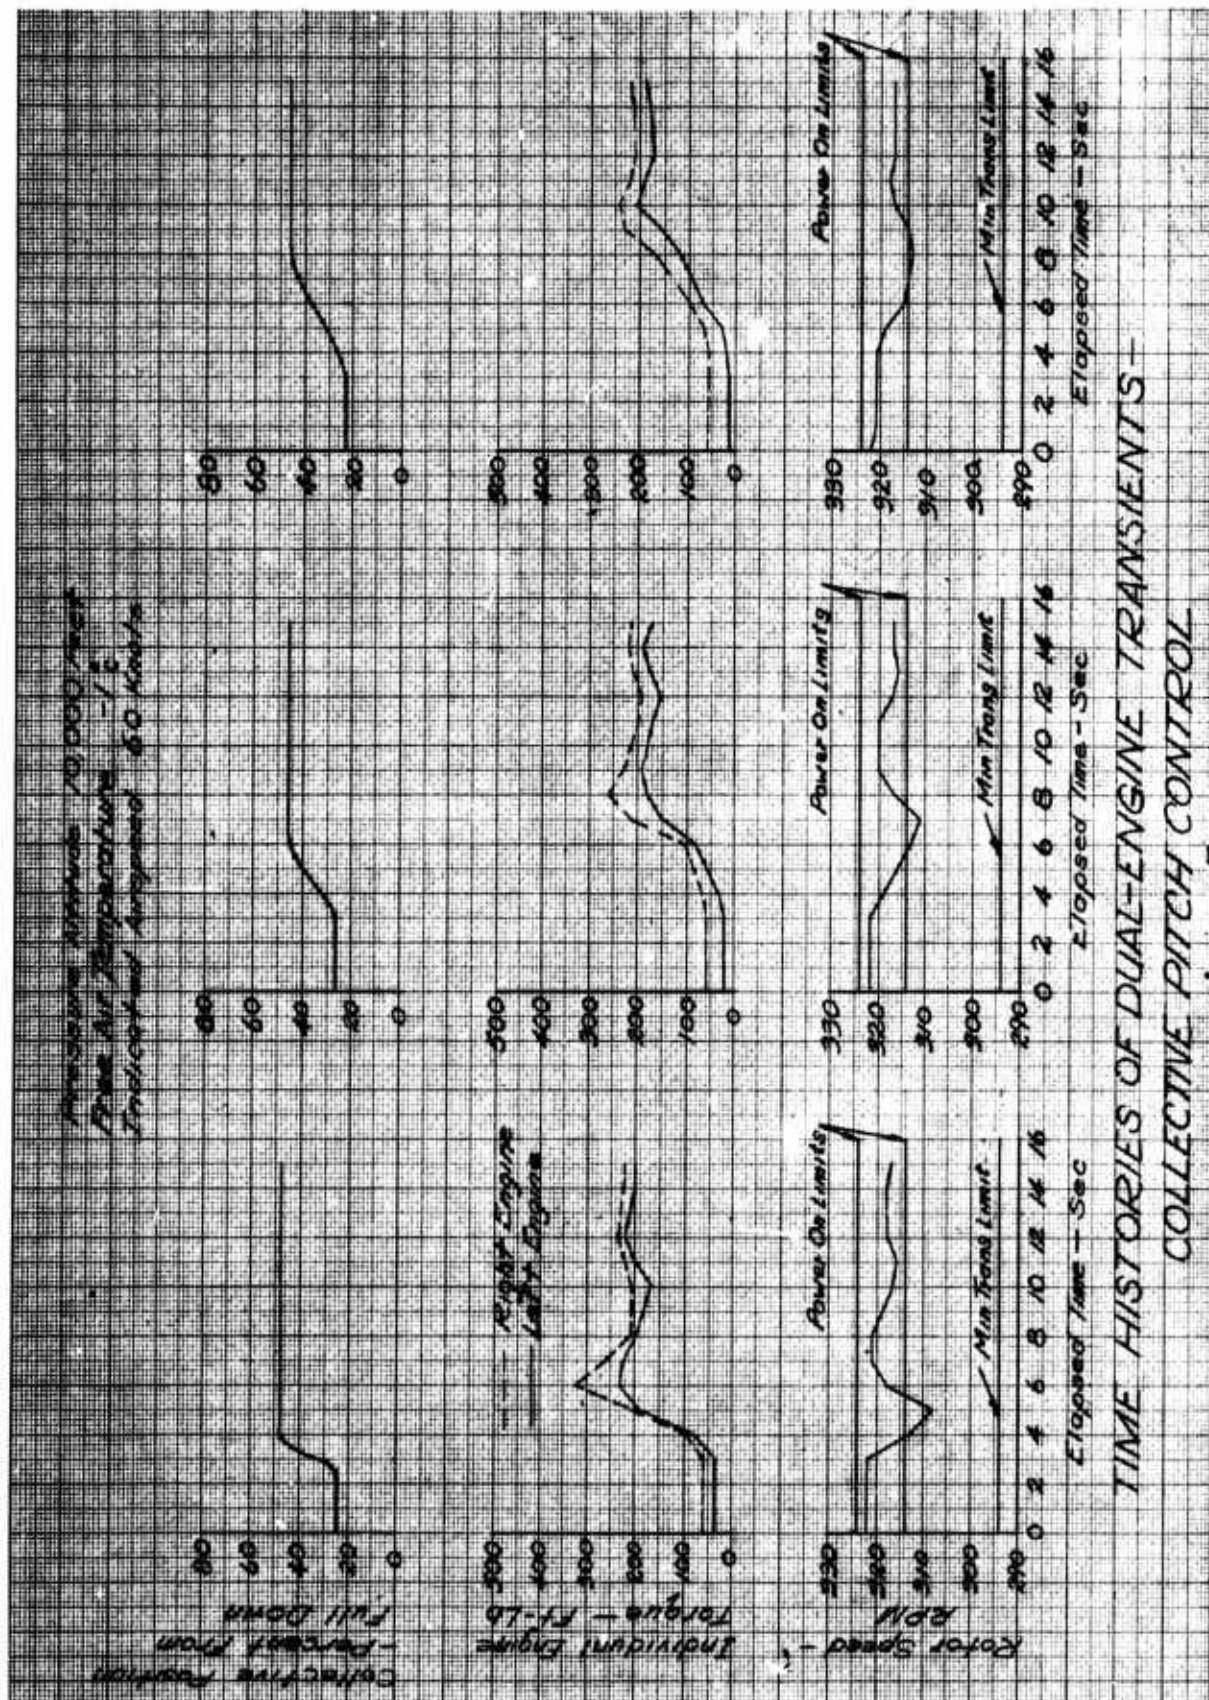
Figure 5

TIME HISTORIES OF DUAL-ENGINE TRANSIENTS —
COLLECTIVE PITCH CONTROL

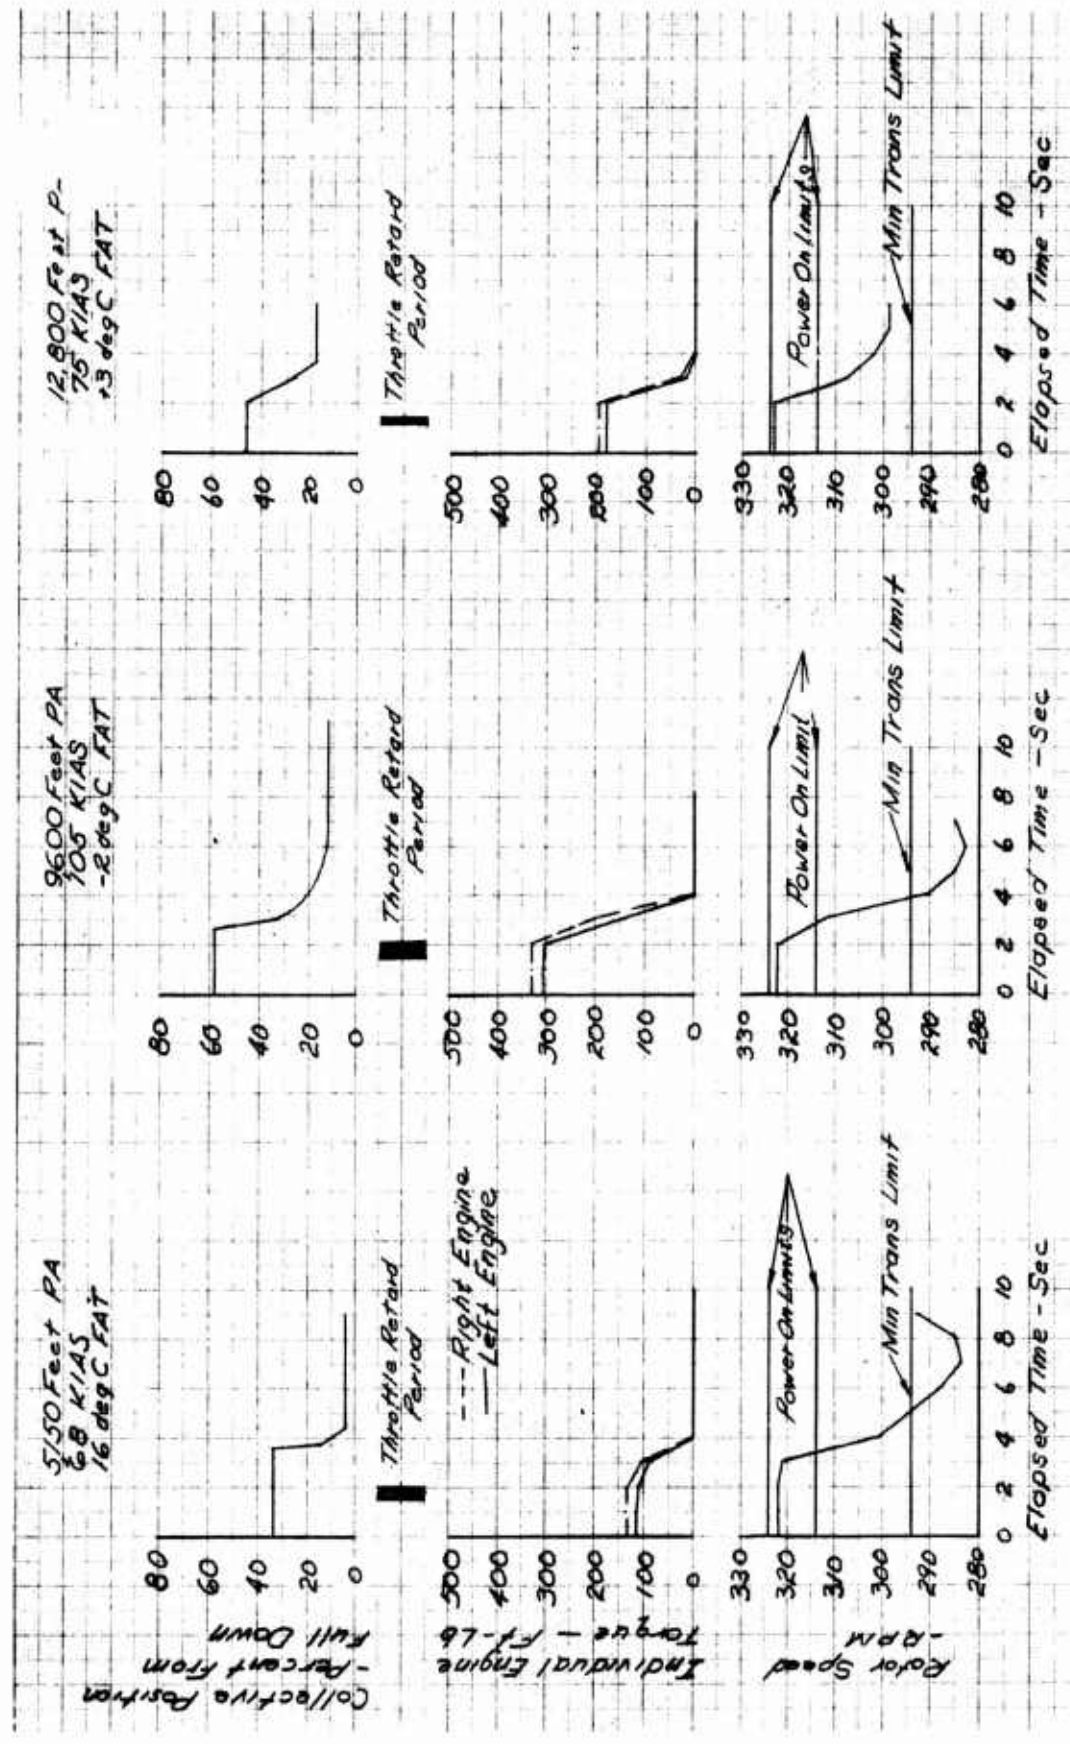
Figure 9 presents typical time histories of several of these tests. The primary characteristic of dual-engine throttle retardations was, as expected, rapid decay in rotor speed. Depending on pilot technique, the collective pitch control could be held at a fixed position for one-half to one and one-half seconds before rotor speed began to decay rapidly. Lowering of the collective pitch control was then mandatory to maintain rotor speed at a safe level. Some pilot anticipation was involved since the pilot knew he was going to lose power. Rotor speed decayed to less than the minimum allowable power-on transient limit of 294 rpm in less than 4 seconds.

No engine problems such as deceleration stalls, rpm hangups, or undershoot of engine parameters were experienced and no detrimental effects of these tests were noted. The effects of bleed air extraction were not detectable during these tests.

Rotor speed decay was considered typical of the H-1 model helicopter. A tendency for nosedown pitch was evident, but was easily corrected. Full control capability was maintained.

TIME HISTORIES OF DUAL-ENGINE TRANSIENTS - THROTTLE RETARDS
